3. The Existing Building

3.8 Roof top - analysis

3.9 Typical Floor - analysis

3.10 Summary

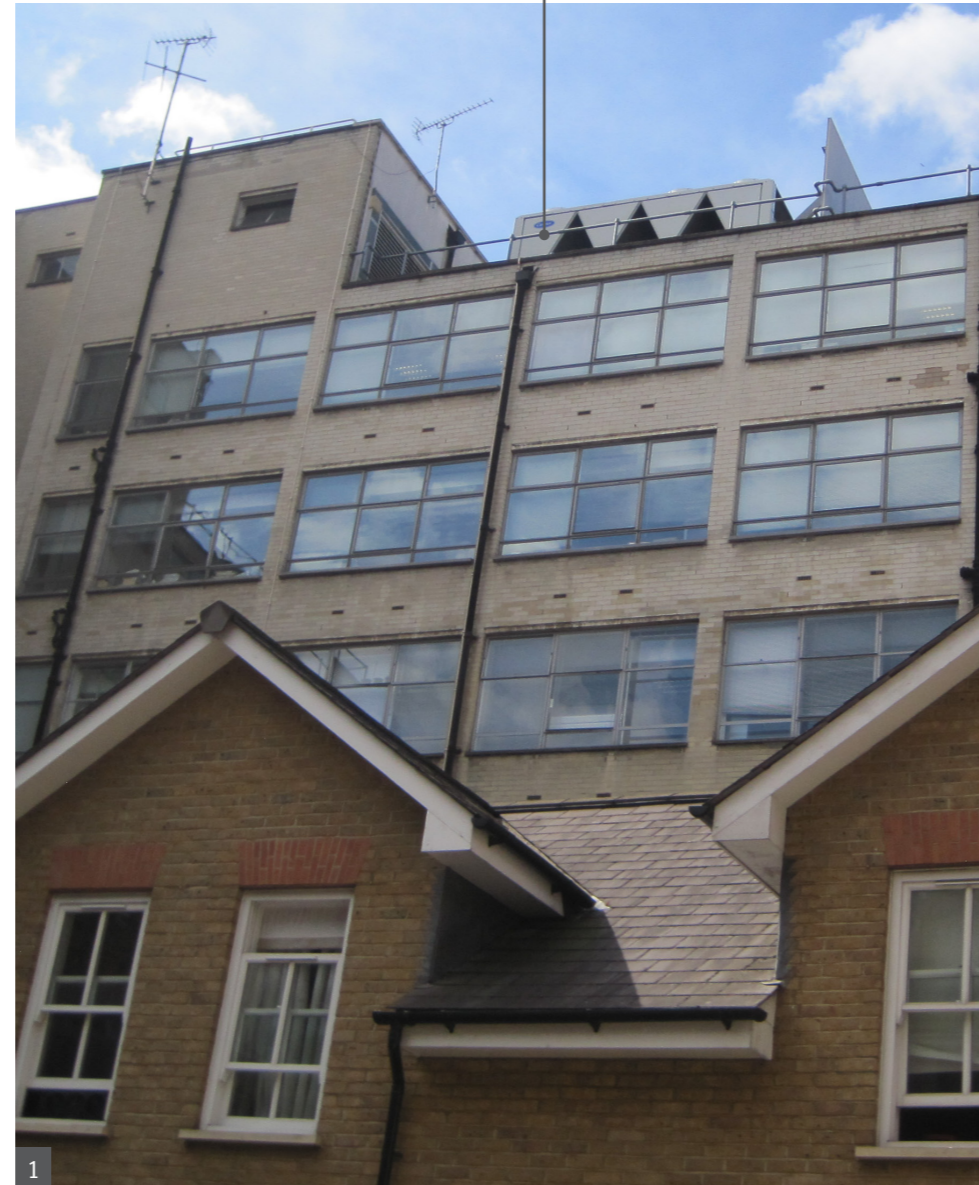
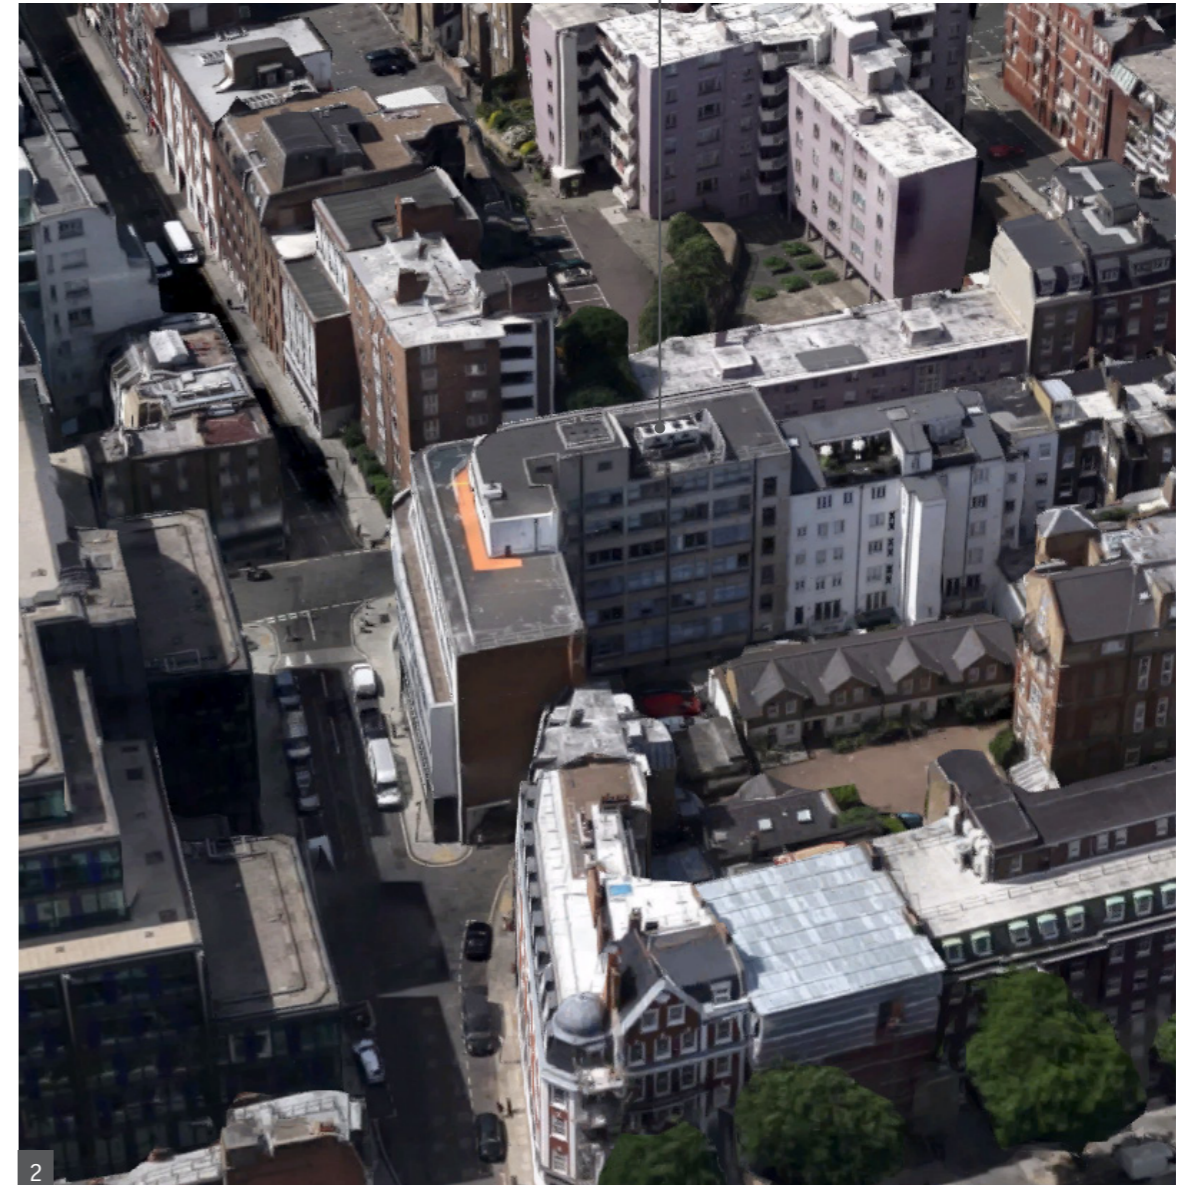
- The existing plant is split between the rooftop and the basement
- Air handling units have acoustic screens, but not to the rear

Roof top plant

- Roof areas are designed to accommodate a mechanical plant deck and plant zones.
- The principal elevations are a combination of through colour rendered brickwork with glazed aluminium framed stick curtain walling, and fixed decorative marble cladding panels at ground level. Rear elevations are formed in steel crittall type glazed curtain walling to the main stair core and aluminium frame single glazed units (with internal secondary glazing) all set within facing calcium silicate brickwork

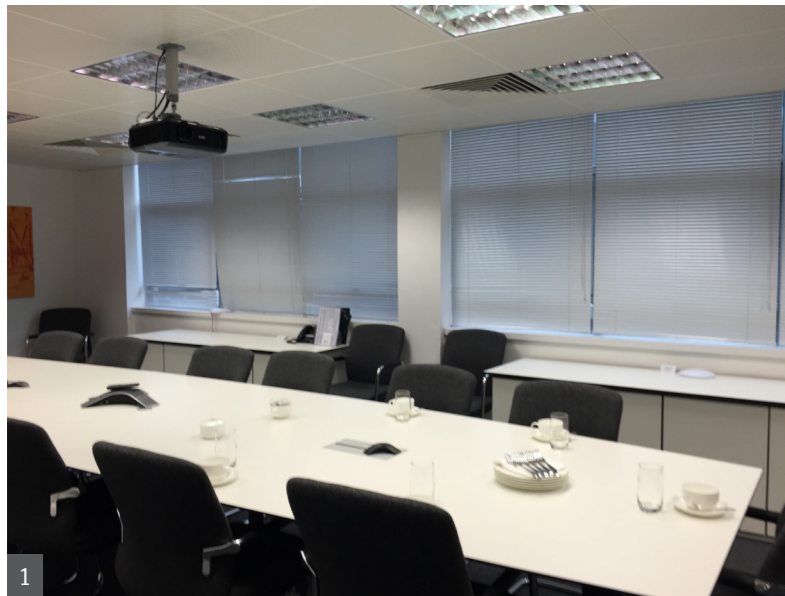
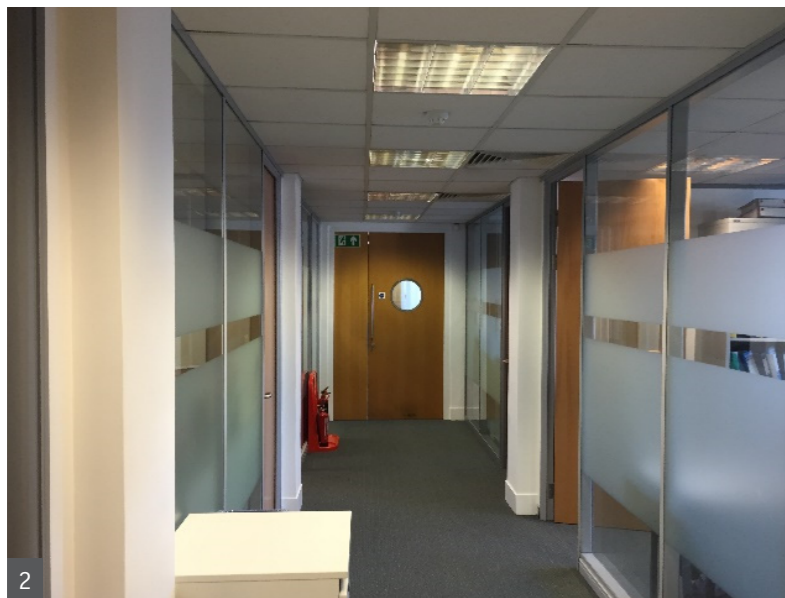
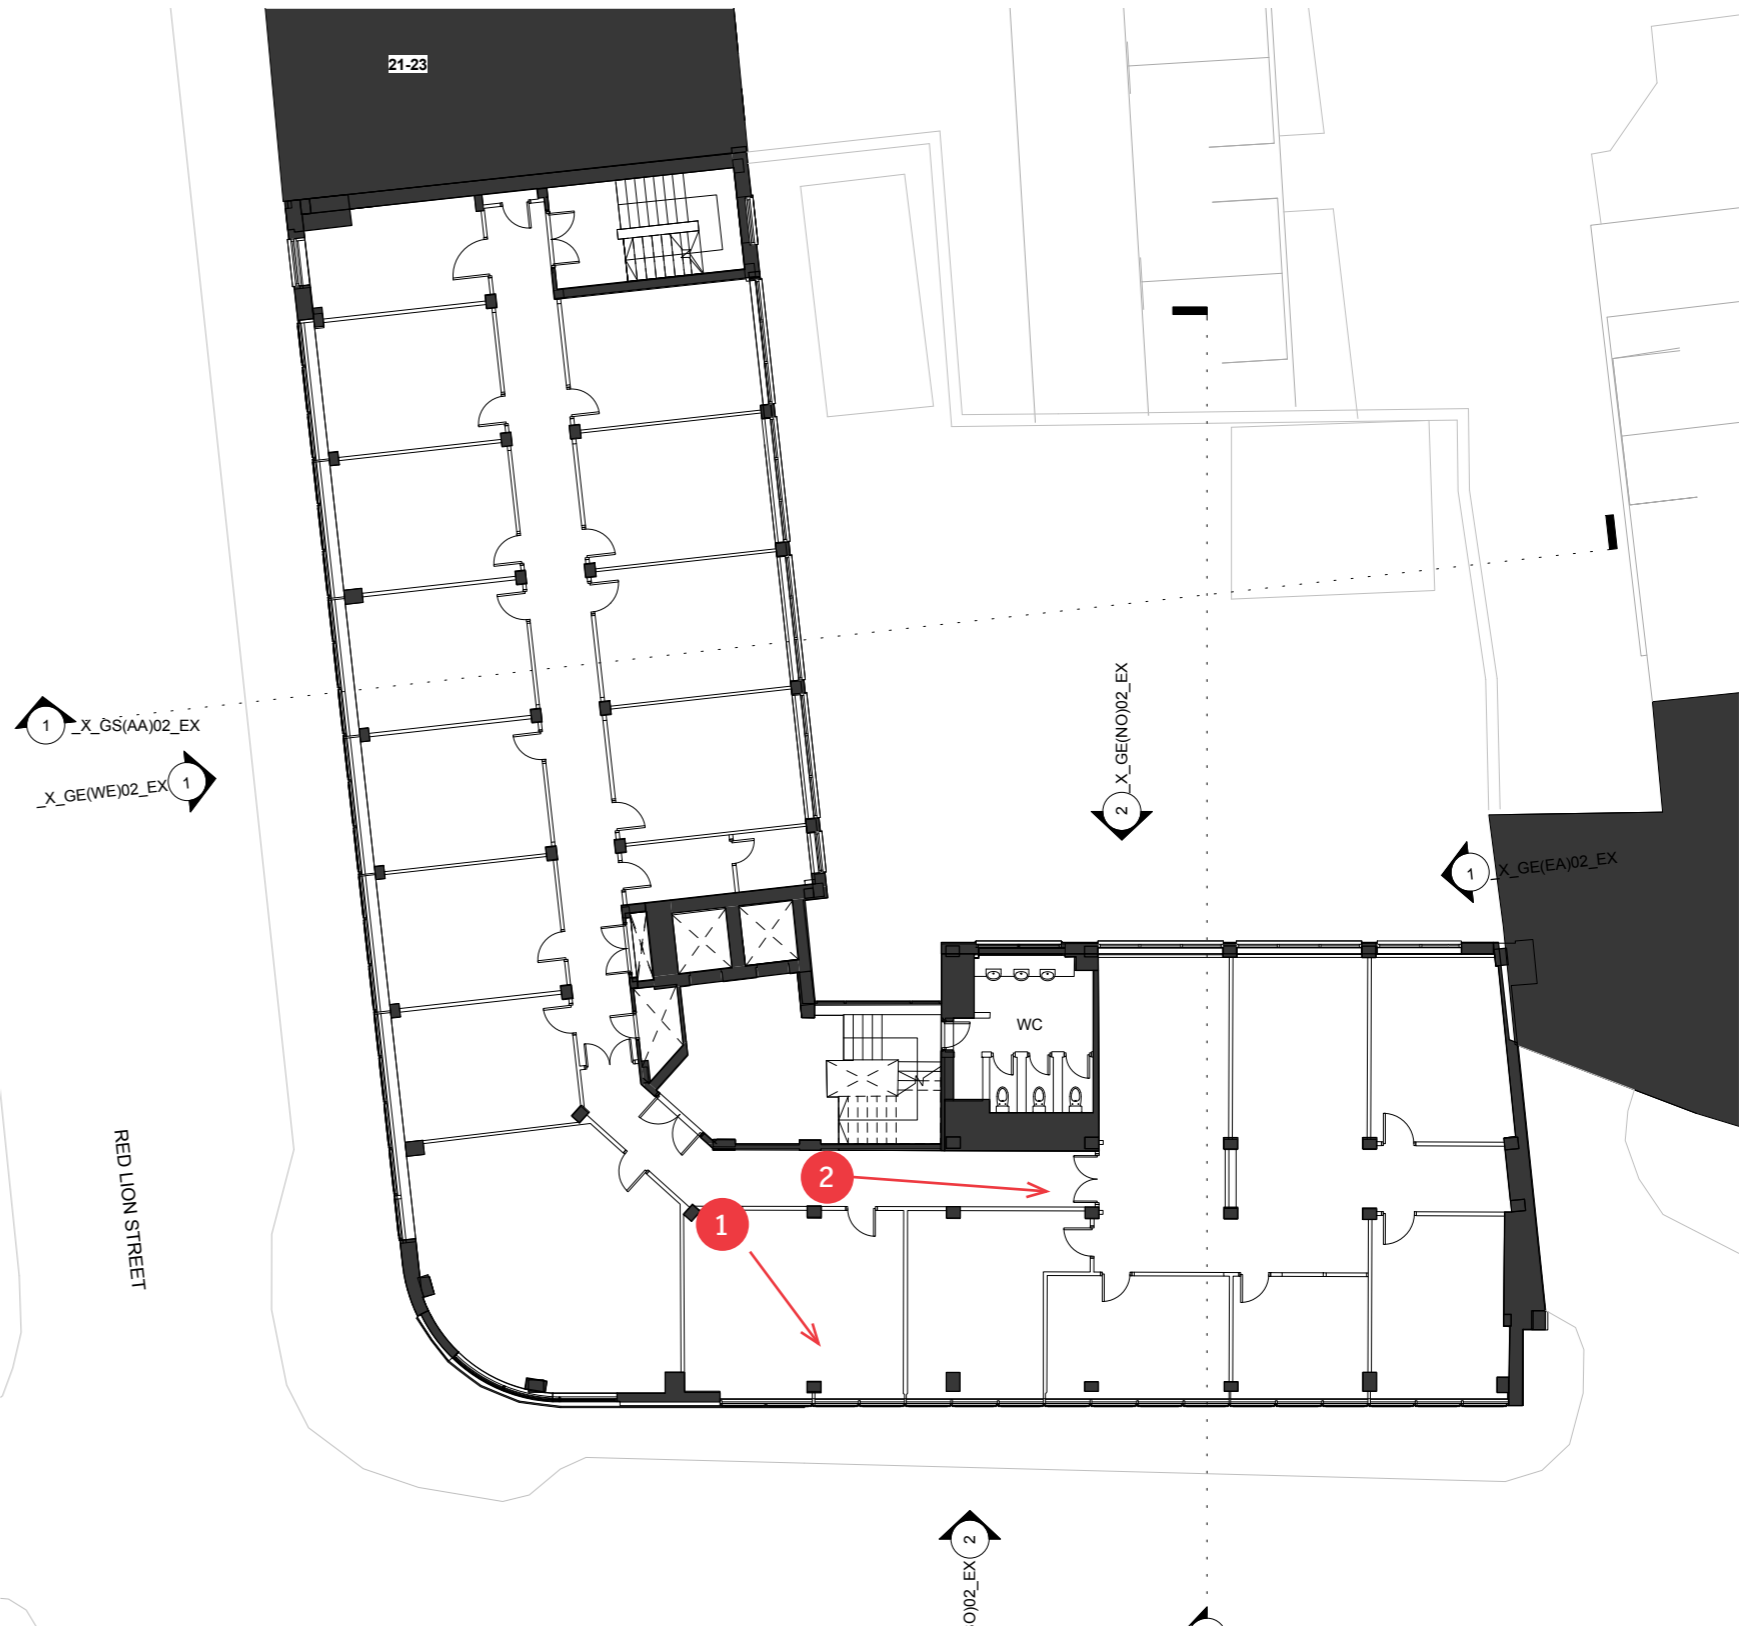
- The existing floors are uniform in appearance lacking character and diversity
- Toilet provision does not meet current guidelines
- Toilet cores accessed on the half landings
- Servicing does not allow for easy flexibility of subdivision
- Suspended ceiling reduce ceiling height and natural light

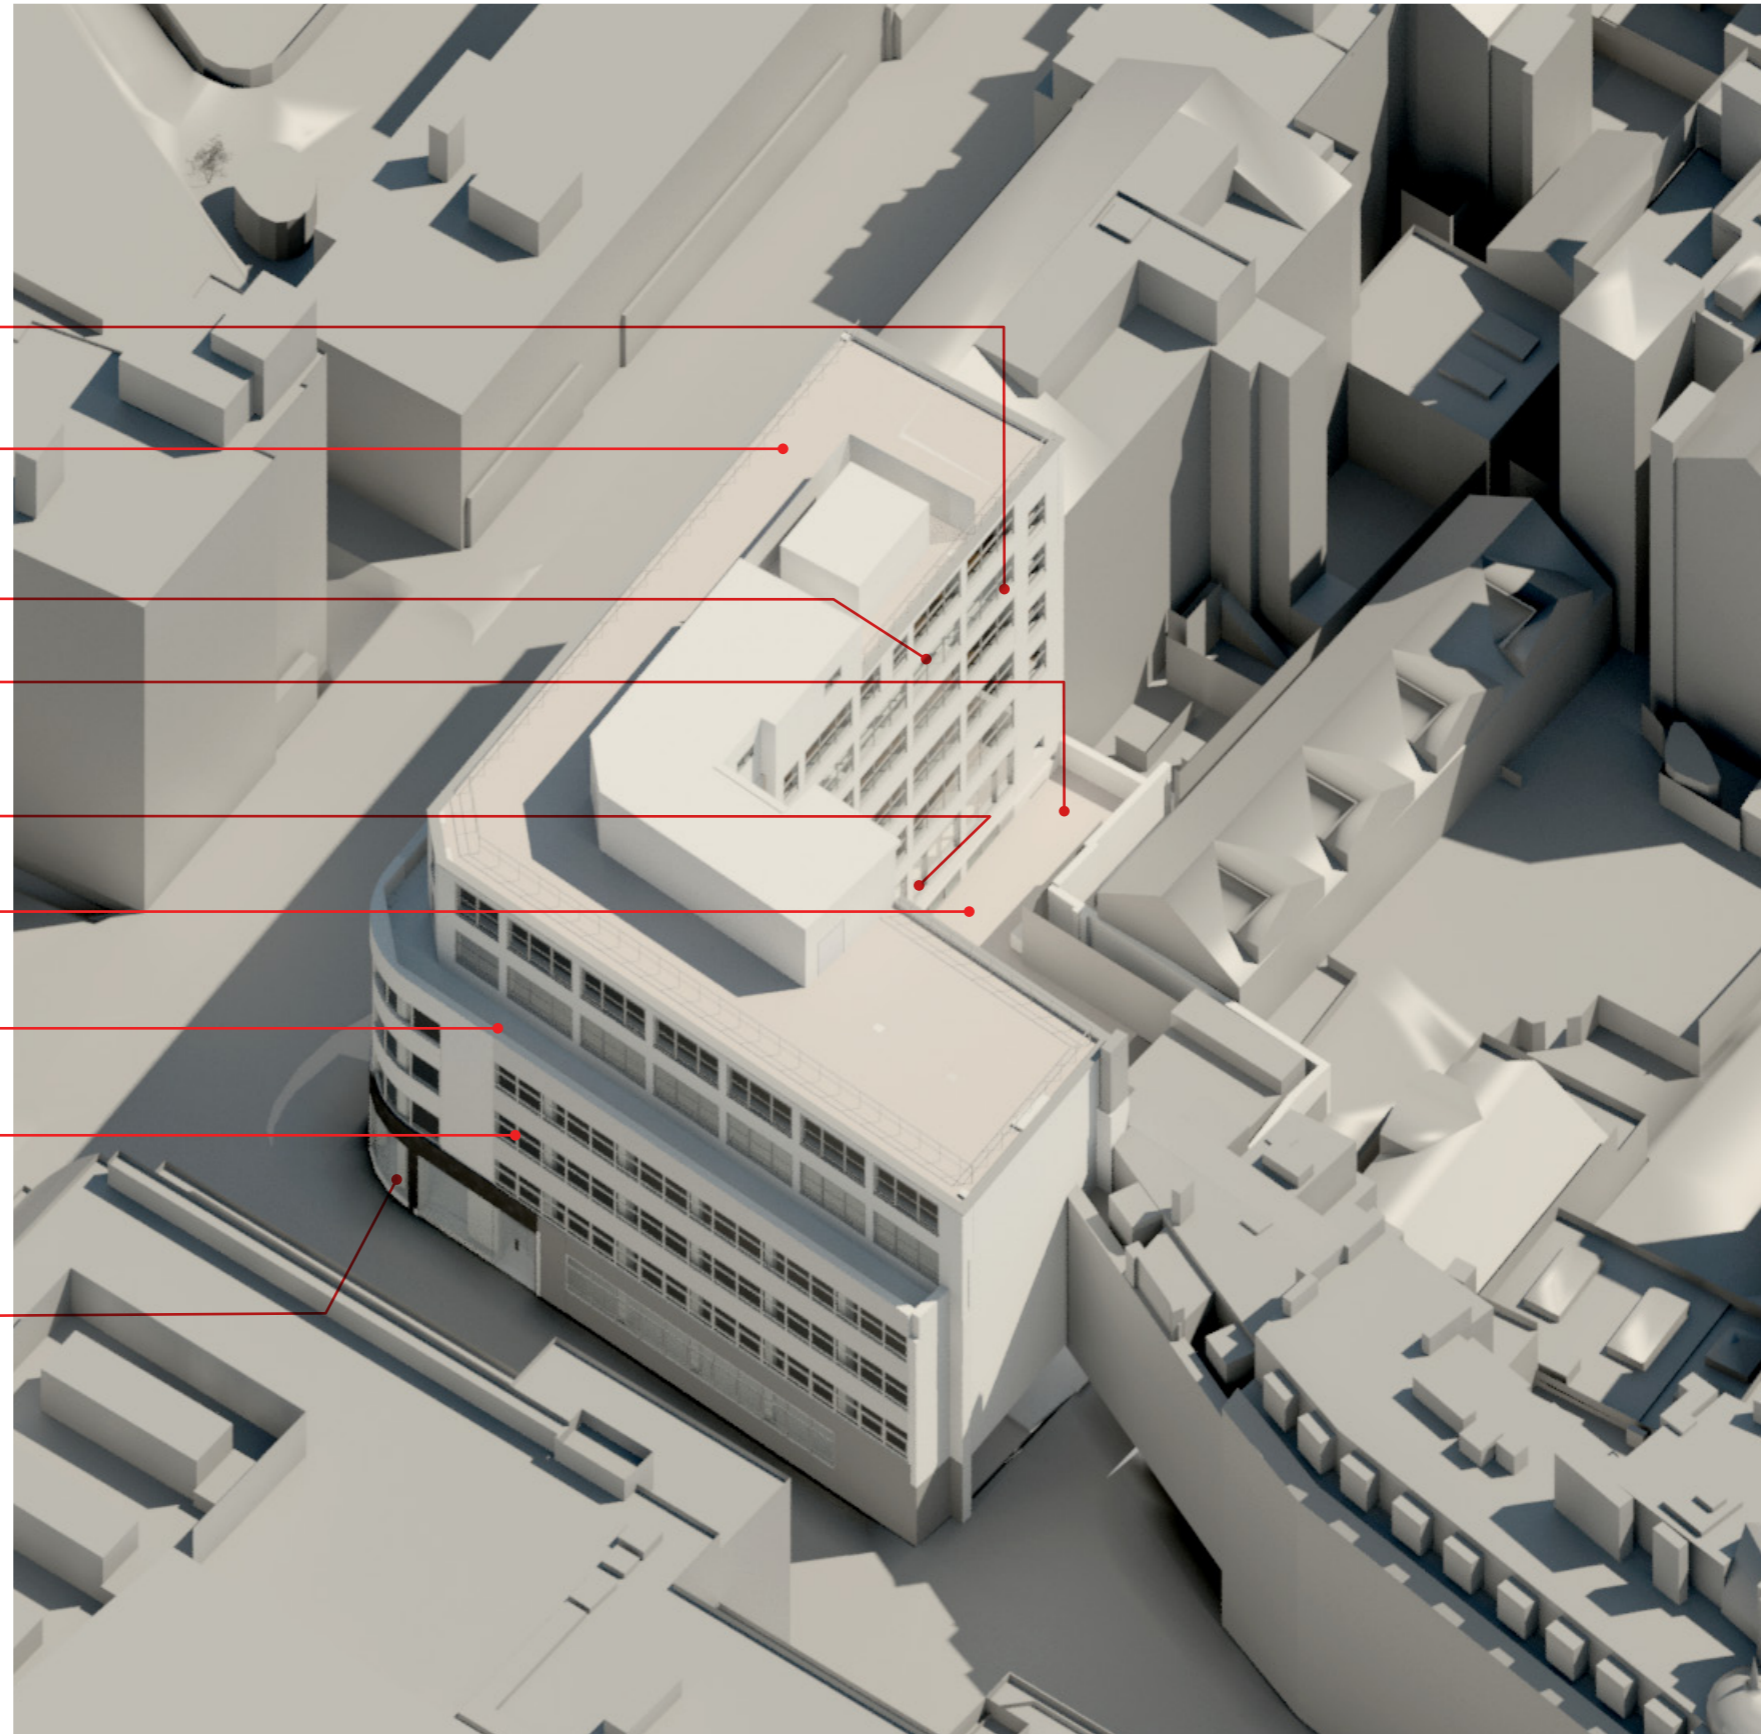
Extend the floorplate into the rear courtyard and maintain character and proportion

Add space whilst respecting the 'stepped' roof line

Replace the single glazed windows on rear facade with double glazed

Improve the cycle parking and facilities

Create a connection from the cycle park to the core

Create a terrace in the external space

Create terraces to the upper office floorplates

Create a modern work environment

Reinstate the corner entrance
