Note submitted in response to query from Camden Planners re choice of materials to clad dormer to flat 3 at no 28 Mansfield Road. Photographs show the existing context and the rear of properties to the east and the west, facing onto the interior of the block of housing bounded by Mansfield Road, Shirlock Road and Roderick Road

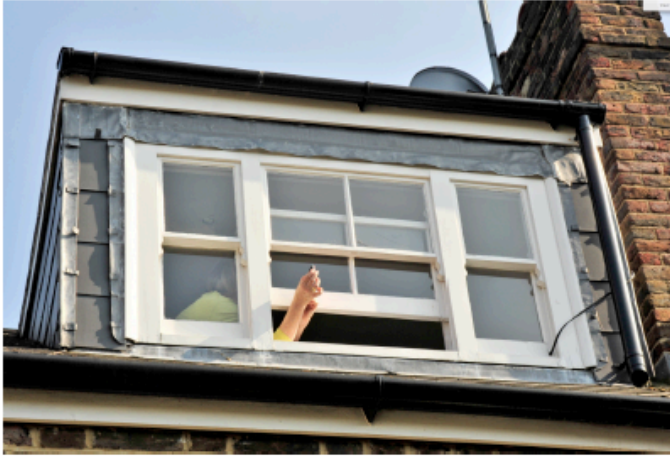
1 Existing dormer at 28 Mansfield Road, showing slate and clumpy lead detailing

In summary, the use of metal cladding to dormers is well established in this context. The use of slate on the vertical face looks relatively alien, and is possibly because it is not a very traditional use for slate in a dormer addition. Making the cladding out of metal more clearly articulates the dormer as a separate, additional element to the roof. Using a quality material in this location should also reduce the need for expensive access in the future.

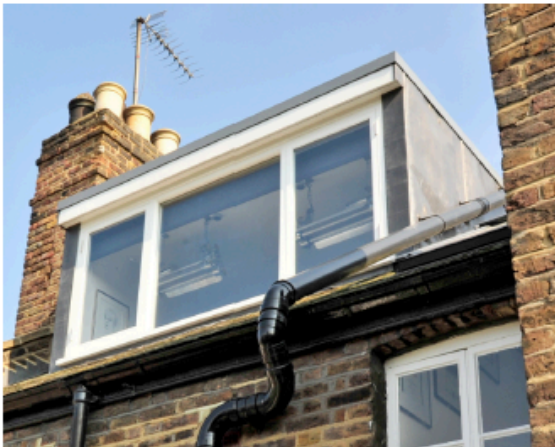
2 Dormer immediately next door, to the east, with crisp metal cladding

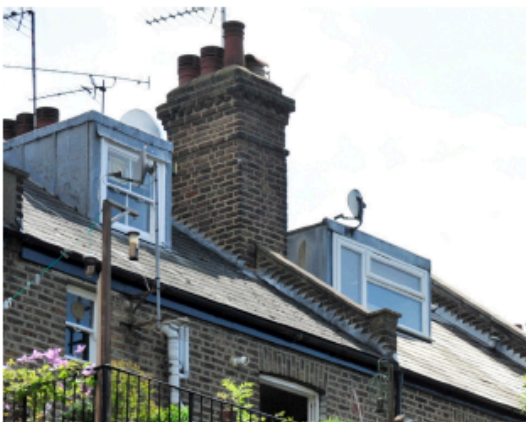
3 Other metal clad dormers to properties to the west on Mansfield Street

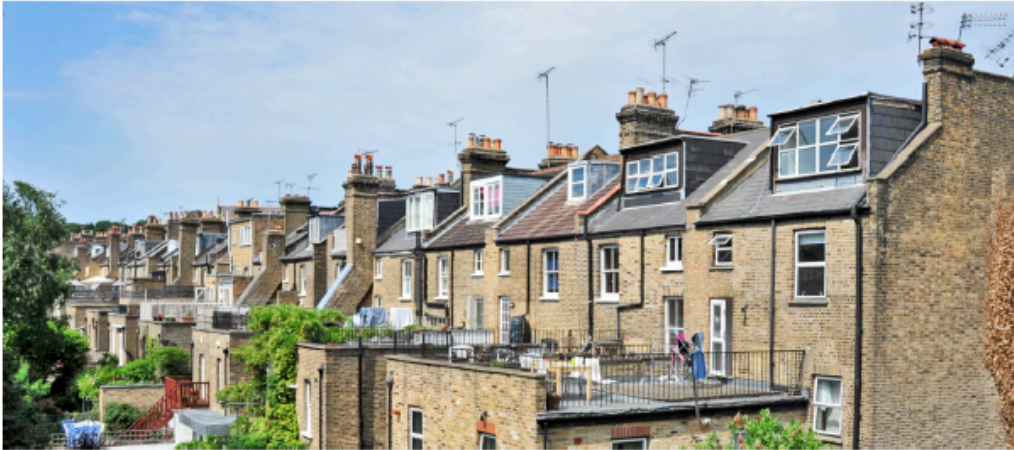
- 4 Rear of properties on Shirlock Rd, showing mixture of cladding to dormer windows. Horizontal lines of slate clad dormer in foreground looks incongruous

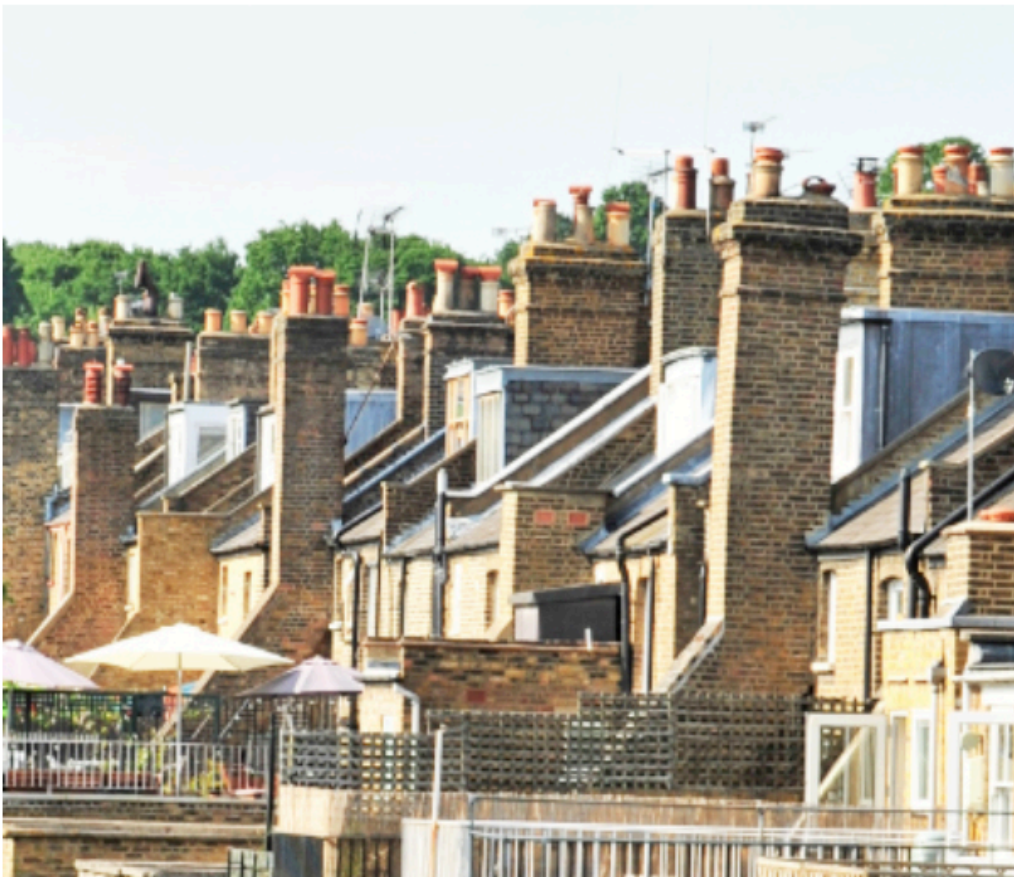
- 5 Enlargement of above photo showing one slate clad dormer (centre of photograph) which looks odd in context with other metal clad dormers

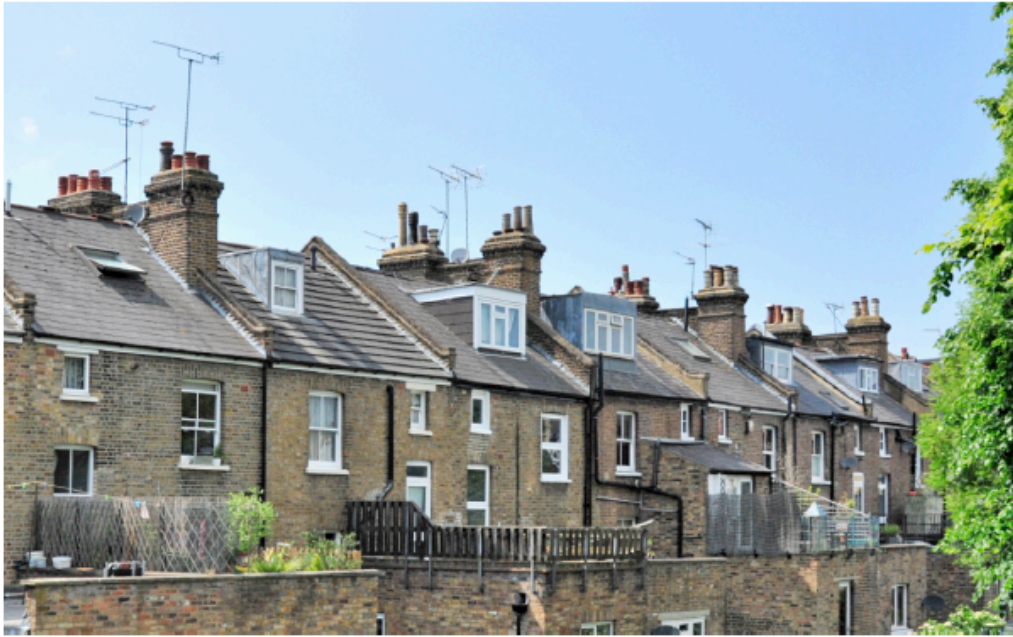
6 Dormers to rear of Roderick Road

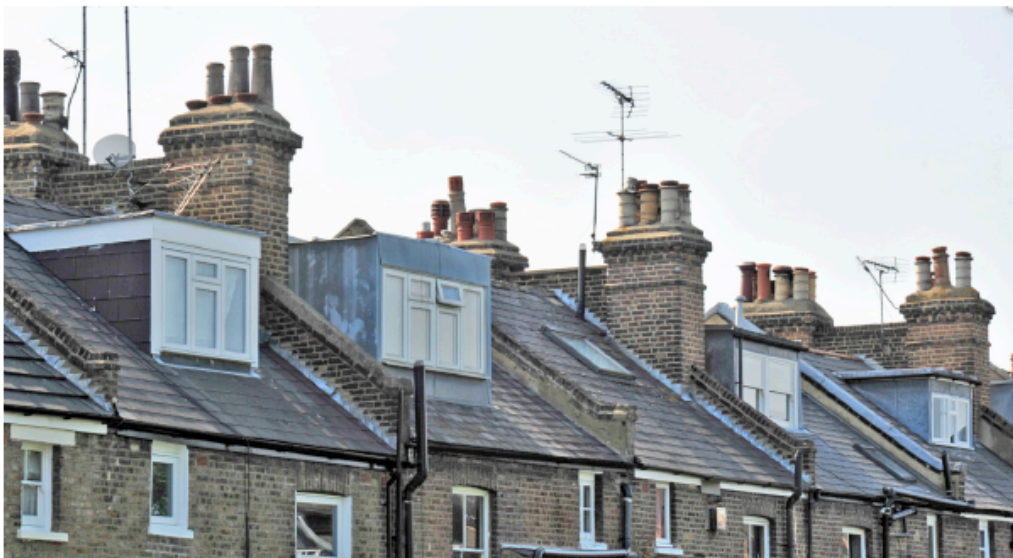
7 Enlargement of above, showing majority of metal clad dormers and rather suburban looking slate tiled dormer in foreground
