*Lord Cameron Hall (1935)*

### 3.2 Listed Buildings- within and outside the application site boundary

#### Kidderpore Hall (1843- Grade II listed)

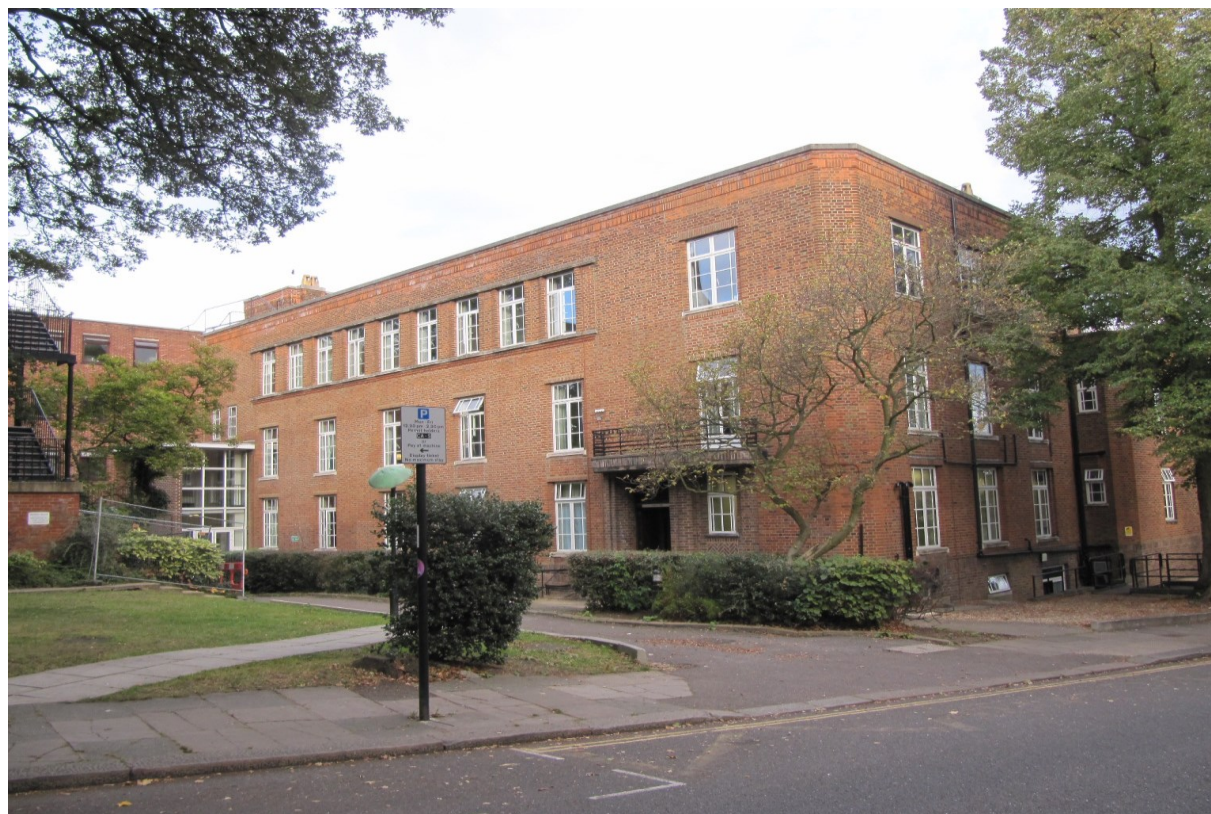
**Figure 40** A photograph of the west and south elevations to Kidderpore Avenue

- 3.42 The west elevation encloses the space to the east of Dudin Brown Hall and is of simple design, with the only relieving features being the rectangular windows which are recessed and have brick soldier courses. These windows have been replaced by casement windows of recent date.

- 3.43 The south elevation of the building to Kidderpore Avenue is awkward and badly proportioned. The building was evidently not designed with an awareness of this view from the south. The form and fenestration of this two storey section disrupts the composition of the three storey main building when seen from Kidderpore Avenue.

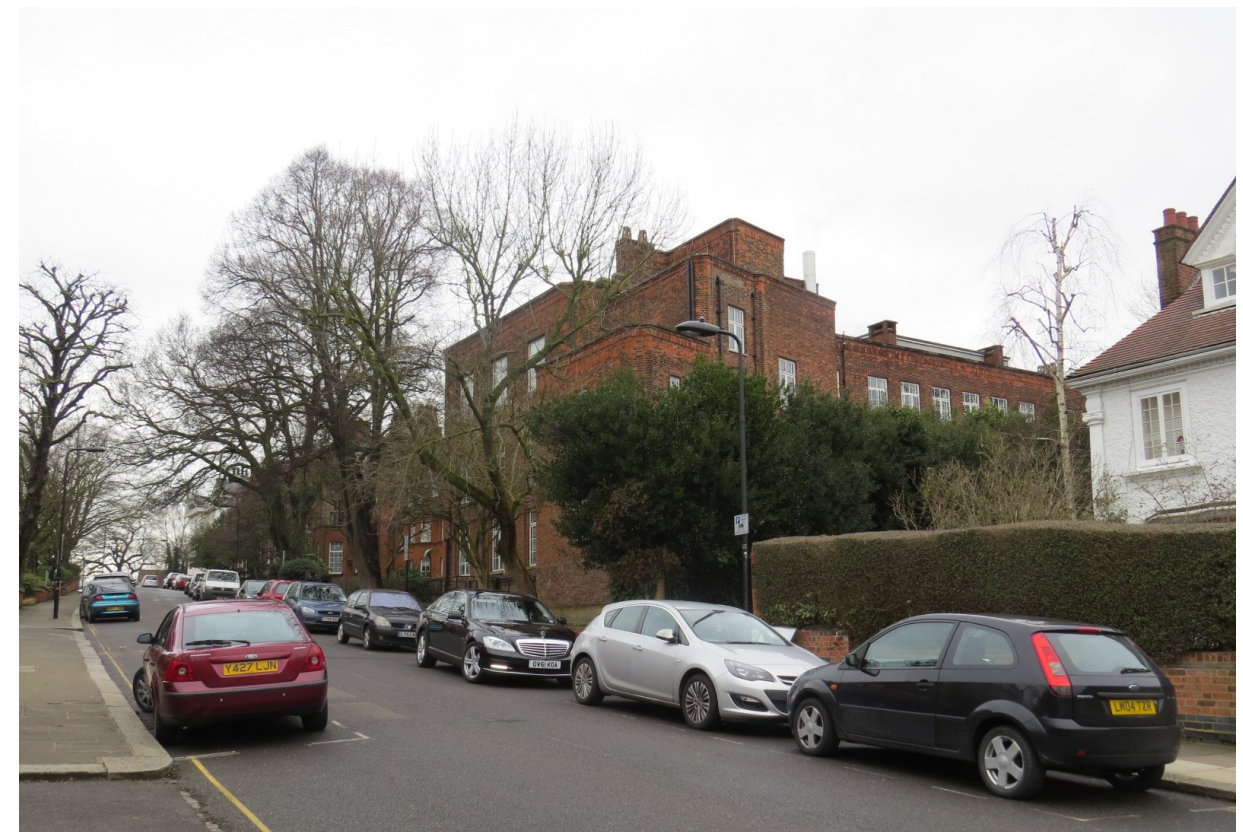
Figure 43 A photograph of Lord Cameron Hall as seen from the south of Kidderpore Avenue looking north.

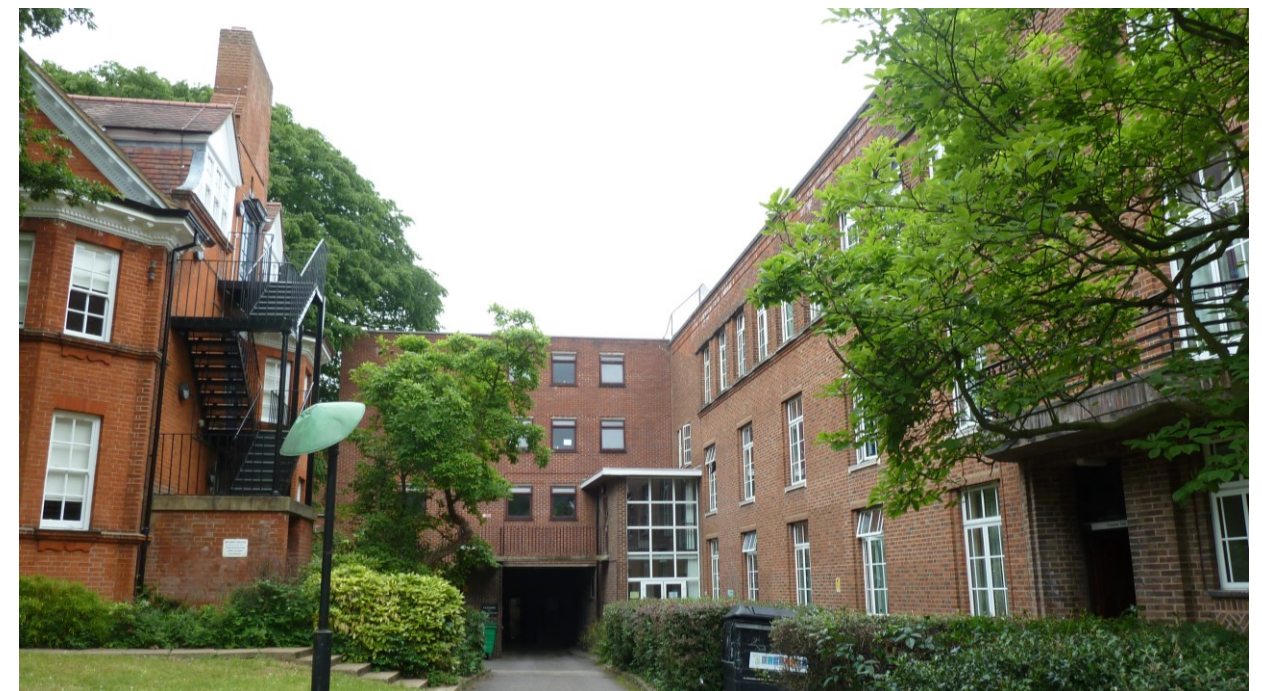
**Figure 45** A view into the site from Kidderpore Avenue, showing the vehicular access into the basement parking level beneath Rosalind Franklin Hall.

- 3.52 The south elevation as seen from Kidderpore Avenue incorporates a vehicular access way. This is a dark and uninviting space which detracts from the composition of this elevation. The appearance of the west elevation in particular as seen from within the eastern quadrangle is repetitive and lacks variety in the fenestration pattern or style on any of the elevations.

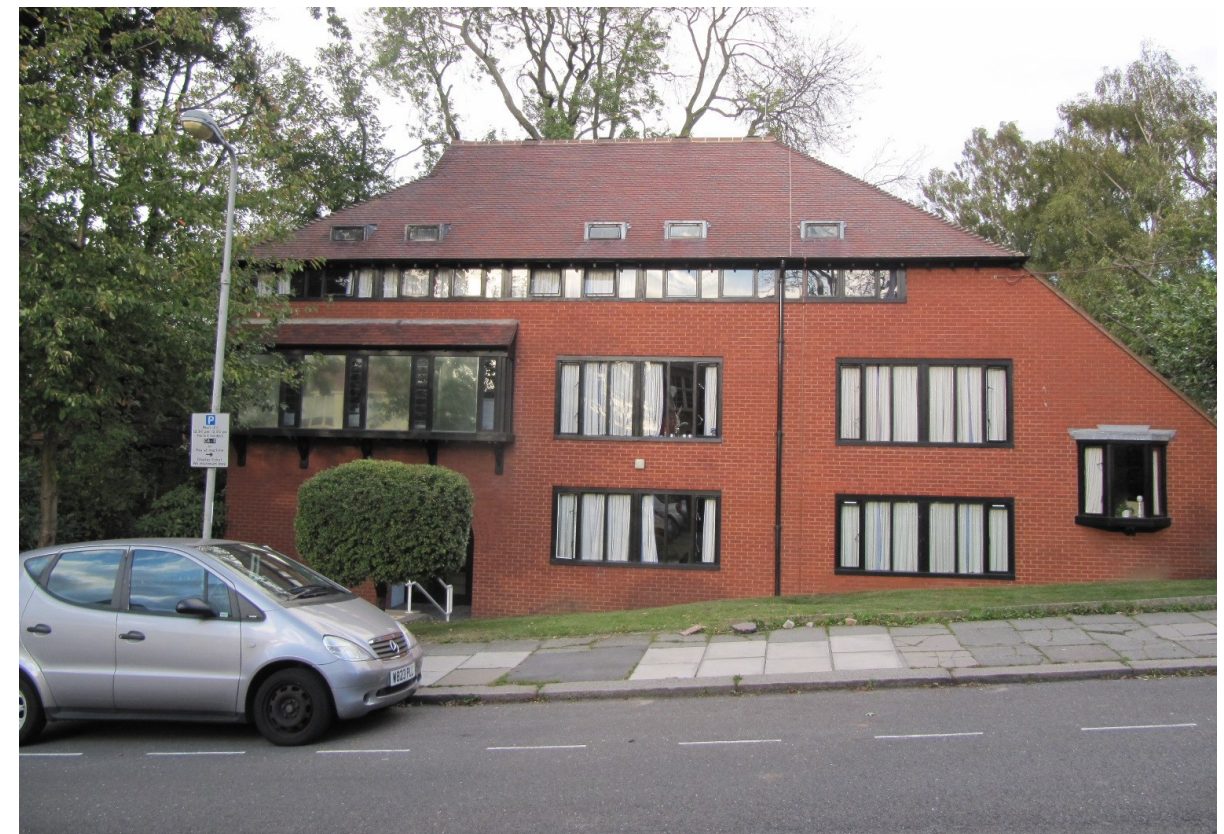
**Figure 46** An image of Queen Mother's Hall as seen from Kidderpore Avenue, current date.

- 3.57 A comparison of this photograph and that of the existing appearance of the building, shown in Figure 46, make it clear that little has been done to the exterior of the building which has altered its appearance since 1982. The building was refurbished in 2010 for continued use as student accommodation.

- 3.59 The building itself is not of architectural quality or high quality materials. The photograph included at Figure 46 shows the principal elevation to Kidderpore Avenue. The detailed design of this building, in terms of the architectural style, fenestration detail and profile; the roof form, and refined materials, do not reflect those of the prevailing characteristics of the Conservation Area.

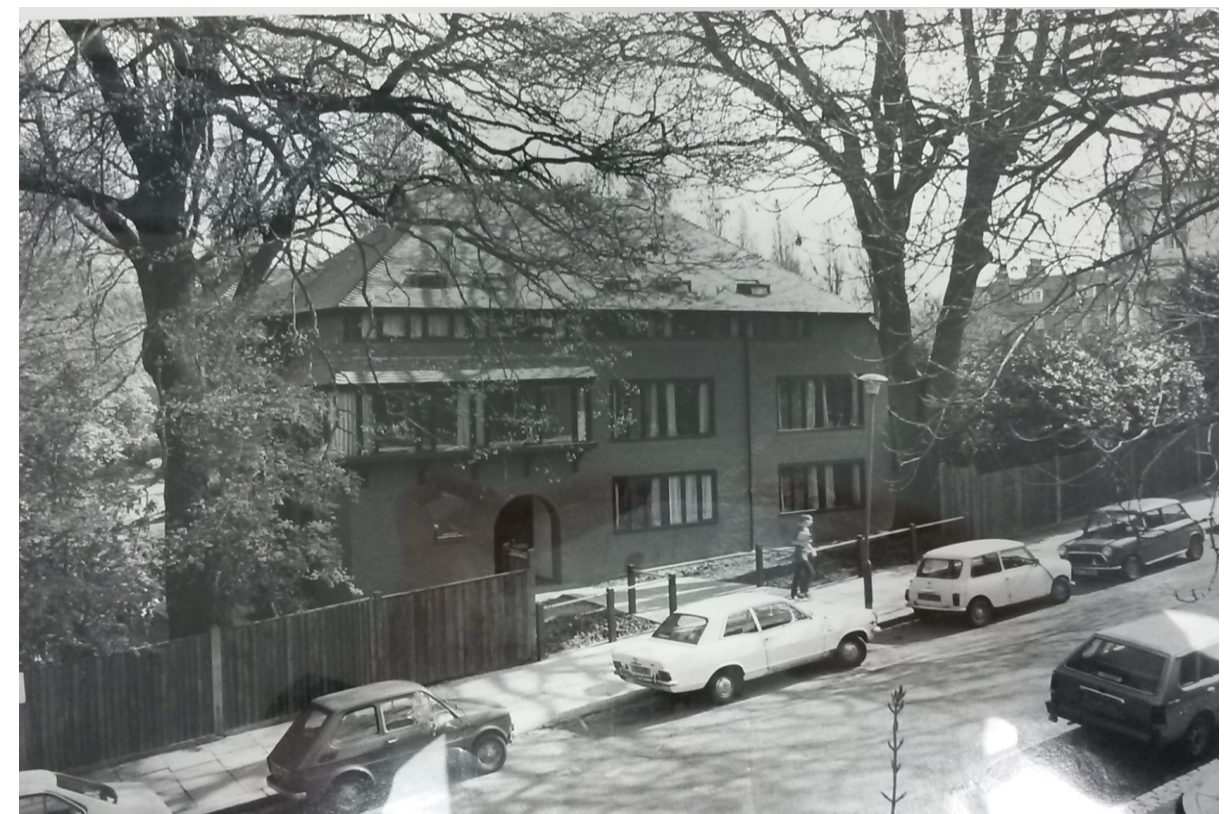
**Figure 47** A photograph of Queen Mother's Hall as seen from Kidderpore Avenue in 1982.

- 3.56 Completed in 1982 to provide student residential accommodation, Queen Mother's Hall was built following a grant of planning permission in July 1981 for residential accommodation to comprise a building of twenty four single study bedrooms and a common room. A photograph of the newly completed Queen Mother's Hall can be seen in Figure 47.

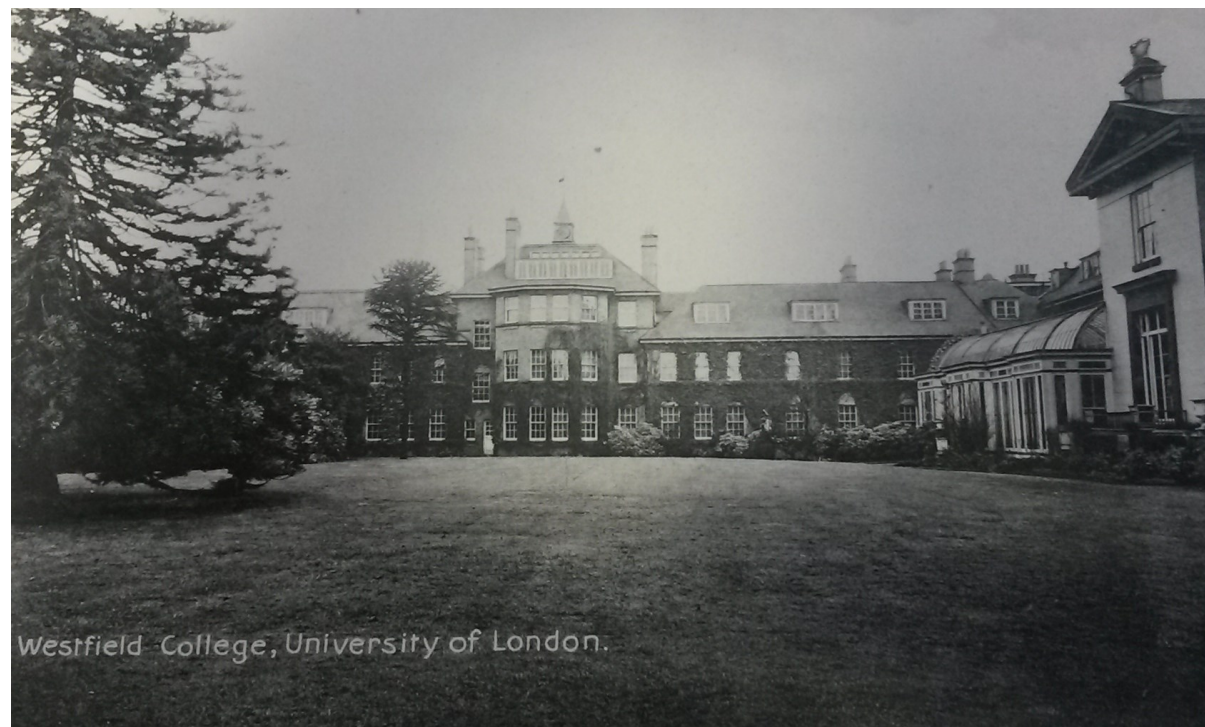
**Figure 50** An image on a postcard c. 1905 of the lawn outside Kidderpore Hall prior to the demolition of the conservatory and its replacement with the 'Bay'.

- 3.68 A *'handsome conservatory'* is also noted within the sale particulars, and the photograph at Figure 50 provide evidence for this conservatory which previously existed connected to the southeast of the Hall and which was demolished at a point in the early twentieth century, this part of the site then being re-used for the 1921 extension known as 'Bay House.'

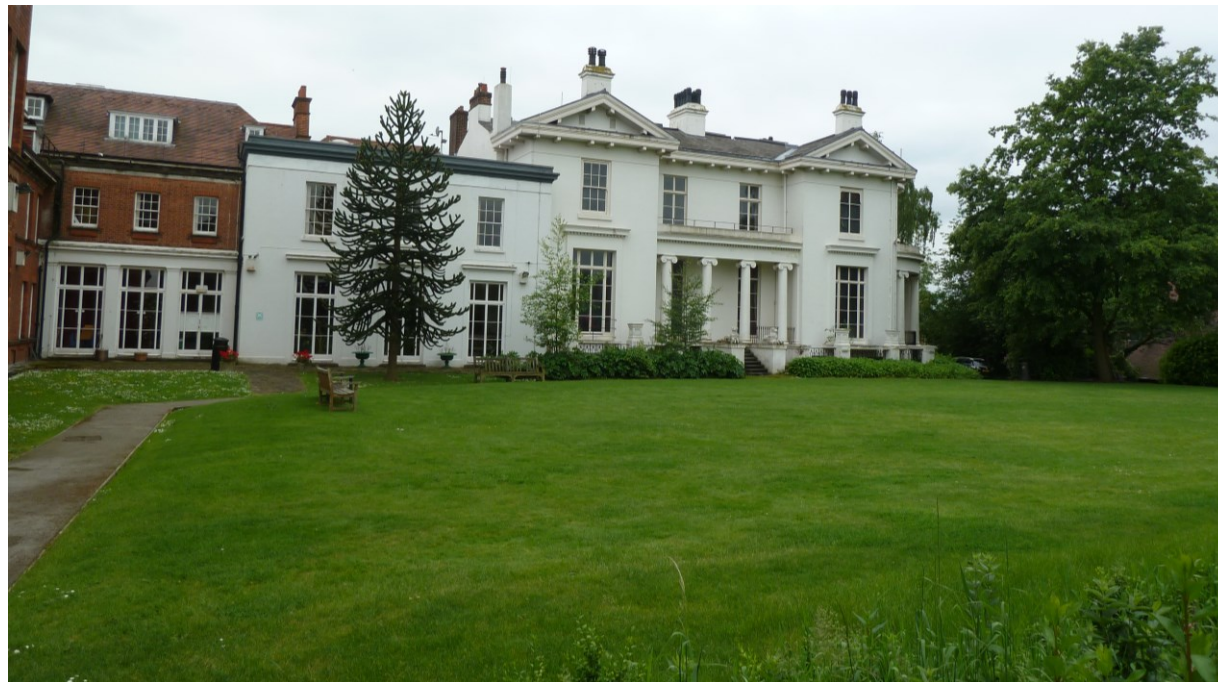
**Figure 53.** The rear elevation of Kidderpore Hall taken from a location near to the north boundary of the application site, with the Maynard Wing located to the left of this view. The 1921 Bay House extension which was built to replace the former conservatory can be seen to the left of Kidderpore Hall.

- 3.73 Now, the D shaped lawn is the only remaining part of the original pleasure garden laid out with the house in the 1840s, and the green bank to the west of Kidderpore Hall marks the original division between the pleasure garden and the wider grounds which have now been built upon. This green bank does not retain a meaningful relationship with the Hall or contribute to the significance of the listed building. The reservoir and the tennis courts continue to occupy parts of the original garden to Kidderpore Hall to the north. This greened bank can be seen in the photograph included at Figure 53.

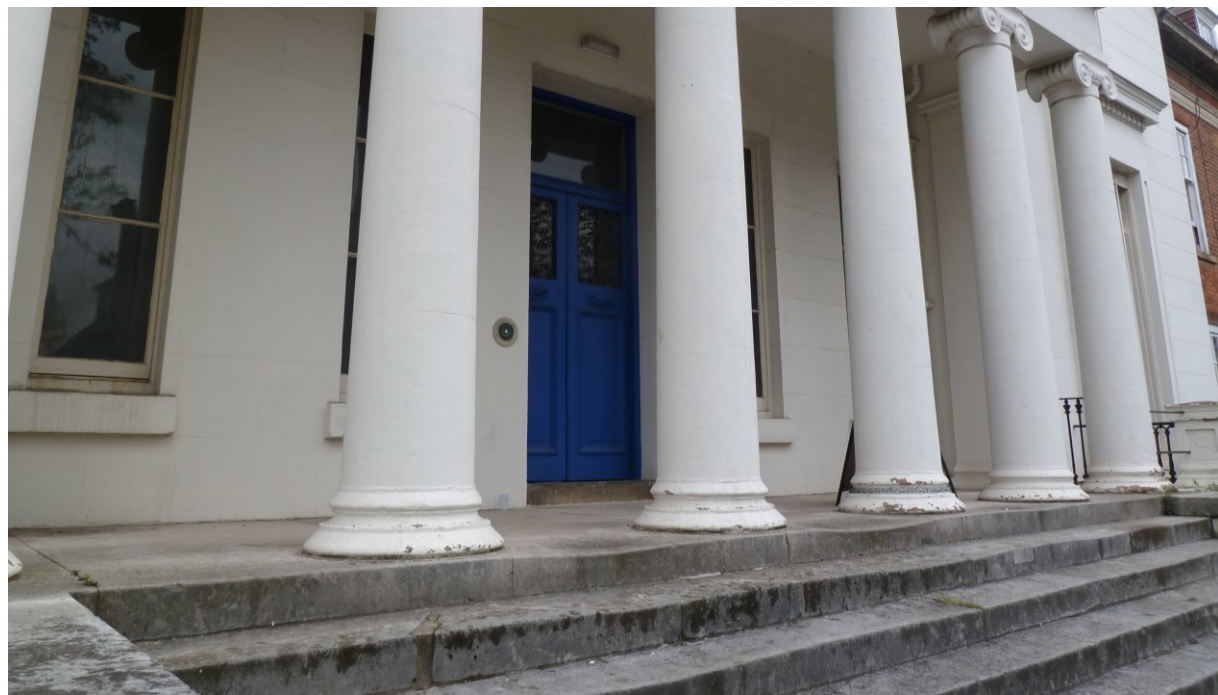
**Figure 54** The entrance steps to Kidderpore Hall accessed from Kidderpore Avenue. The plaster render and the stonework of the steps are in need of refurbishment.

- 3.74 The exterior of Kidderpore Hall is, in some areas, in need of significant repair and refurbishment. The windows have been replaced at different times and to different specifications which has reduced the architectural integrity of the appearance of the elevations. In many places the plaster render and stonework require repair, and the roof slates are damaged in places.

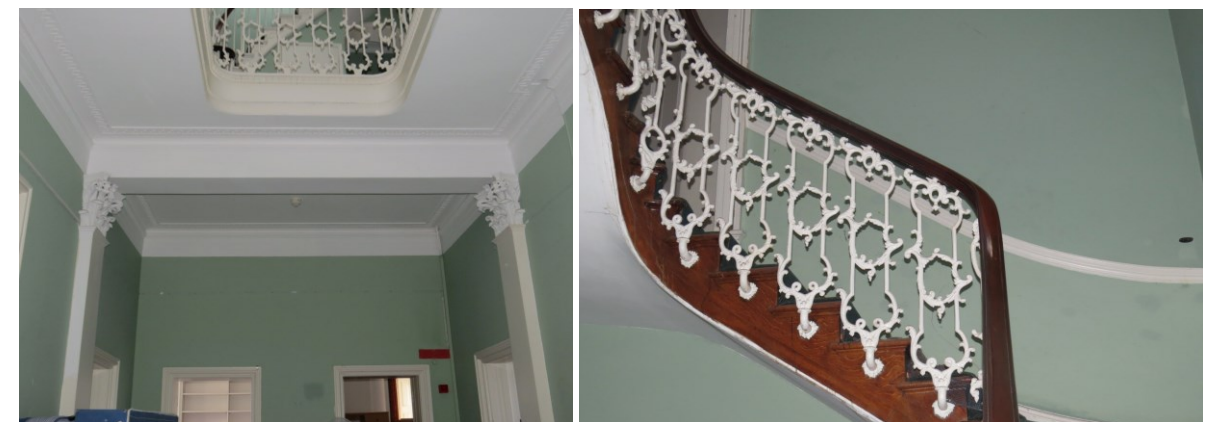
**Figure 56** A photograph of the ceiling of the entrance hallway to Kidderpore Hall, and detail of the balustrade of the principal staircase, current date.

- 3.75 Internally, the layout of Kidderpore Hall is as one would expect of a nineteenth century villa built as the grand suburban residence of a wealthy merchant. Room proportions are generous, and the principal entrance hallway retains its original grandeur created by the high ceilings and classical details which include engaged Corinthian columns and the cantilevered stone staircase. The impression of the high ceilings is augmented by the landing gallery which allows light down from the skylight at the second floor ceiling level.
