Greenwood Place, Highgate Road, NW5

Report Reference Number: 1655,GI/LF,PD/23-06-16/V1
Project Number: 1655,GI
Issue Reference: 1
Issue Date: 23 June 2016

Foundation Inspection Pit Logs
(FIP1 to FIP4)

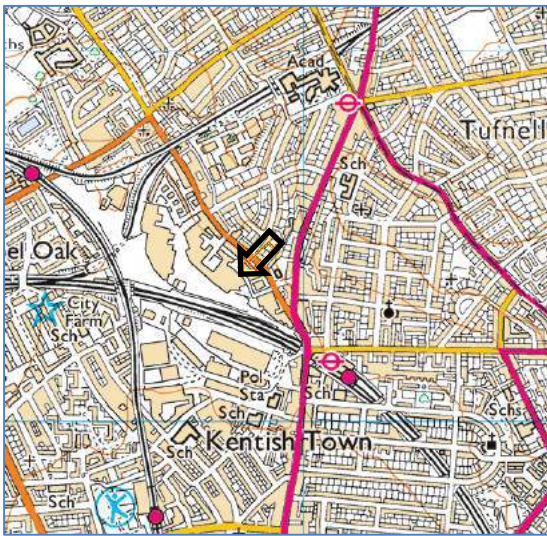
Figure 1 – Site Location Plan

A Site Location Plan, Drawing ref. 1655,GI 001/Rev 0 is included in Appendix 8 at the back of the report, and in Figure 1 below:

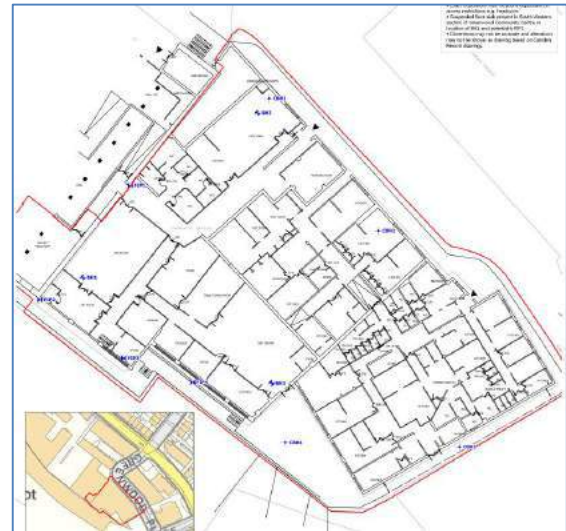
Figure 2 – Site Plan

Ground levels were found to decrease toward the south west of the site, falling from approximately 40mAOD in the north, to approximately 34mAOD in the south.

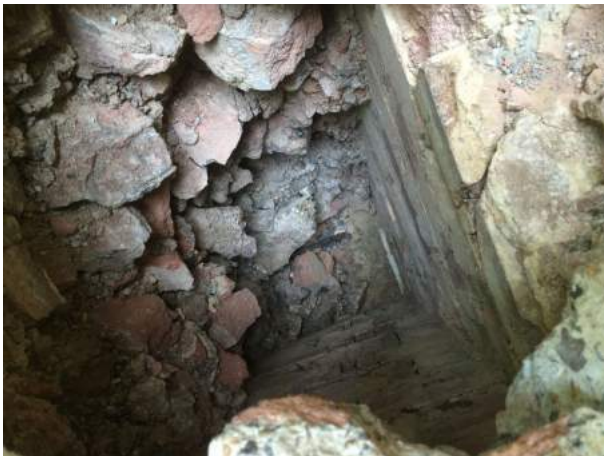
Foundation profile sketches were produced for each foundation inspection pits, these are provided within Appendix 4 of this report.

Shoring/Support: None
 Stability: Stable

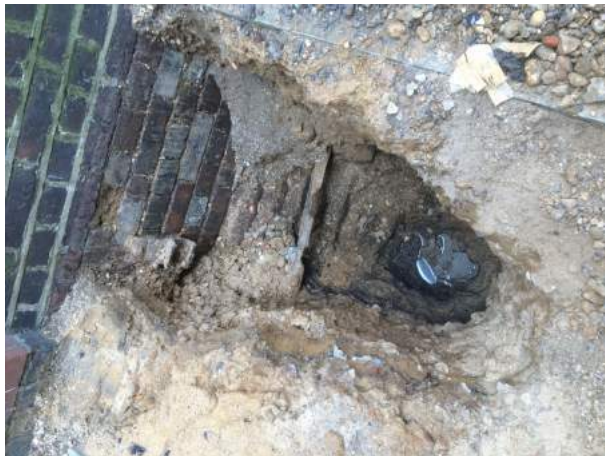
Shoring/Support: None
 Stability: Stable

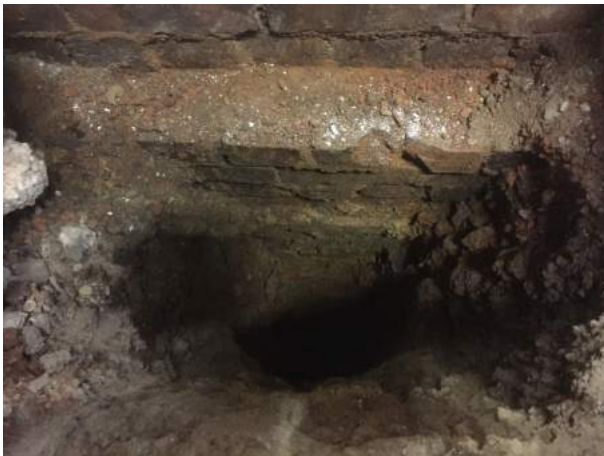
Shoring/Support: None
 Stability: Stable

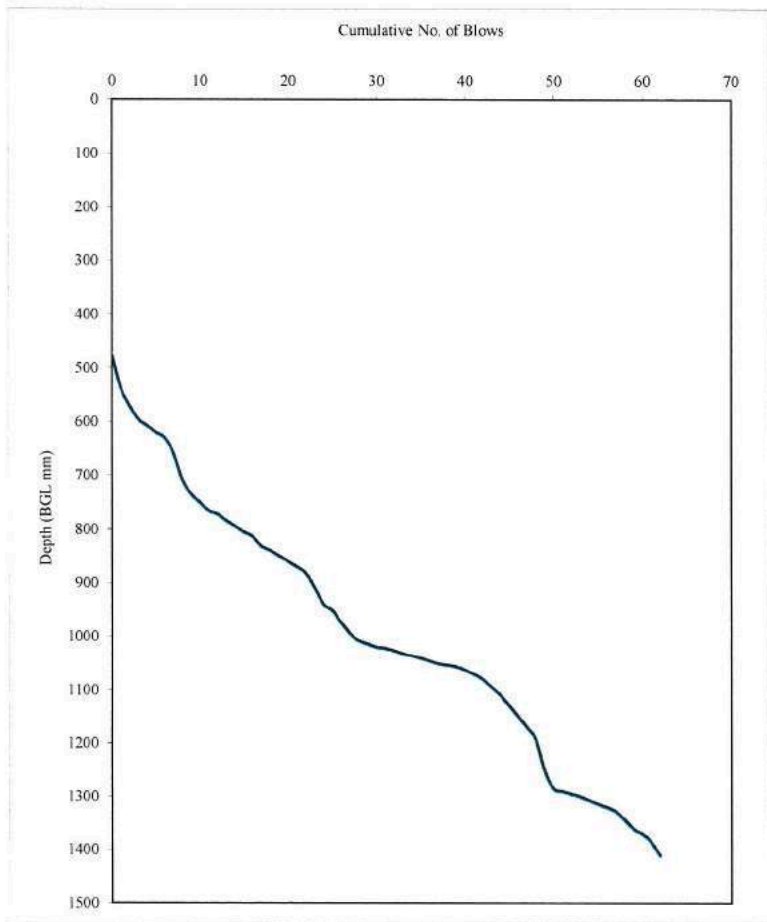
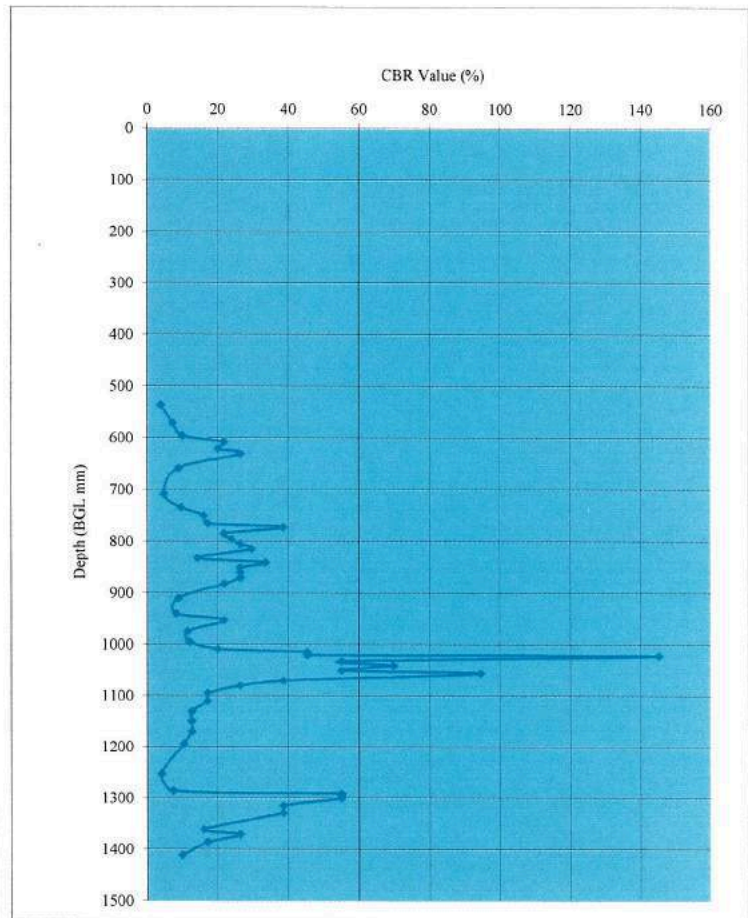
Dynamic Cone Penetrometer Graph

Remarks:	<p>Dark yellowish brown slightly silty gravelly SAND. Gravel is brown white and black fine to coarse sub angular to sub rounded flint with occasional brick fragments.</p> <p>Test started at 450mm below Ground Level. Material removed was engineered fill consisting of crushed concrete, brick and asphalt.</p> <p>Excessively high or anomalous readings may be the result of cone encountering obstructions such as large gravel fragments.</p> <p>See attached sheet for Equivalent CBR values for each penetration</p>
-----------------	--

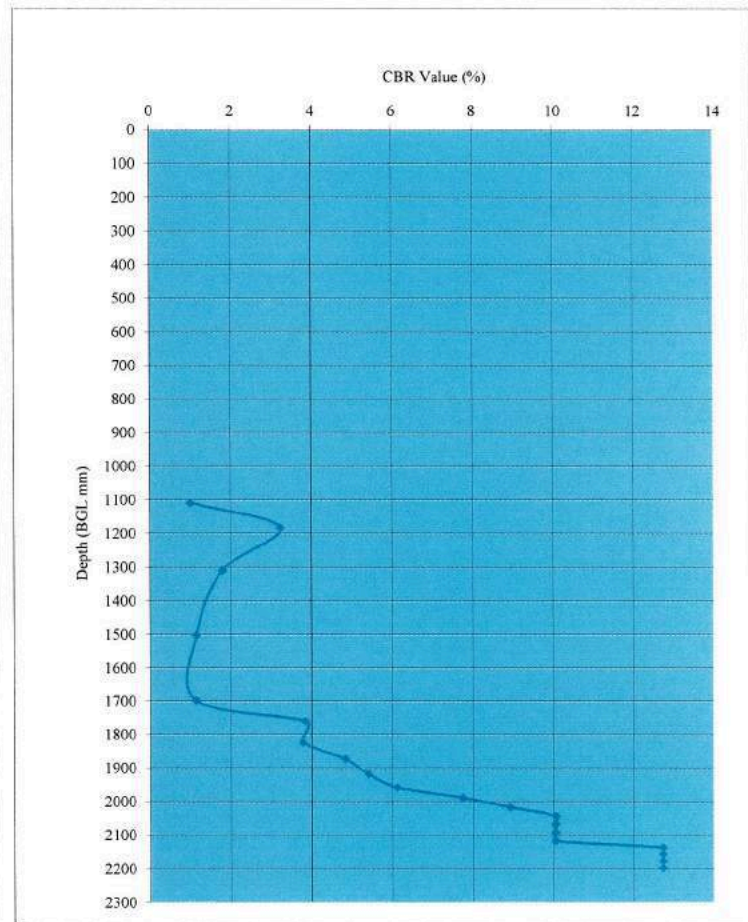
Dynamic Cone Penetrometer Graph

Remarks:	<p>Greyish brown slightly sandy gravelly CLAY. Gravel is brown white and black fine to coarse sub angular to sub rounded flint with occasional brick fragments.</p> <p>Rod appeared very wet on retrieval</p> <p>Test started at 850mm below ground level. Material removed was engineered fill consisting of crushed concrete, brick and asphalt.</p> <p>Excessively high or anomalous readings may be the result of cone encountering obstructions such as large gravel fragments.</p> <p>See attached sheet for Equivalent CBR values for each penetration.</p>
-----------------	--
