**27 Russell Square, London WC1
Assessment of Internal Partitions**

The above property was visited by Dr Michael Shapland of Archaeology South-East on Monday 5th July 2016 in order to assess the nature and date of the floor structure to the upper three storeys of the front range of the house.

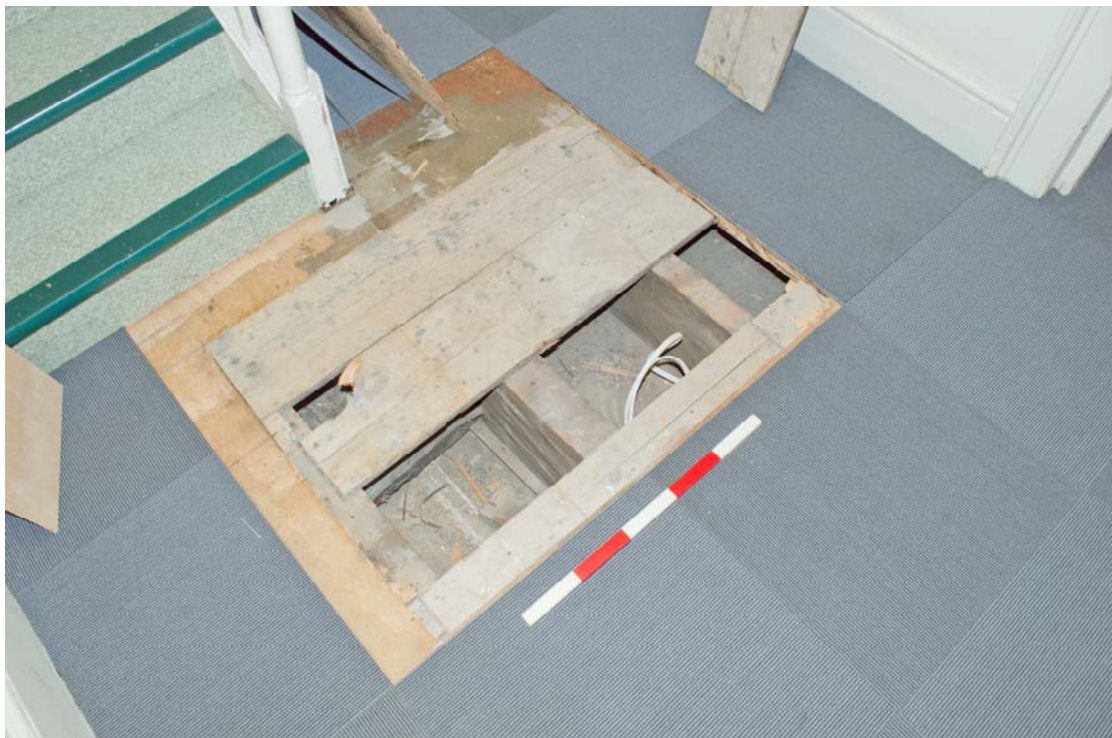
To provide a comparison with the floor structures of the building's front range, that of the stair landing at second floor level was investigated, as it is not thought to have been previously modified or replaced. It consists of joists measuring 240mm deep by 60mm broad, spaced c. 300mm apart: one of the visible joists was slightly broader, but this may be due to the structural

demands of the adjacent stair. They run north-west/south-east between the building's party walls. Some of the joists were sawn, others appear to have been split and then dressed square. They bear pine floorboards 200mm wide. The substantial depth of the joists, the use of pine and the width of the floorboards are all consistent with the building's early 19th century date, making it likely that they are original to its construction.

Floor structure of the second floor landing, looking south

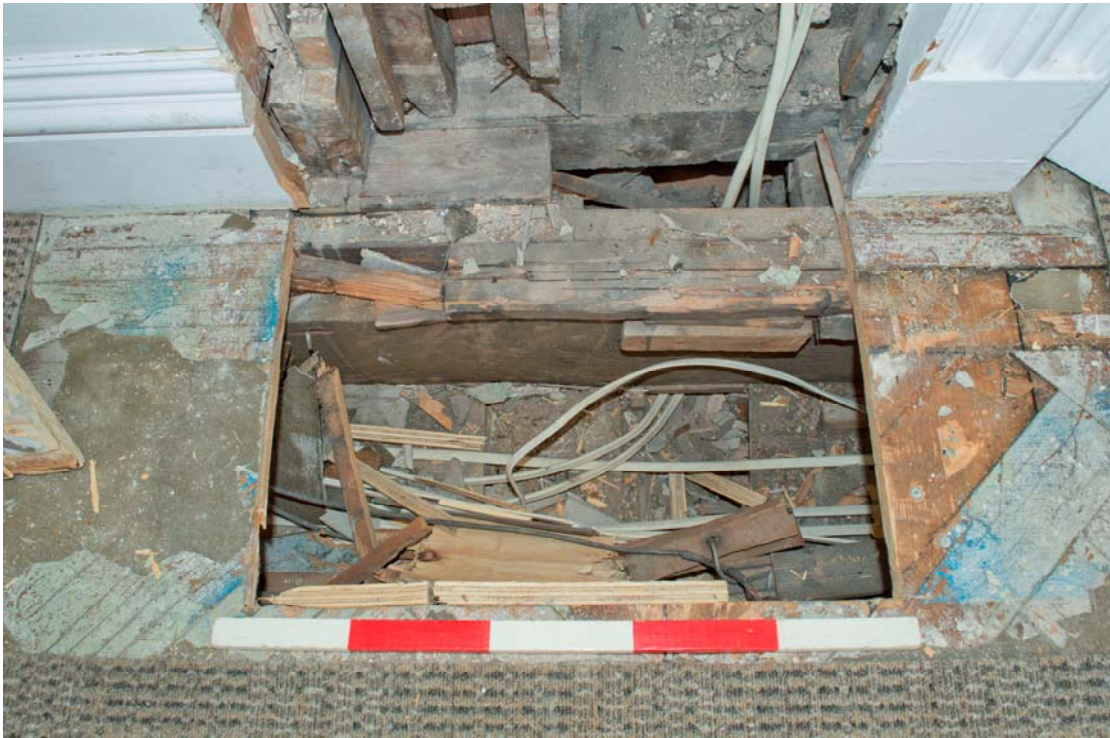
A small area adjacent to the rear wall of the front room at first floor level was available for investigation. The floor joists consist of sawn lengths of pine, measuring 250mm deep by 50mm broad, spaced c. 250mm apart. They run north-west/south-east between the building's party walls, and are very similar in size and appearance to those of the second floor landing, and as such are likely to be original to the building. Their floorboards, however, are only 150mm wide and are probably later 19th or early 20th century replacements, since this room (the *piano nobile*) would have been used for grand receptions, and so would originally have been fitted with the finest, broadest floorboards in the house.

Structure of the first floor (front range), looking south-west

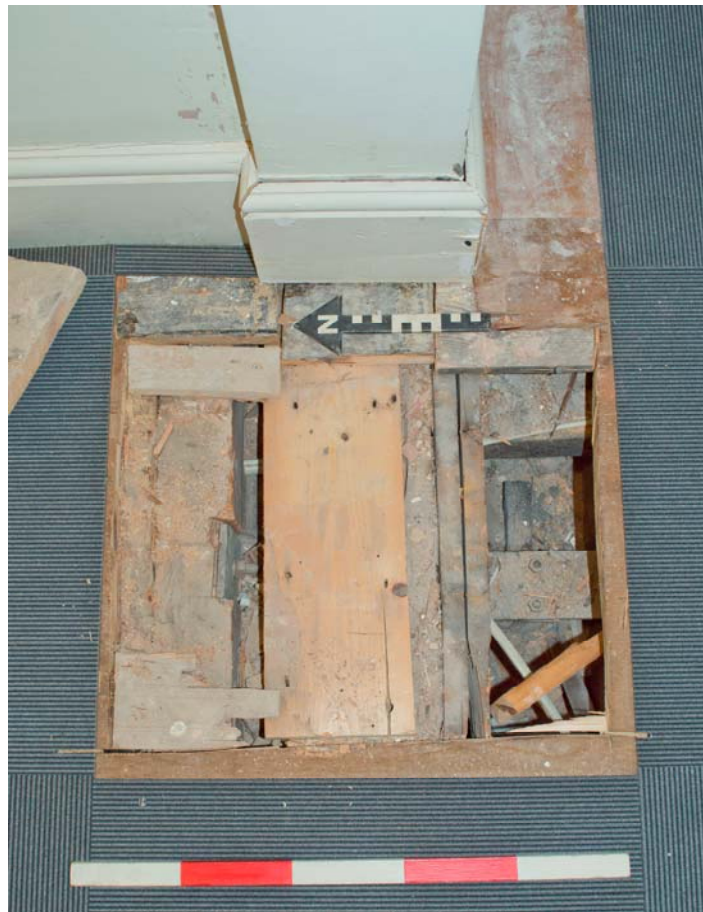
A small area towards the south-western end of the front room at second floor level was available for investigation, adjacent to an early/mid-20th century partition wall. The floor joists consist of sawn lengths of pine, one measuring 190mm deep by 65mm broad, the other only 100mm deep by 90mm broad, spaced c. 150mm apart. The upper face of one of the joists has been made up with smaller pieces of wood to provide a level surface for the floorboards. These joists are therefore of quite different character to those seen elsewhere, and they run north-east/south-west along the building, which is perpendicular to the direction of the visible joists across the rest of the building. The joists have been further stiffened by secondary timbers of various sizes running across the space in between, some lapped into the joists, others simply nailed.

The visible floorboards are vary in width between 150mm and 210mm, so are likely to consist of a mixture of re-used boards original to the house and later material brought in from elsewhere.

One interesting aspect of the floor is the presence of two visible metal strengthening plates, an older one of iron (which has begun to corrode) and a newer of steel. These run perpendicularly between the main joists, into which the newer strengthening plate appears to have been cut.

Structure of the second floor (front range), looking north-east. Note the steel plate running perpendicular to the main timbers.

Overall, the original floor structure has been wholly replaced, apparently over at least two major phases of work, using heterogeneous timbers and floorboards of various sizes rather than to a single consistent design. The timbers used in this way are not sufficiently visible or distinctive to be dateable in their own right, but their use of nails with rectangular shanks is indicative of the 19th or early 20th centuries. Both the timbers and the nails may, of course, have been re-used. The earlier (iron) strengthening plate uses screw-thread nuts and bolts, dating it to the late 19th or early 20th centuries; the steel strengthening plate appears to be a mid-20th century or later insertion.

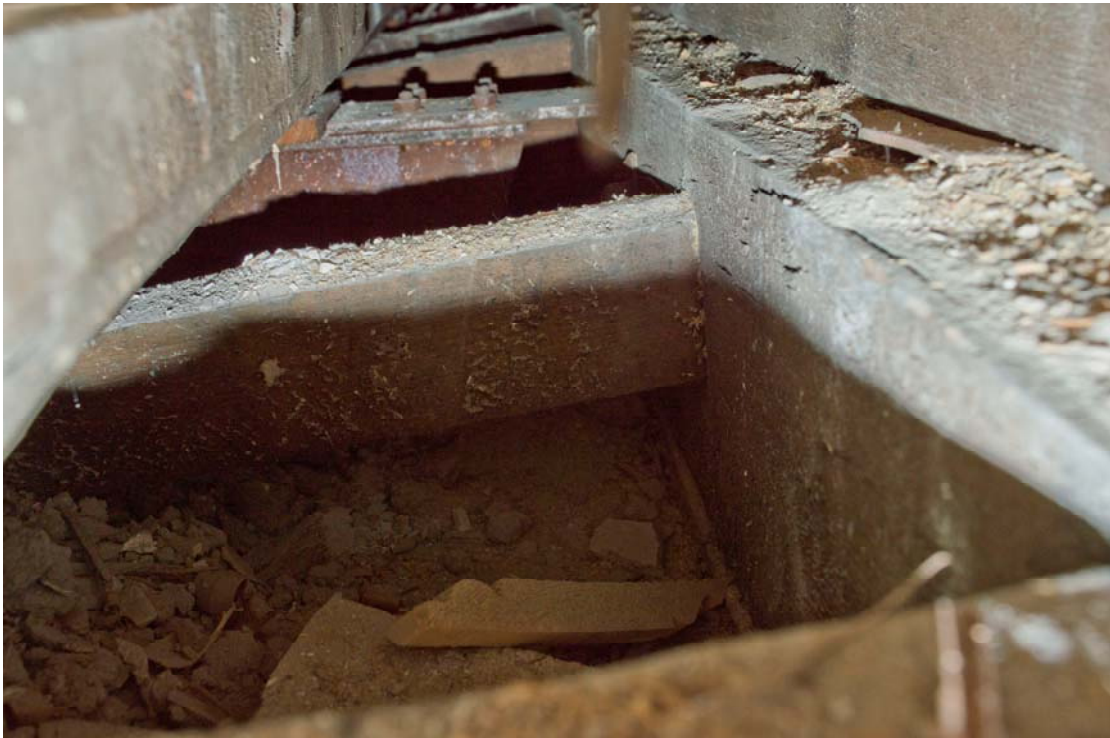
Structure of the second floor (front range), looking north-east along the joists. Note the corroded iron plate running perpendicular to the main timbers.

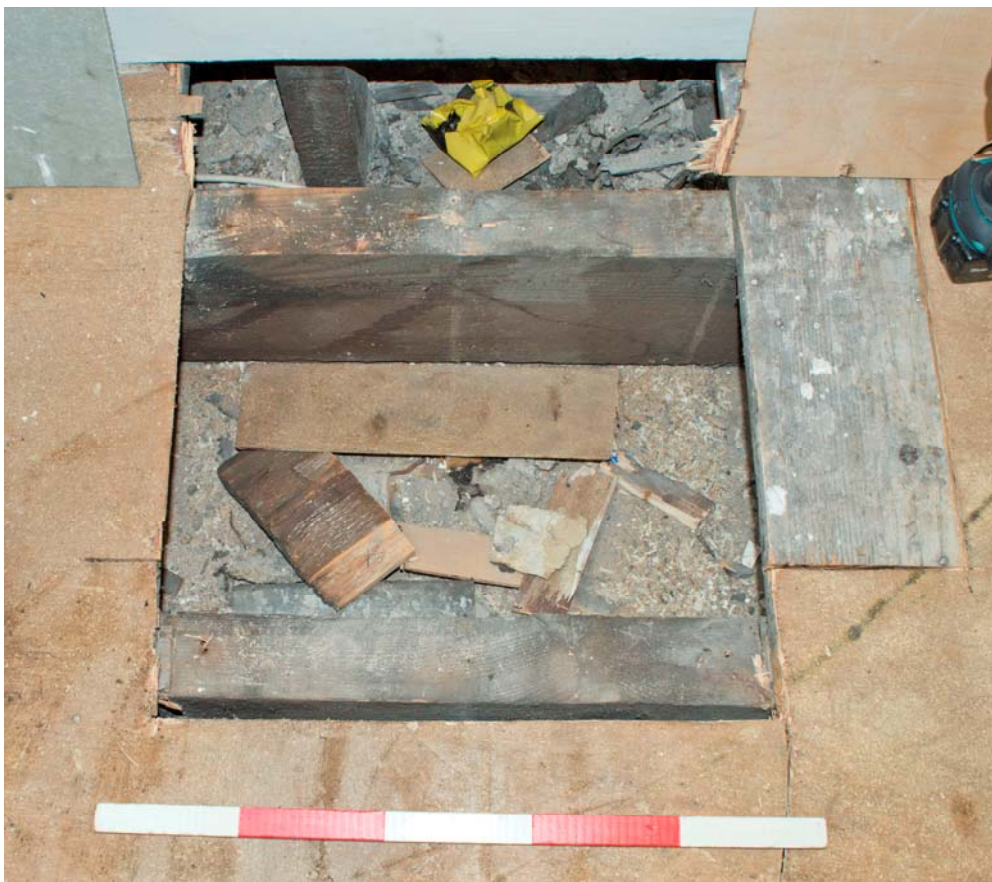
A small area adjacent to the rear wall of the front room at third floor level was available for investigation. The floor joists consist of sawn lengths of pine, measuring 220mm deep by 60mm broad, spaced c. 300mm apart. Their marginally smaller size and wider spacing is explicable by the floor's location at the top of the house, within what was originally the servants' quarters, which may not have been considered to have needed to have been as sturdy as the floors lower down. The joists run north-west/south-east between the building's party walls, and are similar to those of the first floor and second floor landing, and as such are likely to be original to the building. The floorboards are relatively broad, at 200mm wide, so are also probably original.

Structure of the third floor (front range), looking south-west.
