# Asbestos Pre-Demolition Survey Report

Job Ref No: **125146**, Account Ref No: **17637**, Contract Ref No: **15270**

## Block B, Bacton Low Rise, Haverstock Road, London, NW5 4PS

**Title:** Pre-demolition Survey - Block B, **Including:** All of property

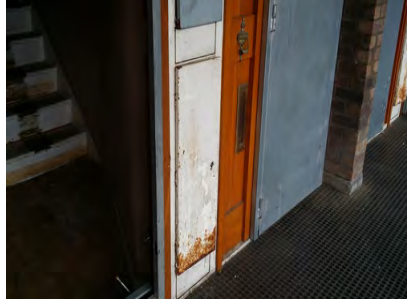
Bacton Low Rise, Block B - Community Centre	0	001/ Hall	shelving panels beneath stairs	125146-38	Asbestos-containing insulating board	Chrysotile, Amosite	7	6 Sqm.	R2	Remove

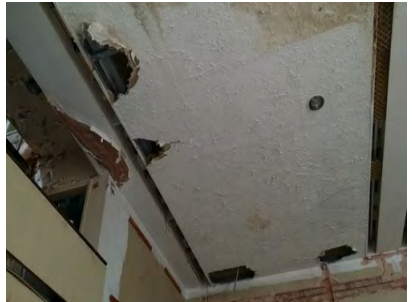
Bacton Low Rise, Block B - Community Centre	0	001/ Hall	coating to suspended ceiling	125146-37	Asbestos-containing textured coating	Chrysotile	4	67 Sqm.	R3	Remove

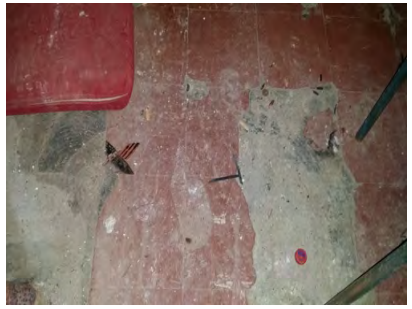
Building	Level	Location	Item / Product Examined	Sample No.	Material Description	Fibre Type	Material Score	Extent	Risk Level Assessment	Initial Control Recommendation	Photograph
Bacton Low Rise, Block B - Community Centre	0	003/ Plant Room	floor covering	125146-39	Asbestos-containing floor tiles & bituminous product	Chrysotile	3	8 Sqm.	R3	Remove

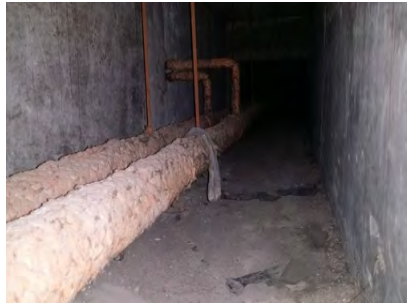
Bacton Low Rise, Block B - Community Centre	0	003/ Plant Room - Service Duct	flange gaskets		Asbestos-containing gasket	Presume Chrysotile	5	Not Quantifiable	PRESUME	Remove

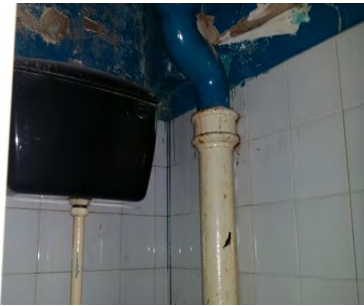
Building	Level	Location	Item / Product Examined	Sample No.	Material Description	Fibre Type	Material Score	Extent	Risk Level Assessment	Initial Control Recommendation	Photograph
Bacton Low Rise, Block B - Community Centre	1	001/ Toilet	toilet cistern		Asbestos-containing composite	Strongly Presume Amosite	4	1 No.	R3	Remove

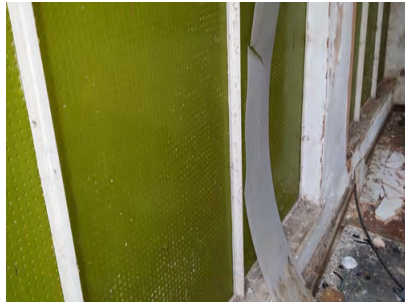
Bacton Low Rise, Block B - Community Centre	2	001/ Entrance	durasteel wall panels	125146-36	Asbestos-containing insulating board	Chrysotile, Amosite	5	40 Sqm.	R2	Remove

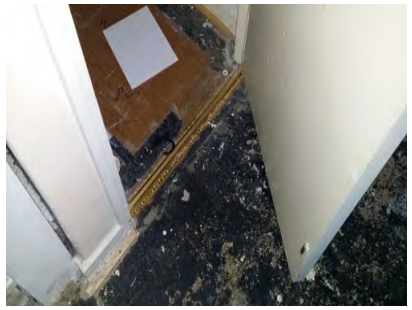
Building	Level	Location	Item / Product Examined	Sample No.	Material Description	Fibre Type	Material Score	Extent	Risk Level Assessment	Initial Control Recommendation	Photograph
Bacton Low Rise, Block B - Flat 132	-3	001/ Stairs & Cupboard	floor covering	125146-6	Asbestos-containing floor tiles & bitumen adhesive	Chrysotile	3	4 Sqm.	R3	Remove

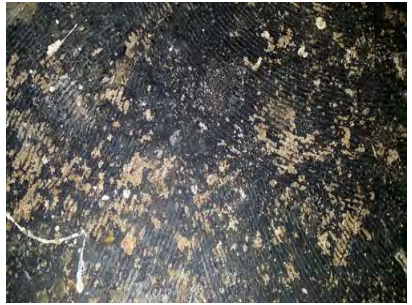
Bacton Low Rise, Block B - Flat 132	-3	003/ Bathroom	adhesive to concrete floor	125146-4	Asbestos-containing bituminous product	Chrysotile	3	6 Sqm.	R3	Remove

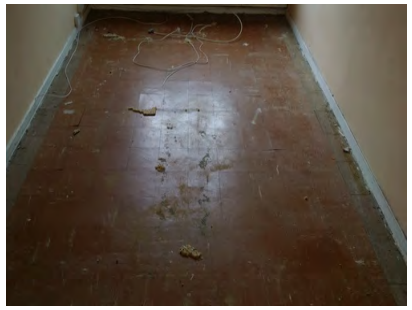
Building	Level	Location	Item / Product Examined	Sample No.	Material Description	Fibre Type	Material Score	Extent	Risk Level Assessment	Initial Control Recommendation	Photograph
Bacton Low Rise, Block B - Flat 132	-2	001/ Bedroom	floor covering	125146-6	Asbestos-containing floor tiles & bitumen adhesive	Chrysotile	3	12 Sqm.	R3	Remove

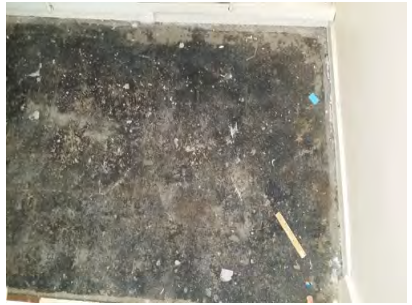
Bacton Low Rise, Block B - Flat 132	-1	001/ Stairs	adhesive to concrete floor	125146-4	Asbestos-containing bituminous product	Chrysotile	3	2 Sqm.	R3	Remove

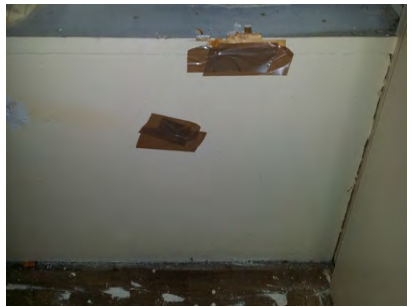
Building	Level	Location	Item / Product Examined	Sample No.	Material Description	Fibre Type	Material Score	Extent	Risk Level Assessment	Initial Control Recommendation	Photograph
Bacton Low Rise, Block B - Flat 132	-1	002/ Kitchen & Lounge	boxing within wooden cupboard	125146-8	Asbestos-containing insulating board	Chrysotile, Amosite	6	2 Sqm.	R2	Remove

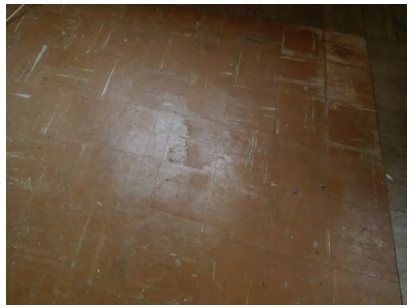
Bacton Low Rise, Block B - Flat 132	-1	002/ Kitchen & Lounge	floor covering	125146-6	Asbestos-containing floor tiles & bitumen adhesive	Chrysotile	3	14 Sqm.	R3	Remove

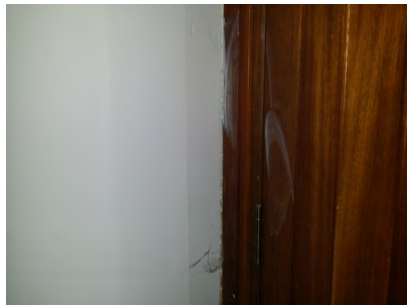
Bacton Low Rise, Block B - Flat 132	0	001/ Entrance Hall	boxing to electric cupboard	125146-2	Asbestos-containing insulating board	Chrysotile, Amosite	6	2 Sqm.	R2	Remove

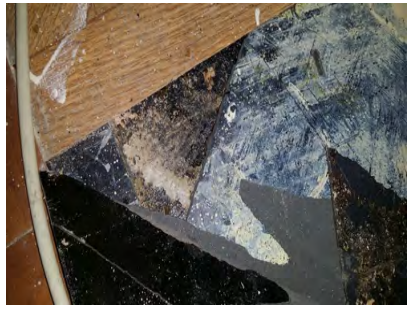
Building	Level	Location	Item / Product Examined	Sample No.	Material Description	Fibre Type	Material Score	Extent	Risk Level Assessment	Initial Control Recommendation	Photograph
Bacton Low Rise, Block B - Flat 132	0	001/ Entrance Hall	adhesive to concrete floor	125146-1	Asbestos-containing bituminous product	Chrysotile	3	4 Sqm.	R3	Remove

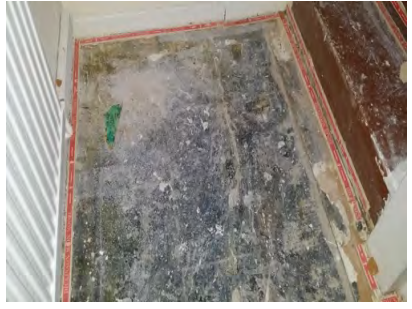
Bacton Low Rise, Block B - Flat 132	1	001/ Stairs	adhesive to concrete floor	125146-1	Asbestos-containing bituminous product	Chrysotile	3	2 Sqm.	R3	Remove

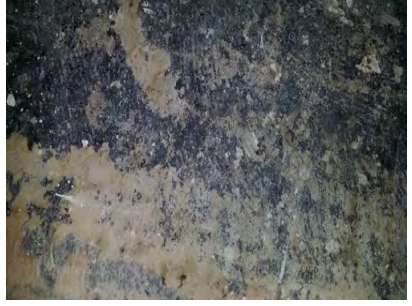
Bacton Low Rise, Block B - Flat 132	1	002/ Kitchen & Lounge	adhesive to concrete floor	125146-1	Asbestos-containing bituminous product	Chrysotile	3	14 Sqm.	R3	Remove

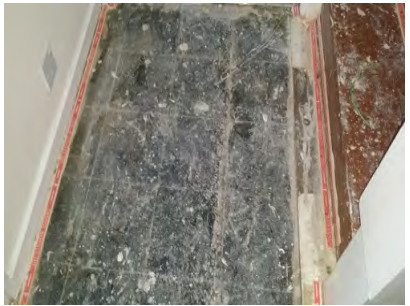
Building	Level	Location	Item / Product Examined	Sample No.	Material Description	Fibre Type	Material Score	Extent	Risk Level Assessment	Initial Control Recommendation	Photograph
Bacton Low Rise, Block B - Flat 132	2	001/ Stairs	adhesive to concrete floor	125146-1	Asbestos-containing bituminous product	Chrysotile	3	2 Sqm.	R3	Remove

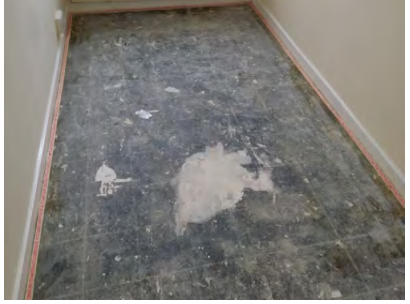
Bacton Low Rise, Block B - Flat 132	2	003/ Bedroom	adhesive to concrete floor	125146-1	Asbestos-containing bituminous product	Chrysotile	3	6 Sqm.	R3	Remove

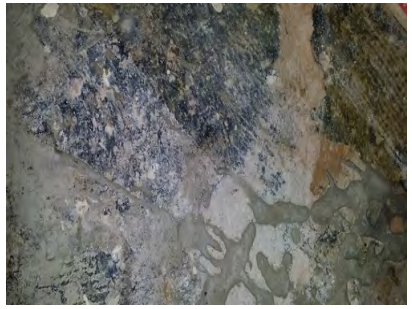
Building	Level	Location	Item / Product Examined	Sample No.	Material Description	Fibre Type	Material Score	Extent	Risk Level Assessment	Initial Control Recommendation	Photograph
Bacton Low Rise, Block B - Flat 132	3	004/ Toilet	adhesive to concrete floor	125146-1	Asbestos-containing bituminous product	Chrysotile	3	2 Sqm.	R3	Remove

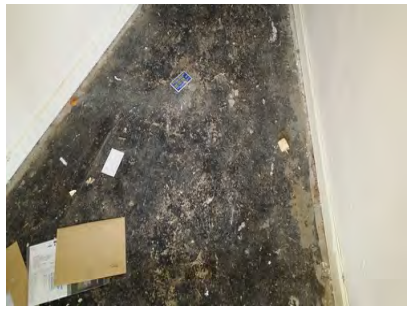
Building	Level	Location	Item / Product Examined	Sample No.	Material Description	Fibre Type	Material Score	Extent	Risk Level Assessment	Initial Control Recommendation	Photograph
Bacton Low Rise, Block B - Flat 133	0	001/ Entrance Hall	adhesive to concrete floor	125146-4	Asbestos-containing bituminous product	Chrysotile	3	4 Sqm.	R3	Remove

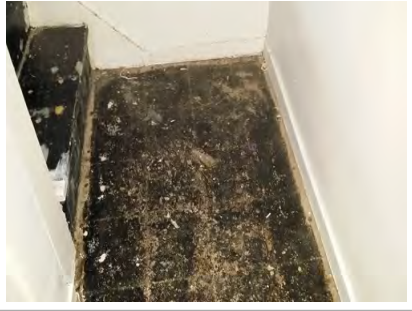
Bacton Low Rise, Block B - Flat 134	-3	001/ Stairs & Cupboard	floor covering	125146-10	Asbestos-containing floor tiles & bitumen adhesive	Chrysotile	3	4 Sqm.	R3	Remove

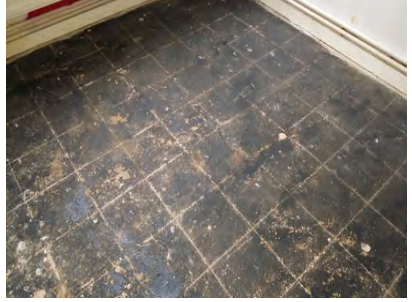
Bacton Low Rise, Block B - Flat 134	-3	002/ Bedroom	floor covering	125146-10	Asbestos-containing floor tiles & bitumen adhesive	Chrysotile	3	8 Sqm.	R3	Remove

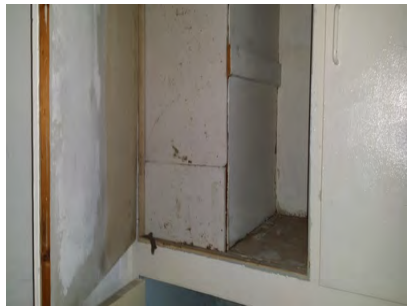
Building	Level	Location	Item / Product Examined	Sample No.	Material Description	Fibre Type	Material Score	Extent	Risk Level Assessment	Initial Control Recommendation	Photograph
Bacton Low Rise, Block B - Flat 134	-3	002/ Bedroom	boxing within wooden cupboard	125146-13	Asbestos-containing insulating board	Chrysotile, Amosite	7	2 Sqm.	R1	Remove

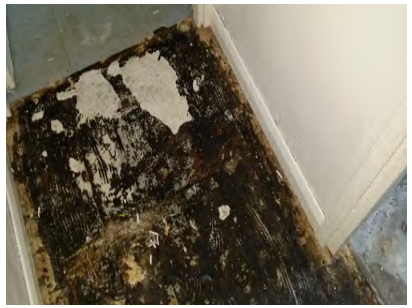
Bacton Low Rise, Block B - Flat 134	-3	003/ Bathroom	adhesive to concrete floor	125146-10	Asbestos-containing bituminous product	Chrysotile	3	6 Sqm.	R3	Remove

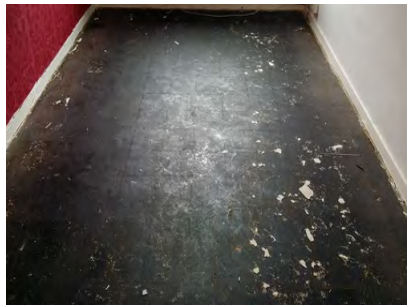
Bacton Low Rise, Block B - Flat 134	-2	001/ Bedroom	adhesive to concrete floor	125146-10	Asbestos-containing bituminous product	Chrysotile	3	12 Sqm.	R3	Remove

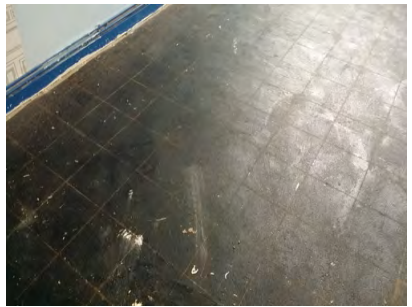
Building	Level	Location	Item / Product Examined	Sample No.	Material Description	Fibre Type	Material Score	Extent	Risk Level Assessment	Initial Control Recommendation	Photograph
Bacton Low Rise, Block B - Flat 134	-2	002/ Bedroom	floor covering	125146-10	Asbestos-containing floor tiles & bitumen adhesive	Chrysotile	3	8 Sqm.	R3	Remove

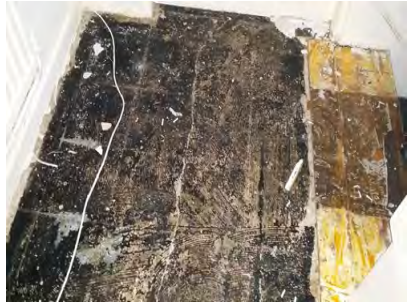
Bacton Low Rise, Block B - Flat 134	-1	001/ Stairs	adhesive to concrete floor	125146-10	Asbestos-containing bituminous product	Chrysotile	3	2 Sqm.	R3	Remove

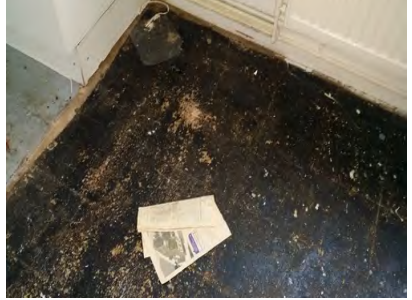
Bacton Low Rise, Block B - Flat 134	-1	002/ Kitchen & Lounge	adhesive to concrete floor	125146-10	Asbestos-containing bituminous product	Chrysotile	3	14 Sqm.	R3	Remove

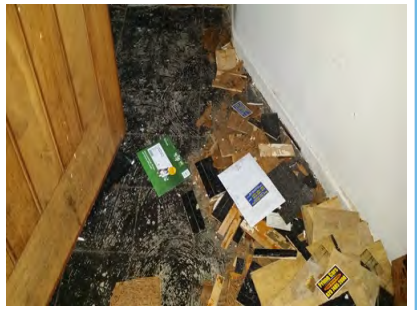
Building	Level	Location	Item / Product Examined	Sample No.	Material Description	Fibre Type	Material Score	Extent	Risk Level Assessment	Initial Control Recommendation	Photograph
Bacton Low Rise, Block B - Flat 134	0	001/ Entrance Hall	adhesive to concrete floor	125146-10	Asbestos-containing bituminous product	Chrysotile	3	4 Sqm.	R3	Remove

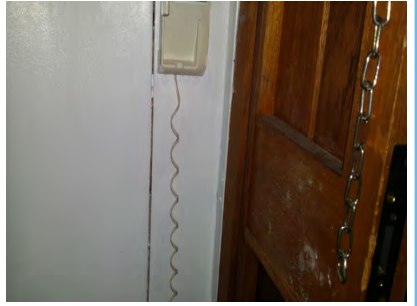
Bacton Low Rise, Block B - Flat 134	0	001/ Entrance Hall	boxing to electric cupboard	125146-11	Asbestos-containing insulating board	Chrysotile, Amosite	6	2 Sqm.	R2	Remove

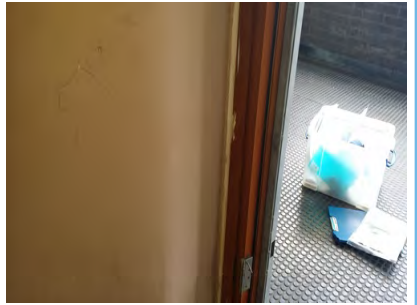
Bacton Low Rise, Block B - Flat 136	0	001/ Entrance Hall	boxing to electric cupboard	125146-25	Asbestos-containing insulating board	Chrysotile, Amosite	6	2 Sqm.	R2	Remove

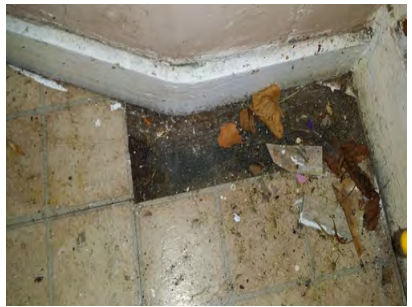
Building	Level	Location	Item / Product Examined	Sample No.	Material Description	Fibre Type	Material Score	Extent	Risk Level Assessment	Initial Control Recommendation	Photograph
Bacton Low Rise, Block B - Flat 136	0	001/ Entrance Hall	adhesive to concrete floor	125146-24	Asbestos-containing bituminous product	Chrysotile	3	4 Sqm.	R3	Remove

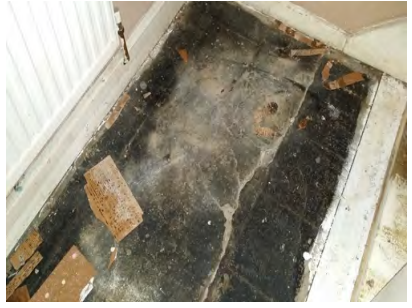
Bacton Low Rise, Block B - Flat 136	1	001/ Stairs	adhesive to concrete floor	125146-24	Asbestos-containing bituminous product	Chrysotile	3	24 Sqm.	R3	Remove

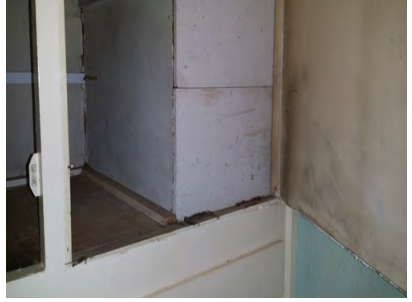
Bacton Low Rise, Block B - Flat 136	1	002/ Kitchen & Lounge	boxing within wooden cupboard	125146-27	Asbestos-containing insulating board	Chrysotile, Amosite	7	2 Sqm.	R1	Remove

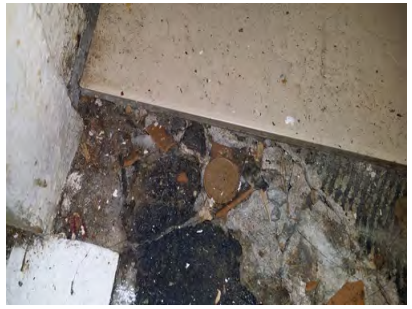
Building	Level	Location	Item / Product Examined	Sample No.	Material Description	Fibre Type	Material Score	Extent	Risk Level Assessment	Initial Control Recommendation	Photograph
Bacton Low Rise, Block B - Flat 136	1	002/ Kitchen & Lounge	adhesive to concrete floor	125146-24	Asbestos-containing bituminous product	Chrysotile	3	14 Sqm.	R3	Remove

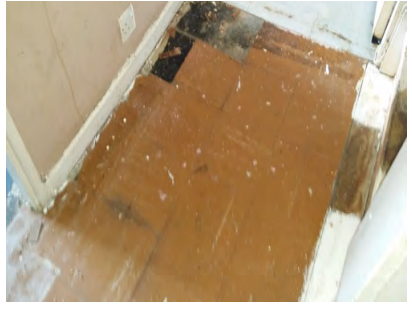
Bacton Low Rise, Block B - Flat 136	2	001/ Stairs	floor covering	125146-29	Asbestos-containing floor tiles & bituminous product	Chrysotile	3	2 Sqm.	R3	Remove

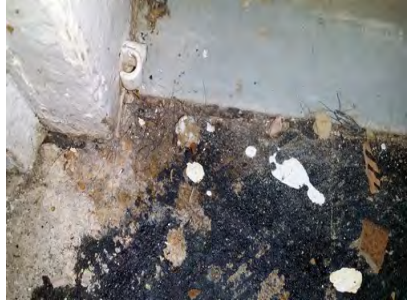
Bacton Low Rise, Block B - Flat 136	2	002/ Bedroom	adhesive to concrete floor	125146-24	Asbestos-containing bituminous product	Chrysotile	3	12 Sqm.	R3	Remove

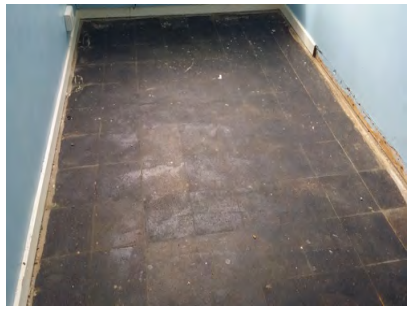
Building	Level	Location	Item / Product Examined	Sample No.	Material Description	Fibre Type	Material Score	Extent	Risk Level Assessment	Initial Control Recommendation	Photograph
Bacton Low Rise, Block B - Flat 136	2	003/ Bedroom	adhesive to concrete floor	125146-24	Asbestos-containing bituminous product	Chrysotile	3	12 Sqm.	R3	Remove

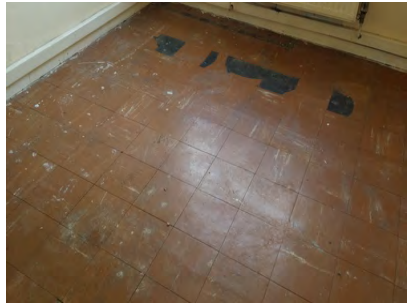
Bacton Low Rise, Block B - Flat 136	3	002/ Bedroom	floor covering	125146-29	Asbestos-containing floor tiles & bituminous product	Chrysotile	3	12 Sqm.	R3	Remove

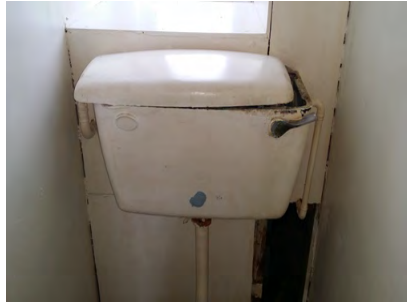
Bacton Low Rise, Block B - Flat 136	3	004/ Toilet	toilet cistern	125146-30	Asbestos-containing composite	Amosite	4	1 No.	R3	Remove

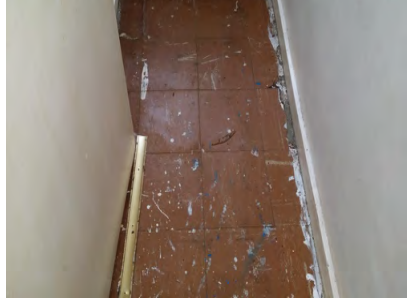
Bacton Low Rise, Block B - Flat 136	3	004/ Toilet	floor covering	125146-29	Asbestos-containing floor tiles & bituminous product	Chrysotile	3	2 Sqm.	R3	Remove

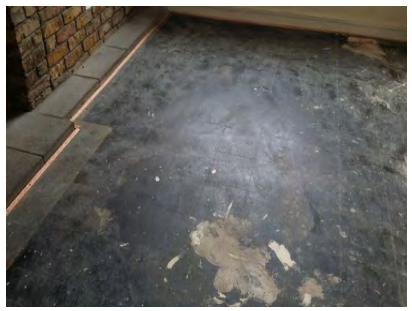
Bacton Low Rise, Block B - Flat 139	2	002/ Bedroom	adhesive to concrete floor	125146-31	Asbestos-containing bituminous product	Chrysotile	3	12 Sqm.	R3	Remove

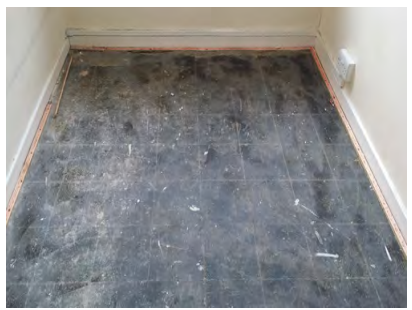
Bacton Low Rise, Block B - Flat 139	2	003/ Bedroom	adhesive to concrete floor	125146-31	Asbestos-containing bituminous product	Chrysotile	3	12 Sqm.	R3	Remove

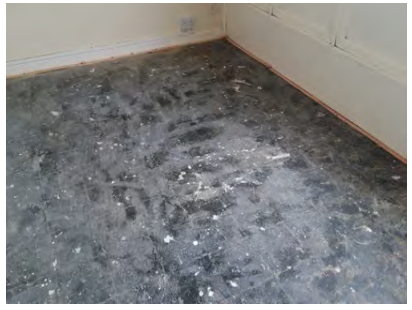
Bacton Low Rise, Block B - Flat 139	4	001/ Bedroom	adhesive to concrete floor	125146-31	Asbestos-containing bituminous product	Chrysotile	3	12 Sqm.	R3	Remove
