# Management Recommendation Detail

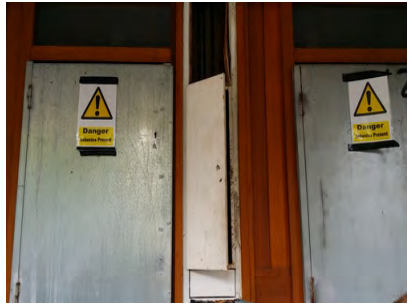
Building	Level	Location	Item / Product Examined	Sample No.	Material Description	Fibre Type	Material Score	Extent	Risk Level Assessment	Initial Control Recommendation	Photograph
Bacton Low Rise, Block H - Communal Area	1	001/ Walkway	panels around electric meter cupboards	126253-2	Asbestos-containing insulating board	Amosite, Chrysotile	6	9x 2 Sqm.	R3	Remove

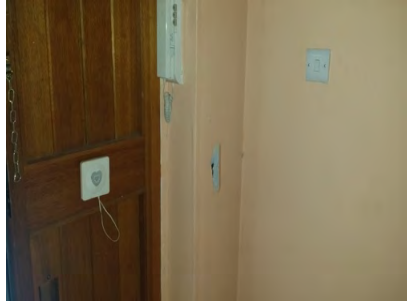
Bacton Low Rise, Block H - Flat 203	0	001/ Entrance Lobby	boxing around electric	126253-6	Asbestos-containing insulating board	Amosite, Chrysotile	7	2 Sqm.	R1	Remove

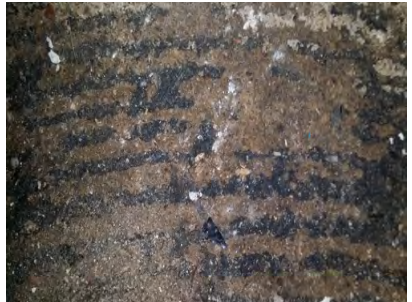
Bacton Low Rise, Block H - Flat 203	0	001/ Entrance Lobby	adhesive to concrete floor	126253-5	Asbestos-containing bituminous product	Chrysotile	3	4 Sqm.	R3	Remove

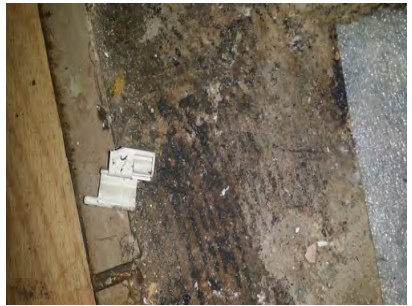
Building	Level	Location	Item / Product Examined	Sample No.	Material Description	Fibre Type	Material Score	Extent	Risk Level Assessment	Initial Control Recommendation	Photograph
Bacton Low Rise, Block H - Flat 203	1	001/ Stairs	adhesive to concrete floor	126253-5	Asbestos-containing bituminous product	Chrysotile	3	2 Sqm.	R3	Remove

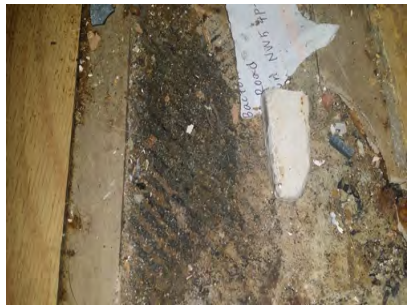
Bacton Low Rise, Block H - Flat 203	1	002/ Kitchen & Lounge	adhesive to concrete floor	126253-5	Asbestos-containing bituminous product	Chrysotile	3	14 Sqm.	R3	Remove

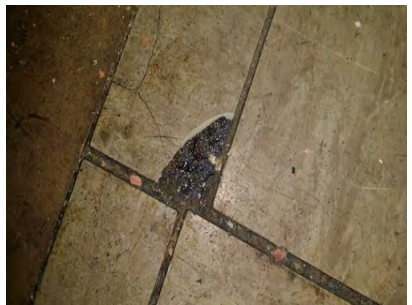
Bacton Low Rise, Block H - Flat 203	2	001/ Stairs	adhesive to concrete floor	126253-5	Asbestos-containing bituminous product	Chrysotile	3	2 Sqm.	R3	Remove

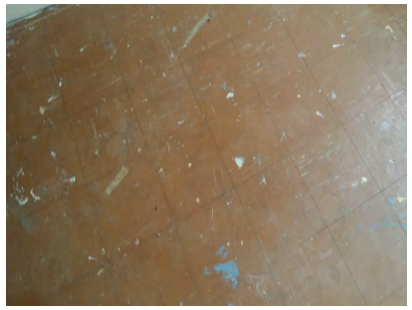
Building	Level	Location	Item / Product Examined	Sample No.	Material Description	Fibre Type	Material Score	Extent	Risk Level Assessment	Initial Control Recommendation	Photograph
Bacton Low Rise, Block H - Flat 203	2	002/ Bedroom	floor covering	126253-8	Asbestos-containing floor tiles & bituminous product	Chrysotile	3	6 Sqm.	R3	Remove

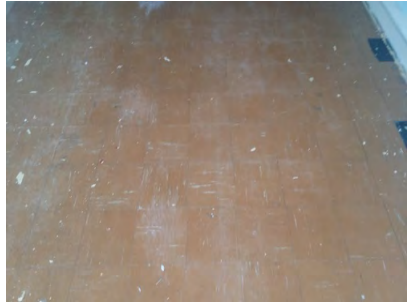
Bacton Low Rise, Block H - Flat 203	2	003/ Bedroom	floor covering	126253-8	Asbestos-containing floor tiles & bituminous product	Chrysotile	3	12 Sqm.	R3	Remove

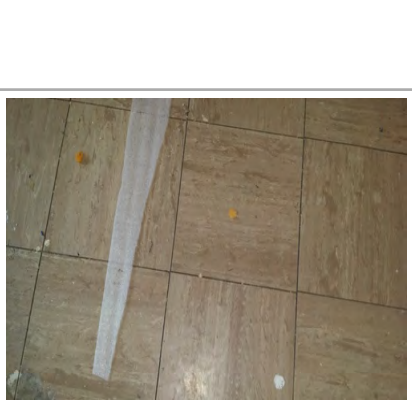
Bacton Low Rise, Block H - Flat 203	3	001/ Stairs	floor covering	126253-4	Asbestos-containing floor tiles & bituminous product	Chrysotile	3	2 Sqm.	R3	Remove

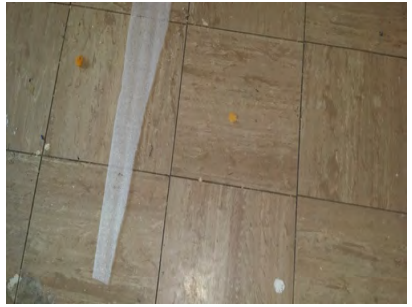
Bacton Low Rise, Block H - Flat 203	3	001/ Stairs	floor covering	126253-5	Asbestos-containing floor tiles & bituminous product	Chrysotile	3	2 Sqm.	R3	Remove

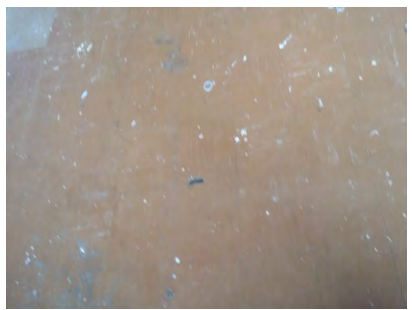
Building	Level	Location	Item / Product Examined	Sample No.	Material Description	Fibre Type	Material Score	Extent	Risk Level Assessment	Initial Control Recommendation	Photograph
Bacton Low Rise, Block H - Flat 203	3	002/ Bedroom	floor covering	126253-5	Asbestos-containing floor tiles & bituminous product	Chrysotile	3	12 Sqm.	R3	Remove

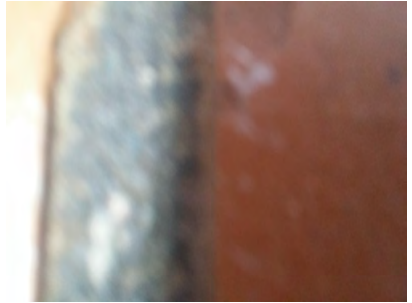
Bacton Low Rise, Block H - Flat 203	3	003/ Bathroom	adhesive to concrete floor	126253-5	Asbestos-containing bituminous product	Chrysotile	3	4 Sqm.	R3	Remove

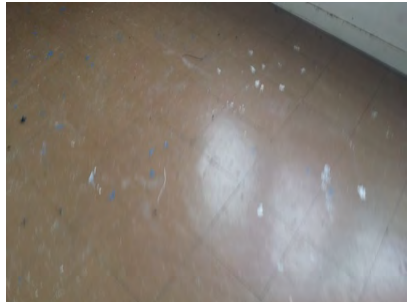
Bacton Low Rise, Block H - Flat 203	4	001/ Bedroom	floor covering	126253-8	Asbestos-containing floor tiles & bituminous product	Chrysotile	3	12 Sqm.	R3	Remove

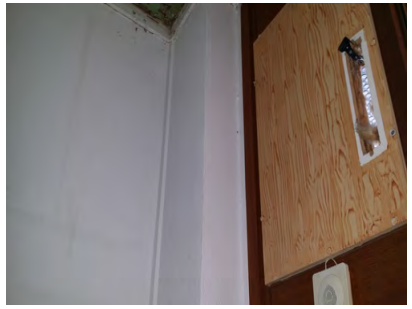
Building	Level	Location	Item / Product Examined	Sample No.	Material Description	Fibre Type	Material Score	Extent	Risk Level Assessment	Initial Control Recommendation	Photograph
Bacton Low Rise, Block H - Flat 204	0	001/ Entrance Lobby	boxing around electric	126253-2	Asbestos-containing insulating board	Amosite, Chrysotile	6	2 Sqm.	R2	Remove

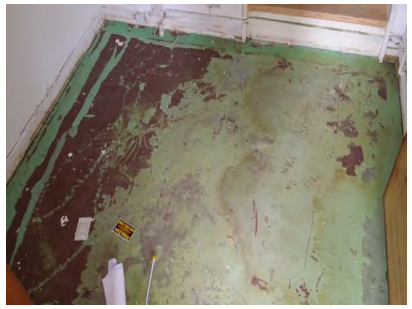
Bacton Low Rise, Block H - Flat 204	0	001/ Entrance Lobby	adhesive to concrete floor	126253-1	Asbestos-containing bituminous product	Chrysotile	3	4 Sqm.	R3	Remove

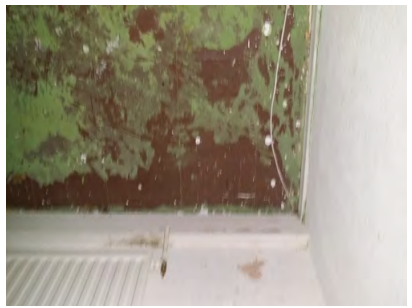
Bacton Low Rise, Block H - Flat 204	1	001/ Stairs	adhesive to concrete floor	126253-1	Asbestos-containing bituminous product	Chrysotile	3	2 Sqm.	R3	Remove

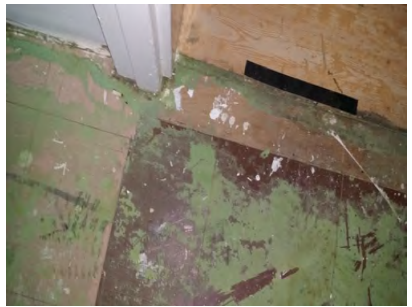
Building	Level	Location	Item / Product Examined	Sample No.	Material Description	Fibre Type	Material Score	Extent	Risk Level Assessment	Initial Control Recommendation	Photograph
Bacton Low Rise, Block H - Flat 204	1	002/ Kitchen & Lounge	adhesive to concrete floor	126253-1	Asbestos-containing bituminous product	Chrysotile	3	14 Sqm.	R3	Remove

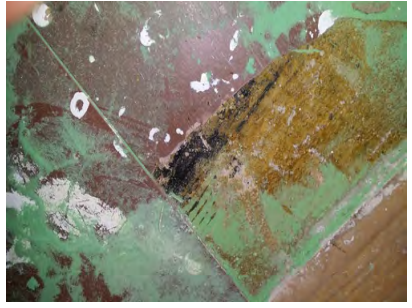
Bacton Low Rise, Block H - Flat 204	2	001/ Stairs	adhesive to concrete floor	126253-1	Asbestos-containing bituminous product	Chrysotile	3	2 Sqm.	R3	Remove

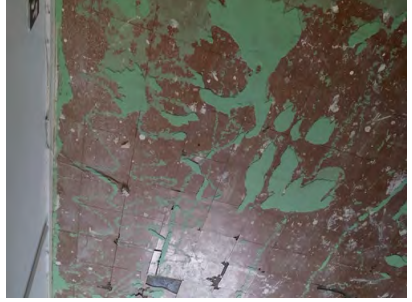
Bacton Low Rise, Block H - Flat 204	2	002/ Bedroom	floor covering	126253-4	Asbestos-containing floor tiles & bituminous product	Chrysotile	3	12 Sqm.	R3	Remove

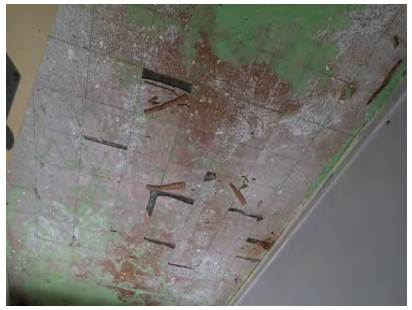
Building	Level	Location	Item / Product Examined	Sample No.	Material Description	Fibre Type	Material Score	Extent	Risk Level Assessment	Initial Control Recommendation	Photograph
Bacton Low Rise, Block H - Flat 204	2	003/ Bedroom	floor covering	126253-4	Asbestos-containing floor tiles & bituminous product	Chrysotile	3	12 Sqm.	R3	Remove

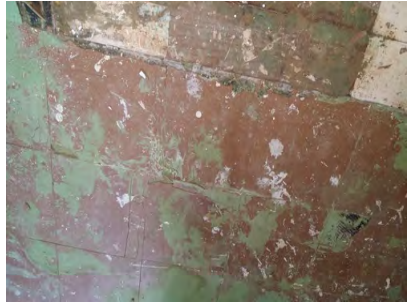
Bacton Low Rise, Block H - Flat 204	3	001/ Stairs	floor covering	126253-4	Asbestos-containing floor tiles & bituminous product	Chrysotile	3	2 Sqm.	R3	Remove

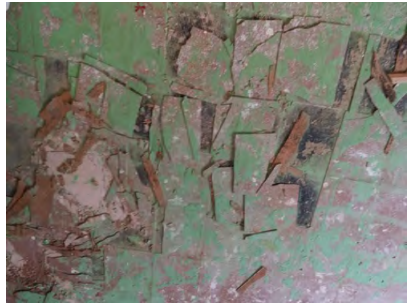
Bacton Low Rise, Block H - Flat 204	3	002/ Bedroom	floor covering	126253-4	Asbestos-containing floor tiles & bituminous product	Chrysotile	3	12 Sqm.	R3	Remove

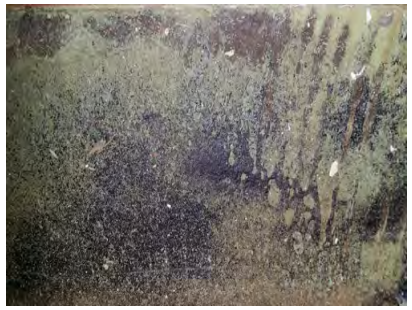
Building	Level	Location	Item / Product Examined	Sample No.	Material Description	Fibre Type	Material Score	Extent	Risk Level Assessment	Initial Control Recommendation	Photograph
Bacton Low Rise, Block H - Flat 204	3	003/ Bathroom	adhesive to concrete floor	126253-4	Asbestos-containing bituminous product	Chrysotile	3	4 Sqm.	R3	Remove

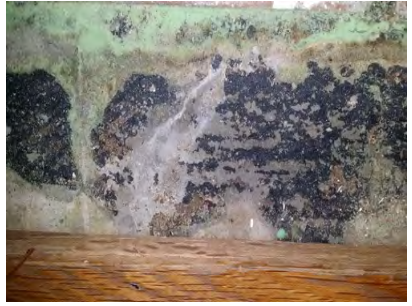
Bacton Low Rise, Block H - Flat 204	3	004/ Toilet	adhesive to concrete floor	126253-4	Asbestos-containing bituminous product	Chrysotile	3	2 Sqm.	R3	Remove

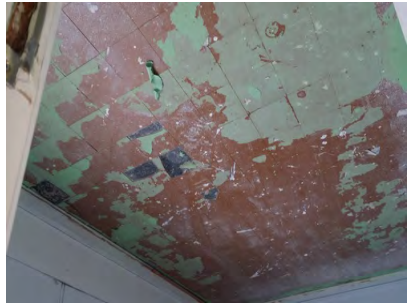
Bacton Low Rise, Block H - Flat 204	4	001/ Bedroom	floor covering	126253-4	Asbestos-containing floor tiles & bituminous product	Chrysotile	3	12 Sqm.	R3	Remove

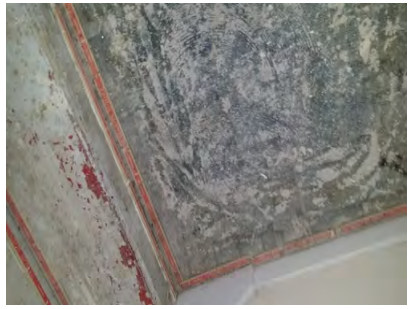
Building	Level	Location	Item / Product Examined	Sample No.	Material Description	Fibre Type	Material Score	Extent	Risk Level Assessment	Initial Control Recommendation	Photograph
Bacton Low Rise, Block H - Flat 205	-3	001/Stairs & Cupboard	bitumen to concrete floor	126253-9	Asbestos-containing bitumen adhesive	Chrysotile	3	2 Sqm.	R3	Remove

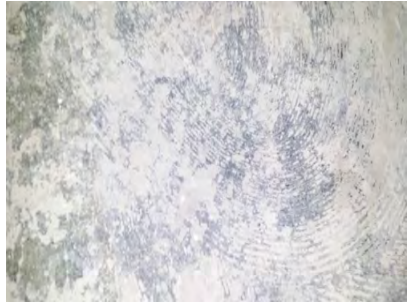
Bacton Low Rise, Block H - Flat 205	-3	002/Bathroom	bitumen to concrete floor	126253-9	Asbestos-containing bitumen adhesive	Chrysotile	3	8 Sqm.	R3	Remove

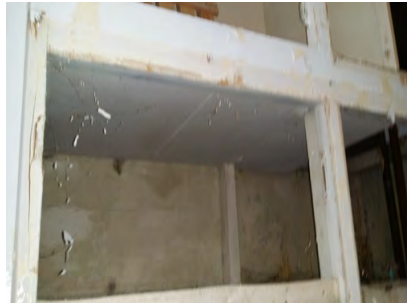
Bacton Low Rise, Block H - Flat 205	-3	003/Bedroom	panel to shelf	126253-10	Asbestos-containing insulating board	Amosite, Chrysotile	6	2 Sqm.	R3	Remove

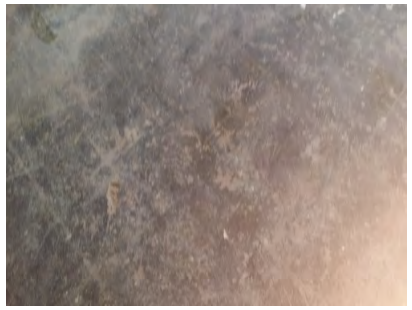
Building	Level	Location	Item / Product Examined	Sample No.	Material Description	Fibre Type	Material Score	Extent	Risk Level Assessment	Initial Control Recommendation	Photograph
Bacton Low Rise, Block H - Flat 205	-3	003/Bedroom	bitumen to concrete floor	126253-9	Asbestos-containing bitumen adhesive	Chrysotile	3	8 Sqm.	R3	Remove

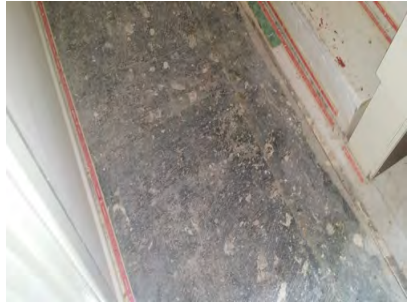
Bacton Low Rise, Block H - Flat 205	-2	001/Stairs	bitumen to concrete floor	126253-9	Asbestos-containing bitumen adhesive	Chrysotile	3	2 Sqm.	R3	Remove

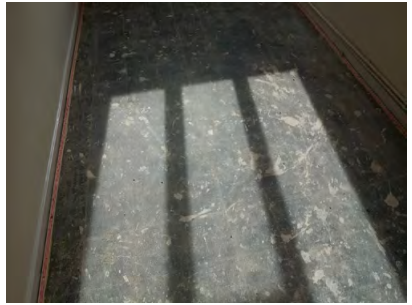
Bacton Low Rise, Block H - Flat 205	-2	002/Bedroom 1	bitumen to concrete floor	126253-9	Asbestos-containing bitumen adhesive	Chrysotile	3	8 Sqm.	R3	Remove

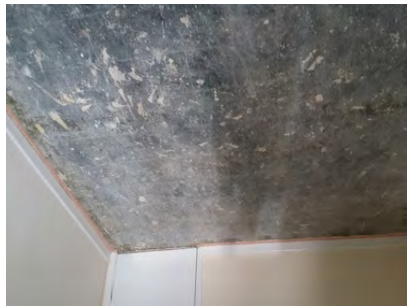
Building	Level	Location	Item / Product Examined	Sample No.	Material Description	Fibre Type	Material Score	Extent	Risk Level Assessment	Initial Control Recommendation	Photograph
Bacton Low Rise, Block H - Flat 205	-2	003/ Bedroom 2	bitumen to concrete floor	126253-9	Asbestos-containing bitumen adhesive	Chrysotile	3	8 Sqm.	R3	Remove

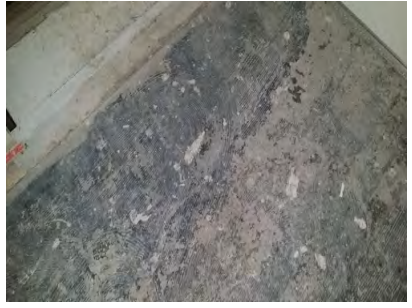
Bacton Low Rise, Block H - Flat 205	-1	001/Stairs	bitumen to concrete floor	126253-9	Asbestos-containing bitumen adhesive	Chrysotile	3	2 Sqm.	R3	Remove

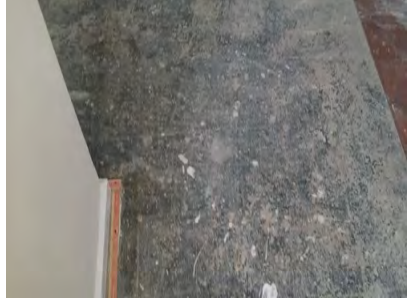
Bacton Low Rise, Block H - Flat 205	-1	002/ Kitchen/ Living room	bitumen to concrete floor	126253-9	Asbestos-containing bitumen adhesive	Chrysotile	3	12 Sqm.	R3	Remove

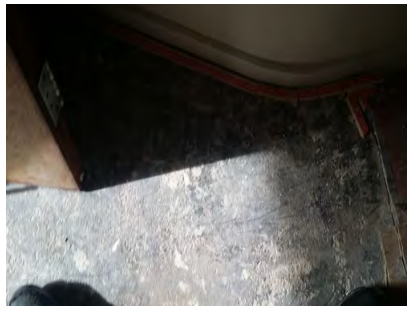
Building	Level	Location	Item / Product Examined	Sample No.	Material Description	Fibre Type	Material Score	Extent	Risk Level Assessment	Initial Control Recommendation	Photograph
Bacton Low Rise, Block H - Flat 205	0	001/ Entrance Lobby	bitumen to concrete floor	126253-9	Asbestos-containing bitumen adhesive	Chrysotile	3	2 Sqm.	R3	Remove

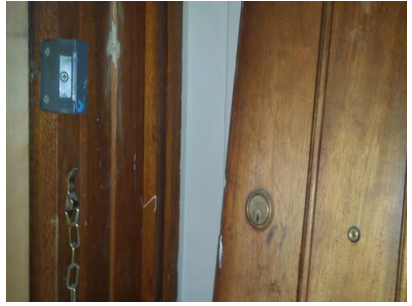
Bacton Low Rise, Block H - Flat 205	0	001/ Entrance Lobby	panel to electrics	126253-10	Asbestos-containing insulating board	Amosite, Chrysotile	6	2 Lm.	R3	Remove

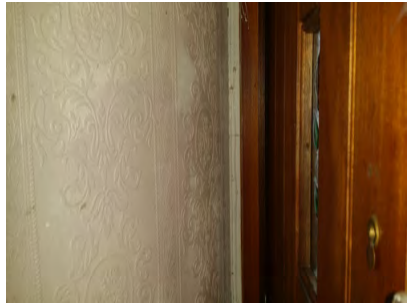
Bacton Low Rise, Block H - Flat 206	0	001/ Entrance Lobby	panel to electrics	126253-13	Asbestos-containing insulating board	Amosite, Chrysotile	6	2 Lm.	R3	Remove

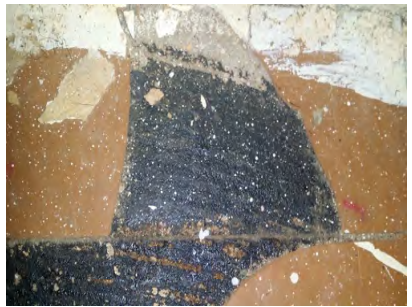
Building	Level	Location	Item / Product Examined	Sample No.	Material Description	Fibre Type	Material Score	Extent	Risk Level Assessment	Initial Control Recommendation	Photograph
Bacton Low Rise, Block H - Flat 206	0	001/ Entrance Lobby	floor covering	126253-12	Asbestos-containing vinyl tile & adhesive	Chrysotile	3	2 Sqm.	R3	Remove

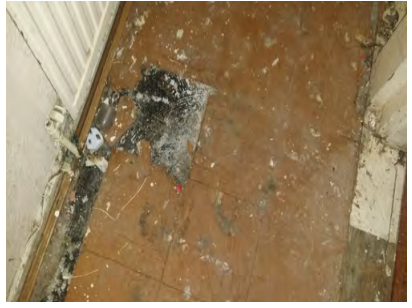
Bacton Low Rise, Block H - Flat 206	1	001/Stairs	floor covering	126253-12	Asbestos-containing vinyl tile & adhesive	Chrysotile	3	2 Sqm.	R3	Remove

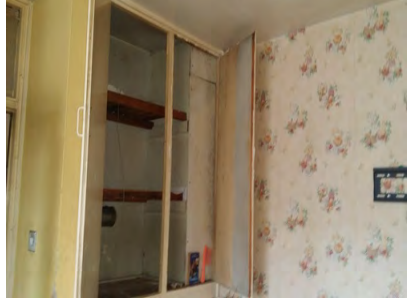
Bacton Low Rise, Block H - Flat 206	1	002 /Kitchen / Living room	boxing within cupboard	126253-14	Asbestos-containing insulating board	Amosite, Chrysotile	6	4 Sqm.	R2	Remove

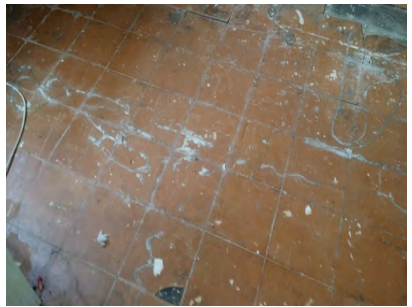
Building	Level	Location	Item / Product Examined	Sample No.	Material Description	Fibre Type	Material Score	Extent	Risk Level Assessment	Initial Control Recommendation	Photograph
Bacton Low Rise, Block H - Flat 206	1	002 /Kitchen / Living room	floor covering	126253-12	Asbestos-containing vinyl tile & adhesive	Chrysotile	3	12 Sqm.	R3	Remove

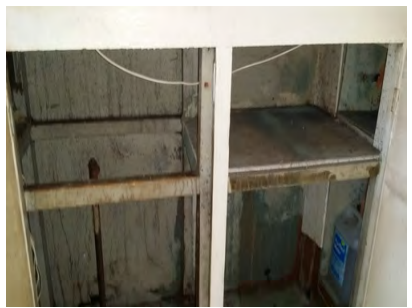
Bacton Low Rise, Block H - Flat 206	1	002 /Kitchen / Living room	panels to shelves	126253-14	Asbestos-containing insulating board	Amosite, Chrysotile	7	2 Sqm.	R1	Remove

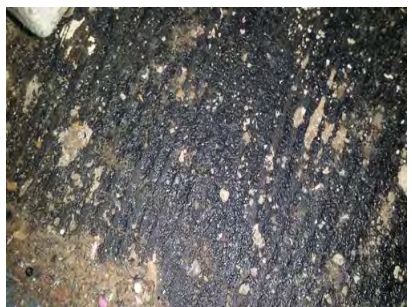
Bacton Low Rise, Block H - Flat 206	2	001/Stairs	adhesive to concrete floor	126253-12	Asbestos-containing bitumen adhesive	Chrysotile	3	2 Sqm.	R3	Remove

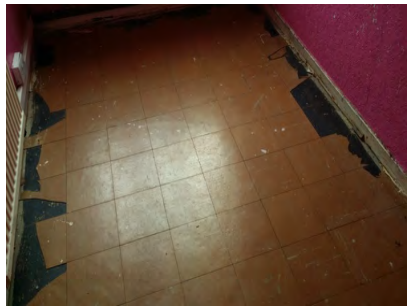
Building	Level	Location	Item / Product Examined	Sample No.	Material Description	Fibre Type	Material Score	Extent	Risk Level Assessment	Initial Control Recommendation	Photograph
Bacton Low Rise, Block H - Flat 206	2	002/Bedroom 1	floor covering	126253-12	Asbestos-containing vinyl tile & adhesive	Chrysotile	3	12 Sqm.	R3	Remove

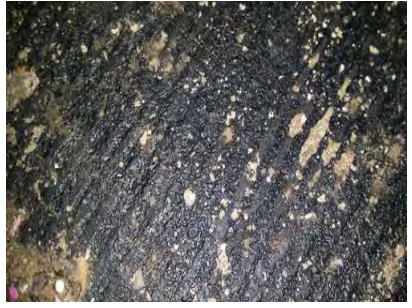
Bacton Low Rise, Block H - Flat 206	2	003/Bedroom 2	adhesive to concrete floor	126253-12	Asbestos-containing bitumen adhesive	Chrysotile	3	12 Sqm.	R3	Remove

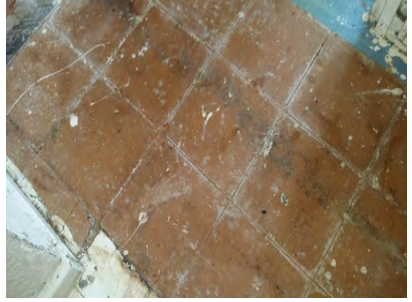
Bacton Low Rise, Block H - Flat 206	3	001/Stairs	floor covering	126253-12	Asbestos-containing vinyl tile & adhesive	Chrysotile	3	2 Sqm.	R3	Remove

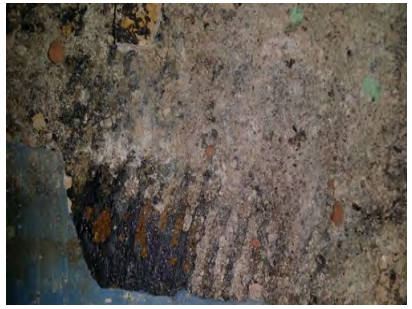
Building	Level	Location	Item / Product Examined	Sample No.	Material Description	Fibre Type	Material Score	Extent	Risk Level Assessment	Initial Control Recommendation	Photograph
Bacton Low Rise, Block H - Flat 206	3	003/ Bathroom	adhesive to concrete floor	126253-12	Asbestos-containing bitumen adhesive	Chrysotile	3	6 Sqm.	R3	Remove

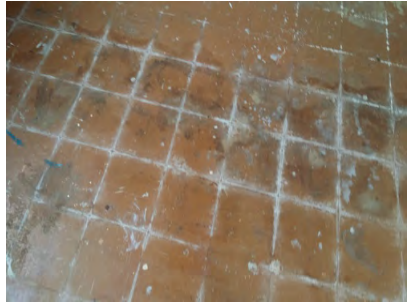
Bacton Low Rise, Block H - Flat 206	3	003/ Bedroom 3	floor covering	126253-12	Asbestos-containing vinyl tile & adhesive	Chrysotile	3	12 Sqm.	R3	Remove

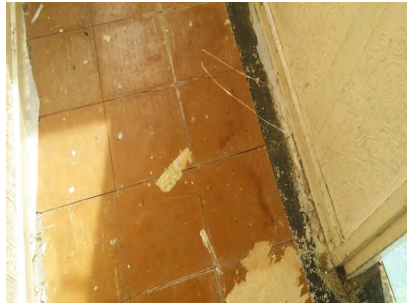
Bacton Low Rise, Block H - Flat 206	4	001/ Bedroom 4	floor covering	126253-12	Asbestos-containing vinyl tile & adhesive	Chrysotile	3	4 Sqm.	R3	Remove

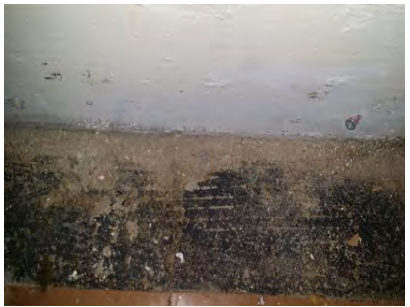
Building	Level	Location	Item / Product Examined	Sample No.	Material Description	Fibre Type	Material Score	Extent	Risk Level Assessment	Initial Control Recommendation	Photograph
Bacton Low Rise, Block H - Flat 207	0	001/ Entrance Lobby	adhesive to concrete floor	126253-16	Asbestos-containing bituminous product	Chrysotile	3	4 Sqm.	R3	Remove

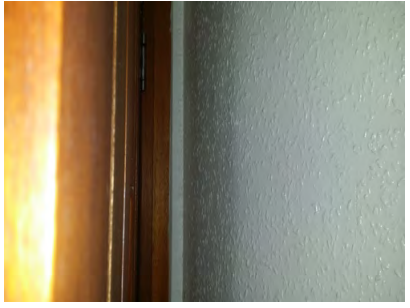
Bacton Low Rise, Block H - Flat 207	0	001/ Entrance Lobby	boxing around electric	126253-17	Asbestos-containing insulating board	Amosite, Chrysotile	6	2 Sqm.	R2	Remove

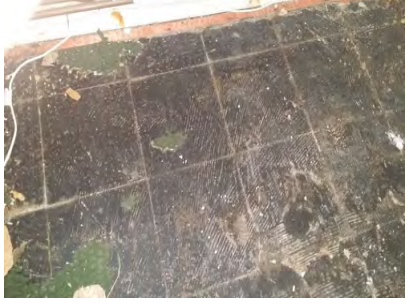
Bacton Low Rise, Block H - Flat 207	1	001/ Stairs	adhesive to concrete floor	126253-16	Asbestos-containing bituminous product	Chrysotile	3	2 Sqm.	R3	Remove

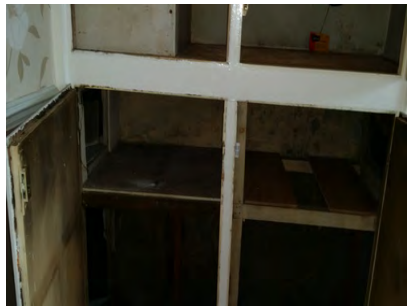
Building	Level	Location	Item / Product Examined	Sample No.	Material Description	Fibre Type	Material Score	Extent	Risk Level Assessment	Initial Control Recommendation	Photograph
Bacton Low Rise, Block H - Flat 207	1	002/ Kitchen/ Living room	panels to shelves	126253-18	Asbestos-containing insulating board	Amosite, Chrysotile	7	2 Sqm.	R1	Remove

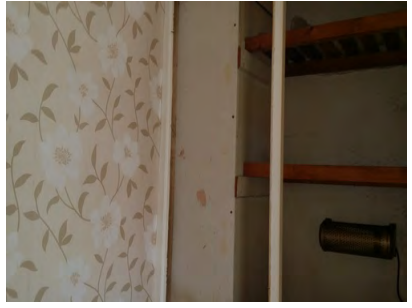
Bacton Low Rise, Block H - Flat 207	1	002/ Kitchen/ Living room	boxing within cupboard	126253-18	Asbestos-containing insulating board	Amosite, Chrysotile	7	4 Sqm.	R2	Remove

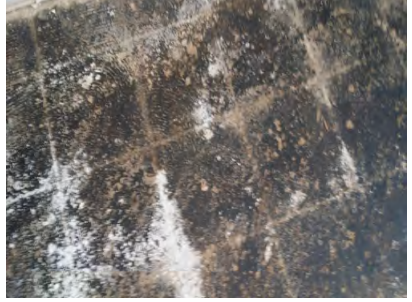
Bacton Low Rise, Block H - Flat 207	1	002/ Kitchen/ Living room	adhesive to concrete floor	126253-16	Asbestos-containing bituminous product	Chrysotile	3	12 Sqm.	R3	Remove

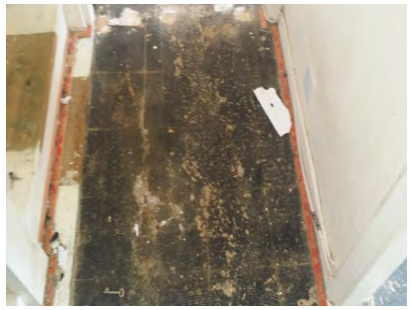
Building	Level	Location	Item / Product Examined	Sample No.	Material Description	Fibre Type	Material Score	Extent	Risk Level Assessment	Initial Control Recommendation	Photograph
Bacton Low Rise, Block H - Flat 207	2	001/ Stairs	adhesive to concrete floor	126253-16	Asbestos-containing bituminous product	Chrysotile	3	2 Sqm.	R3	Remove

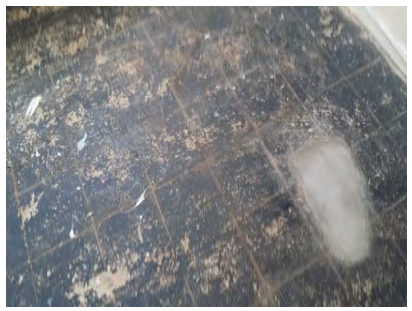
Bacton Low Rise, Block H - Flat 207	2	002/ Bedroom 1	adhesive to concrete floor	126253-16	Asbestos-containing bituminous product	Chrysotile	3	6 Sqm.	R3	Remove

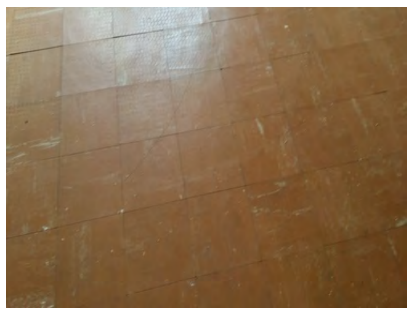
Bacton Low Rise, Block H - Flat 207	2	003/ Bedroom 2	floor covering	126253-21	Asbestos-containing vinyl tile & adhesive	Chrysotile	3	6 Sqm.	R3	Remove

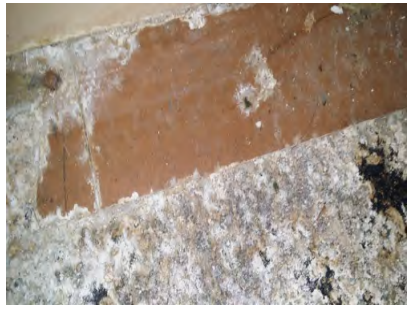
Building	Level	Location	Item / Product Examined	Sample No.	Material Description	Fibre Type	Material Score	Extent	Risk Level Assessment	Initial Control Recommendation	Photograph
Bacton Low Rise, Block H - Flat 207	3	001/Stairs	floor covering	126253-21	Asbestos-containing vinyl tile & adhesive	Chrysotile	3	2 Sqm.	R3	Remove

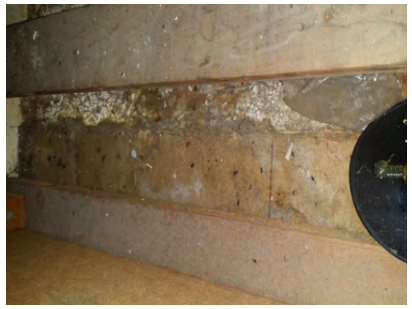
Bacton Low Rise, Block H - Flat 207	3	002/Bathroom	floor covering	126253-21	Asbestos-containing vinyl tile & adhesive	Chrysotile	3	6 Sqm.	R3	Remove

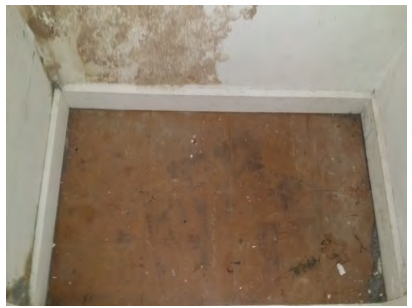
Bacton Low Rise, Block H - Flat 207	3	003/Bedroom	floor covering	126253-21	Asbestos-containing vinyl tile & adhesive	Chrysotile	3	10 Sqm.	R3	Remove

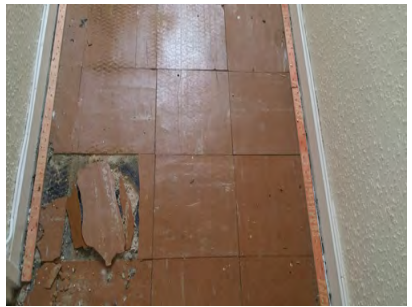
Building	Level	Location	Item / Product Examined	Sample No.	Material Description	Fibre Type	Material Score	Extent	Risk Level Assessment	Initial Control Recommendation	Photograph
Bacton Low Rise, Block H - Flat 207	4	001/ Bedroom	floor covering	126253-21	Asbestos-containing vinyl tile & adhesive	Chrysotile	3	10 Sqm.	R3	Remove

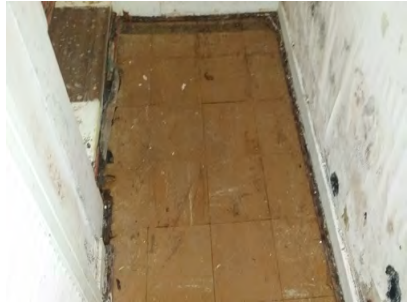
Bacton Low Rise, Block H - Flat 208	-3	001/Stairs	floor covering	126253-22	Asbestos-containing vinyl tile & adhesive	Chrysotile	3	2 Sqm.	R3	Remove

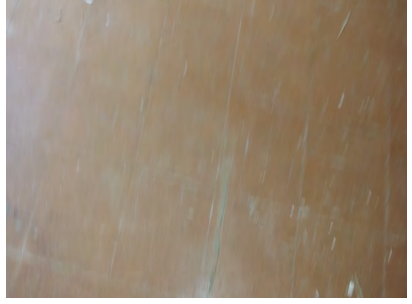
Bacton Low Rise, Block H - Flat 208	-3	002/ Bathroom	floor covering	126253-22	Asbestos-containing vinyl tile & adhesive	Chrysotile	3	8 Sqm.	R3	Remove

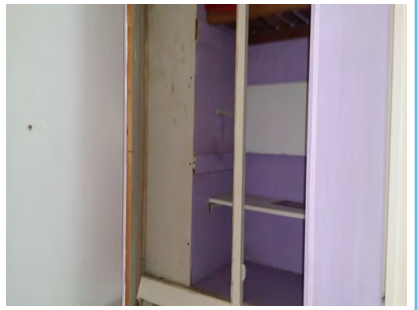
Building	Level	Location	Item / Product Examined	Sample No.	Material Description	Fibre Type	Material Score	Extent	Risk Level Assessment	Initial Control Recommendation	Photograph
Bacton Low Rise, Block H - Flat 208	-3	003/ Bedroom	boxing within cupboard	126253-24	Asbestos-containing insulating board	Amosite, Chrysotile	7	4 Sqm.	R2	Remove

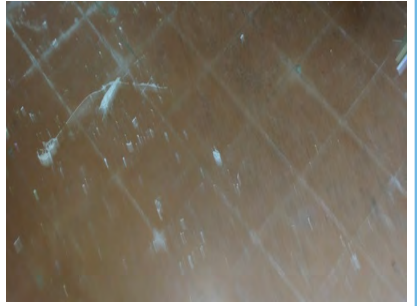
Bacton Low Rise, Block H - Flat 208	-3	003/ Bedroom	floor covering	126253-22	Asbestos-containing vinyl tile & adhesive	Chrysotile	3	12 Sqm.	R3	Remove

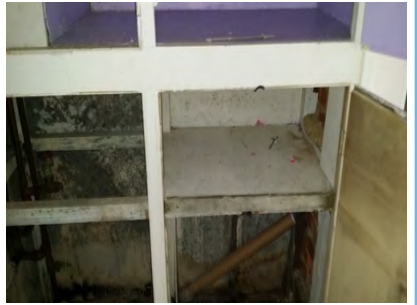
Bacton Low Rise, Block H - Flat 208	-3	003/ Bedroom	panels to shelves	126253-24	Asbestos-containing insulating board	Amosite, Chrysotile	7	2 Sqm.	R1	Remove

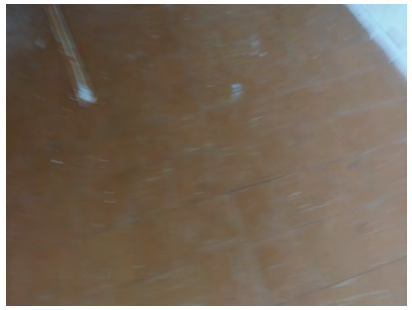
Building	Level	Location	Item / Product Examined	Sample No.	Material Description	Fibre Type	Material Score	Extent	Risk Level Assessment	Initial Control Recommendation	Photograph
Bacton Low Rise, Block H - Flat 208	-2	001/Stairs/Bedroom	floor covering	126253-22	Asbestos-containing vinyl tile & adhesive	Chrysotile	3	12 Sqm.	R3	Remove

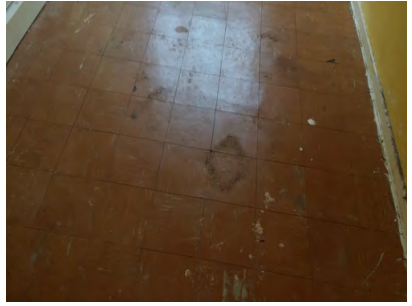
Bacton Low Rise, Block H - Flat 208	-2	002/Bedroom	floor covering	126253-22	Asbestos-containing vinyl tile & adhesive	Chrysotile	3	8 Sqm.	R3	Remove

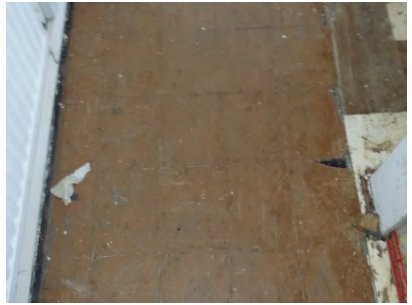
Bacton Low Rise, Block H - Flat 208	-1	001/Stairs	floor covering	126253-22	Asbestos-containing vinyl tile & adhesive	Chrysotile	3	4 Sqm.	R3	Remove

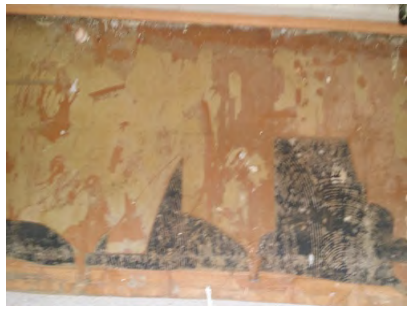
Building	Level	Location	Item / Product Examined	Sample No.	Material Description	Fibre Type	Material Score	Extent	Risk Level Assessment	Initial Control Recommendation	Photograph
Bacton Low Rise, Block H - Flat 208	-1	002/ Kitchen/ Living room	sub floor	126253-22	Asbestos-containing vinyl tile & adhesive	Chrysotile	3	12 Sqm.	R3	Remove

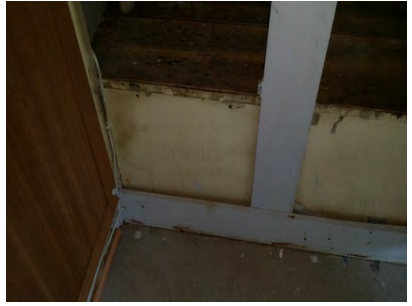
Bacton Low Rise, Block H - Flat 208	-1	002/ Kitchen/ Living room	boxing within cupboard	126253-24	Asbestos-containing insulating board	Amosite, Chrysotile	7	4 Sqm.	R2	Remove

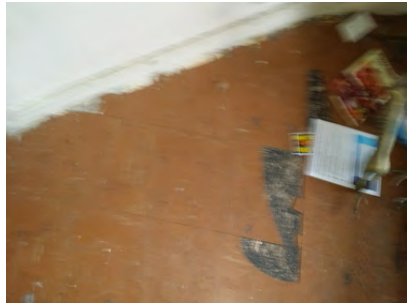
Bacton Low Rise, Block H - Flat 208	0	001/ Entrance Lobby	floor covering	126253-22	Asbestos-containing vinyl tile & adhesive	Chrysotile	3	4 Sqm.	R3	Remove

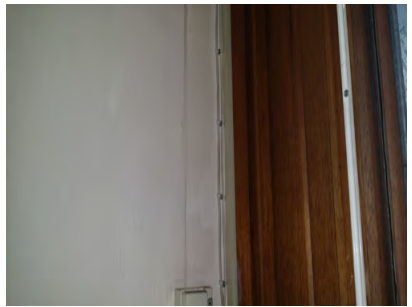
Building	Level	Location	Item / Product Examined	Sample No.	Material Description	Fibre Type	Material Score	Extent	Risk Level Assessment	Initial Control Recommendation	Photograph
Bacton Low Rise, Block H - Flat 208	0	001/ Entrance Lobby	boxing around electric	126253-23	Asbestos-containing insulating board	Amosite, Chrysotile	6	2 Sqm.	R2	Remove

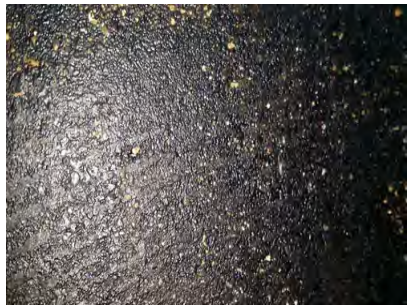
Bacton Low Rise, Block H - Flat 209	-3	001/Stairs	adhesive to concrete floor	126253-26	Asbestos-containing bitumen adhesive	Chrysotile	3	2 Sqm.	R3	Remove

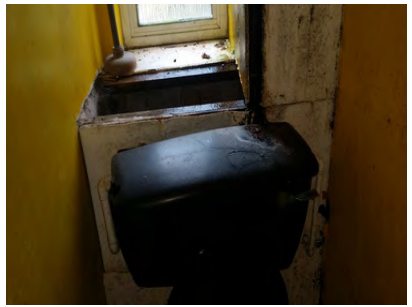
Bacton Low Rise, Block H - Flat 209	-3	002/ Bathroom	toilet cistern	126253-30	Asbestos-containing composite	Amosite	4	1 No.	R3	Remove

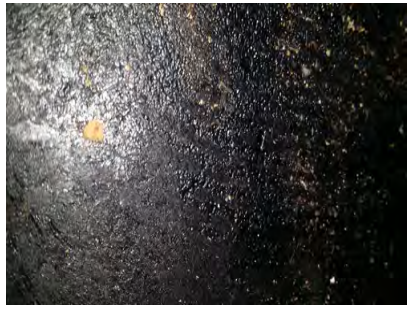
Building	Level	Location	Item / Product Examined	Sample No.	Material Description	Fibre Type	Material Score	Extent	Risk Level Assessment	Initial Control Recommendation	Photograph
Bacton Low Rise, Block H - Flat 209	-3	002/ Bathroom	adhesive to concrete floor	126253-22	Asbestos-containing bitumen adhesive	Chrysotile	3	8 Sqm.	R3	Remove

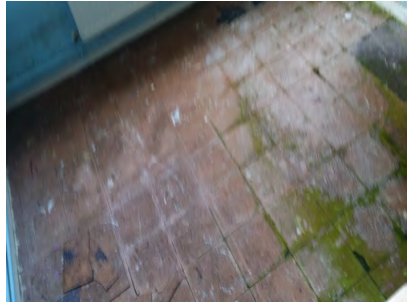
Bacton Low Rise, Block H - Flat 209	-3	003/ Bedroom	floor covering	126253-29	Asbestos-containing vinyl tile & adhesive	Chrysotile	3	12 Sqm.	R3	Remove

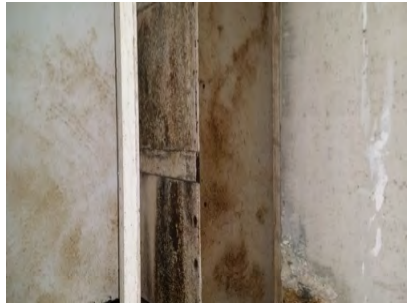
Bacton Low Rise, Block H - Flat 209	-3	003/ Bedroom	boxing within cupboard	126253-31	Asbestos-containing insulating board	Amosite, Chrysotile	7	4 Sqm.	R2	Remove

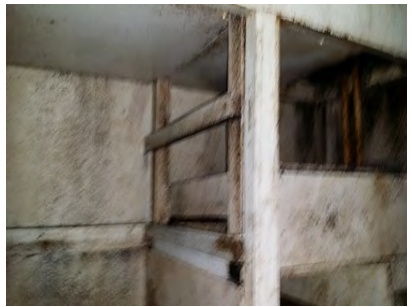
Building	Level	Location	Item / Product Examined	Sample No.	Material Description	Fibre Type	Material Score	Extent	Risk Level Assessment	Initial Control Recommendation	Photograph
Bacton Low Rise, Block H - Flat 209	-3	003/Bedroom	panels to shelves	126253-31	Asbestos-containing insulating board	Amosite, Chrysotile	7	2 Sqm.	R2	Remove

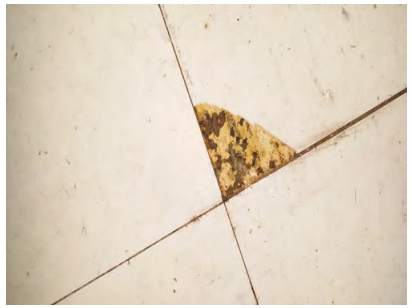
Bacton Low Rise, Block H - Flat 209	-2	001/Stairs/Bedroom	adhesive to concrete floor	126253-26	Asbestos-containing bitumen adhesive	Chrysotile	3	12 Sqm.	R3	Remove

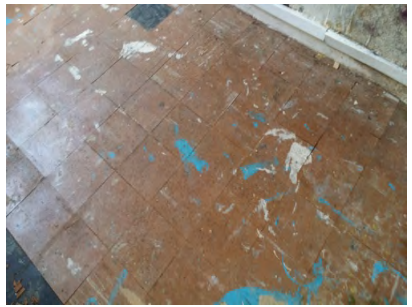
Bacton Low Rise, Block H - Flat 209	-2	002/Bedroom	floor covering	126253-29	Asbestos-containing vinyl tile & adhesive	Chrysotile	3	8 Sqm.	R3	Remove

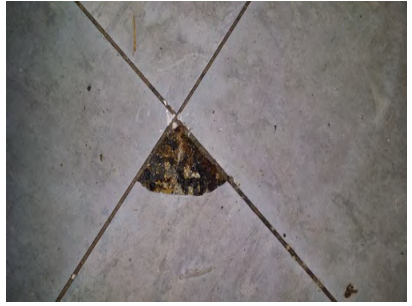
Bacton Low Rise, Block H - Flat 209	-1	002/ Kitchen/ Living room	adhesive to concrete floor	126253-26	Asbestos-containing bitumen adhesive	Chrysotile	3	12 Sqm.	R3	Remove

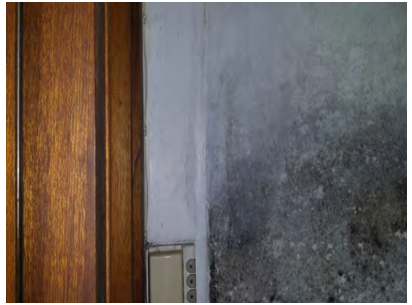
Bacton Low Rise, Block H - Flat 209	0	001/ Entrance Lobby	boxing around electric	126253-27	Asbestos-containing insulating board	Amosite, Chrysotile	6	2 Sqm.	R2	Remove

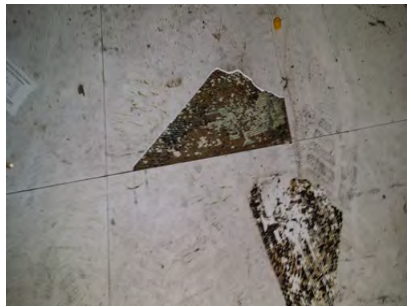
Building	Level	Location	Item / Product Examined	Sample No.	Material Description	Fibre Type	Material Score	Extent	Risk Level Assessment	Initial Control Recommendation	Photograph
Bacton Low Rise, Block H - Flat 209	0	001/ Entrance Lobby	adhesive backing to concrete floor	126253-26	Asbestos-containing bitumen adhesive	Chrysotile	3	4 Sqm.	R3	Remove

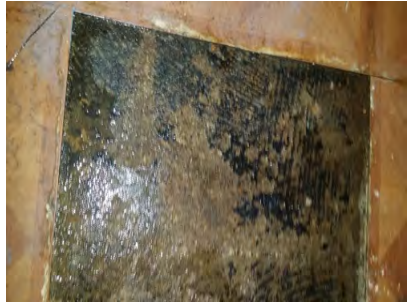
Bacton Low Rise, Block H - Flat 210	1	001/Stairs	adhesive to concrete floor	126253-34	Asbestos-containing bitumen adhesive	Chrysotile	3	4 Sqm.	R3	Remove

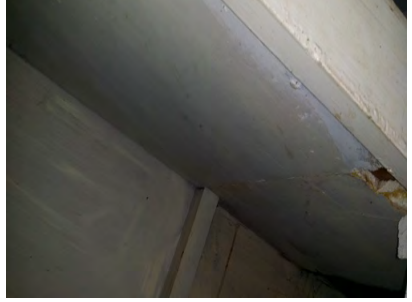
Bacton Low Rise, Block H - Flat 210	1	002/ Kitchen/ Living room	panel to shelf in cupboard	126253-35	Asbestos-containing insulating board	Amosite, Chrysotile	7	1 Sqm.	R2	Remove

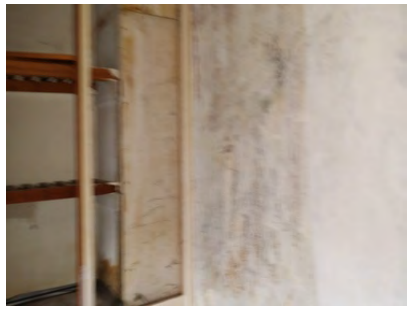
Building	Level	Location	Item / Product Examined	Sample No.	Material Description	Fibre Type	Material Score	Extent	Risk Level Assessment	Initial Control Recommendation	Photograph
Bacton Low Rise, Block H - Flat 210	1	002/ Kitchen/ Living room	boxing within cupboard	126253-35	Asbestos-containing insulating board	Amosite, Chrysotile	7	4 Sqm.	R2	Remove

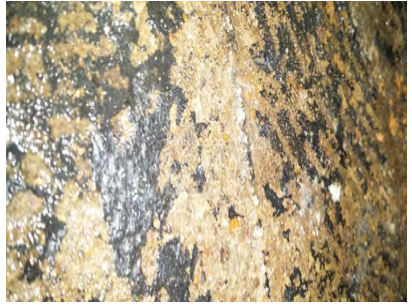
Bacton Low Rise, Block H - Flat 210	1	002/ Kitchen/ Living room	adhesive to concrete floor	126253-34	Asbestos-containing bitumen adhesive	Chrysotile	3	12 Sqm.	R3	Remove

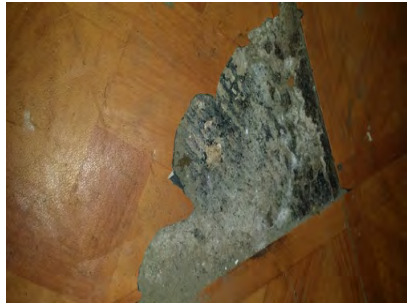
Bacton Low Rise, Block H - Flat 210	2	001/ Stairs	adhesive to concrete floor	126253-34	Asbestos-containing bituminous product	Chrysotile	3	2 Sqm.	R3	Remove

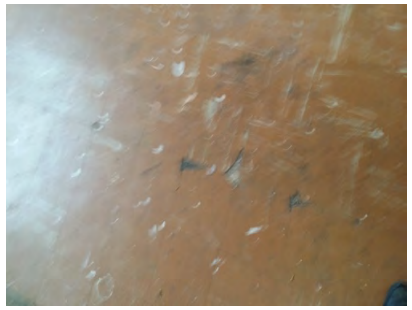
Building	Level	Location	Item / Product Examined	Sample No.	Material Description	Fibre Type	Material Score	Extent	Risk Level Assessment	Initial Control Recommendation	Photograph
Bacton Low Rise, Block H - Flat 210	2	001/Stairs/Bedroom	adhesive to concrete floor	126253-32	Asbestos-containing bitumen adhesive	Chrysotile	3	8 Sqm.	R3	Remove

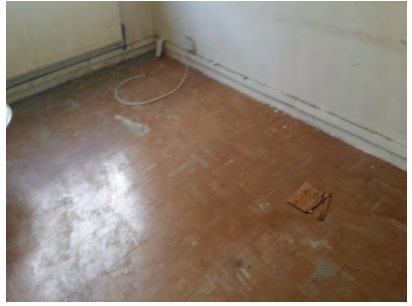
Bacton Low Rise, Block H - Flat 210	2	002/Bedroom	floor covering	126253-32	Asbestos-containing vinyl tile & adhesive	Chrysotile	3	12 Sqm.	R3	Remove

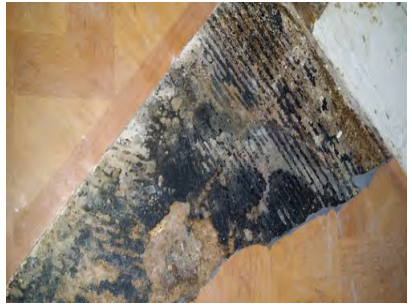
Bacton Low Rise, Block H - Flat 210	3	001/Stairs	floor covering	126253-34	Asbestos-containing vinyl tile & adhesive	Chrysotile	3	2 Sqm.	R3	Remove

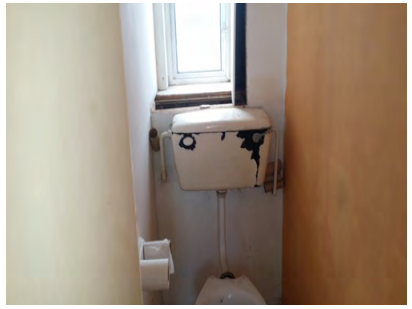
Building	Level	Location	Item / Product Examined	Sample No.	Material Description	Fibre Type	Material Score	Extent	Risk Level Assessment	Initial Control Recommendation	Photograph
Bacton Low Rise, Block H - Flat 210	3	002/ Bathroom	toilet cistern	126253-37	Asbestos-containing composite	Amosite	4	1 No.	R3	Remove

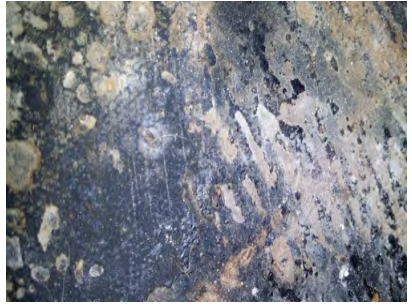
Bacton Low Rise, Block H - Flat 210	3	002/ Bathroom	adhesive to concrete floor	126253-34	Asbestos-containing bitumen adhesive	Chrysotile	3	6 Sqm.	R3	Remove

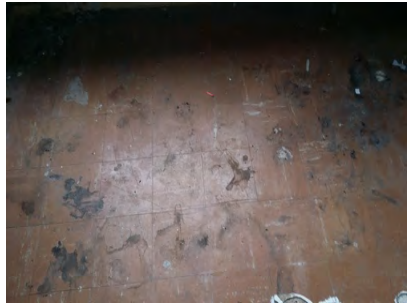
Bacton Low Rise, Block H - Flat 210	3	003/ Bedroom	floor covering	126253-32	Asbestos-containing vinyl tile & adhesive	Chrysotile	3	10 Sqm.	R3	Remove

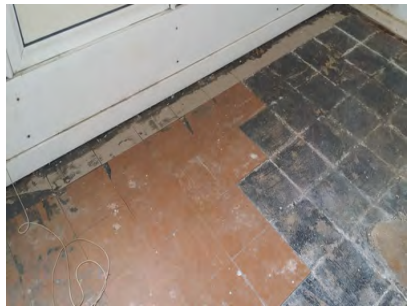
Building	Level	Location	Item / Product Examined	Sample No.	Material Description	Fibre Type	Material Score	Extent	Risk Level Assessment	Initial Control Recommendation	Photograph
Bacton Low Rise, Block H - Flat 210	4	001/ Bedroom	floor covering	126253-32	Asbestos-containing vinyl tile & adhesive	Chrysotile	3	10 Sqm.	R3	Remove

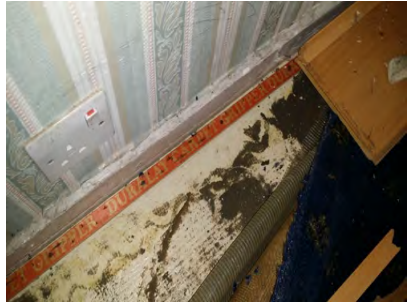
Bacton Low Rise, Block H - Flat 211	0	001/ Entrance Lobby	adhesive to concrete floor	126253-38	Asbestos-containing bitumen adhesive	Chrysotile	3	4 Sqm.	R3	Remove

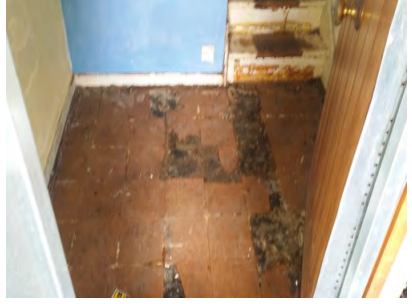
Bacton Low Rise, Block H - Flat 211	0	001/ Entrance Lobby	floor covering	126253-32	Asbestos-containing vinyl tile & adhesive	Chrysotile	3	4 Sqm.	R3	Remove

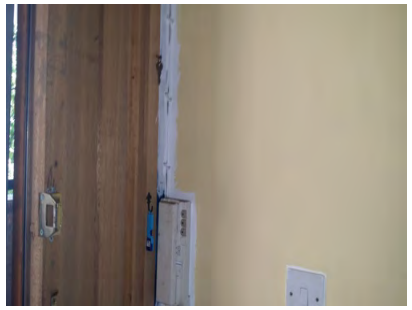
Building	Level	Location	Item / Product Examined	Sample No.	Material Description	Fibre Type	Material Score	Extent	Risk Level Assessment	Initial Control Recommendation	Photograph
Bacton Low Rise, Block H - Flat 211	0	001/ Entrance Lobby	boxing around electric	126253-33	Asbestos-containing insulating board	Amosite, Chrysotile	6	2 Sqm.	R2	Remove

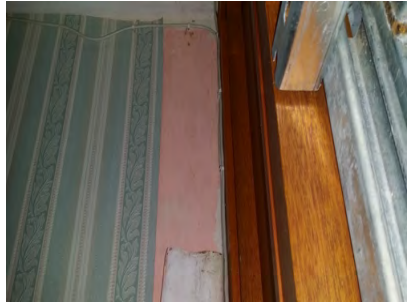
Bacton Low Rise, Block H - Flat 211	0	001/ Entrance Lobby	boxing around electric	126253-39	Asbestos-containing insulating board	Amosite, Chrysotile	6	2 Sqm.	R2	Remove

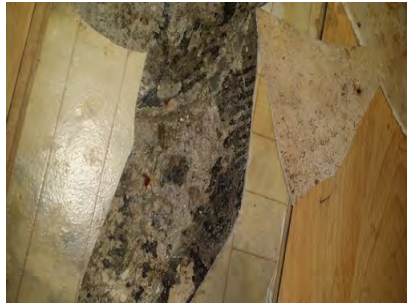
Bacton Low Rise, Block H - Flat 211	1	001/Stairs	adhesive to concrete floor	126253-38	Asbestos-containing bitumen adhesive	Chrysotile	3	4 Sqm.	R3	Remove

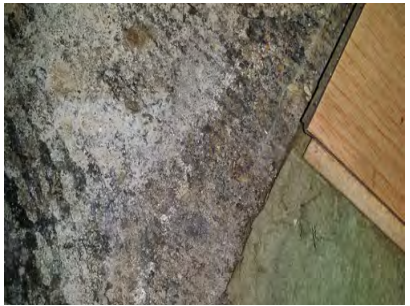
Building	Level	Location	Item / Product Examined	Sample No.	Material Description	Fibre Type	Material Score	Extent	Risk Level Assessment	Initial Control Recommendation	Photograph
Bacton Low Rise, Block H - Flat 211	1	002/ Kitchen/ Living room	adhesive to concrete floor	126253-38	Asbestos-containing bitumen adhesive	Chrysotile	3	12 Sqm.	R3	Remove

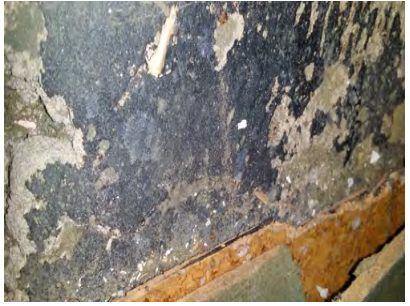
Bacton Low Rise, Block H - Flat 211	2	001/ Stairs	adhesive to concrete floor	126253-38	Asbestos-containing bituminous product	Chrysotile	3	2 Sqm.	R3	Remove

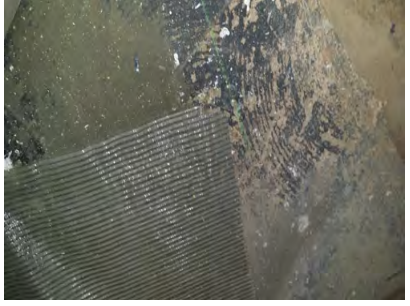
Bacton Low Rise, Block H - Flat 211	2	002/ Bedroom	adhesive to concrete floor	126253-38	Asbestos-containing bitumen adhesive	Chrysotile	3	12 Sqm.	R3	Remove

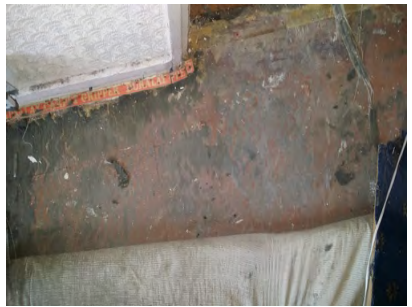
Building	Level	Location	Item / Product Examined	Sample No.	Material Description	Fibre Type	Material Score	Extent	Risk Level Assessment	Initial Control Recommendation	Photograph
Bacton Low Rise, Block H - Flat 211	2	003/Bedroom	floor covering	126253-42	Asbestos-containing vinyl tile & adhesive	Chrysotile	3	12 Sqm.	R3	Remove

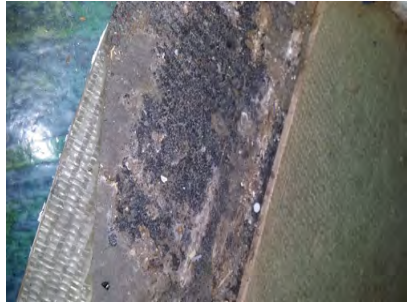
Bacton Low Rise, Block H - Flat 211	3	001/Stairs	adhesive to concrete floor	126253-38	Asbestos-containing bitumen adhesive	Chrysotile	3	2 Sqm.	R3	Remove

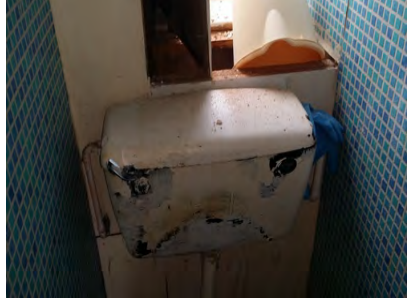
Bacton Low Rise, Block H - Flat 211	3	002/Bathroom	toilet cistern	126253-43	Asbestos-containing composite	Amosite	4	1 No.	R3	Remove

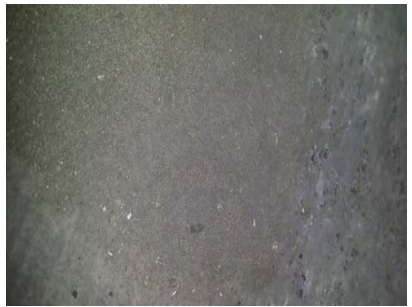
Building	Level	Location	Item / Product Examined	Sample No.	Material Description	Fibre Type	Material Score	Extent	Risk Level Assessment	Initial Control Recommendation	Photograph
Bacton Low Rise, Block H - Flat 211	3	002/ Bathroom	adhesive to concrete floor	126253-38	Asbestos-containing bitumen adhesive	Chrysotile	3	6 Sqm.	R3	Remove

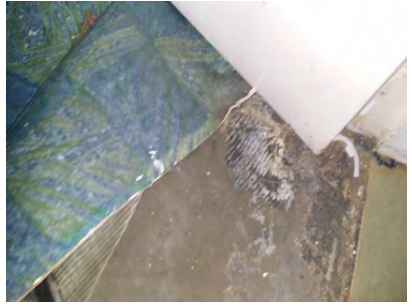
Bacton Low Rise, Block H - Flat 211	3	003/ Bedroom	adhesive to concrete floor	126253-38	Asbestos-containing bitumen adhesive	Chrysotile	3	10 Sqm.	R3	Remove

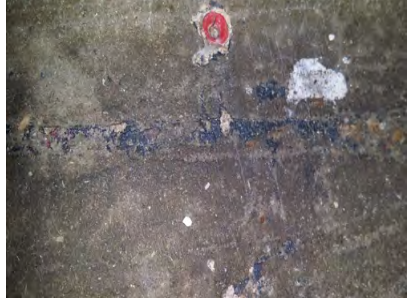
Bacton Low Rise, Block H - Flat 211	4	001/ Bedroom	adhesive to concrete floor	126253-38	Asbestos-containing bitumen adhesive	Chrysotile	3	10 Sqm.	R3	Remove

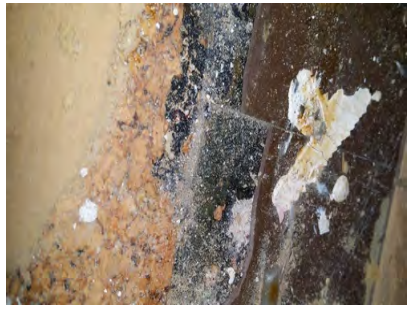
Building	Level	Location	Item / Product Examined	Sample No.	Material Description	Fibre Type	Material Score	Extent	Risk Level Assessment	Initial Control Recommendation	Photograph
Bacton Low Rise, Block H - Flat 212	-3	001/Stairs	adhesive to concrete floor	126253-44	Asbestos-containing bitumen adhesive	Chrysotile	3	2 Sqm.	R3	Remove

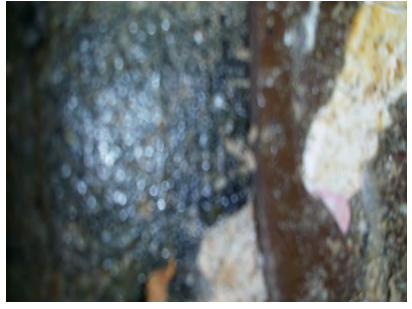
Bacton Low Rise, Block H - Flat 212	-3	002/Bathroom	adhesive to concrete floor	126253-44	Asbestos-containing bitumen adhesive	Chrysotile	3	8 Sqm.	R3	Remove

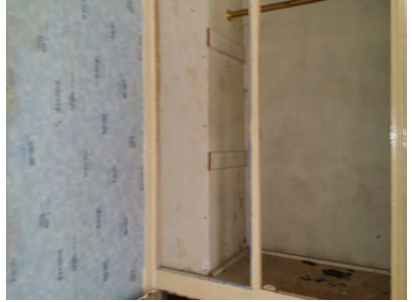
Bacton Low Rise, Block H - Flat 212	-3	003/Bedroom	boxing within cupboard	126253-49	Asbestos-containing insulating board	Amosite, Chrysotile	7	4 Sqm.	R2	Remove

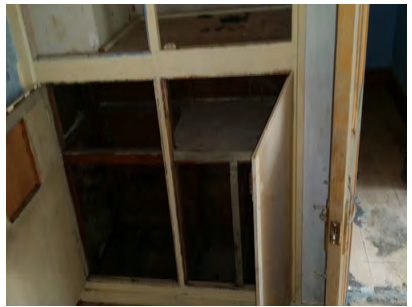
Building	Level	Location	Item / Product Examined	Sample No.	Material Description	Fibre Type	Material Score	Extent	Risk Level Assessment	Initial Control Recommendation	Photograph
Bacton Low Rise, Block H - Flat 212	-3	003/ Bedroom	panels to shelves	126253-49	Asbestos-containing insulating board	Amosite, Chrysotile	7	2 Sqm.	R2	Remove

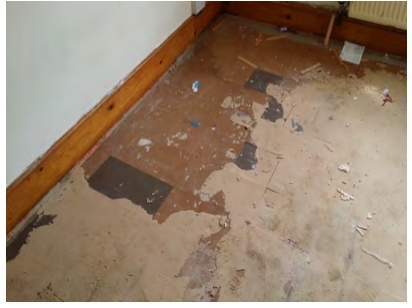
Bacton Low Rise, Block H - Flat 212	-3	003/ Bedroom	floor covering	126253-46	Asbestos-containing vinyl tile & adhesive	Chrysotile	3	12 Sqm.	R3	Remove

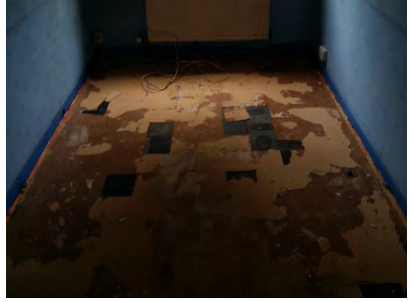
Bacton Low Rise, Block H - Flat 212	-2	001/Stairs/ Bedroom	floor covering	126253-46	Asbestos-containing vinyl tile & adhesive	Chrysotile	3	12 Sqm.	R3	Remove

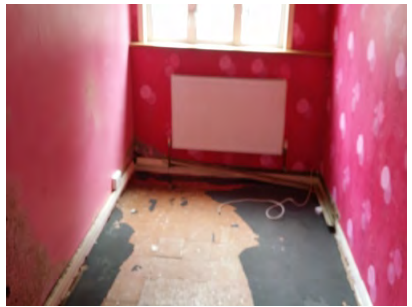
Building	Level	Location	Item / Product Examined	Sample No.	Material Description	Fibre Type	Material Score	Extent	Risk Level Assessment	Initial Control Recommendation	Photograph
Bacton Low Rise, Block H - Flat 212	-2	002/ Bedroom	floor covering	126253-46	Asbestos-containing vinyl tile & adhesive	Chrysotile	3	12 Sqm.	R3	Remove

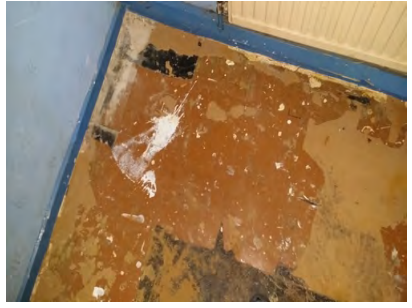
Bacton Low Rise, Block H - Flat 212	-1	001/Stairs	floor covering	126253-46	Asbestos-containing vinyl tile & adhesive	Chrysotile	3	2 Sqm.	R3	Remove

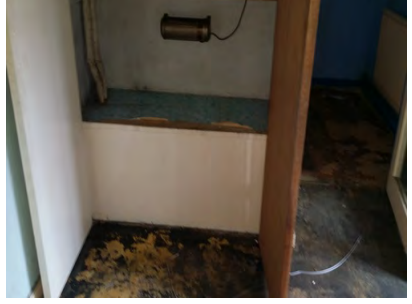
Bacton Low Rise, Block H - Flat 212	-1	002/ Kitchen/ Living room	boxing within cupboard	126253-48	Asbestos-containing insulating board	Amosite, Chrysotile	6	2 Sqm.	R3	Remove
