# Management Recommendation Detail

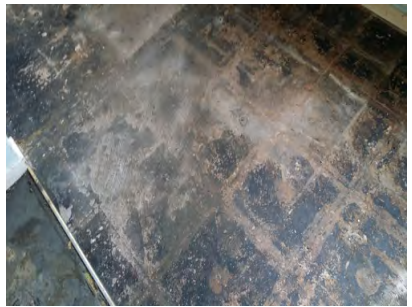
Building	Level	Location	Item / Product Examined	Sample No.	Material Description	Fibre Type	Material Score	Extent	Risk Level Assessment	Initial Control Recommendation	Photograph
Bacton Low Rise, Block H - Flat 212	-1	002/ Kitchen/ Living room	adhesive to concrete floor	126253-44	Asbestos-containing bitumen adhesive	Chrysotile	3	12 Sqm.	R3	Remove

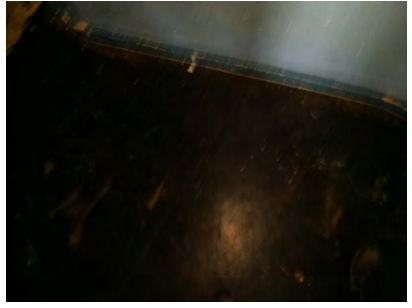
Bacton Low Rise, Block H - Flat 212	0	001/ Entrance Lobby	adhesive to concrete floor	126253-44	Asbestos-containing bitumen adhesive	Chrysotile	3	4 Sqm.	R3	Remove

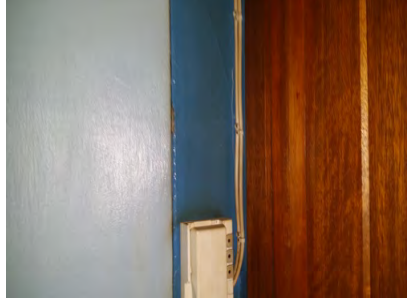
Bacton Low Rise, Block H - Flat 212	0	001/ Entrance Lobby	boxing around electric	126253-45	Asbestos-containing insulating board	Amosite, Chrysotile	6	2 Sqm.	R2	Remove

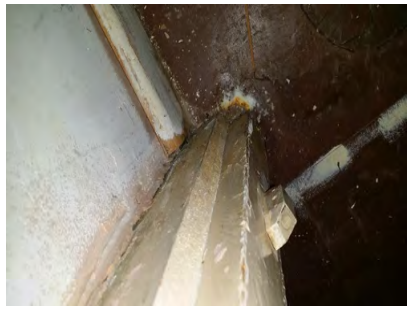
Building	Level	Location	Item / Product Examined	Sample No.	Material Description	Fibre Type	Material Score	Extent	Risk Level Assessment	Initial Control Recommendation	Photograph
Bacton Low Rise, Block H - Flat 213	-3	001/Stairs	adhesive to concrete floor	126253-50	Asbestos-containing bitumen adhesive	Chrysotile	3	2 Sqm.	R3	Remove

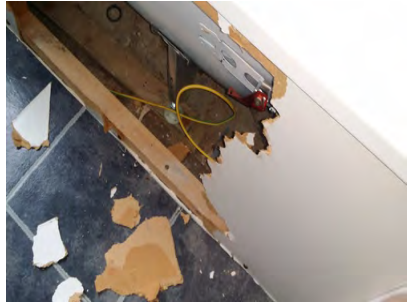
Bacton Low Rise, Block H - Flat 213	-3	002/Bathroom	adhesive to concrete floor	126253-50	Asbestos-containing bitumen adhesive	Chrysotile	3	8 Sqm.	R3	Remove

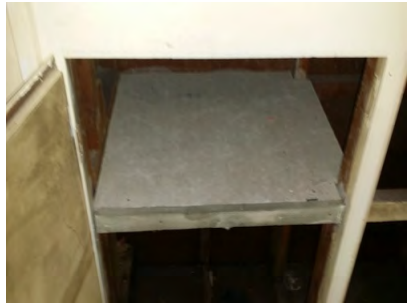
Bacton Low Rise, Block H - Flat 213	-3	003/Bedroom	panels to shelves	126253-52	Asbestos-containing insulating board	Amosite, Chrysotile	7	2 Sqm.	R2	Remove

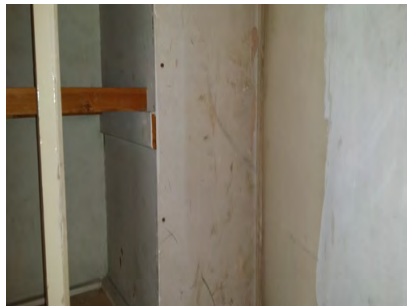
Building	Level	Location	Item / Product Examined	Sample No.	Material Description	Fibre Type	Material Score	Extent	Risk Level Assessment	Initial Control Recommendation	Photograph
Bacton Low Rise, Block H - Flat 213	-3	003/ Bedroom	boxing within cupboard	126253-52	Asbestos-containing insulating board	Amosite, Chrysotile	7	4 Sqm.	R2	Remove

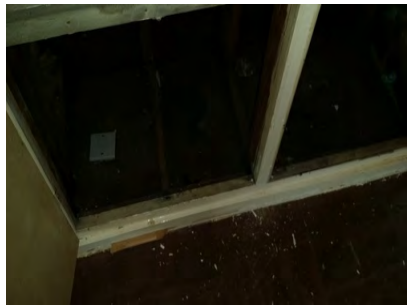
Bacton Low Rise, Block H - Flat 213	-3	003/ Bedroom	adhesive to concrete floor	126253-50	Asbestos-containing bitumen adhesive	Chrysotile	3	12 Sqm.	R3	Remove

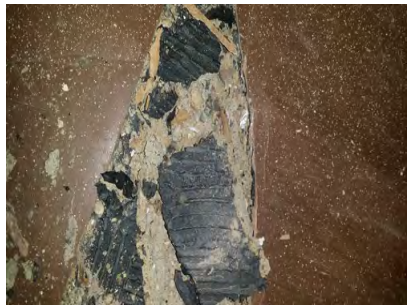
Bacton Low Rise, Block H - Flat 213	-2	002/ Bedroom	adhesive backing to concrete floor	126253-50	Asbestos-containing bitumen adhesive	Chrysotile	3	12 Sqm.	R3	Remove

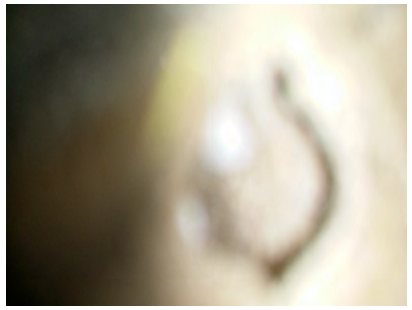
Building	Level	Location	Item / Product Examined	Sample No.	Material Description	Fibre Type	Material Score	Extent	Risk Level Assessment	Initial Control Recommendation	Photograph
Bacton Low Rise, Block H - Flat 213	-1	001/Stairs	floor covering	126253-50	Asbestos-containing vinyl tile & adhesive	Chrysotile	3	2 Sqm.	R3	Remove

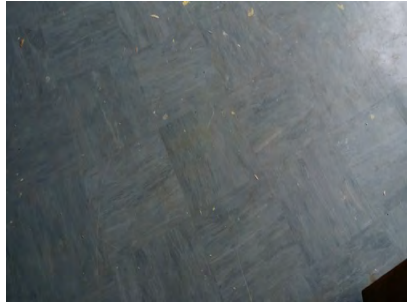
Bacton Low Rise, Block H - Flat 213	-1	002/ Kitchen/ Living room	adhesive to concrete floor	126253-50	Asbestos-containing bitumen adhesive	Chrysotile	3	12 Sqm.	R3	Remove

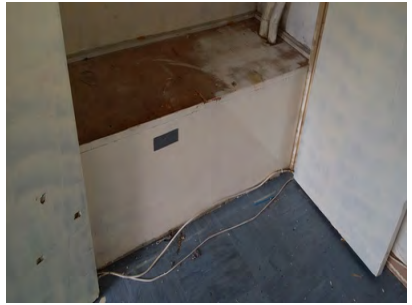
Bacton Low Rise, Block H - Flat 213	-1	002/ Kitchen/ Living room	boxing within cupboard	126253-52	Asbestos-containing insulating board	Amosite, Chrysotile	6	2 Sqm.	R3	Remove

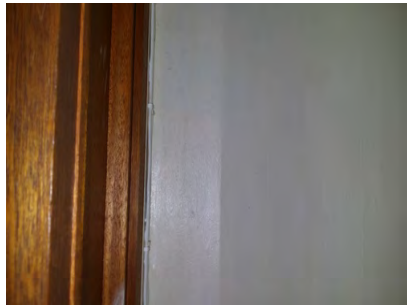
Building	Level	Location	Item / Product Examined	Sample No.	Material Description	Fibre Type	Material Score	Extent	Risk Level Assessment	Initial Control Recommendation	Photograph
Bacton Low Rise, Block H - Flat 213	0	001/ Entrance Lobby	boxing around electric	126253-51	Asbestos-containing insulating board	Amosite, Chrysotile	6	2 Lm.	R2	Remove

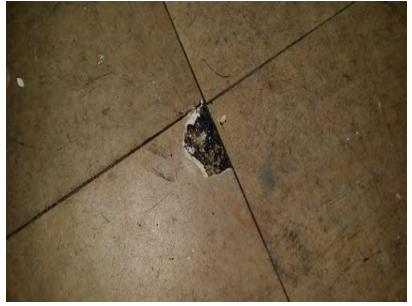
Bacton Low Rise, Block H - Flat 213	0	001/ Entrance Lobby	adhesive to concrete floor	126253-50	Asbestos-containing bitumen adhesive	Chrysotile	3	4 Sqm.	R3	Remove

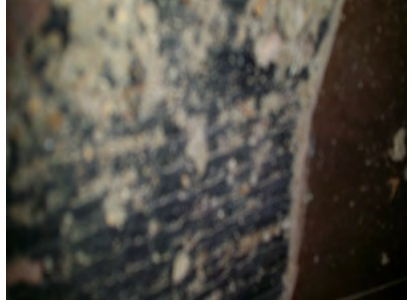
Bacton Low Rise, Block H - Flat 213	2	001/Stairs/ Bedroom	adhesive to concrete floor	126253-50	Asbestos-containing bitumen adhesive	Chrysotile	3	12 Sqm.	R3	Remove

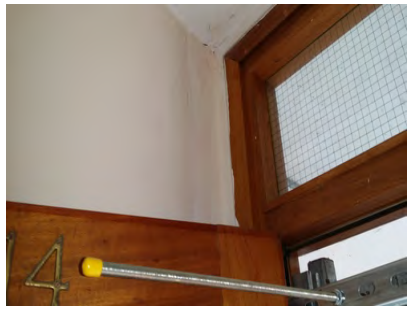
Building	Level	Location	Item / Product Examined	Sample No.	Material Description	Fibre Type	Material Score	Extent	Risk Level Assessment	Initial Control Recommendation	Photograph
Bacton Low Rise, Block H - Flat 214	0	001/ Entrance Lobby	boxing around electric	126253-55	Asbestos-containing insulating board	Amosite, Chrysotile	6	2 Sqm.	R2	Remove

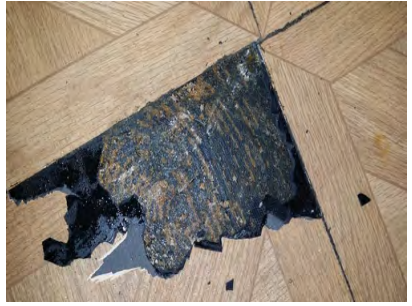
Bacton Low Rise, Block H - Flat 214	0	001/ Entrance Lobby	adhesive to concrete floor	126253-54	Asbestos-containing bitumen adhesive	Chrysotile	3	4 Sqm.	R3	Remove

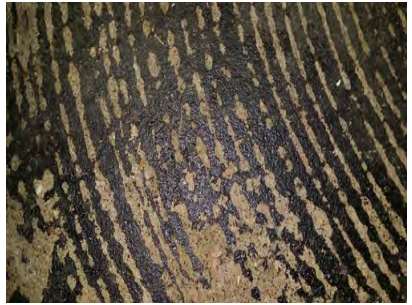
Bacton Low Rise, Block H - Flat 214	1	001/Stairs	adhesive to concrete floor	126253-54	Asbestos-containing bitumen adhesive	Chrysotile	3	4 Sqm.	R3	Remove

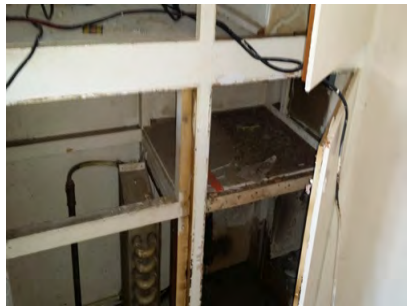
Building	Level	Location	Item / Product Examined	Sample No.	Material Description	Fibre Type	Material Score	Extent	Risk Level Assessment	Initial Control Recommendation	Photograph
Bacton Low Rise, Block H - Flat 214	1	002/ Kitchen/ Living room	panels to shelves	126253-57	Asbestos-containing insulating board	Amosite, Chrysotile	7	2 Sqm.	R2	Remove

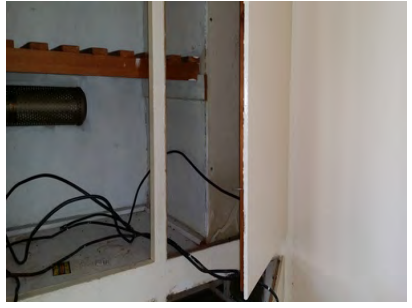
Bacton Low Rise, Block H - Flat 214	1	002/ Kitchen/ Living room	boxing within cupboard	126253-57	Asbestos-containing insulating board	Amosite, Chrysotile	7	4 Sqm.	R2	Remove

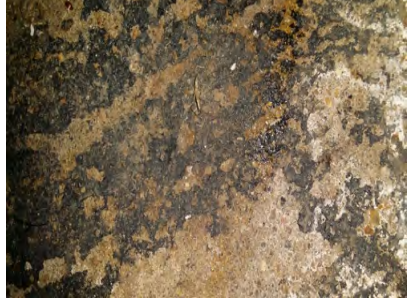
Bacton Low Rise, Block H - Flat 214	1	002/ Kitchen/ Living room	adhesive to concrete floor	126253-54	Asbestos-containing bitumen adhesive	Chrysotile	3	12 Sqm.	R3	Remove

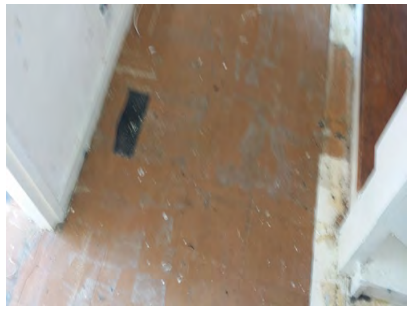
Building	Level	Location	Item / Product Examined	Sample No.	Material Description	Fibre Type	Material Score	Extent	Risk Level Assessment	Initial Control Recommendation	Photograph
Bacton Low Rise, Block H - Flat 214	2	001/ Stairs	floor covering	126253-58	Asbestos-containing vinyl tile & adhesive	Chrysotile	3	2 Sqm.	R3	Remove

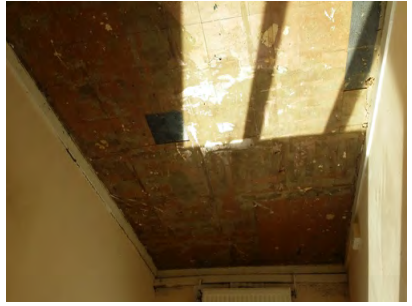
Bacton Low Rise, Block H - Flat 214	2	002/ Bedroom	floor covering	126253-58	Asbestos-containing vinyl tile & adhesive	Chrysotile	3	8 Sqm.	R3	Remove

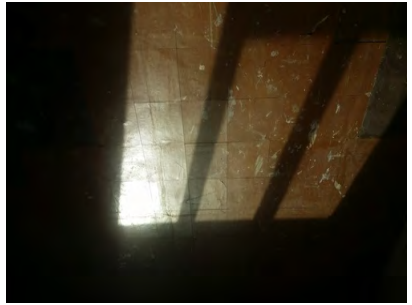
Bacton Low Rise, Block H - Flat 214	2	003/ Bedroom	floor covering	126253-58	Asbestos-containing vinyl tile & adhesive	Chrysotile	3	12 Sqm.	R3	Remove

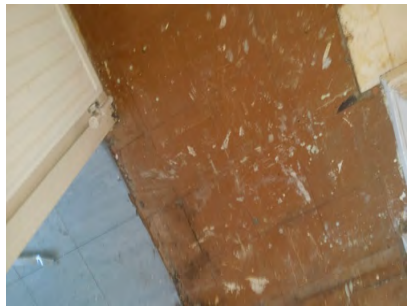
Building	Level	Location	Item / Product Examined	Sample No.	Material Description	Fibre Type	Material Score	Extent	Risk Level Assessment	Initial Control Recommendation	Photograph
Bacton Low Rise, Block H - Flat 214	3	001/Stairs	floor covering	126253-58	Asbestos-containing vinyl tile & adhesive	Chrysotile	3	2 Sqm.	R3	Remove

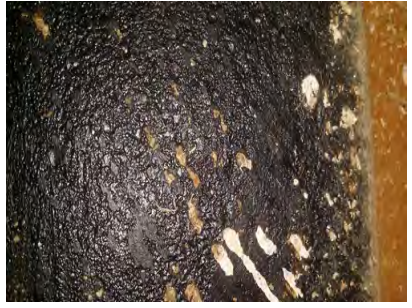
Bacton Low Rise, Block H - Flat 214	3	002/Bathroom	adhesive to concrete floor	126253-54	Asbestos-containing bitumen adhesive	Chrysotile	3	6 Sqm.	R3	Remove

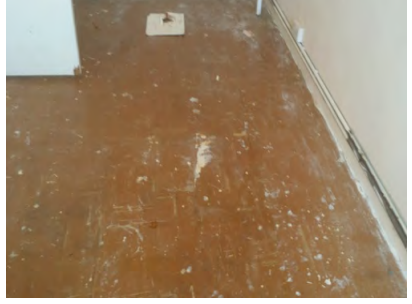
Bacton Low Rise, Block H - Flat 214	3	003/Bedroom	floor covering	126253-58	Asbestos-containing vinyl tile & adhesive	Chrysotile	3	10 Sqm.	R3	Remove

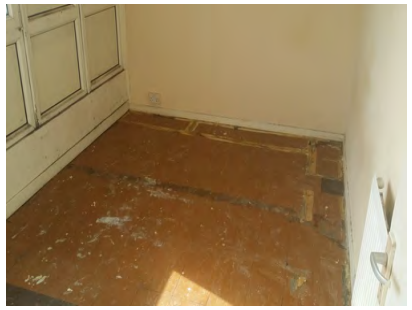
Building	Level	Location	Item / Product Examined	Sample No.	Material Description	Fibre Type	Material Score	Extent	Risk Level Assessment	Initial Control Recommendation	Photograph
Bacton Low Rise, Block H - Flat 214	4	001/Bedroom	floor covering	126253-58	Asbestos-containing vinyl tile & adhesive	Chrysotile	3	10 Sqm.	R3	Remove

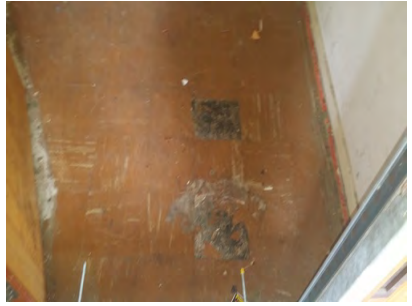
Bacton Low Rise, Block H - Flat 215	0	001/Stairs	floor covering	126253-62	Asbestos-containing vinyl tile & adhesive	Chrysotile	3	4 Sqm.	R3	Remove

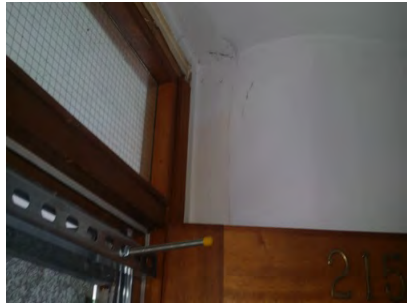
Bacton Low Rise, Block H - Flat 215	0	001/Stairs	panel to electrics	126253-63	Asbestos-containing insulating board	Amosite, Chrysotile	6	2 Lm.	R3	Remove

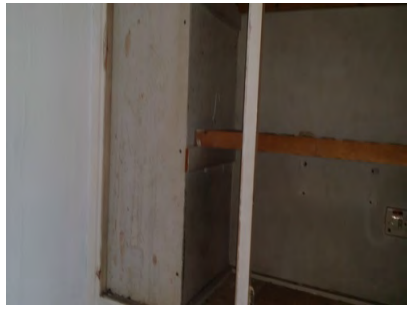
Building	Level	Location	Item / Product Examined	Sample No.	Material Description	Fibre Type	Material Score	Extent	Risk Level Assessment	Initial Control Recommendation	Photograph
Bacton Low Rise, Block H - Flat 215	1	002/ Kitchen/ Living room	boxing within cupboard	126253-65	Asbestos-containing insulating board	Amosite, Chrysotile	7	4 Sqm.	R2	Remove

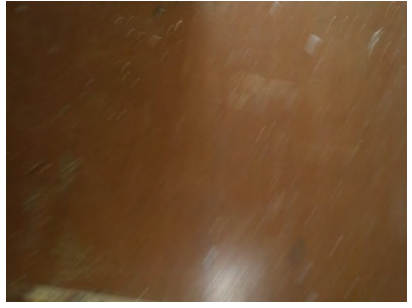
Bacton Low Rise, Block H - Flat 215	1	002/ Kitchen/ Living room	adhesive to concrete floor	126253-54	Asbestos-containing bitumen adhesive	Chrysotile	3	12 Sqm.	R3	Remove	
Bacton Low Rise, Block H - Flat 215	2	001/ Stairs	floor covering	126253-62	Asbestos-containing vinyl tile & adhesive	Chrysotile	3	2 Sqm.	R3	Remove

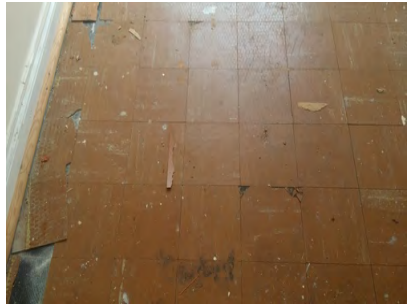
Bacton Low Rise, Block H - Flat 215	2	002/ Bedroom	floor covering	126253-62	Asbestos-containing vinyl tile & adhesive	Chrysotile	3	8 Sqm.	R3	Remove

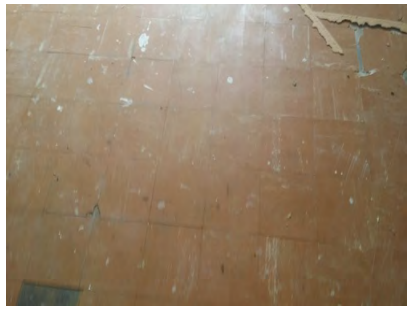
Building	Level	Location	Item / Product Examined	Sample No.	Material Description	Fibre Type	Material Score	Extent	Risk Level Assessment	Initial Control Recommendation	Photograph
Bacton Low Rise, Block H - Flat 215	2	003/Bedroom	floor covering	126253-62	Asbestos-containing vinyl tile & adhesive	Chrysotile	3	12 Sqm.	R3	Remove

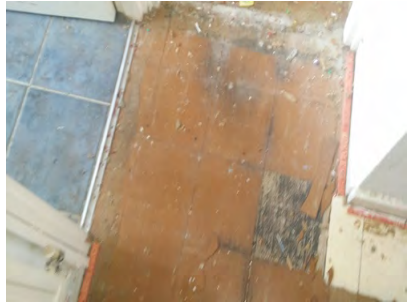
Bacton Low Rise, Block H - Flat 215	3	001/Stairs	floor covering	126253-62	Asbestos-containing vinyl tile & adhesive	Chrysotile	3	2 Sqm.	R3	Remove

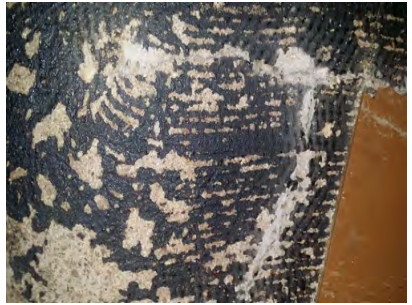
Bacton Low Rise, Block H - Flat 215	3	002/Bathroom	adhesive to concrete floor	126253-62	Asbestos-containing bitumen adhesive	Chrysotile	3	6 Sqm.	R3	Remove

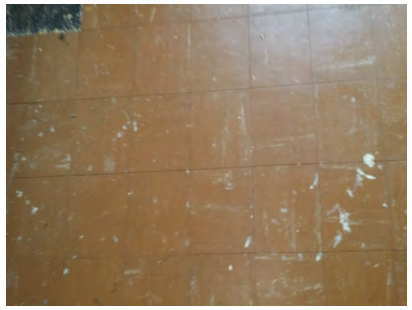
Building	Level	Location	Item / Product Examined	Sample No.	Material Description	Fibre Type	Material Score	Extent	Risk Level Assessment	Initial Control Recommendation	Photograph
Bacton Low Rise, Block H - Flat 215	3	003/Bedroom	floor covering	126253-62	Asbestos-containing vinyl tile & adhesive	Chrysotile	3	10 Sqm.	R3	Remove

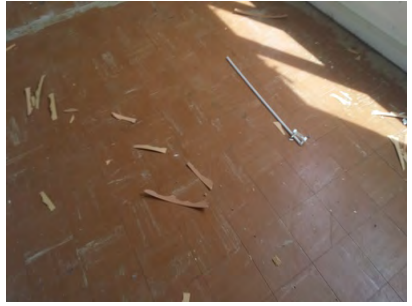
Bacton Low Rise, Block H - Flat 215	4	001/Bedroom	floor covering	126253-62	Asbestos-containing vinyl tile & adhesive	Chrysotile	3	10 Sqm.	R3	Remove

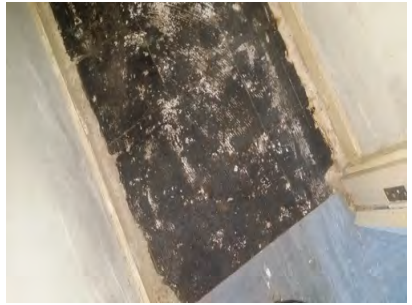
Bacton Low Rise, Block H - Flat 217	-3	001/Stairs	adhesive to concrete floor	126253-60	Asbestos-containing bitumen adhesive	Chrysotile	3	2 Sqm.	R3	Remove

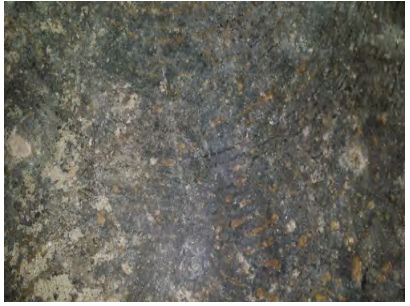
Bacton Low Rise, Block H - Flat 217	-2	001/Stairs	adhesive to concrete floor	126253-60	Asbestos-containing bitumen adhesive	Chrysotile	3	12 Sqm.	R3	Remove

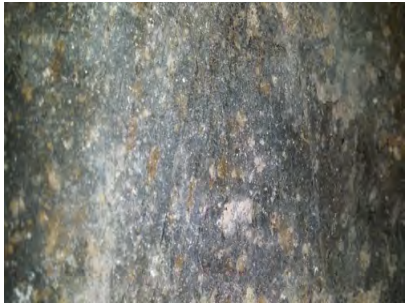
Bacton Low Rise, Block H - Flat 217	-2	002/ Bedroom	adhesive to concrete floor	126253-60	Asbestos-containing bitumen adhesive	Chrysotile	3	12 Sqm.	R3	Remove

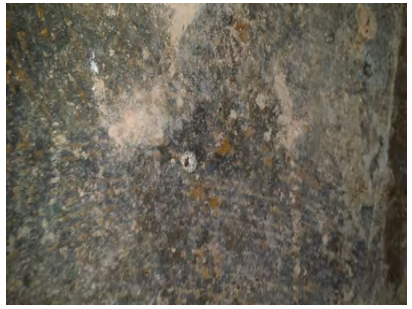
Building	Level	Location	Item / Product Examined	Sample No.	Material Description	Fibre Type	Material Score	Extent	Risk Level Assessment	Initial Control Recommendation	Photograph
Bacton Low Rise, Block H - Flat 217	-2	003/Bedroom	adhesive to concrete floor	126253-60	Asbestos-containing bitumen adhesive	Chrysotile	3	12 Sqm.	R3	Remove

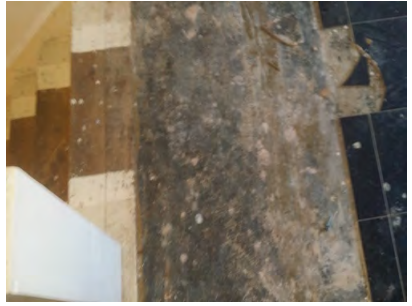
Bacton Low Rise, Block H - Flat 217	-1	001/Stairs	adhesive to concrete floor	126253-60	Asbestos-containing bitumen adhesive	Chrysotile	3	2 Sqm.	R3	Remove

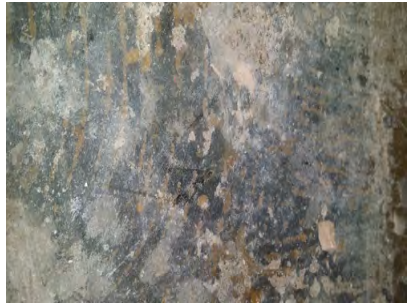
Bacton Low Rise, Block H - Flat 217	-1	002/ Kitchen/ Living room	adhesive to concrete floor	126253-60	Asbestos-containing bitumen adhesive	Chrysotile	3	12 Sqm.	R3	Remove

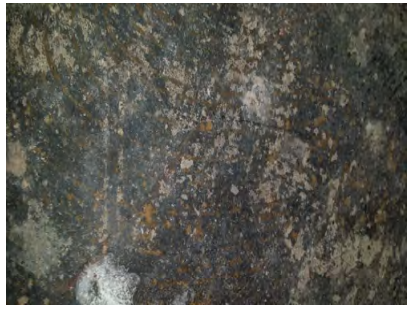
Building	Level	Location	Item / Product Examined	Sample No.	Material Description	Fibre Type	Material Score	Extent	Risk Level Assessment	Initial Control Recommendation	Photograph
Bacton Low Rise, Block H - Flat 217	0	001/ Entrance Lobby	adhesive to concrete floor	126253-60	Asbestos-containing bitumen adhesive	Chrysotile	3	4 Sqm.	R3	Remove

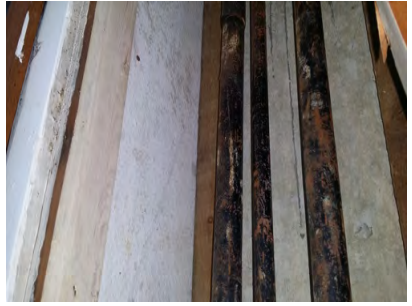
Bacton Low Rise, Block H - Flat 217	0	001/ Entrance Lobby	panel around electric cupboard	126253-59	Asbestos-containing insulating board	Amosite, Chrysotile	6	2 Sqm.	R3	Remove

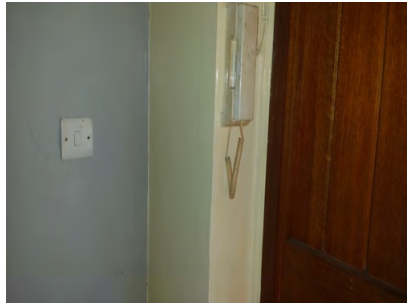
Bacton Low Rise, Block H - Flat 219	0	001/Stairs	panel to electrics	126253-68	Asbestos-containing insulating board	Amosite, Chrysotile	6	2 Lm.	R3	Remove

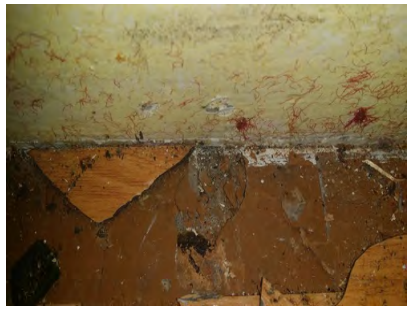
Building	Level	Location	Item / Product Examined	Sample No.	Material Description	Fibre Type	Material Score	Extent	Risk Level Assessment	Initial Control Recommendation	Photograph
Bacton Low Rise, Block H - Flat 219	0	001/Stairs	floor covering	126253-67	Asbestos-containing vinyl tile & adhesive	Chrysotile	3	4 Sqm.	R3	Remove

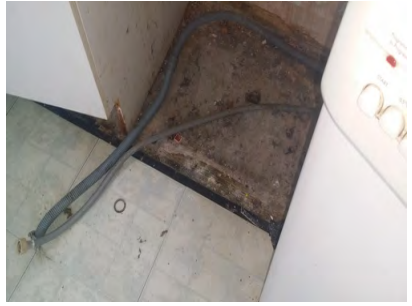
Bacton Low Rise, Block H - Flat 219	1	001/Stairs	floor covering	126253-67	Asbestos-containing vinyl tile & adhesive	Chrysotile	3	4 Sqm.	R3	Remove

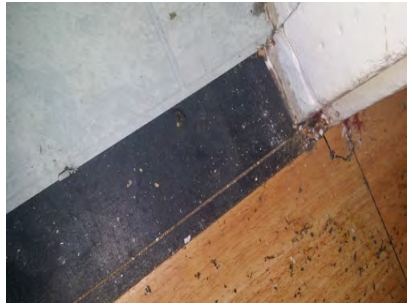
Bacton Low Rise, Block H - Flat 219	1	002/ Kitchen/ Living room	adhesive to concrete floor	126253-67	Asbestos-containing bitumen adhesive	Chrysotile	3	12 Sqm.	R3	Remove

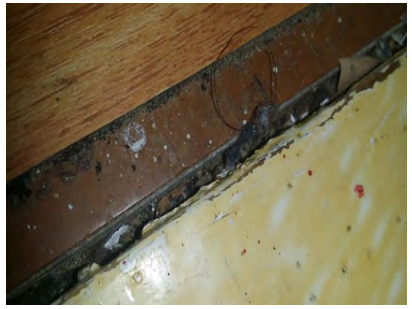
Building	Level	Location	Item / Product Examined	Sample No.	Material Description	Fibre Type	Material Score	Extent	Risk Level Assessment	Initial Control Recommendation	Photograph
Bacton Low Rise, Block H - Flat 219	2	001/ Stairs	floor covering	126253-67	Asbestos-containing vinyl tile & adhesive	Chrysotile	3	2 Sqm.	R3	Remove

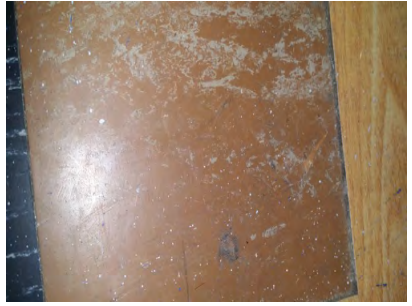
Bacton Low Rise, Block H - Flat 219	2	002/ Bedroom	floor covering	126253-67	Asbestos-containing vinyl tile & adhesive	Chrysotile	3	8 Sqm.	R3	Remove

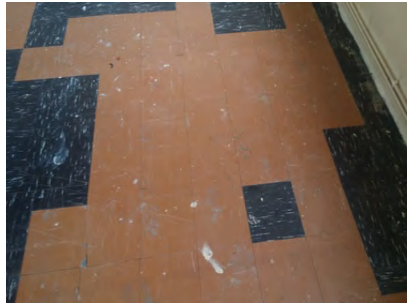
Bacton Low Rise, Block H - Flat 219	2	003/ Bedroom	floor covering	126253-67	Asbestos-containing vinyl tile & adhesive	Chrysotile	3	12 Sqm.	R3	Remove

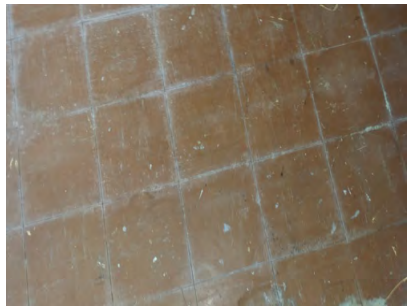
Building	Level	Location	Item / Product Examined	Sample No.	Material Description	Fibre Type	Material Score	Extent	Risk Level Assessment	Initial Control Recommendation	Photograph
Bacton Low Rise, Block H - Flat 219	3	001/Stairs	floor covering	126253-67	Asbestos-containing vinyl tile & adhesive	Chrysotile	3	2 Sqm.	R3	Remove

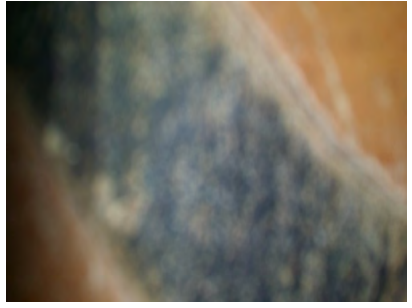
Bacton Low Rise, Block H - Flat 219	3	002/Bathroom	adhesive to concrete floor	126253-67	Asbestos-containing bitumen adhesive	Chrysotile	3	6 Sqm.	R3	Remove

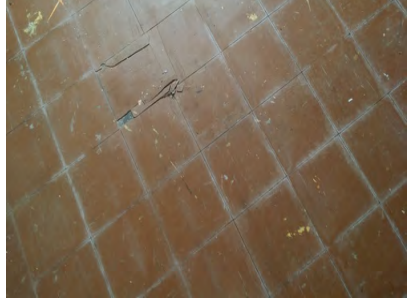
Bacton Low Rise, Block H - Flat 219	3	003/Bedroom	floor covering	126253-67	Asbestos-containing vinyl tile & adhesive	Chrysotile	3	10 Sqm.	R3	Remove

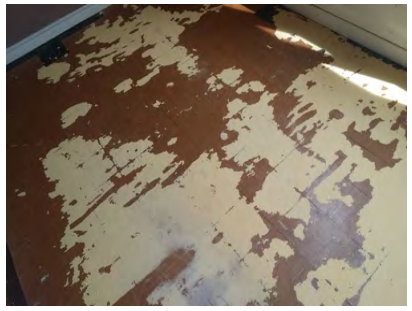
Building	Level	Location	Item / Product Examined	Sample No.	Material Description	Fibre Type	Material Score	Extent	Risk Level Assessment	Initial Control Recommendation	Photograph
Bacton Low Rise, Block H - Flat 219	4	001/ Bedroom	floor covering	126253-67	Asbestos-containing vinyl tile & adhesive	Chrysotile	3	10 Sqm.	R3	Remove
