Title: Pre-demolition Survey - Block F, Including: All of property

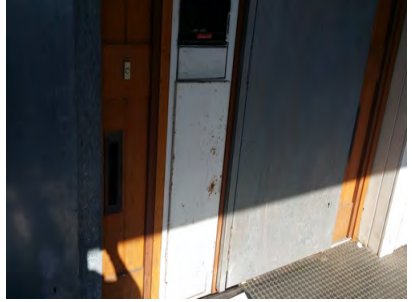
Building	Level	Location	Item / Product Examined	Sample No.	Material Description	Fibre Type	Material Score	Extent	Risk Level Assessment	Initial Control Recommendation	Photograph
Bacton Low Rise, Block F - Communal Area	1	001/ Walkway	panels around electric meter cupboard	126254-37	Asbestos-containing insulating board	Amosite, Chrysotile	6	7x 2 Sqm.	R3	Remove

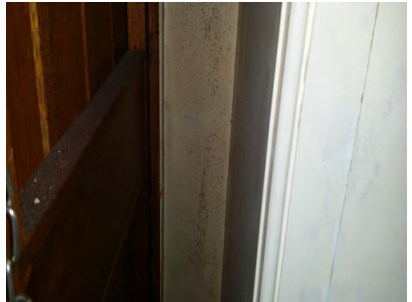
Bacton Low Rise, Block F - Flat 182	0	001/ Entrance Lobby	boxing to electric cupboard	126254-2	Asbestos-containing insulating board	Amosite, Chrysotile	6	2 Sqm.	R2	Remove

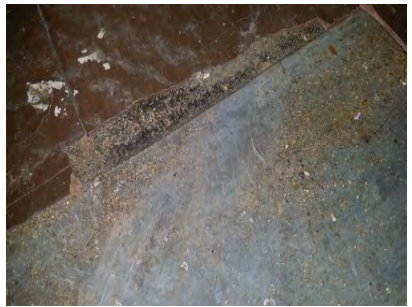
Building	Level	Location	Item / Product Examined	Sample No.	Material Description	Fibre Type	Material Score	Extent	Risk Level Assessment	Initial Control Recommendation	Photograph
Bacton Low Rise, Block F - Flat 182	1	001/ Stairs	adhesive to concrete floor	126254-1	Asbestos-containing bituminous product	Chrysotile	3	2 Sqm.	R3	Remove

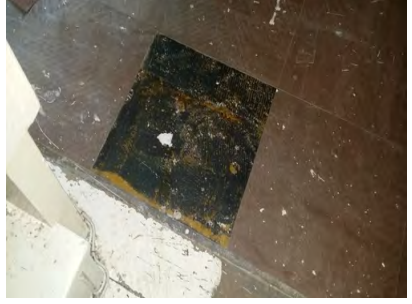
Bacton Low Rise, Block F - Flat 182	2	001/ Stairs	adhesive to concrete floor	126254-1	Asbestos-containing bituminous product	Chrysotile	3	2 Sqm.	R3	Remove

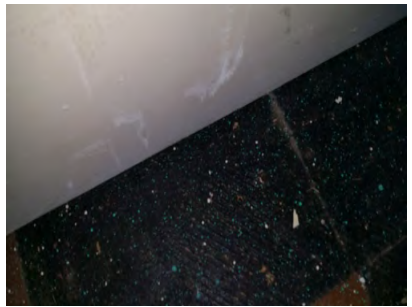
Building	Level	Location	Item / Product Examined	Sample No.	Material Description	Fibre Type	Material Score	Extent	Risk Level Assessment	Initial Control Recommendation	Photograph
Bacton Low Rise, Block F - Flat 182	2	002/ Bedroom	adhesive to concrete floor	126254-1	Asbestos-containing bituminous product	Chrysotile	3	12 Sqm.	R3	Remove

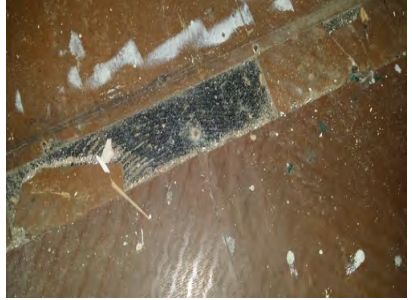
Bacton Low Rise, Block F - Flat 182	3	001/ Stairs	adhesive to concrete floor	126254-1	Asbestos-containing bituminous product	Chrysotile	3	2 Sqm.	R3	Remove

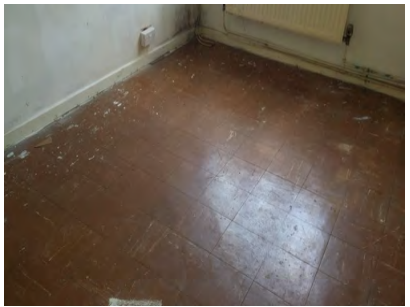
Building	Level	Location	Item / Product Examined	Sample No.	Material Description	Fibre Type	Material Score	Extent	Risk Level Assessment	Initial Control Recommendation	Photograph
Bacton Low Rise, Block F - Flat 182	3	002/ Bedroom	floor covering	126254-5	Asbestos-containing floor tiles & bituminous product	Chrysotile	3	12 Sqm.	R3	Remove

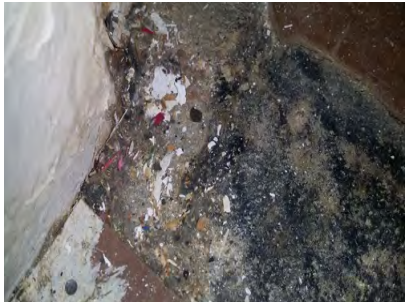
Bacton Low Rise, Block F - Flat 182	3	003/ Bathroom	adhesive to concrete floor	126254-1	Asbestos-containing bituminous product	Chrysotile	3	6 Sqm.	R3	Remove

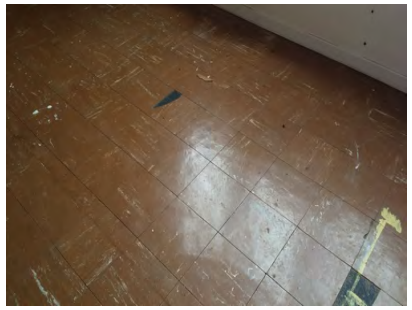
Building	Level	Location	Item / Product Examined	Sample No.	Material Description	Fibre Type	Material Score	Extent	Risk Level Assessment	Initial Control Recommendation	Photograph
Bacton Low Rise, Block F - Flat 182	4	001/ Bedroom	floor covering	126254-5	Asbestos-containing floor tiles & bituminous product	Chrysotile	3	12 Sqm.	R3	Remove

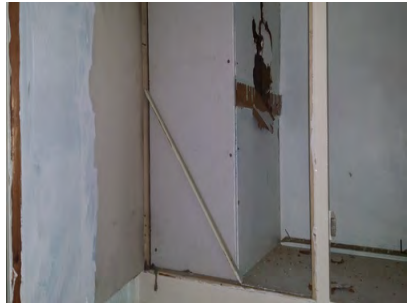
Bacton Low Rise, Block F - Flat 184	-3	002/ Bedroom	boxing within wooden cupboard	126254-11	Asbestos-containing insulating board	Chrysotile, Amosite	7	2 Sqm.	R1	Remove

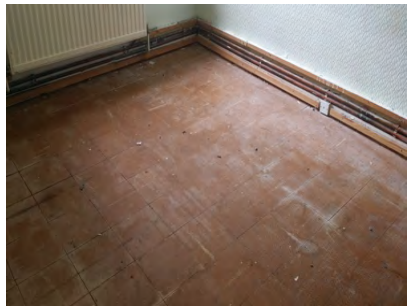
Building	Level	Location	Item / Product Examined	Sample No.	Material Description	Fibre Type	Material Score	Extent	Risk Level Assessment	Initial Control Recommendation	Photograph
Bacton Low Rise, Block F - Flat 184	-3	002/ Bedroom	floor covering	126254-7	Asbestos-containing floor tiles & bituminous product	Chrysotile	3	12 Sqm.	R3	Remove

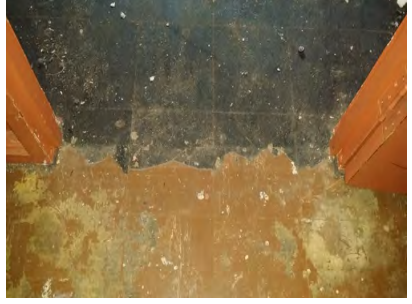
Bacton Low Rise, Block F - Flat 184	-2	001/ Bedroom	floor covering	126254-7	Asbestos-containing floor tiles & bituminous product	Chrysotile	3	12 Sqm.	R3	Remove

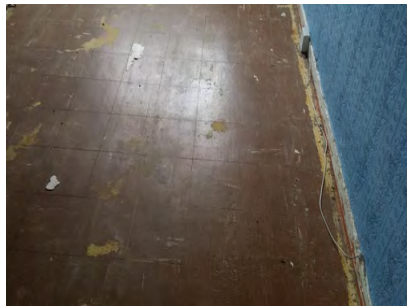
Building	Level	Location	Item / Product Examined	Sample No.	Material Description	Fibre Type	Material Score	Extent	Risk Level Assessment	Initial Control Recommendation	Photograph
Bacton Low Rise, Block F - Flat 184	-2	002/ Bedroom	floor covering	126254-7	Asbestos-containing floor tiles & bituminous product	Chrysotile	3	12 Sqm.	R3	Remove

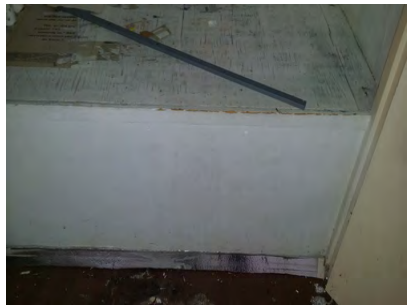
Bacton Low Rise, Block F - Flat 184	-1	002/ Kitchen & Lounge	boxing within wooden cupboard	126254-10	Asbestos-containing insulating board	Chrysotile, Amosite	6	2 Sqm.	R2	Remove

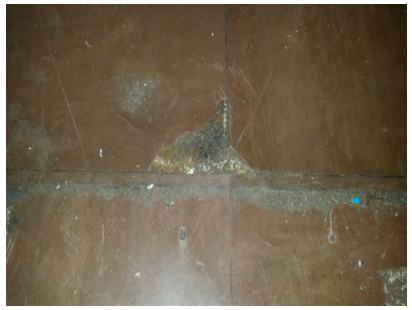
Building	Level	Location	Item / Product Examined	Sample No.	Material Description	Fibre Type	Material Score	Extent	Risk Level Assessment	Initial Control Recommendation	Photograph
Bacton Low Rise, Block F - Flat 184	-1	002/ Kitchen & Lounge	adhesive to concrete floor	126254-7	Asbestos-containing bituminous product	Chrysotile	3	14 Sqm.	R3	Remove

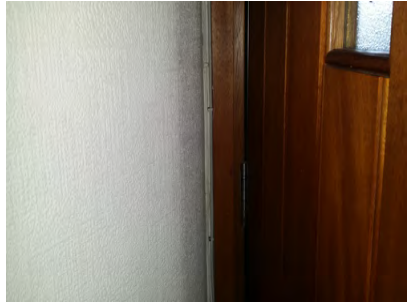
Bacton Low Rise, Block F - Flat 186	0	001/ Entrance Lobby	boxing to electric cupboard	126254-13	Asbestos-containing insulating board	Chrysotile, Amosite	6	2 Sqm.	R2	Remove

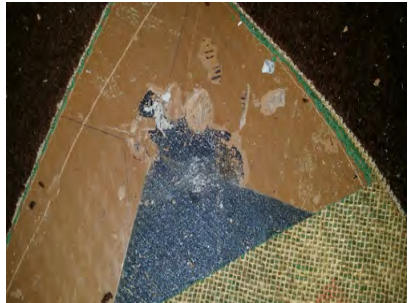
Bacton Low Rise, Block F - Flat 186	0	001/ Entrance Lobby	subfloor	126254-12	Asbestos-containing floor tiles & bituminous product	Chrysotile	3	4 Sqm.	R3	Remove

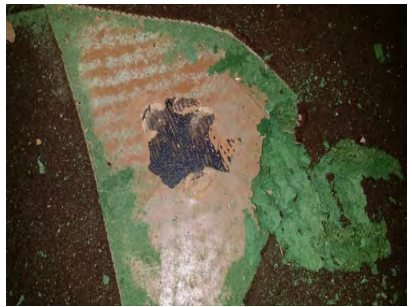
Building	Level	Location	Item / Product Examined	Sample No.	Material Description	Fibre Type	Material Score	Extent	Risk Level Assessment	Initial Control Recommendation	Photograph
Bacton Low Rise, Block F - Flat 186	1	001/ Stairs	subfloor	126254-12	Asbestos-containing floor tiles & bituminous product	Chrysotile	3	2 Sqm.	R3	Remove

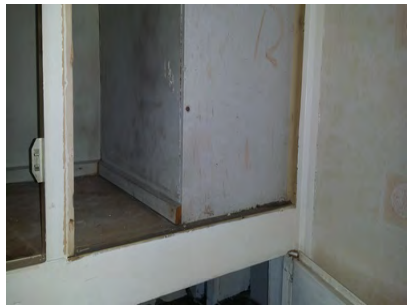
Bacton Low Rise, Block F - Flat 186	1	002/ Kitchen & Lounge	boxing within wooden cupboard	126254-15	Asbestos-containing insulating board	Chrysotile, Amosite	7	2 Sqm.	R1	Remove
