Building: Bacton Low Rise, Block F - Flat 190			Level: 3		Location: 003/ Bathroom						
Item / Product Examined	Material Description	Sampling Strategy	Sample No.	Extent	Product Score	Material Condition	Surface Treatment	Fibre Id.	Material Score	Accessibility Score	Risk Level Assessment
floor	concrete										
panels to external wall	insulating board	Cross Reference	126254-26

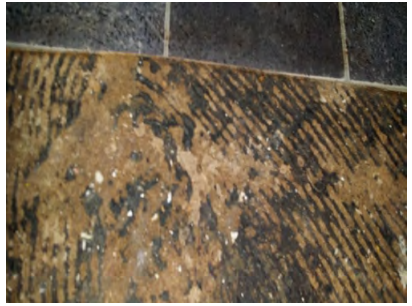
Building	Level	Location	Item / Product Examined	Sample No.	Material Description	Fibre Type	Material Score	Extent	Risk Level Assessment	Initial Control Recommendation	Photograph
Bacton Low Rise Block G Flat 195	-3	002/Bathroom	adhesive to concrete floor	126255-8	Asbestos-containing bitumen adhesive	Chrysotile	3	8 Sqm.	R3	Remove

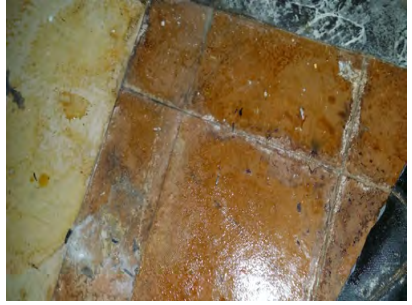
Bacton Low Rise Block G Flat 195	1	002/Kitchen / Living room	floor covering	126255-1	Asbestos-containing vinyl tile & adhesive	Chrysotile	3	12 Sqm.	R3	Remove

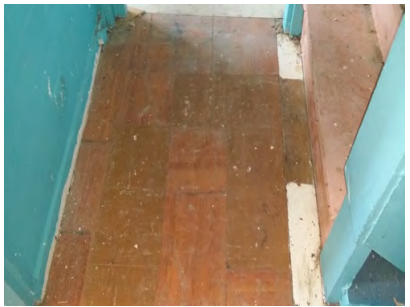
Building	Level	Location	Item / Product Examined	Sample No.	Material Description	Fibre Type	Material Score	Extent	Risk Level Assessment	Initial Control Recommendation	Photograph
Bacton Low Rise Block G Flat 195	2	001/Stairs	floor covering	126255-1	Asbestos-containing vinyl tile & adhesive	Chrysotile	3	2 Sqm.	R3	Remove

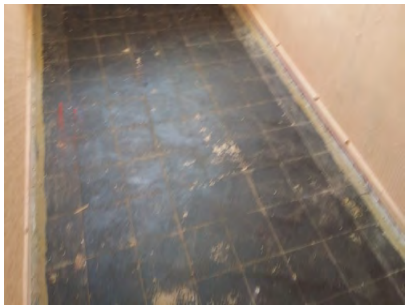
Bacton Low Rise Block G Flat 195	2	002/Bedroom	adhesive to concrete floor	126255-1	Asbestos-containing bitumen adhesive	Chrysotile	3	8 Sqm.	R3	Remove

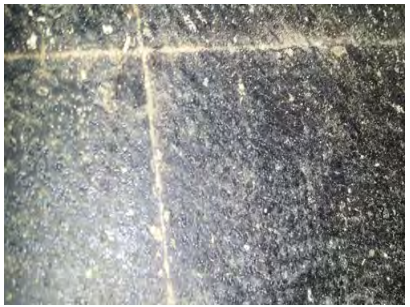
Bacton Low Rise Block G Flat 195	2	003/Bedroom	adhesive to concrete floor	126255-1	Asbestos-containing bitumen adhesive	Chrysotile	3	12 Sqm.	R3	Remove

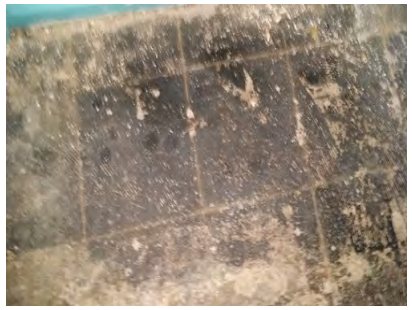
Building	Level	Location	Item / Product Examined	Sample No.	Material Description	Fibre Type	Material Score	Extent	Risk Level Assessment	Initial Control Recommendation	Photograph
Bacton Low Rise Block G Flat 195	3	001/Stairs	adhesive to concrete floor	126255-1	Asbestos-containing bitumen adhesive	Chrysotile	3	2 Sqm.	R3	Remove

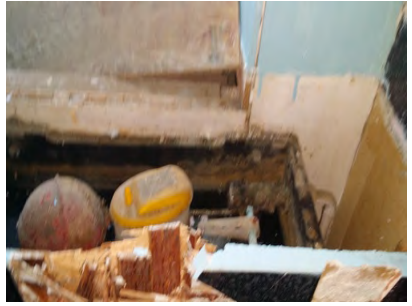
Bacton Low Rise Block G Flat 195	3	002/Bathroom	toilet cistern	126255-7	Asbestos-containing composite	Amosite	4	1 No.	R3	Remove

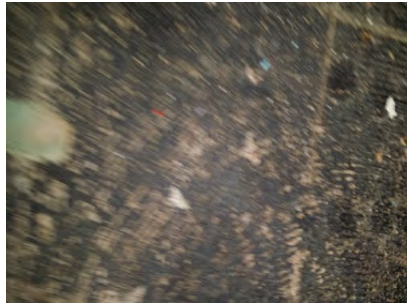
Bacton Low Rise Block G Flat 195	3	002/Bathroom	adhesive to concrete floor	126255-1	Asbestos-containing bitumen adhesive	Chrysotile	3	8 Sqm.	R3	Remove

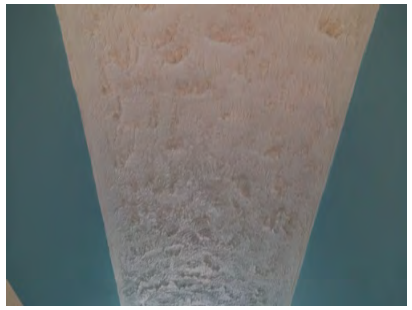
Building	Level	Location	Item / Product Examined	Sample No.	Material Description	Fibre Type	Material Score	Extent	Risk Level Assessment	Initial Control Recommendation	Photograph
Bacton Low Rise Block G Flat 195	3	002/Bathroom	ceiling	126255-6	Asbestos-containing textured coating	Chrysotile	3	8 Sqm.	R3	Remove

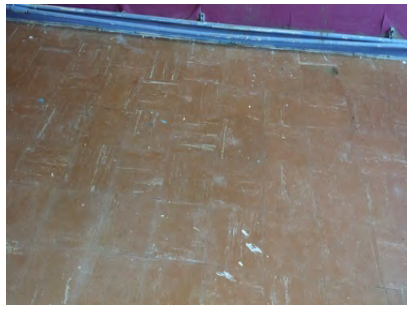
Bacton Low Rise Block G Flat 195	3	003/Stairs	floor covering	126255-1	Asbestos-containing vinyl tile & adhesive	Chrysotile	3	12 Sqm.	R3	Remove

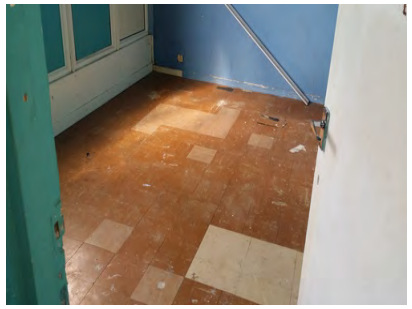
Bacton Low Rise Block G Flat 195	4	001/Bedroom	floor covering	126255-1	Asbestos-containing vinyl tile & adhesive	Chrysotile	3	10 Sqm.	R3	Remove

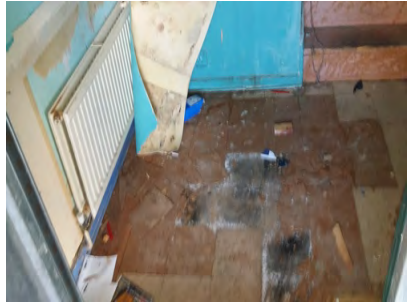
Bacton Low Rise Block G Flat 195F	0	001/Entrance Lobby	floor covering	126255-1	Asbestos-containing vinyl tile & adhesive	Chrysotile	3	4 Sqm.	R3	Remove

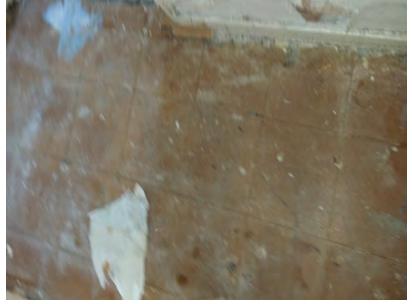
Bacton Low Rise Block G Flat 196	-3	001/Stairs	floor covering	126255-7	Asbestos-containing vinyl tile & adhesive	Amosite	4	12 Sqm.	R3	Remove

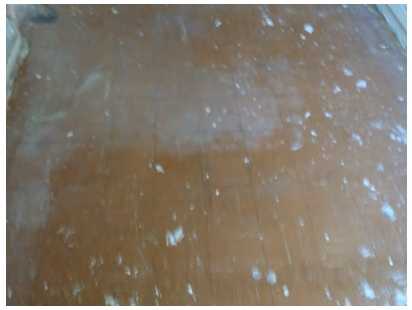
Building	Level	Location	Item / Product Examined	Sample No.	Material Description	Fibre Type	Material Score	Extent	Risk Level Assessment	Initial Control Recommendation	Photograph
Bacton Low Rise Block G Flat 196	-3	002/Bedroom	floor covering	126255-8	Asbestos-containing vinyl tile & adhesive	Chrysotile	3	12 Sqm.	R3	Remove

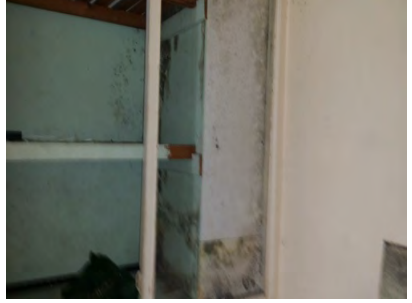
Bacton Low Rise Block G Flat 196	-3	002/Bedroom	boxing within cupboard	126255-11	Asbestos-containing insulating board	Amosite, Chrysotile	7	2 Sqm.	R2	Remove

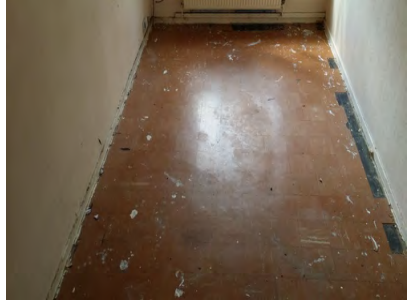
Bacton Low Rise Block G Flat 196	-2	001/Stairs / Bedroom	floor covering	126255-7	Asbestos-containing vinyl tile & adhesive	Amosite	4	12 Sqm.	R3	Remove

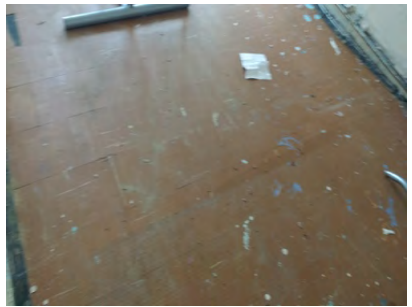
Building	Level	Location	Item / Product Examined	Sample No.	Material Description	Fibre Type	Material Score	Extent	Risk Level Assessment	Initial Control Recommendation	Photograph
Bacton Low Rise Block G Flat 196	-2	002/Bedroom	floor covering	126255-7	Asbestos-containing vinyl tile & adhesive	Amosite	4	12 Sqm.	R3	Remove

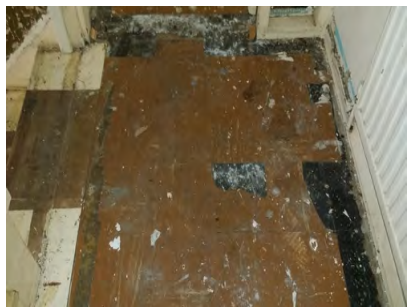
Bacton Low Rise Block G Flat 196	-1	001/Stairs	floor covering	126255-8	Asbestos-containing vinyl tile & adhesive	Chrysotile	3	2 Sqm.	R3	Remove

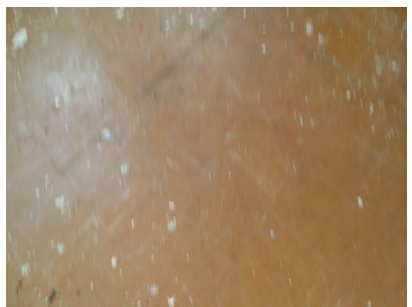
Bacton Low Rise Block G Flat 196	-1	002/Kitchen / Living room	floor covering	126255-8	Asbestos-containing vinyl tile & adhesive	Chrysotile	3	12 Sqm.	R3	Remove

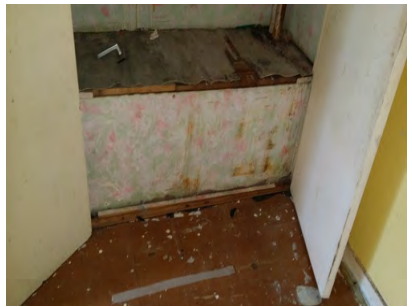
Building	Level	Location	Item / Product Examined	Sample No.	Material Description	Fibre Type	Material Score	Extent	Risk Level Assessment	Initial Control Recommendation	Photograph
Bacton Low Rise Block G Flat 196	-1	002/Kitchen / Living room	boxing within cupboard	126255-11	Asbestos-containing insulating board	Amosite, Chrysotile	7	2 Sqm.	R2	Remove

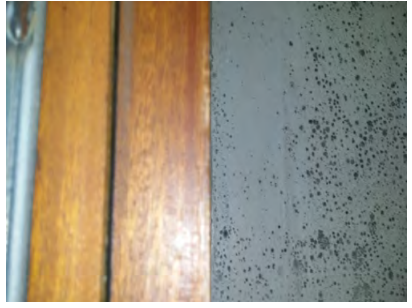
Bacton Low Rise Block G Flat 196	0	001/Entrance Lobby	panel to electrics	126255-9	Asbestos-containing insulating board	Amosite, Chrysotile	6	2 Lm.	R3	Remove

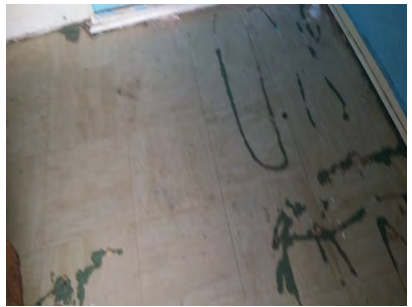
Building	Level	Location	Item / Product Examined	Sample No.	Material Description	Fibre Type	Material Score	Extent	Risk Level Assessment	Initial Control Recommendation	Photograph
Bacton Low Rise Block G Flat 198	0	001/Entrance Lobby	adhesive to concrete floor	126255-14	Asbestos-containing bitumen adhesive	Chrysotile	3	4 Sqm.	R3	Remove

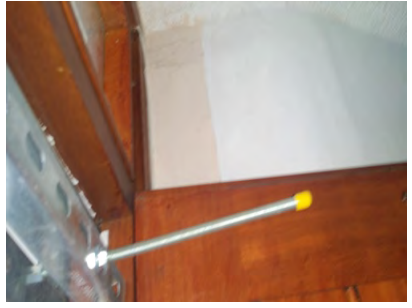
Bacton Low Rise Block G Flat 198	0	001/Entrance Lobby	panel to electrics	126255-15	Asbestos-containing insulating board	Amosite, Chrysotile	6	2 Lm.	R3	Remove

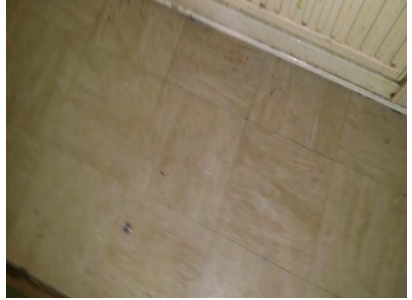
Bacton Low Rise Block G Flat 198	1	001/Stairs	adhesive to concrete floor	126255-14	Asbestos-containing bitumen adhesive	Chrysotile	3	2 Sqm.	R3	Remove

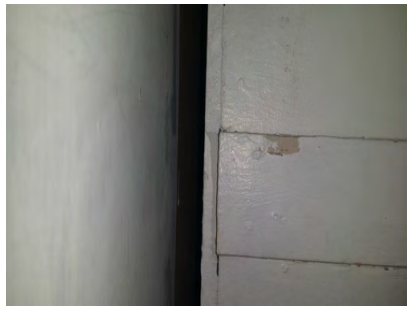
Building	Level	Location	Item / Product Examined	Sample No.	Material Description	Fibre Type	Material Score	Extent	Risk Level Assessment	Initial Control Recommendation	Photograph
Bacton Low Rise Block G Flat 198	1	002/Kitchen / Living room	boxing within cupboard	126255-17	Asbestos-containing insulating board	Amosite, Chrysotile	7	2 Sqm.	R2	Remove

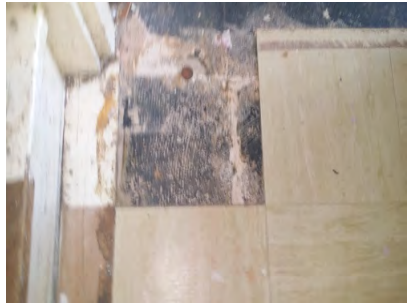
Bacton Low Rise Block G Flat 198	2	001/Stairs	adhesive to concrete floor	126255-14	Asbestos-containing bitumen adhesive	Chrysotile	3	2 Sqm.	R3	Remove

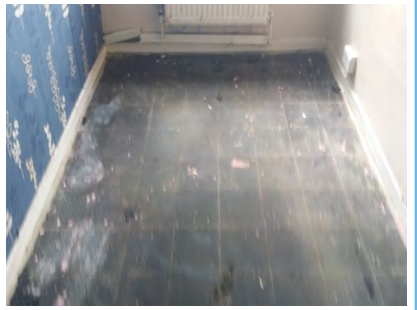
Building	Level	Location	Item / Product Examined	Sample No.	Material Description	Fibre Type	Material Score	Extent	Risk Level Assessment	Initial Control Recommendation	Photograph
Bacton Low Rise Block G Flat 198	2	002/Bedroom	adhesive to concrete floor	126255-14	Asbestos-containing bitumen adhesive	Chrysotile	3	8 Sqm.	R3	Remove

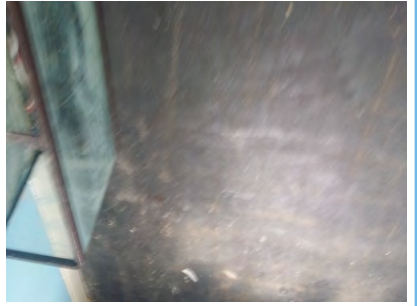
Bacton Low Rise Block G Flat 198	2	003/Bedroom	adhesive to concrete floor	126255-14	Asbestos-containing bitumen adhesive	Chrysotile	3	12 Sqm.	R3	Remove

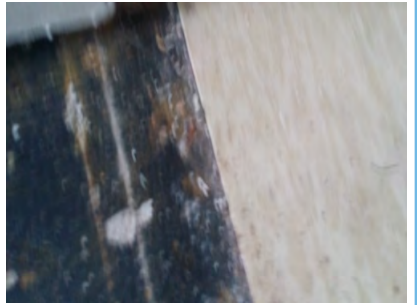
Bacton Low Rise Block G Flat 198	3	001/Stairs	adhesive to concrete floor	126255-1	Asbestos-containing bitumen adhesive	Chrysotile	3	2 Sqm.	R3	Remove

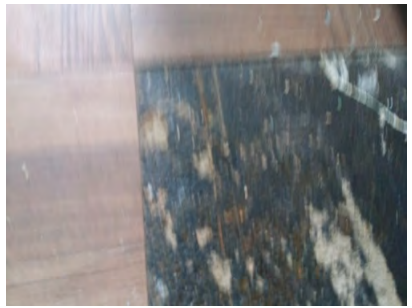
Building	Level	Location	Item / Product Examined	Sample No.	Material Description	Fibre Type	Material Score	Extent	Risk Level Assessment	Initial Control Recommendation	Photograph
Bacton Low Rise Block G Flat 198	3	002/Bathroom	adhesive to concrete floor	126255-14	Asbestos-containing bitumen adhesive	Chrysotile	3	8 Sqm.	R3	Remove

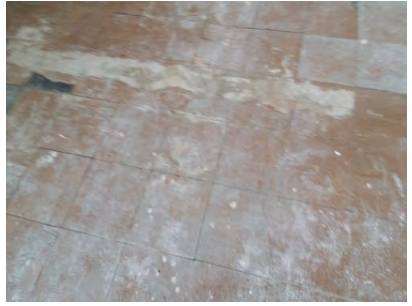
Bacton Low Rise Block G Flat 198	4	001/Bedroom	floor covering	126255-21	Asbestos-containing bitumen adhesive	Chrysotile	3	2 Sqm.	R3	Remove

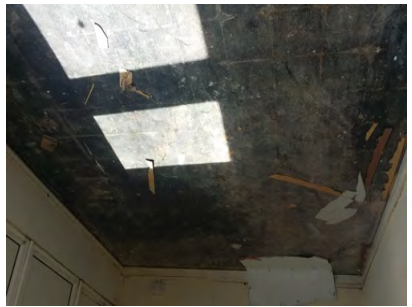
Building	Level	Location	Item / Product Examined	Sample No.	Material Description	Fibre Type	Material Score	Extent	Risk Level Assessment	Initial Control Recommendation	Photograph
Bacton Low Rise Block G Flat 198	4	001/Bedroom	adhesive to concrete floor	126255-14	Asbestos-containing bitumen adhesive	Chrysotile	3	2 Sqm.	R3	Remove

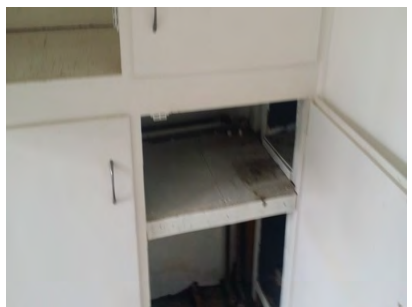
Bacton Low Rise Block G Flat 199	1	002/Kitchen / Living room	panel to shelf	126255-24	Asbestos-containing insulating board	Amosite, Chrysotile	7	2 Sqm.	R2	Remove

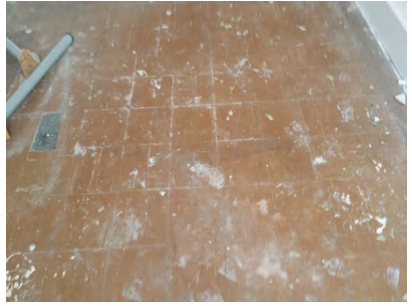
Building	Level	Location	Item / Product Examined	Sample No.	Material Description	Fibre Type	Material Score	Extent	Risk Level Assessment	Initial Control Recommendation	Photograph
Bacton Low Rise Block G Flat 199	1	002/Kitchen / Living room	floor covering	126255-21	Asbestos-containing vinyl tile & adhesive	Chrysotile	3	12 Sqm.	R3	Remove	 
Bacton Low Rise Block G Flat 199	2	002/Bedroom	floor covering	126255-14	Asbestos-containing vinyl tile & adhesive	Chrysotile	3	8 Sqm.	R3	Remove	 
Bacton Low Rise Block G Flat 199	3	002/Bathroom	ceiling	126255-6	Asbestos-containing concrete	Chrysotile	3	8 Sqm.	R3	Remove	
Bacton Low Rise Block G Flat 199	3	003/Bedroom	floor covering	126255-21	Asbestos-containing vinyl tile & adhesive	Chrysotile	3	12 Sqm.	R3	Remove

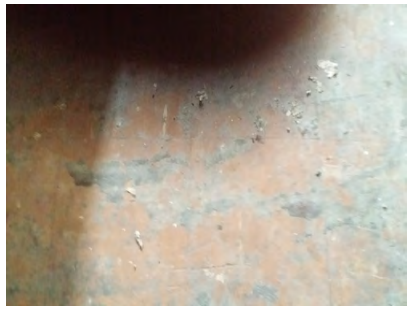
Building	Level	Location	Item / Product Examined	Sample No.	Material Description	Fibre Type	Material Score	Extent	Risk Level Assessment	Initial Control Recommendation	Photograph
Bacton Low Rise Block G Flat 200	-3	001/Stairs	floor covering	126255-29	Asbestos-containing vinyl tile & adhesive	Chrysotile	3	2 Sqm.	R3	Remove

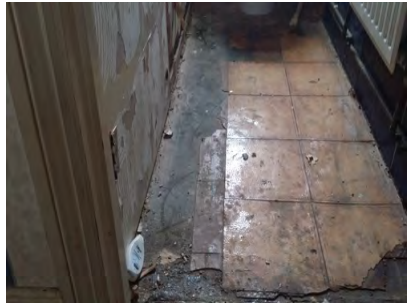
Bacton Low Rise Block G Flat 200	-3	002/Bathroom	floor covering	126255-29	Asbestos-containing vinyl tile & adhesive	Chrysotile	3	8 Sqm.	R3	Remove

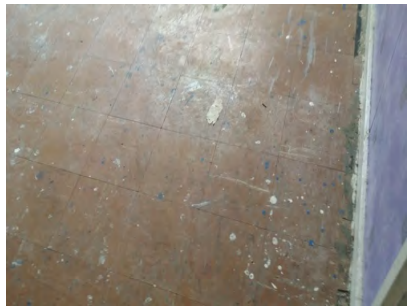
Building	Level	Location	Item / Product Examined	Sample No.	Material Description	Fibre Type	Material Score	Extent	Risk Level Assessment	Initial Control Recommendation	Photograph
Bacton Low Rise Block G Flat 200	-3	002/Bedroom	floor covering	126255-29	Asbestos-containing vinyl tile & adhesive	Chrysotile	3	12 Sqm.	R3	Remove

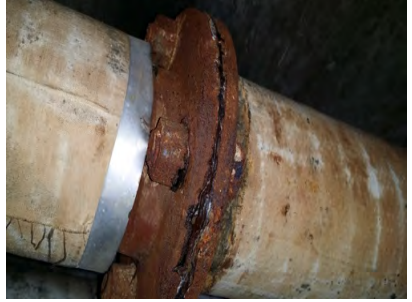
Building	Level	Location	Item / Product Examined	Sample No.	Material Description	Fibre Type	Material Score	Extent	Risk Level Assessment	Initial Control Recommendation	Photograph
Bacton Low Riser, Block E - Communal Area	0	003/ Garage 46	flange gaskets to pipework	126256-34	Asbestos-containing gasket	Chrysotile	5	4 No.	R3	Remove

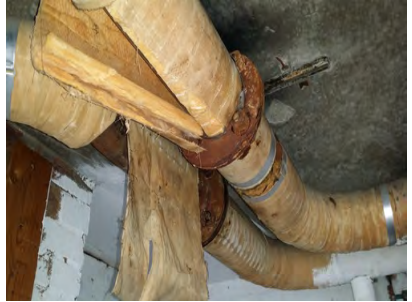
Bacton Low Riser, Block E - Communal Area	0	004/ Garage 45	flange gaskets to pipework	126256-34	Asbestos-containing gasket	Chrysotile	5	4 No.	R3	Remove

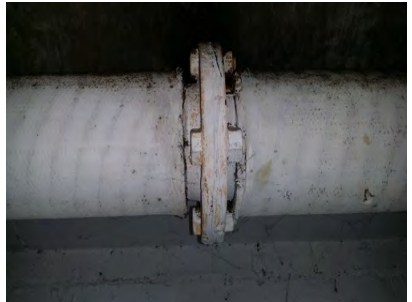
Bacton Low Riser, Block E - Communal Area	0	005/ Garage 44	flange gaskets to pipework	126256-34	Asbestos-containing gasket	Chrysotile	5	4 No.	R3	Remove

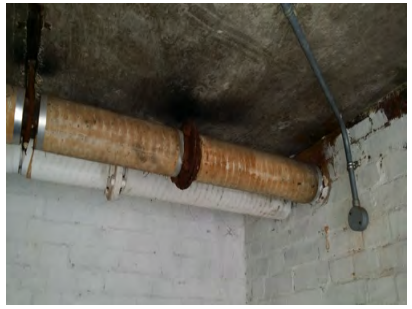
Building	Level	Location	Item / Product Examined	Sample No.	Material Description	Fibre Type	Material Score	Extent	Risk Level Assessment	Initial Control Recommendation	Photograph
Bacton Low Riser, Block E - Communal Area	0	006/ Garage 43	flange gaskets to pipework	126256-34	Asbestos-containing gasket	Chrysotile	5	4 No.	R3	Remove

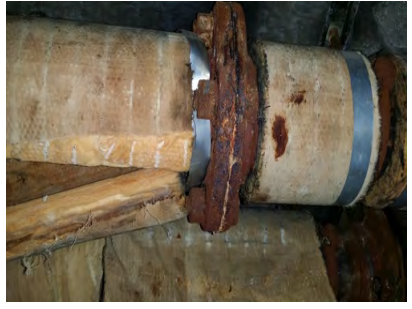
Bacton Low Riser, Block E - Communal Area	0	007/ Garage 42	flange gaskets to pipework	126256-34	Asbestos-containing gasket	Chrysotile	5	4 No.	R3	Remove

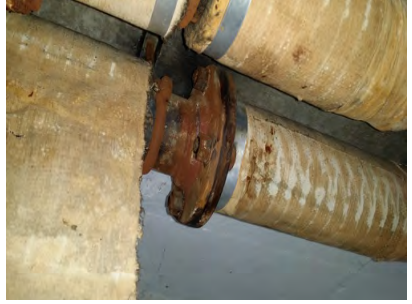
Bacton Low Riser, Block E - Communal Area	0	008/ Garage 41	flange gaskets to pipework	126256-34	Asbestos-containing gasket	Chrysotile	5	4 No.	R3	Remove

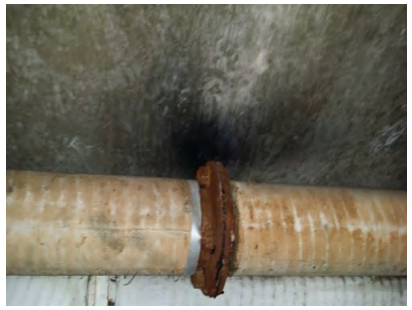
Building	Level	Location	Item / Product Examined	Sample No.	Material Description	Fibre Type	Material Score	Extent	Risk Level Assessment	Initial Control Recommendation	Photograph
Bacton Low Riser, Block E - Communal Area	0	009/ Garage 40	flange gaskets to pipework	126256-34	Asbestos-containing gasket	Chrysotile	5	4 No.	R3	Remove

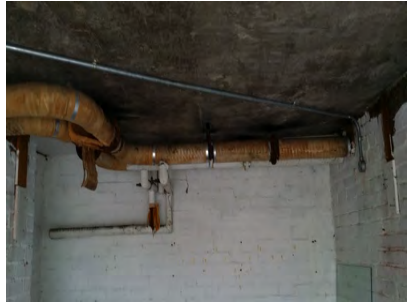
Bacton Low Riser, Block E - Communal Area	0	010/ Garage 39	flange gaskets to pipework	126256-34	Asbestos-containing gasket	Chrysotile	5	4 No.	R3	Remove

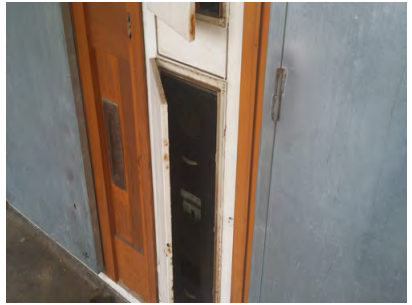
Bacton Low Riser, Block E - Communal Area	1	001/ Walkway	panels around electric meter cupboards	126256-27	Asbestos-containing insulating board	Amosite, Chrysotile	6	2x 4 Sqm.	R3	Remove

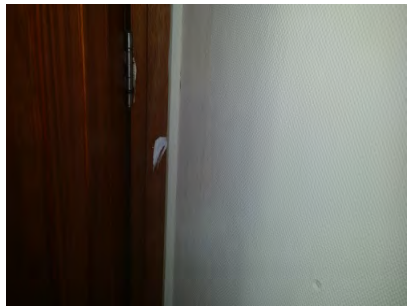
Building	Level	Location	Item / Product Examined	Sample No.	Material Description	Fibre Type	Material Score	Extent	Risk Level Assessment	Initial Control Recommendation	Photograph
Bacton Low Riser, Block E - Flat 176	0	001/ Entrance Lobby	boxing to electric cupboard	126256-27	Asbestos-containing insulating board	Amosite, Chrysotile	6	2 Sqm.	R2	Remove

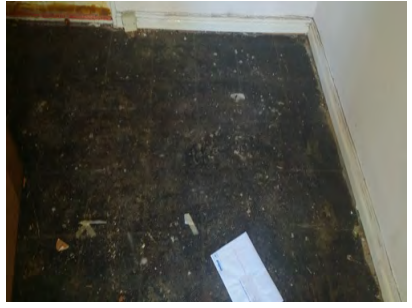
Bacton Low Riser, Block E - Flat 176	0	001/ Entrance Lobby	adhesive to concrete floor	126256-26	Asbestos-containing bituminous product	Chrysotile	3	4 Sqm.	R3	Remove

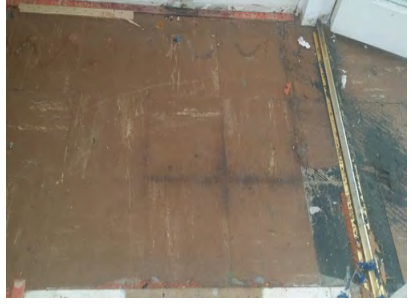
Bacton Low Riser, Block E - Flat 176	1	001/ Stairs	floor covering	126256-28	Asbestos-containing floor tiles & bituminous product	Chrysotile	3	2 Sqm.	R3	Remove

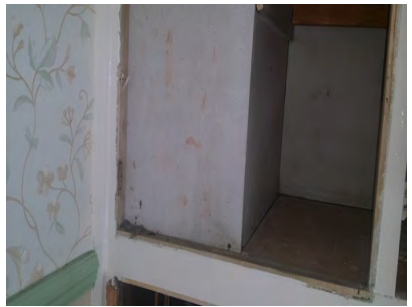
Building	Level	Location	Item / Product Examined	Sample No.	Material Description	Fibre Type	Material Score	Extent	Risk Level Assessment	Initial Control Recommendation	Photograph
Bacton Low Riser, Block E - Flat 176	1	002/ Kitchen & Lounge	boxing within wooden cupboard	126256-30	Asbestos-containing insulating board	Amosite, Chrysotile	7	2 Sqm.	R1	Remove

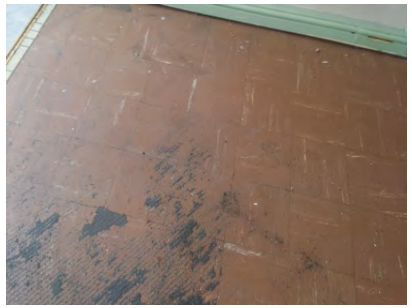
Bacton Low Riser, Block E - Flat 176	1	002/ Kitchen & Lounge	floor covering	126256-28	Asbestos-containing floor tiles & bituminous product	Chrysotile	3	14 Sqm.	R3	Remove

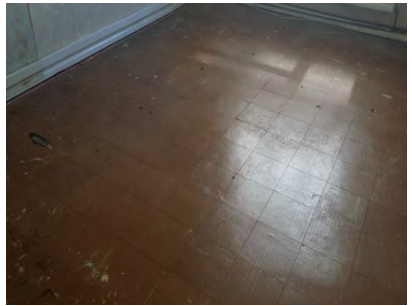
Building	Level	Location	Item / Product Examined	Sample No.	Material Description	Fibre Type	Material Score	Extent	Risk Level Assessment	Initial Control Recommendation	Photograph
Bacton Low Riser, Block E - Flat 176	2	002/ Bedroom	floor covering	126256-28	Asbestos-containing floor tiles & bituminous product	Chrysotile	3	12 Sqm.	R3	Remove

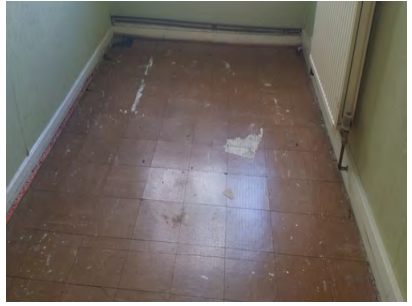
Bacton Low Riser, Block E - Flat 176	2	003/ Bedroom	floor covering	126256-28	Asbestos-containing floor tiles & bituminous product	Chrysotile	3	12 Sqm.	R3	Remove

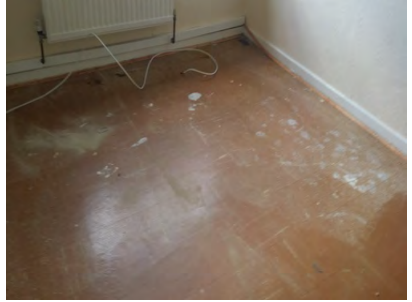
Bacton Low Riser, Block E - Flat 176	3	002/ Bedroom	floor covering	126256-28	Asbestos-containing floor tiles & bituminous product	Chrysotile	3	12 Sqm.	R3	Remove

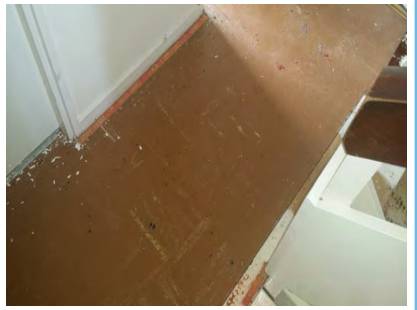
Building	Level	Location	Item / Product Examined	Sample No.	Material Description	Fibre Type	Material Score	Extent	Risk Level Assessment	Initial Control Recommendation	Photograph
Bacton Low Riser, Block E - Flat 176	3	002/ Stairs & Landing	floor covering	126256-28	Asbestos-containing floor tiles & bituminous product	Chrysotile	3	2 Sqm.	R3	Remove

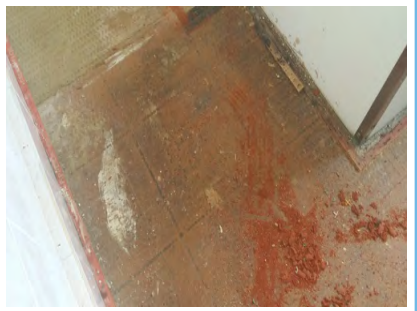
Bacton Low Riser, Block E - Flat 176	3	003/ Bathroom	floor covering	126256-28	Asbestos-containing floor tiles & bituminous product	Chrysotile	3	6 Sqm.	R3	Remove

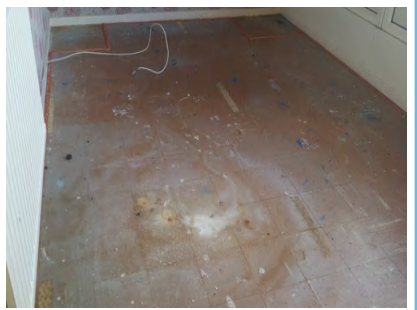
Bacton Low Riser, Block E - Flat 176	4	001/ Bedroom	floor covering	126256-28	Asbestos-containing floor tiles & bituminous product	Chrysotile	3	12 Sqm.	R3	Remove

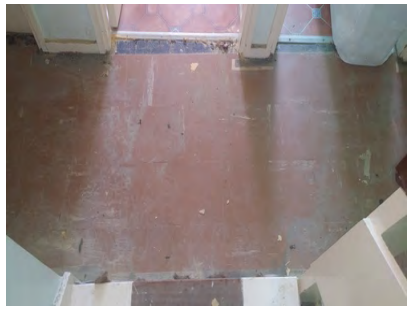
Building	Level	Location	Item / Product Examined	Sample No.	Material Description	Fibre Type	Material Score	Extent	Risk Level Assessment	Initial Control Recommendation	Photograph
Bacton Low Riser, Block E - Flat 177	-2	001/ Stairs, Hall & Cupboards	floor covering	126256-21	Asbestos-containing floor tiles & bituminous product	Chrysotile	3	10 Sqm.	R3	Remove

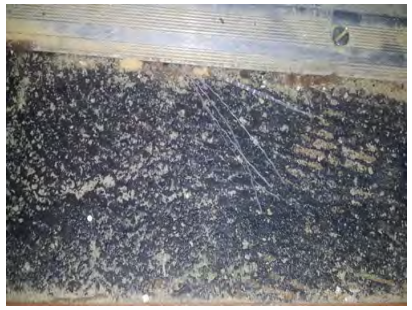
Building	Level	Location	Item / Product Examined	Sample No.	Material Description	Fibre Type	Material Score	Extent	Risk Level Assessment	Initial Control Recommendation	Photograph
Bacton Low Riser, Block E - Flat 177	-2	004/ Toilet	adhesive to concrete floor	126256-21	Asbestos-containing bituminous product	Chrysotile	3	2 Sqm.	R3	Remove

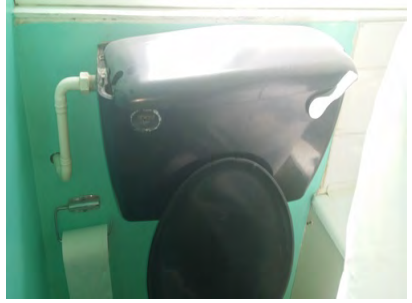
Bacton Low Riser, Block E - Flat 177	-2	005/ Bathroom	toilet cistern	126256-25	Asbestos-containing composite	Amosite	4	1 No.	R3	Remove

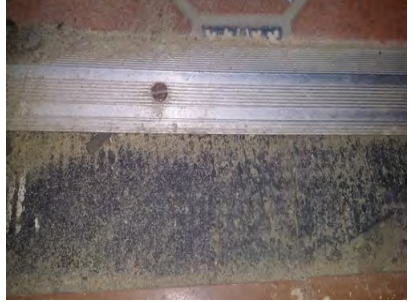
Bacton Low Riser, Block E - Flat 177	-2	005/ Bathroom	adhesive to concrete floor	126256-21	Asbestos-containing bituminous product	Chrysotile	3	4 Sqm.	R3	Remove

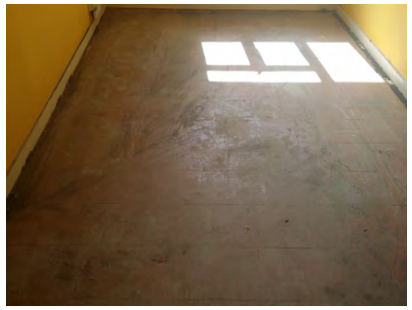
Building	Level	Location	Item / Product Examined	Sample No.	Material Description	Fibre Type	Material Score	Extent	Risk Level Assessment	Initial Control Recommendation	Photograph
Bacton Low Riser, Block E - Flat 177	-2	006/ Bedroom	floor covering	126256-21	Asbestos-containing floor tiles & bituminous product	Chrysotile	3	14 Sqm.	R3	Remove

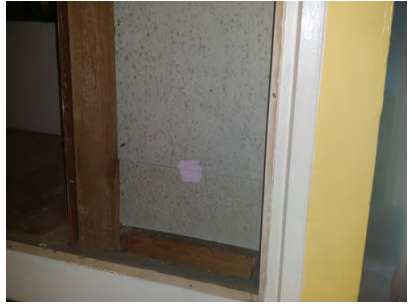
Bacton Low Riser, Block E - Flat 177	-2	006/ Bedroom	boxing within wooden cupboard	126256-32	Asbestos-containing insulating board	Amosite, Chrysotile	7	2 Sqm.	R1	Remove

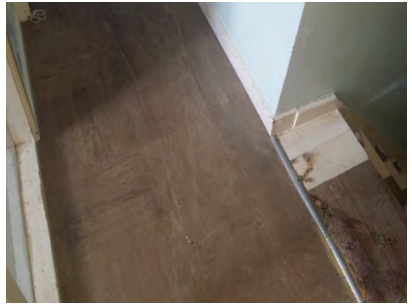
Bacton Low Riser, Block E - Flat 177	-1	001/ Stairs	adhesive to concrete floor	126256-21	Asbestos-containing bituminous product	Chrysotile	3	4 Sqm.	R3	Remove

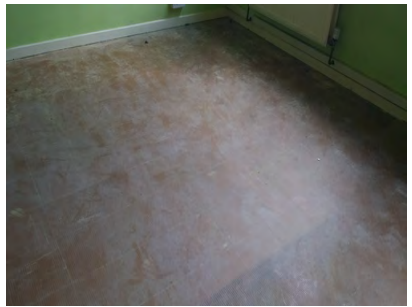
Building	Level	Location	Item / Product Examined	Sample No.	Material Description	Fibre Type	Material Score	Extent	Risk Level Assessment	Initial Control Recommendation	Photograph
Bacton Low Riser, Block E - Flat 177	-1	002/ Lounge & Cupboard	floor covering	126256-21	Asbestos-containing floor tiles & bituminous product	Chrysotile	3	14 Sqm.	R3	Remove

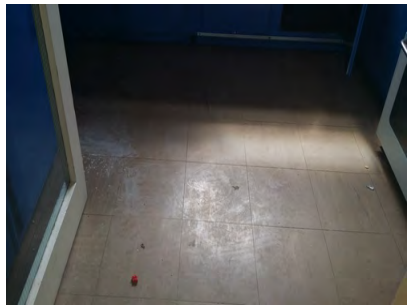
Bacton Low Riser, Block E - Flat 177	-1	003/ Kitchen	adhesive to concrete floor	126256-21	Asbestos-containing bituminous product	Chrysotile	3	6 Sqm.	R3	Remove

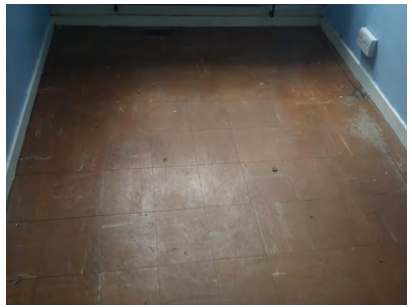
Bacton Low Riser, Block E - Flat 177	-1	004/ Bedroom	floor covering	126256-21	Asbestos-containing floor tiles & bituminous product	Chrysotile	3	14 Sqm.	R3	Remove

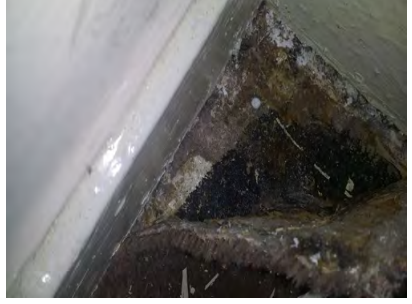
Bacton Low Riser, Block E - Flat 178	0	001/ Entrance Lobby	adhesive to concrete floor	126256-18	Asbestos-containing bituminous product	Chrysotile	3	4 Sqm.	R3	Remove

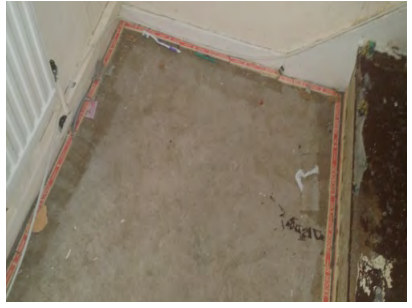
Bacton Low Riser, Block E - Flat 178	1	001/ Stairs	adhesive to concrete floor	126256-18	Asbestos-containing bituminous product	Chrysotile	3	2 Sqm.	R3	Remove

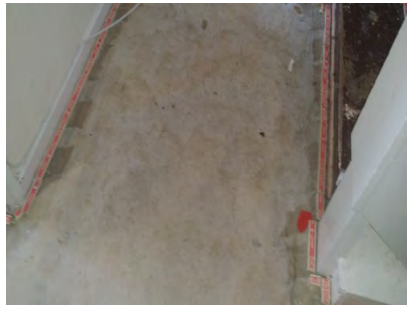
Building	Level	Location	Item / Product Examined	Sample No.	Material Description	Fibre Type	Material Score	Extent	Risk Level Assessment	Initial Control Recommendation	Photograph
Bacton Low Riser, Block E - Flat 178	2	001/ Stairs	adhesive to concrete floor	126256-18	Asbestos-containing bituminous product	Chrysotile	3	2 Sqm.	R3	Remove

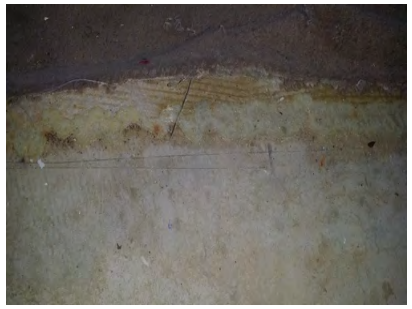
Bacton Low Riser, Block E - Flat 178	2	002/ Bedroom	adhesive to concrete floor	126256-18	Asbestos-containing bituminous product	Chrysotile	3	12 Sqm.	R3	Remove

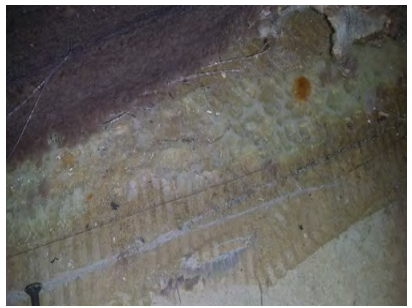
Bacton Low Riser, Block E - Flat 178	2	003/ Bedroom	adhesive to concrete floor	126256-18	Asbestos-containing bituminous product	Chrysotile	3	12 Sqm.	R3	Remove

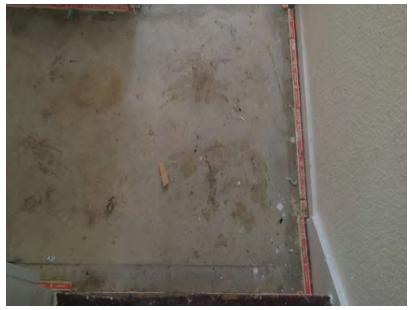
Building	Level	Location	Item / Product Examined	Sample No.	Material Description	Fibre Type	Material Score	Extent	Risk Level Assessment	Initial Control Recommendation	Photograph
Bacton Low Riser, Block E - Flat 178	3	001/ Stairs & Landing	adhesive to concrete floor	126256-18	Asbestos-containing bituminous product	Chrysotile	3	2 Sqm.	R3	Remove

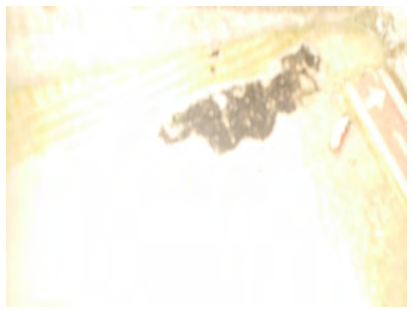
Bacton Low Riser, Block E - Flat 178	3	002/ Bedroom	adhesive to concrete floor	126256-18	Asbestos-containing bituminous product	Chrysotile	3	12 Sqm.	R3	Remove

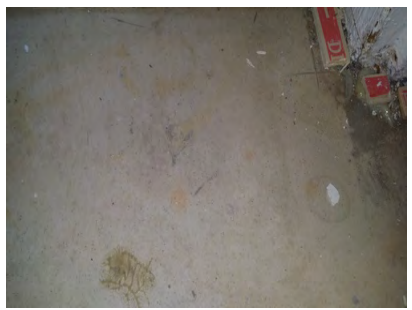
Bacton Low Riser, Block E - Flat 178	3	003/ Bathroom	adhesive to concrete floor	126256-18	Asbestos-containing bituminous product	Chrysotile	3	4 Sqm.	R3	Remove

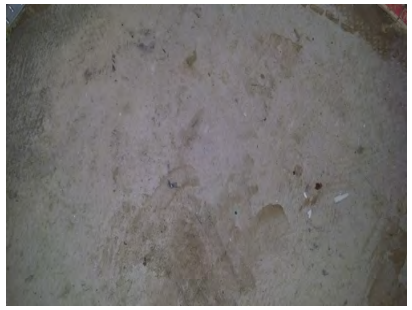
Building	Level	Location	Item / Product Examined	Sample No.	Material Description	Fibre Type	Material Score	Extent	Risk Level Assessment	Initial Control Recommendation	Photograph
Bacton Low Riser, Block E - Flat 178	3	004/ Toilet	adhesive to concrete floor	126256-18	Asbestos-containing bituminous product	Chrysotile	3	2 Sqm.	R3	Remove

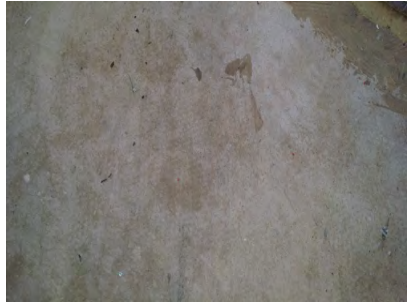
Bacton Low Riser, Block E - Flat 178	4	001/ Bedroom	adhesive to concrete floor	126256-18	Asbestos-containing bituminous product	Chrysotile	3	12 Sqm.	R3	Remove

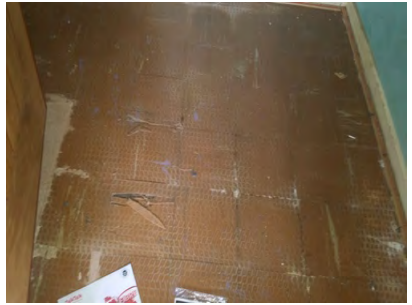
Bacton Low Riser, Block E - Flat 179	0	001/ Entrance Lobby	floor covering	126256-13	Asbestos-containing floor tiles & bituminous product	Chrysotile	3	4 Sqm.	R3	Remove

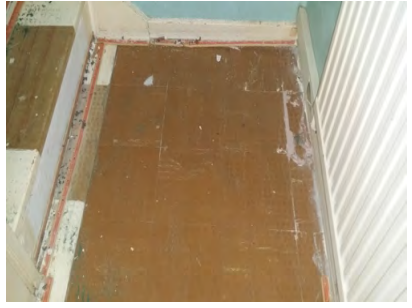
Bacton Low Riser, Block E - Flat 179	1	001/ Stairs	floor covering	126256-13	Asbestos-containing floor tiles & bituminous product	Chrysotile	3	2 Sqm.	R3	Remove

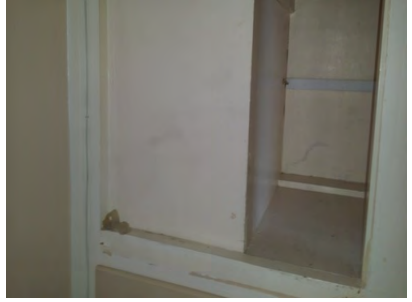
Bacton Low Riser, Block E - Flat 179	1	002/ Kitchen & Lounge	boxing within wooden cupboard	126256-16	Asbestos-containing insulating board	Amosite, Chrysotile	6	2 Sqm.	R2	Remove

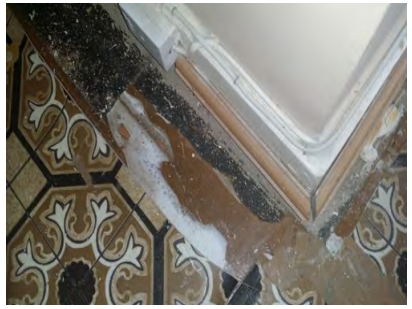
Building	Level	Location	Item / Product Examined	Sample No.	Material Description	Fibre Type	Material Score	Extent	Risk Level Assessment	Initial Control Recommendation	Photograph
Bacton Low Riser, Block E - Flat 179	1	002/ Kitchen & Lounge	subfloor	126256-13	Asbestos-containing floor tiles & bituminous product	Chrysotile	3	14 Sqm.	R3	Remove

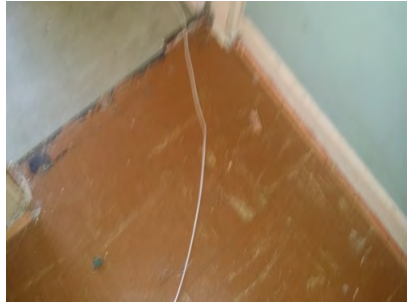
Bacton Low Riser, Block E - Flat 179	2	001/ Stairs	floor covering	126256-13	Asbestos-containing floor tiles & bituminous product	Chrysotile	3	2 Sqm.	R3	Remove

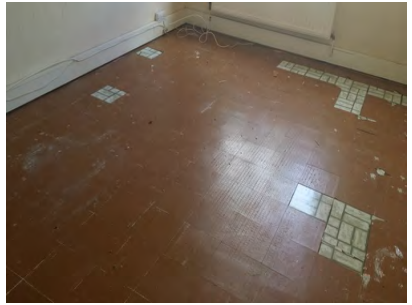
Bacton Low Riser, Block E - Flat 179	2	002/ Bedroom	floor covering	126256-13	Asbestos-containing floor tiles & bituminous product	Chrysotile	3	12 Sqm.	R3	Remove

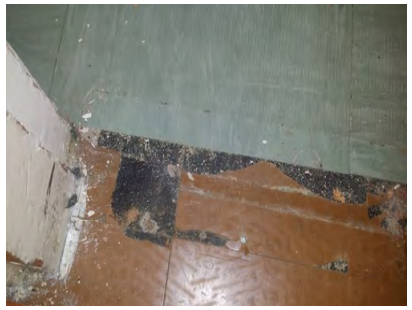
Building	Level	Location	Item / Product Examined	Sample No.	Material Description	Fibre Type	Material Score	Extent	Risk Level Assessment	Initial Control Recommendation	Photograph
Bacton Low Riser, Block E - Flat 179	2	003/ Bedroom	adhesive to concrete floor	126256-13	Asbestos-containing bituminous product	Chrysotile	3	12 Sqm.	R3	Remove

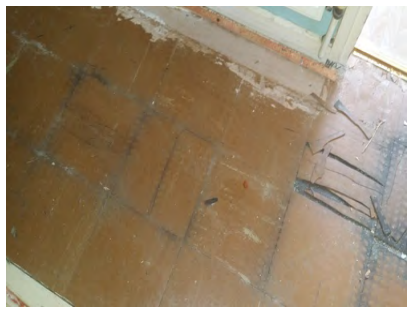
Bacton Low Riser, Block E - Flat 179	3	001/ Stairs & Landing	floor covering	126256-13	Asbestos-containing floor tiles & bituminous product	Chrysotile	3	2 Sqm.	R3	Remove

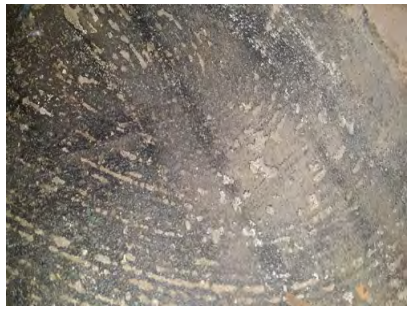
Building	Level	Location	Item / Product Examined	Sample No.	Material Description	Fibre Type	Material Score	Extent	Risk Level Assessment	Initial Control Recommendation	Photograph
Bacton Low Riser, Block E - Flat 179	3	003/ Bathroom	adhesive to concrete floor	126256-13	Asbestos-containing bituminous product	Chrysotile	3	4 Sqm.	R3	Remove

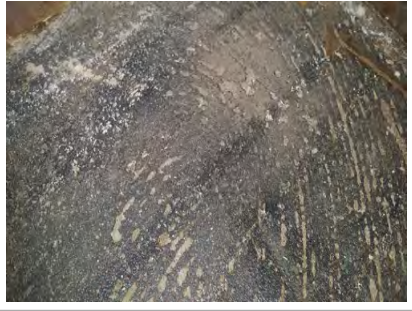
Bacton Low Riser, Block E - Flat 179	3	004/ Toilet	adhesive to concrete floor	126256-13	Asbestos-containing bituminous product	Chrysotile	3	2 Sqm.	R3	Remove

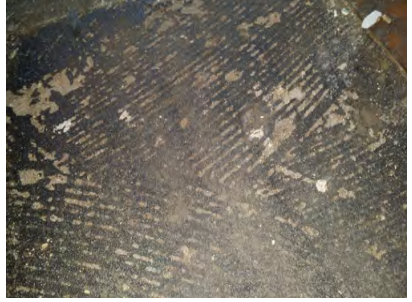
Bacton Low Riser, Block E - Flat 179	4	001/ Bedroom	floor covering	126256-13	Asbestos-containing floor tiles & bituminous product	Chrysotile	3	12 Sqm.	R3	Remove

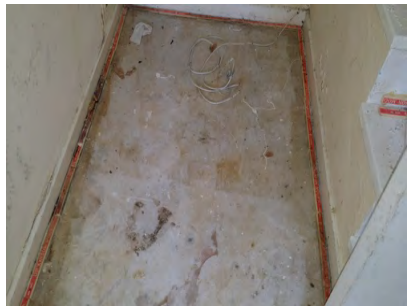
Building	Level	Location	Item / Product Examined	Sample No.	Material Description	Fibre Type	Material Score	Extent	Risk Level Assessment	Initial Control Recommendation	Photograph
Bacton Low Riser, Block E - Flat 180	-2	001/ Stairs, Hall & Cupboards	adhesive to concrete floor	126256-8	Asbestos-containing bituminous product	Chrysotile	3	10 Sqm.	R3	Remove

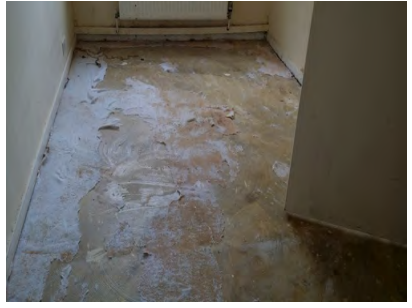
Bacton Low Riser, Block E - Flat 180	-2	002/ Bedroom	adhesive to concrete floor	126256-8	Asbestos-containing bituminous product	Chrysotile	3	14 Sqm.	R3	Remove

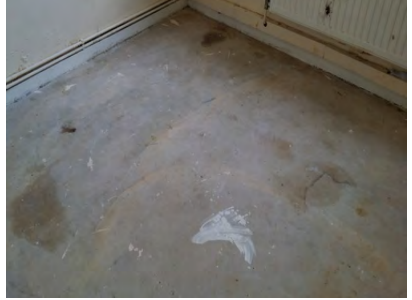
Bacton Low Riser, Block E - Flat 180	-2	003/ Bedroom	adhesive to concrete floor	126256-8	Asbestos-containing bituminous product	Chrysotile	3	14 Sqm.	R3	Remove

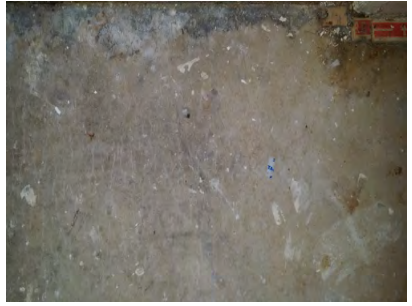
Bacton Low Riser, Block E - Flat 180	-2	005/ Bathroom	adhesive to concrete floor	126256-8	Asbestos-containing bituminous product	Chrysotile	3	4 Sqm.	R3	Remove

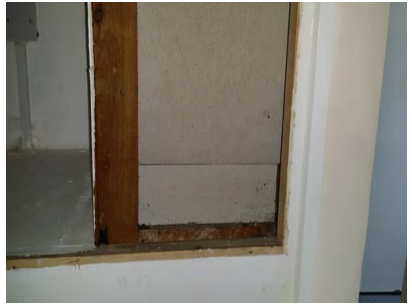
Bacton Low Riser, Block E - Flat 180	-2	006/ Bedroom	boxing within wooden cupboard	126256-12	Asbestos-containing insulating board	Amosite, Chrysotile	7	2 Sqm.	R1	Remove

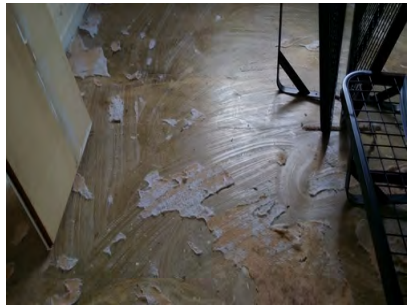
Building	Level	Location	Item / Product Examined	Sample No.	Material Description	Fibre Type	Material Score	Extent	Risk Level Assessment	Initial Control Recommendation	Photograph
Bacton Low Riser, Block E - Flat 180	-2	006/ Bedroom	adhesive to concrete floor	126256-8	Asbestos-containing bituminous product	Chrysotile	3	14 Sqm.	R3	Remove

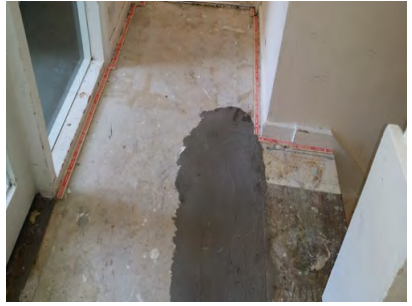
Bacton Low Riser, Block E - Flat 180	-1	001/ Stairs	adhesive to concrete floor	126256-8	Asbestos-containing bituminous product	Chrysotile	3	4 Sqm.	R3	Remove

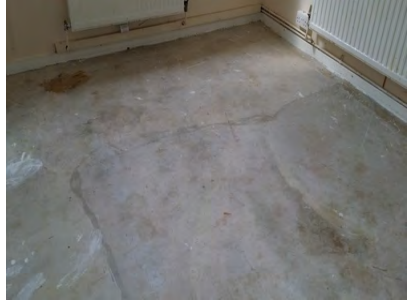
Bacton Low Riser, Block E - Flat 180	-1	002/ Lounge & Cupboard	adhesive to concrete floor	126256-8	Asbestos-containing bituminous product	Chrysotile	3	14 Sqm.	R3	Remove

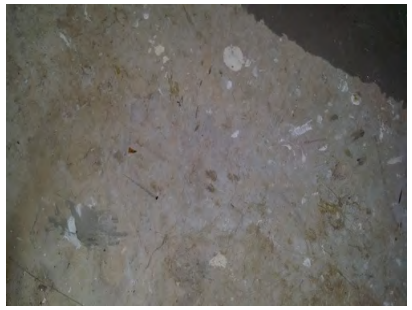
Building	Level	Location	Item / Product Examined	Sample No.	Material Description	Fibre Type	Material Score	Extent	Risk Level Assessment	Initial Control Recommendation	Photograph
Bacton Low Riser, Block E - Flat 180	-1	003/ Kitchen	adhesive to concrete floor	126256-8	Asbestos-containing bituminous product	Chrysotile	3	6 Sqm.	R3	Remove

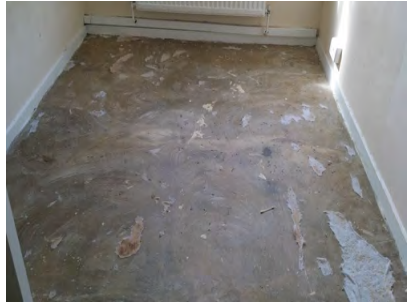
Bacton Low Riser, Block E - Flat 180	-1	004/ Bedroom	adhesive to concrete floor	126256-8	Asbestos-containing bituminous product	Chrysotile	3	14 Sqm.	R3	Remove

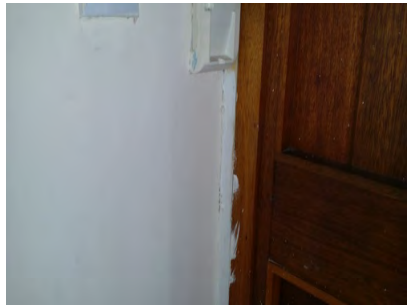
Building	Level	Location	Item / Product Examined	Sample No.	Material Description	Fibre Type	Material Score	Extent	Risk Level Assessment	Initial Control Recommendation	Photograph
Bacton Low Riser, Block E - Flat 180	0	001/ Entrance Lobby	boxing to electric cupboard	126256-9	Asbestos-containing insulating board	Amosite, Chrysotile	6	2 Sqm.	R2	Remove

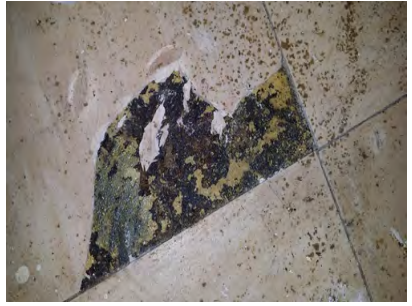
Bacton Low Riser, Block E - Flat 181	0	001/ Entrance Lobby	adhesive to concrete floor	126256-1	Asbestos-containing bituminous product	Chrysotile	3	4 Sqm.	R3	Remove

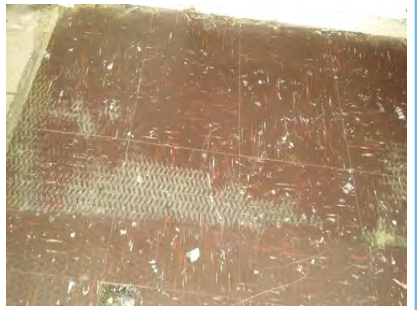
Building	Level	Location	Item / Product Examined	Sample No.	Material Description	Fibre Type	Material Score	Extent	Risk Level Assessment	Initial Control Recommendation	Photograph
Bacton Low Riser, Block E - Flat 181	1	001/ Stairs	floor covering	126256-3	Asbestos-containing floor tiles & bituminous product	Chrysotile	3	2 Sqm.	R3	Remove

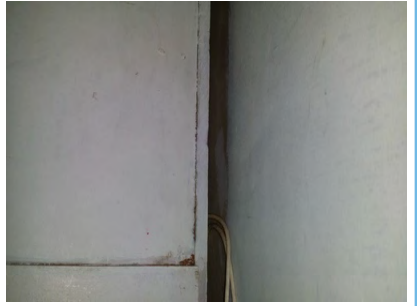
Bacton Low Riser, Block E - Flat 181	1	002/ Kitchen & Lounge	boxing within wooden cupboard	126256-6	Asbestos-containing insulating board	Amosite, Chrysotile	7	2 Sqm.	R1	Remove

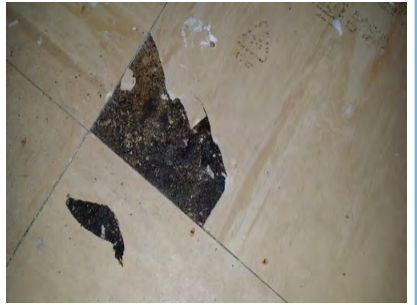
Bacton Low Riser, Block E - Flat 181	1	002/ Kitchen & Lounge	adhesive to concrete floor	126256-1	Asbestos-containing bituminous product	Chrysotile	3	14 Sqm.	R3	Remove

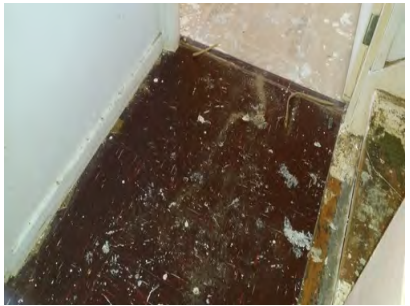
Building	Level	Location	Item / Product Examined	Sample No.	Material Description	Fibre Type	Material Score	Extent	Risk Level Assessment	Initial Control Recommendation	Photograph
Bacton Low Riser, Block E - Flat 181	2	001/ Stairs	floor covering	126256-3	Asbestos-containing floor tiles & bituminous product	Chrysotile	3	2 Sqm.	R3	Remove

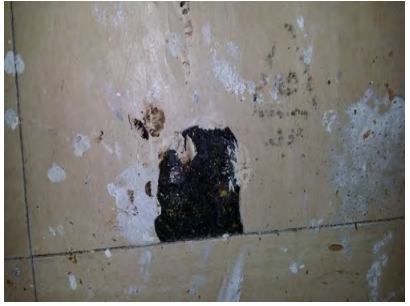
Bacton Low Riser, Block E - Flat 181	2	002/ Bedroom	adhesive to concrete floor	126256-1	Asbestos-containing bituminous product	Chrysotile	3	12 Sqm.	R3	Remove

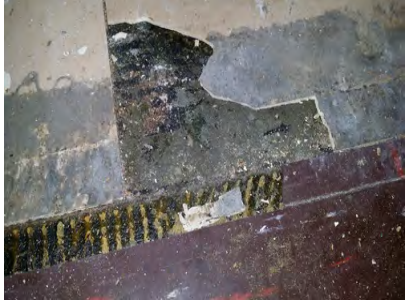
Bacton Low Riser, Block E - Flat 181	2	003/ Bedroom	adhesive to concrete floor	126256-1	Asbestos-containing bituminous product	Chrysotile	3	12 Sqm.	R3	Remove

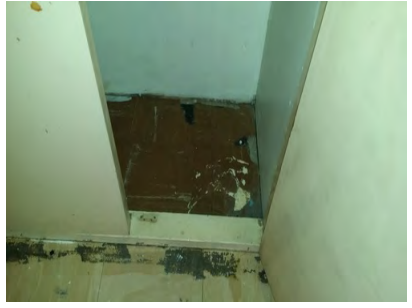
Bacton Low Riser, Block E - Flat 181	3	002/ Bedroom	floor covering within cupboard	126256-3	Asbestos-containing floor tiles & bituminous product	Chrysotile	3	1 Sqm.	R3	Remove

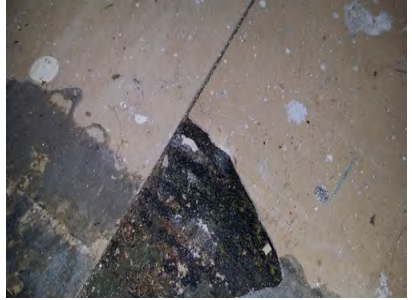
Bacton Low Riser, Block E - Flat 181	3	002/ Bedroom	adhesive to concrete floor	126256-1	Asbestos-containing bituminous product	Chrysotile	3	12 Sqm.	R3	Remove

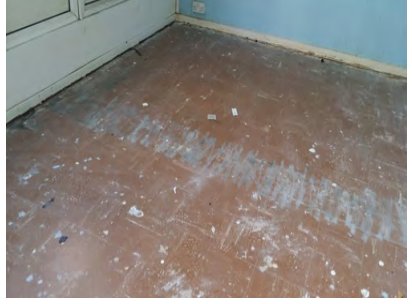
Bacton Low Riser, Block E - Flat 181	4	001/ Bedroom	floor covering	126256-3	Asbestos-containing floor tiles & bituminous product	Chrysotile	3	12 Sqm.	R3	Remove
