Re: 94 Haverstock Hill – Cleaning and Paint Removal Trials

94 HAVERSTOCK HILL - CLEANING TRIAL REPORT

Cleaning and paint removal trials were carried out at 1st floor level to existing brickwork and decorative stucco render

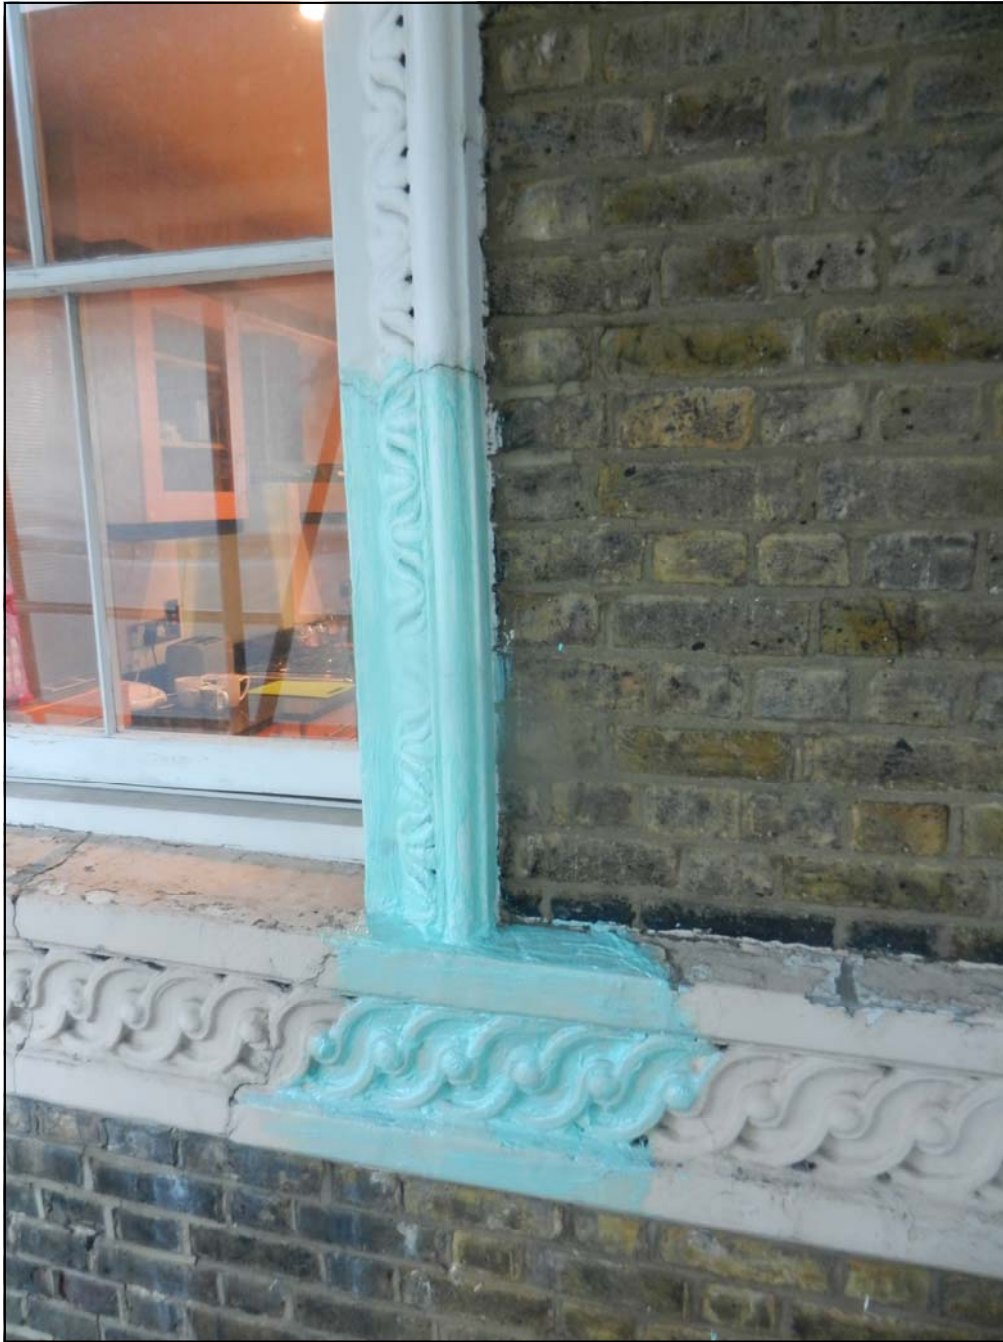
T01: Tavec 201 was brush applied and left to react for 24 hrs

1No application of Tavec 201 was applied initially to a section of window surround and band course and left to react for 24hrs.

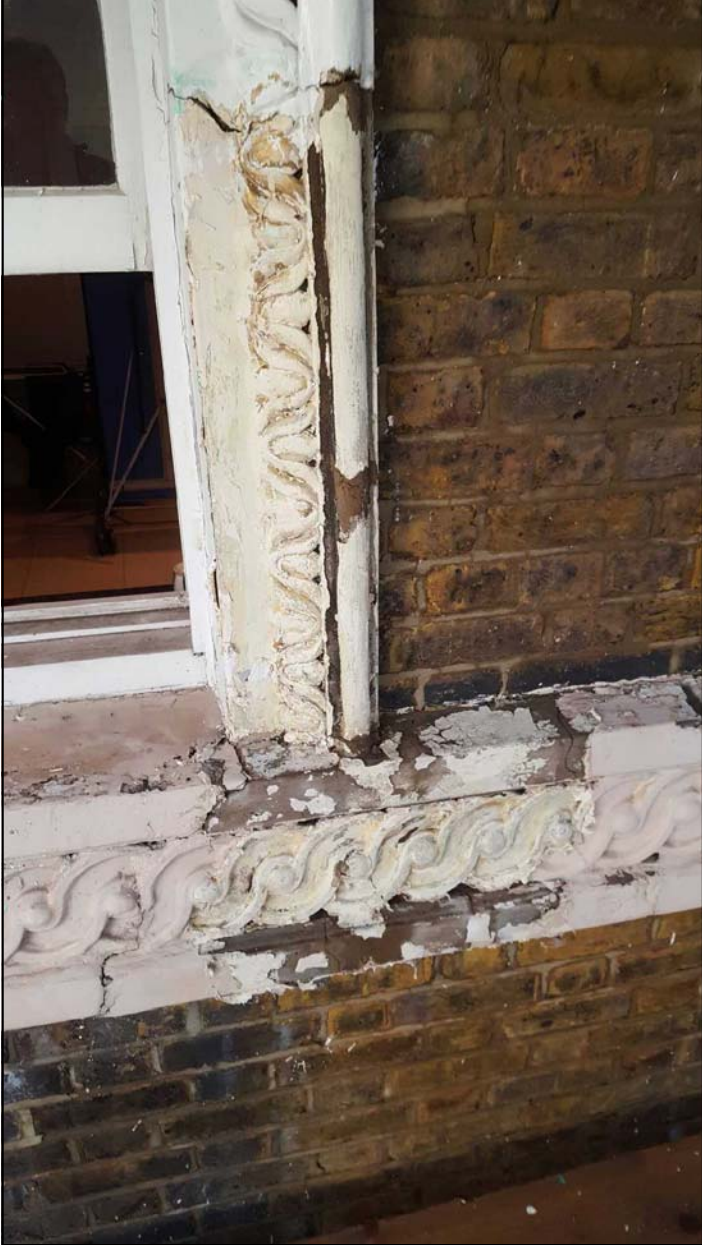
T02: The first application removed approximately 10% of the paint

The first application of Tavec removed approximately 10% of the paint. A second application left to react for a further 24hrs removed around 60%.

2No applications of Tavec 201 achieved mixed results but did not remove all visible paint.

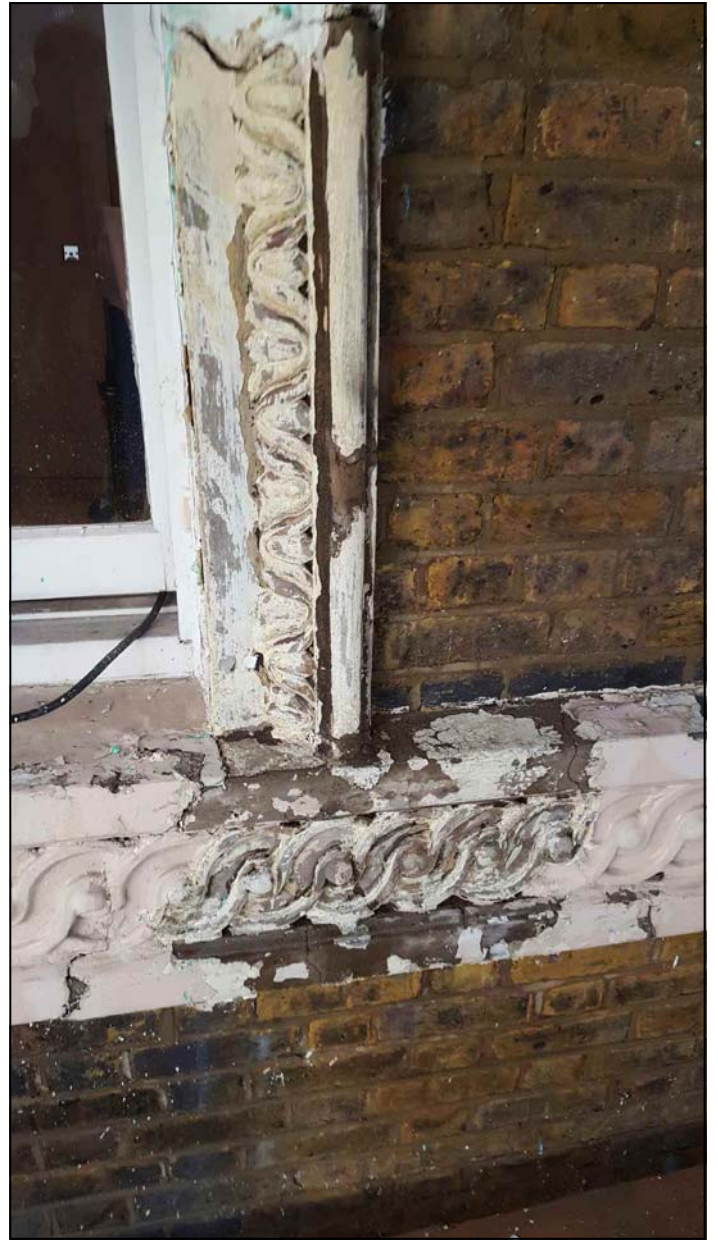
T03: The second application removed around 60% of the paint. The stucco has been extensively filled and previously repaired.

Removing the paint exposed that the stucco had been extensively repaired and filled.

Remove paint using Tavec 201 or Kling-Strip Poulitice combined with the use of Torik to wash down and remove residues.

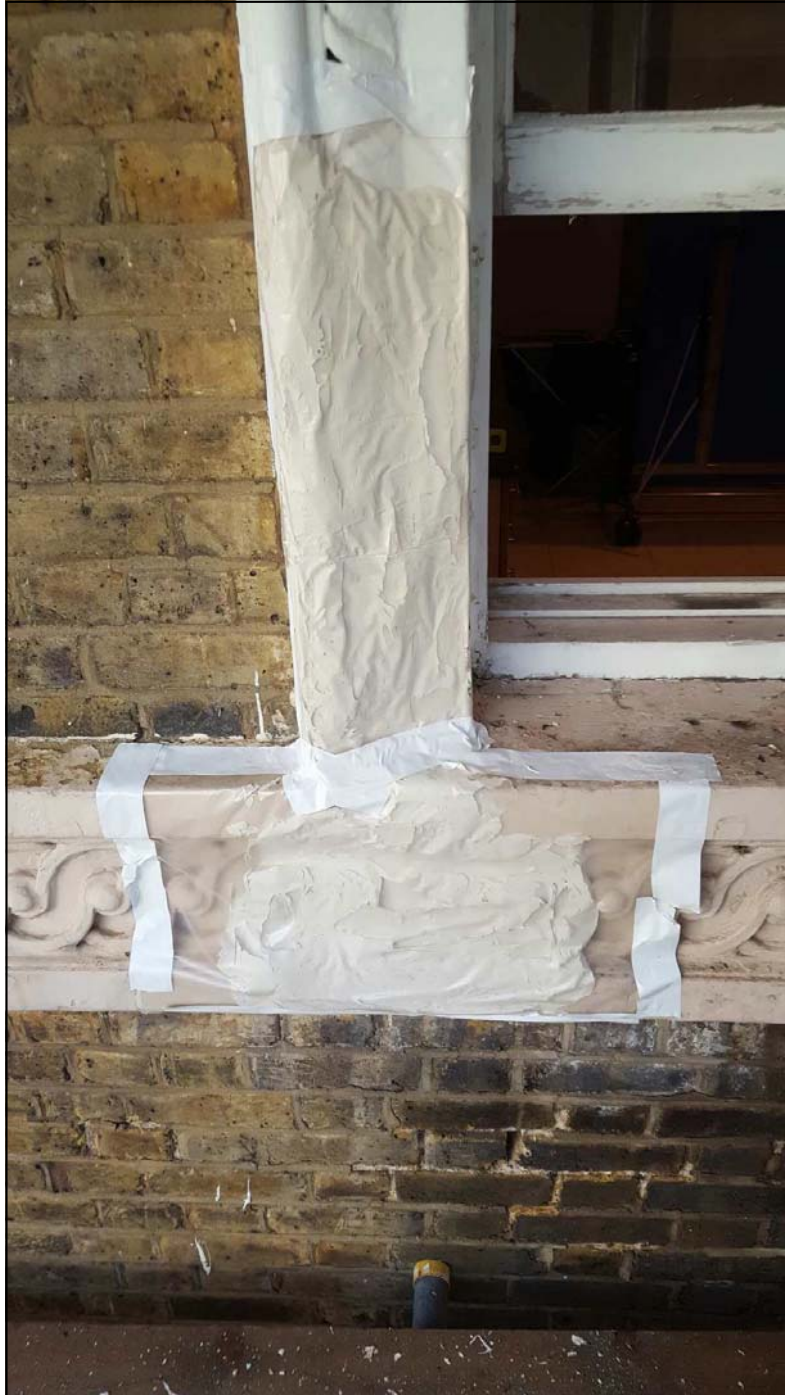
K04: Kling—Strip poultice was applied, covered and left to react for 5 days.

1No application of Kling-Strip Poultice was applied to a section of window surround and band course and left to react for 5 days.

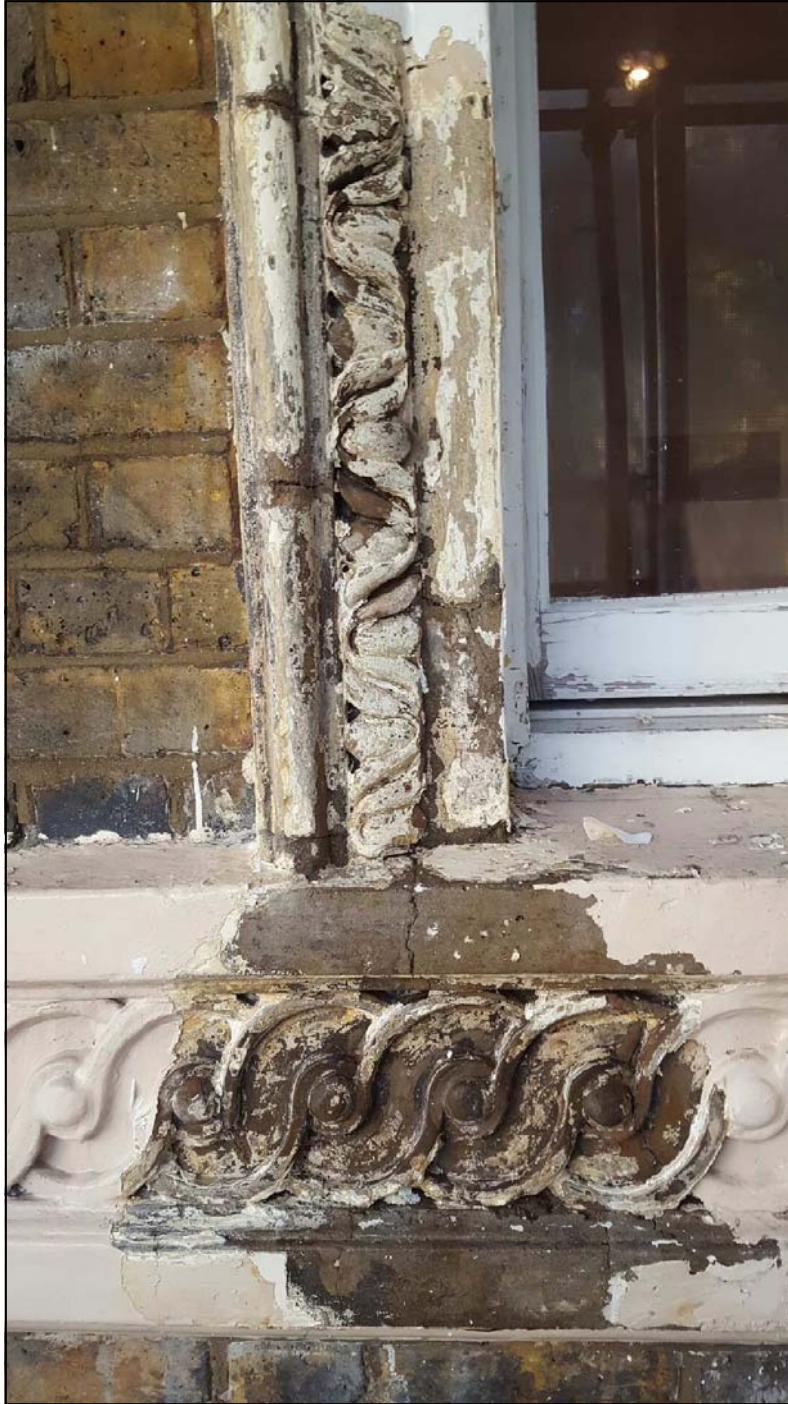
K05: 80% of paint was removed from the trial area using 1No application of Kling-Strip. The stucco has been extensively filled and previously repaired.

The Kling-Strip removed 80% of the paint. The stripped stucco revealed that extensive filling and previous repair had been carried out.

1No application of Kling – Strip achieved an improved result but remnants of paint remained. Further applications of Kling – Strip or Tavec 201 may improve the result.

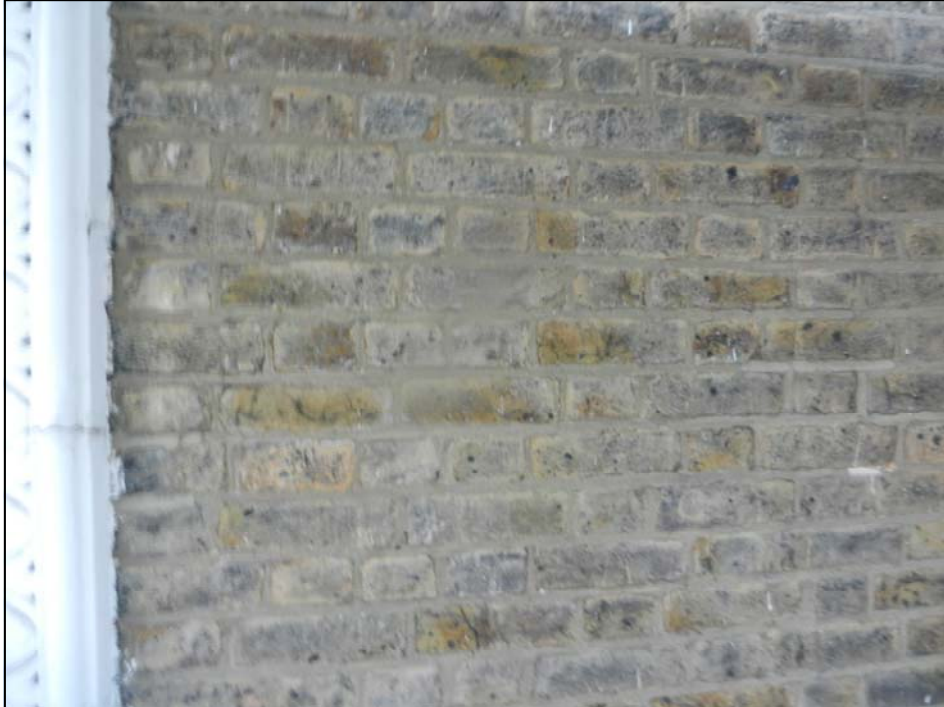
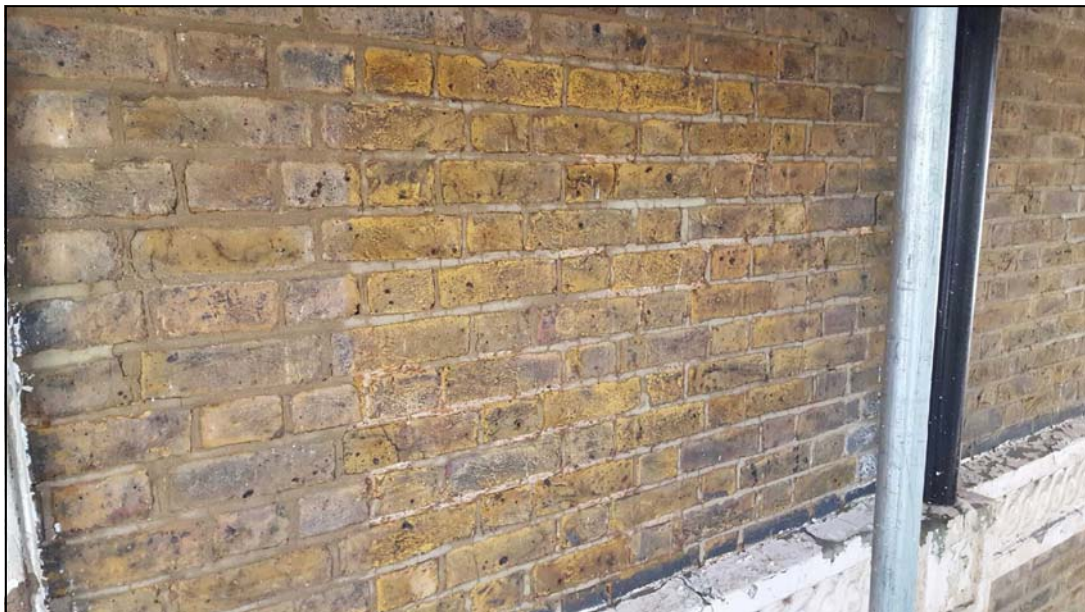
TK06-TK07: The Torik Superheated Pressure Washer achieved a visible result to the trial area removing light surface soiling.

A section of facing brickwork was cleaned down using the Torik Superheated Pressure Washer. The system produced a visible result in removing light surface soiling.

The Torik produced a visible result on the trial area selected in removing light surface soiling. The system would be limited in removing heavier levels and deposits of hardened atmospheric soiling.

Consideration would need to be given to the use of alternative systems in order to achieve an improvement in appearance and removing heavier levels of surface soiling.

Clean down unpainted brick façades using TORIK to achieve a light conservation clean. Additional cleaning using alternative systems to help improve the general appearance and lighten and remove heavier soiling
