DESK STUDY & BASEMENT IMPACT ASSESSMENT REPORT

The Hall School
23 Crossfield Street
London NW3

J15302

August 2016

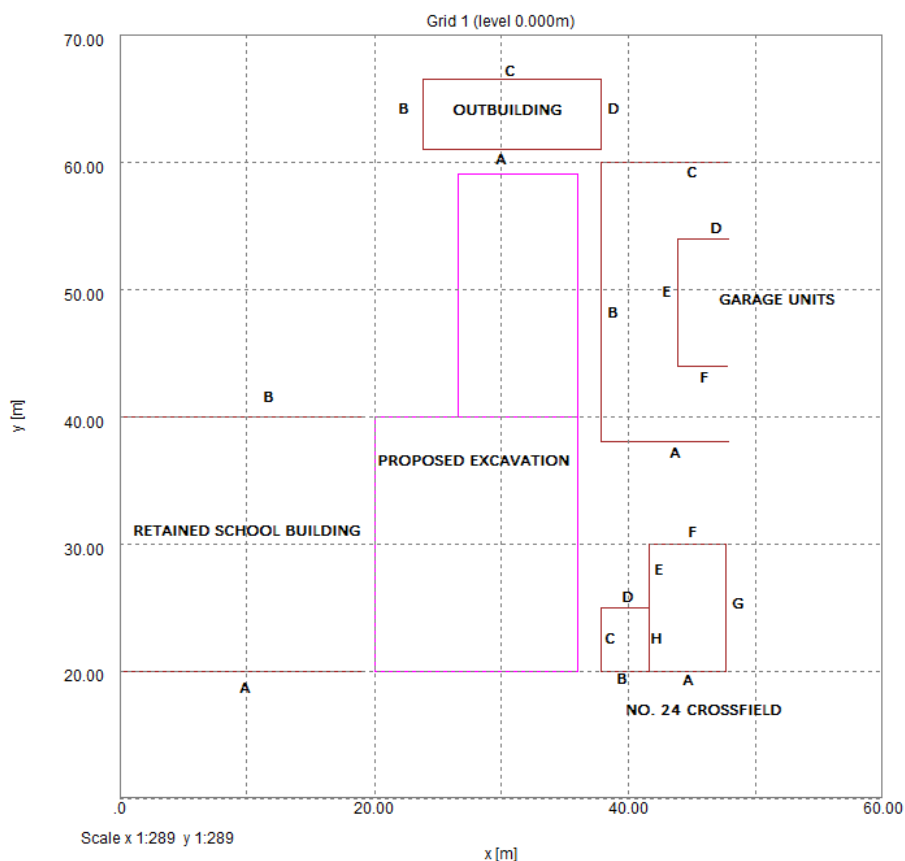
*From Table 2.5 of C580¹: Classification of visible damage to walls.

The analysis has predicted that the proposed installation of the bored pile wall, in addition to the excavation of the proposed basement, may generally result in building damage of sensitive structures of between Category 0 (negligible) and Category 1 (very slight), although a single elevation to the lockup garage block is indicated as Category 2 (slight). For those structures, some of the elevations will be subject to repointing and repair during and after the construction process.

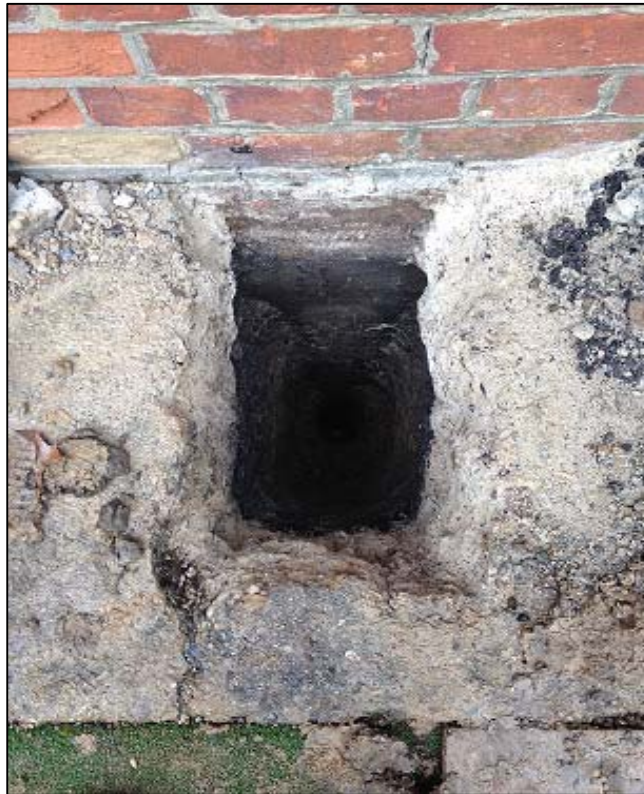
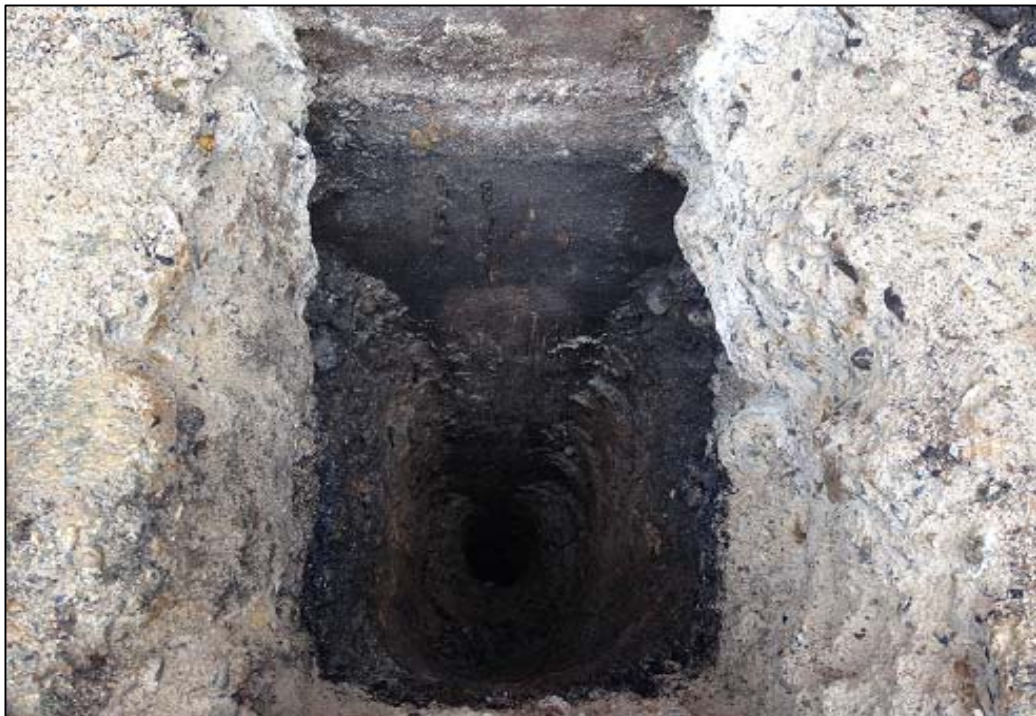
Excavation Method Manual	Dimensions 500 x 400 x 750	Ground Level (mOD)	Client The Hall School	Job Number J15302
	Location	Dates 30/10/2015	Engineer Elliott Wood	Sheet 1 / 1

Remarks: All dimensions in millimetres Sides of trial pit remained stable during excavation Groundwater: not encountered	Base of footing not proved. Borehole No 2 advanced through base of trial pit. Sample: 0.4 m	Scale: 1:20
		Logged by: ML

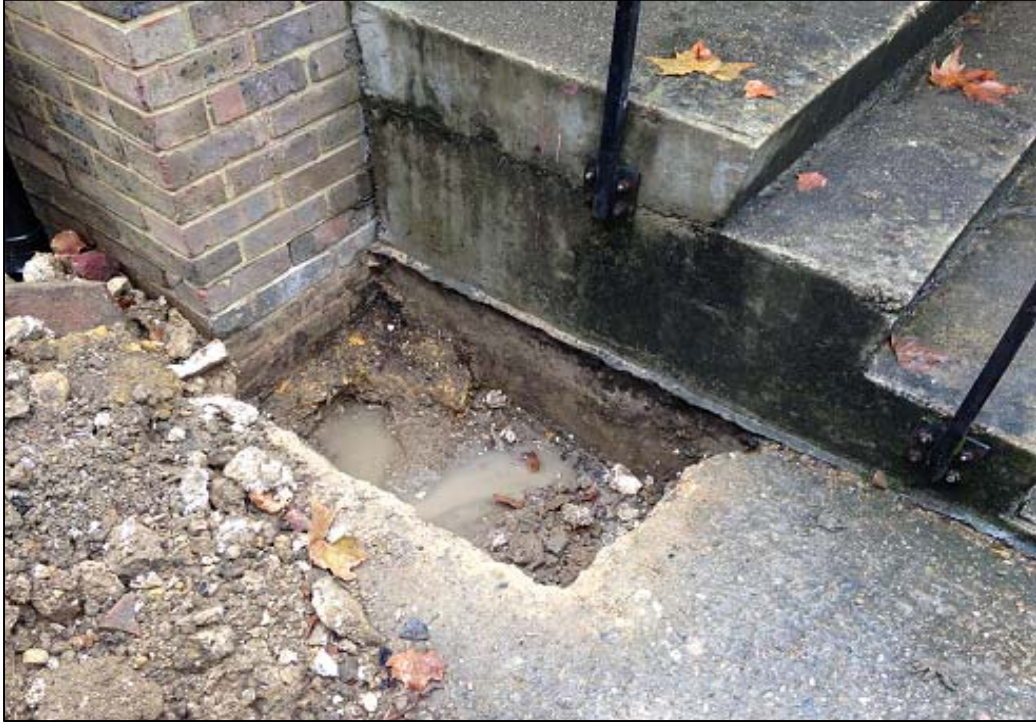
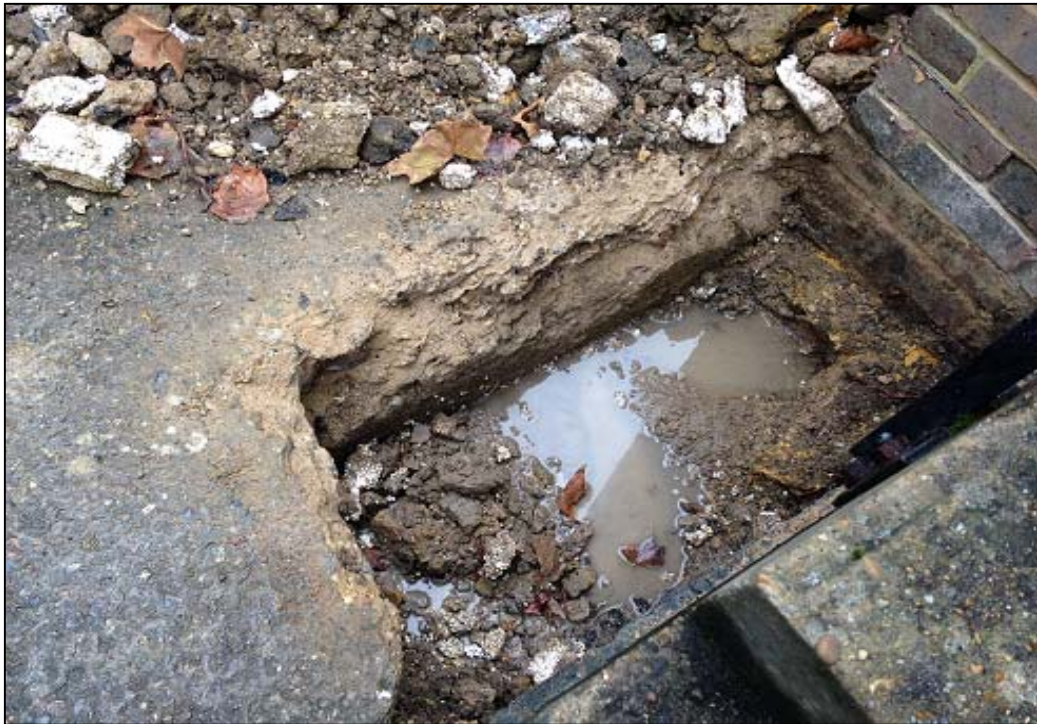
Excavation Method Manual	Dimensions 1200 x 600 x 360	Ground Level (mOD)	Client The Hall School	Job Number J15302
	Location	Dates 30/10/2015	Engineer Elliott Wood	Sheet 2 / 2

Remarks:
All dimensions in millimetres
Sides of trial pit remained stable during excavation
Groundwater: not encountered

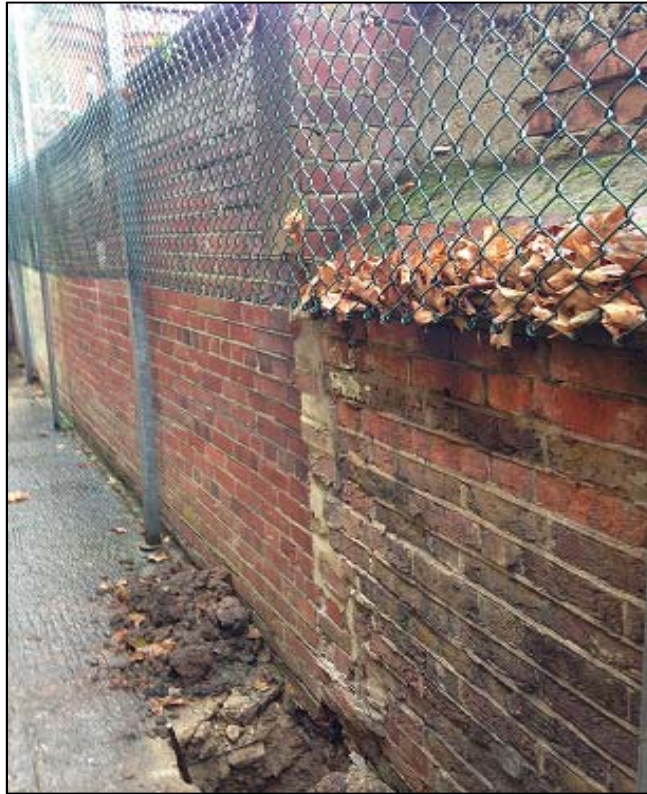
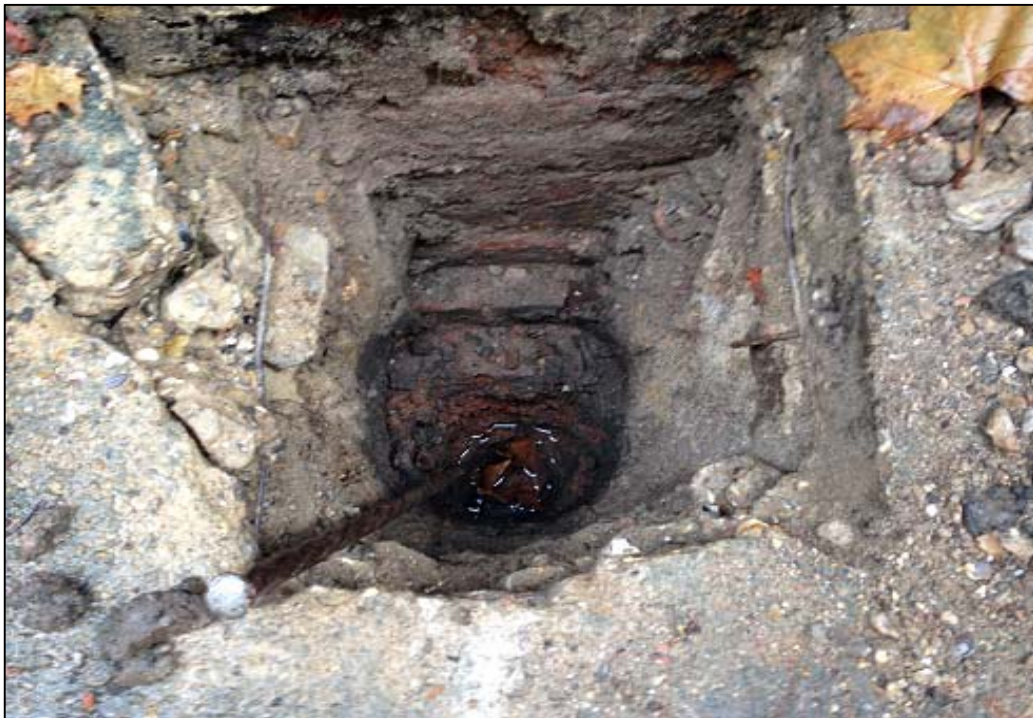
Excavation Method Manual	Dimensions 450 x 400 x 950	Ground Level (mOD)	Client The Hall School	Job Number J15302
	Location	Dates 30/10/2015	Engineer Elliott Wood	Sheet 2 / 2

Remarks:
All dimensions in millimetres
Sides of trial pit remained stable during excavation
Groundwater: not encountered

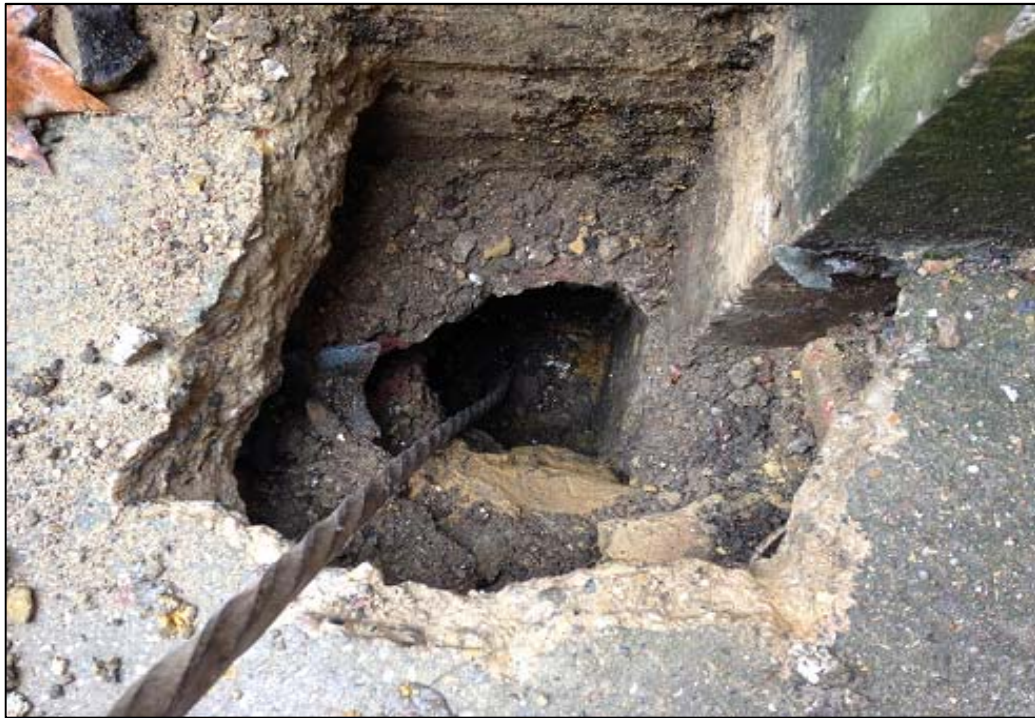
Section B - B: -

Remarks: All dimensions in millimetres Sides of trial pit remained stable during excavation Groundwater: not encountered	Scale: 1:20
	Logged by: ML

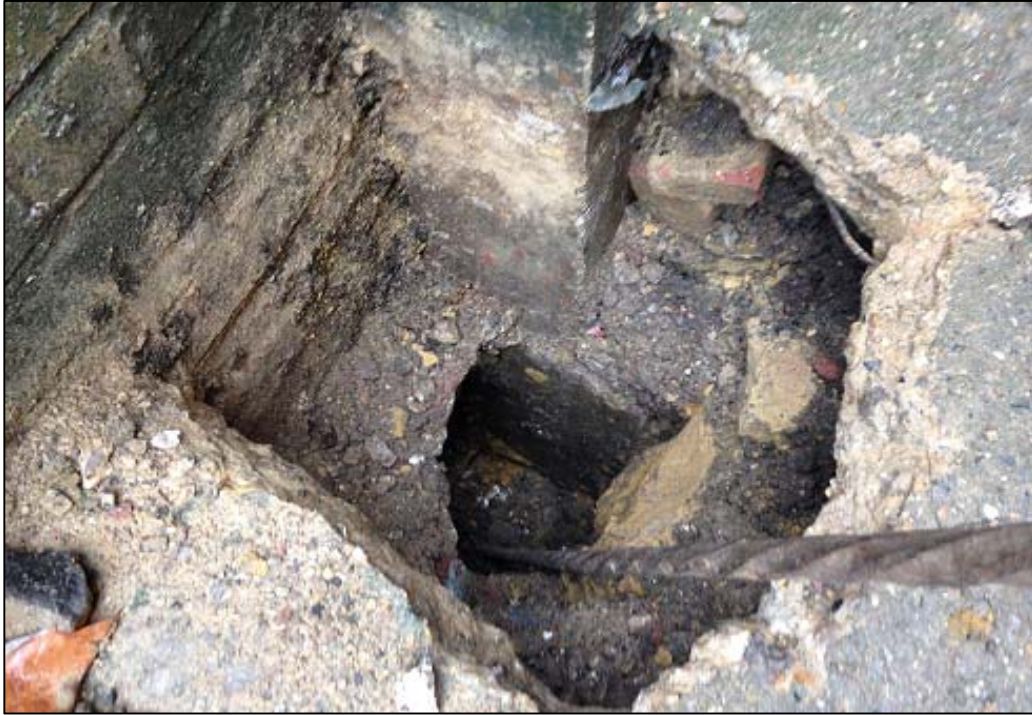
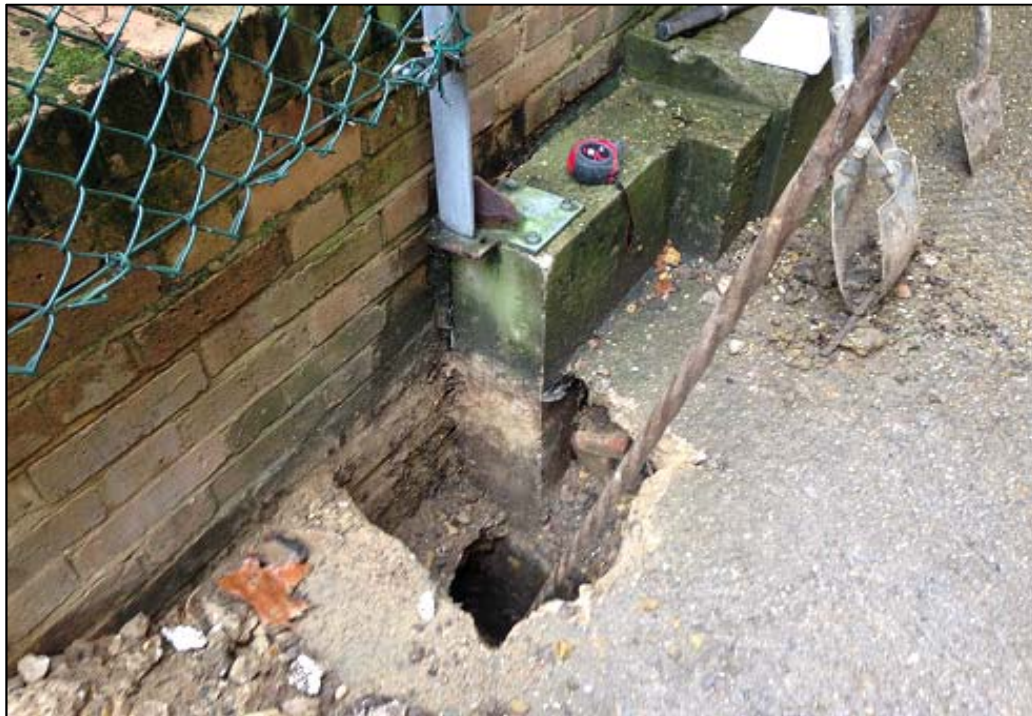
Excavation Method Manual	Dimensions 1300 x 500 x 500	Ground Level (mOD)	Client The Hall School	Job Number J15302
	Location	Dates 30/10/2015	Engineer Elliott Wood	Sheet 3 / 3

Remarks: All dimensions in millimetres Sides of trial pit remained stable during excavation Groundwater: not encountered	Scale: 1:20
	Logged by: ML
