Date
November 2016

Project Number
UK11-23583

THE HALL SCHOOL, LONDON BOROUGH OF CAMDEN ECOLOGY REPORT

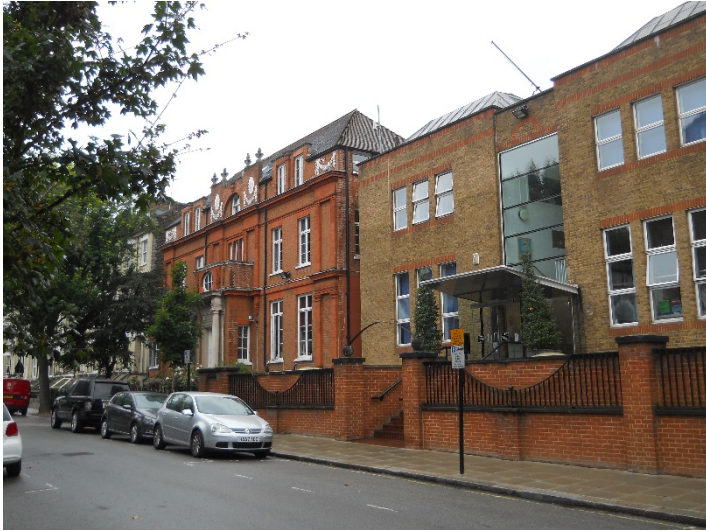
Photo 1: Front (west) side of site, with street trees and introduced shrub in front of building.

All wild birds are protected whilst nesting, with disturbance and destruction of active nests constituting an offence under the Wildlife and Countryside Act 1981 (as amended). If removal or pruning of the introduced shrub to the west front-side of the building or the London plane tree is required, this should be undertaken during September to January, which is outside of the bird breeding season, or following checks for nesting birds. If active nests are identified, work should be delayed until the nests are no longer active.

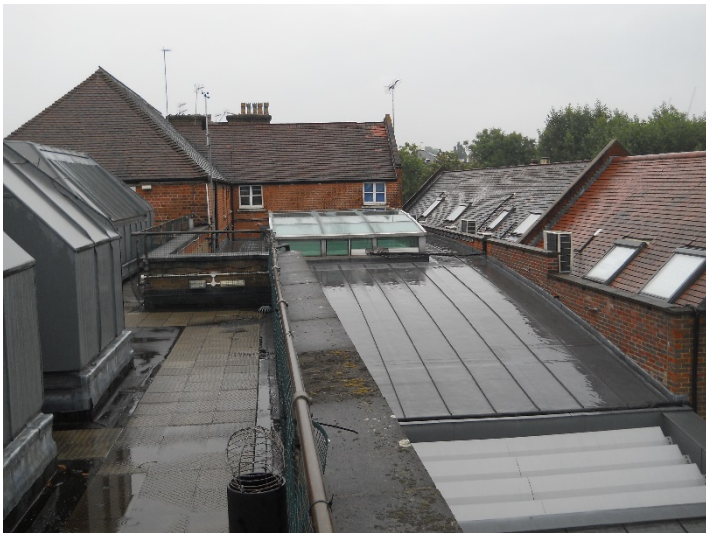
The main building is made from brick, is three to four storeys high and has a pitched roof with tiles and dormer windows. There is a glass and metal atrium roof within the central area of the main building. The southern extension has a flat accessible roof with roof pods, and the Wathen Hall building is linked to this via a single storey roof terrace with planters. Wathen Hall is a single storey brick building with a flat felt roof. Planters on the roof terrace contain introduced shrubs including Japanese aralia *Fatsia japonica*, rosemary *Rosmarinus officinalis*, plum *Prunus* sp. and horse chestnut *Aesculus hippocastanum*. The northwest front-side of the site has introduced shrubs including box *Buxus sempervirens*, ivy *Hedera helix*, rose *Rosa* sp., *Pelargonium* sp., wood sorrel *Oxalis* sp., holly *Ilex aquifolia*, Japanese aralia, bay laurel *Laurus nobilis* and copper beech *Fagus sylvatica*, covering an area of approximately 16 m². The southeast front has a garden infill with a flat felt roof. Street trees to the west include London plane and Norway Maple *Acer platanoides*.

The buildings have no crevices or openings suitable for use by roosting bats, and all tiles and roof areas are intact. The site is likely to be of limited suitability for use by foraging bats, due to the small amounts of vegetation present. Further surveys for bats are not considered necessary. The gardens in the surrounding area are more suitable for use by small numbers of foraging bats.

Photo 2: Roof of the main building, with the older northern section to the rear and right of the photo, and the southern newer part and the atrium to the front.

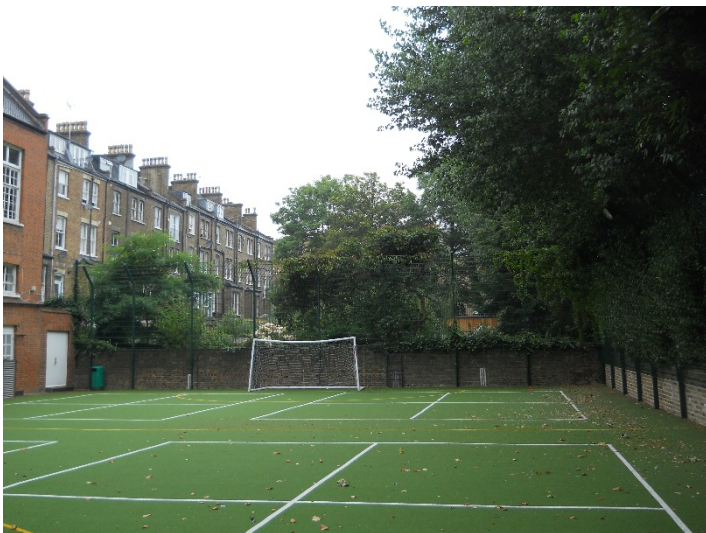
In the courtyard area a number of climbers overhang the site from adjacent gardens, but are not growing within the site itself. These include ivy and non-native climbers.

Photo 3: Artificial turf playground to east of site, with climbers and trees in adjacent gardens.

- provision of further landscape planting, climbers around the playground area or a green roof with nectar-producing flowers to benefit invertebrate species such as bees and butterflies;
- provision of bird boxes close to areas of vegetation or on the London plane tree; and
- provision of bat boxes built within the wall of building or attached to external sides, close to areas of vegetation.

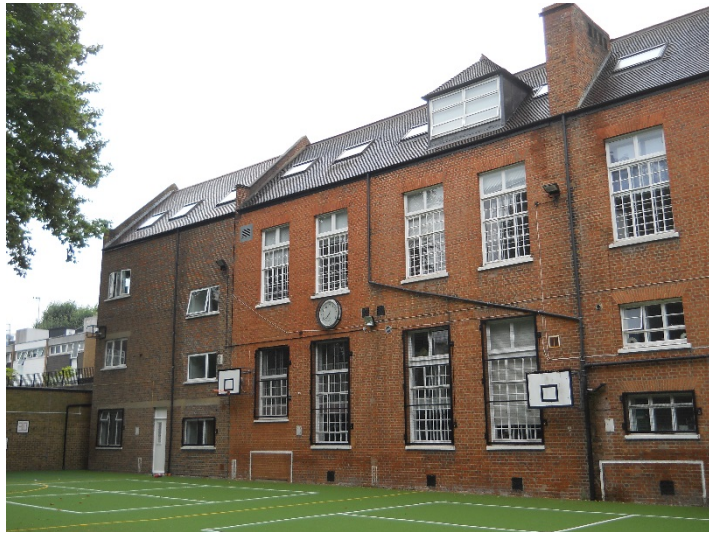
Photo 4: East side of main building.

Impacts on roosting bats are not anticipated as a result of the redevelopment of the site. Night time lighting of the eastern side of the building during the construction phase should be minimised, to reduce impacts on foraging bats.

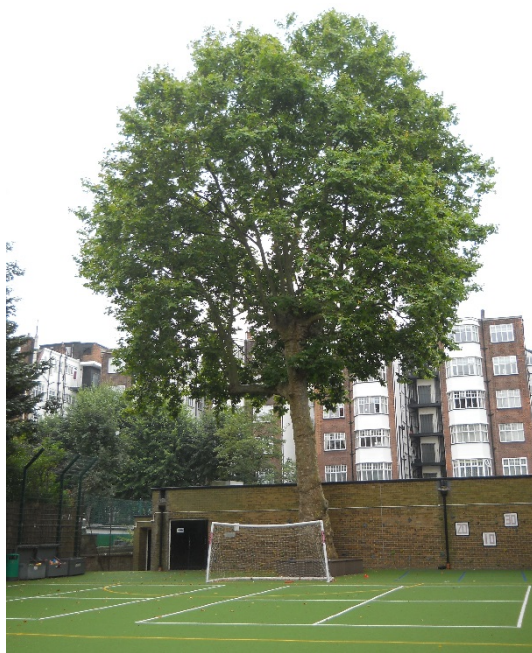
Photo 5: Mature London plant to east of main building, and single-storey Wathen Hall building behind this.
