Mount Vernon

Boundary security enhancements Design & Heritage Statement

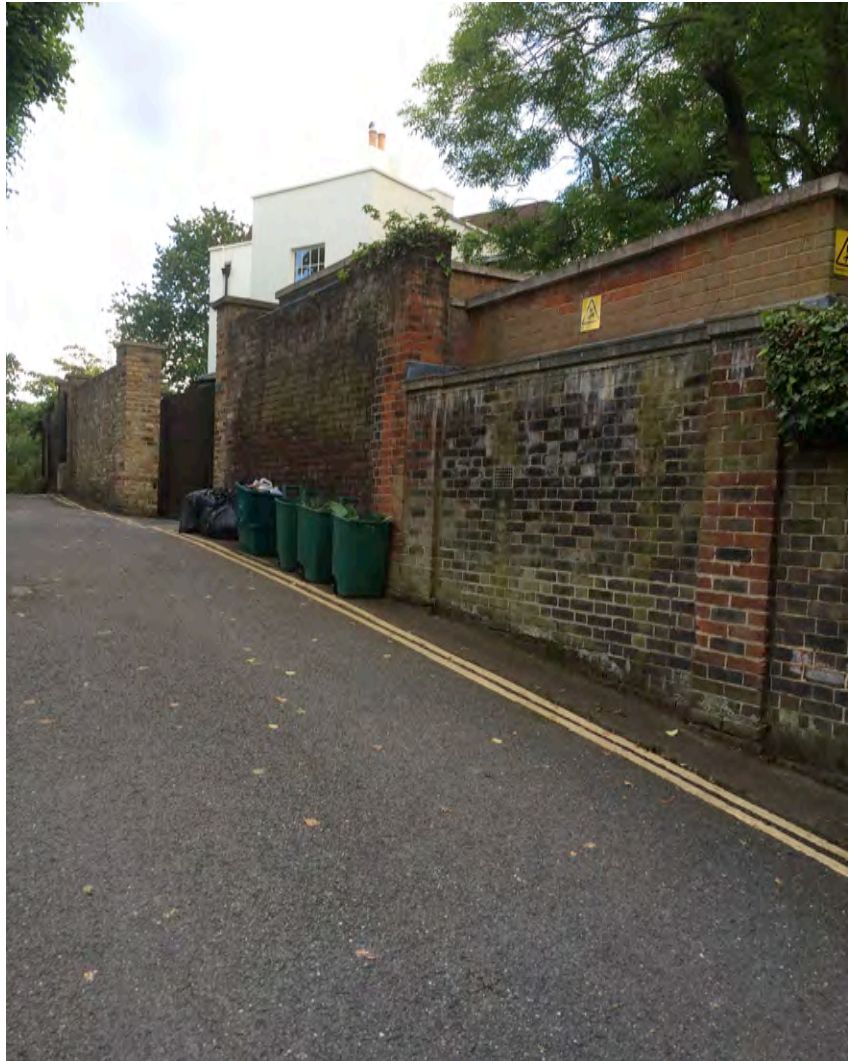
The photograph on this page shows the junction of the old Hospital walls with the Listed walls to Mount Vernon house on Frogna Rise.

The junction of the walls is characterised by the height difference and the sub-station wall that is behind the wall to the Mount Vernon flats.

This is not a successful juxtaposition as the sub station wall is of a different brick type and colour.

The proposed scheme shows a railing on top of the Mount Vernon flats wall that are sufficiently high to hide the substation but still lower and so subservient to the much higher Listed walls.

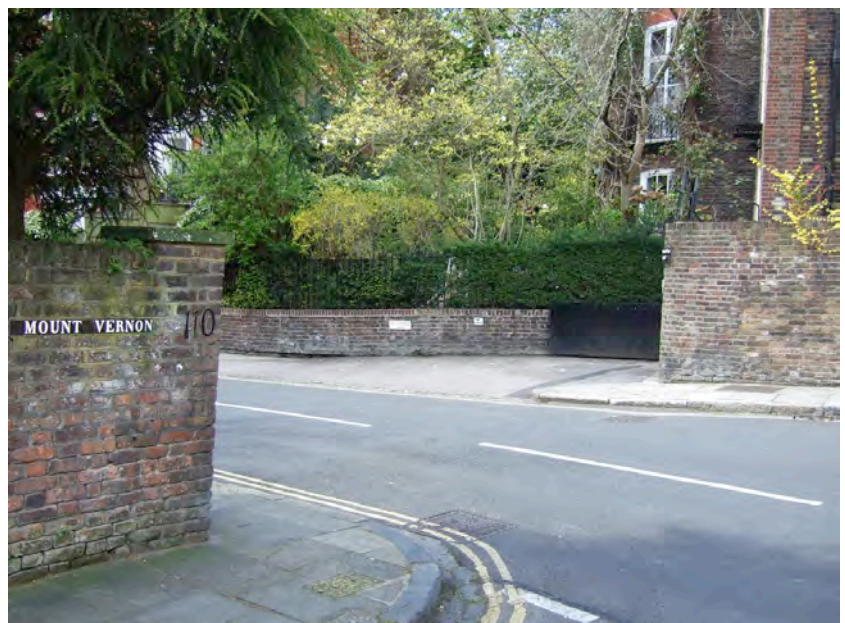
The photograph opposite shows a typical rail topped brick wall seen on Frogna and in the general area.

The rails allow visual permeability whilst improving the security.

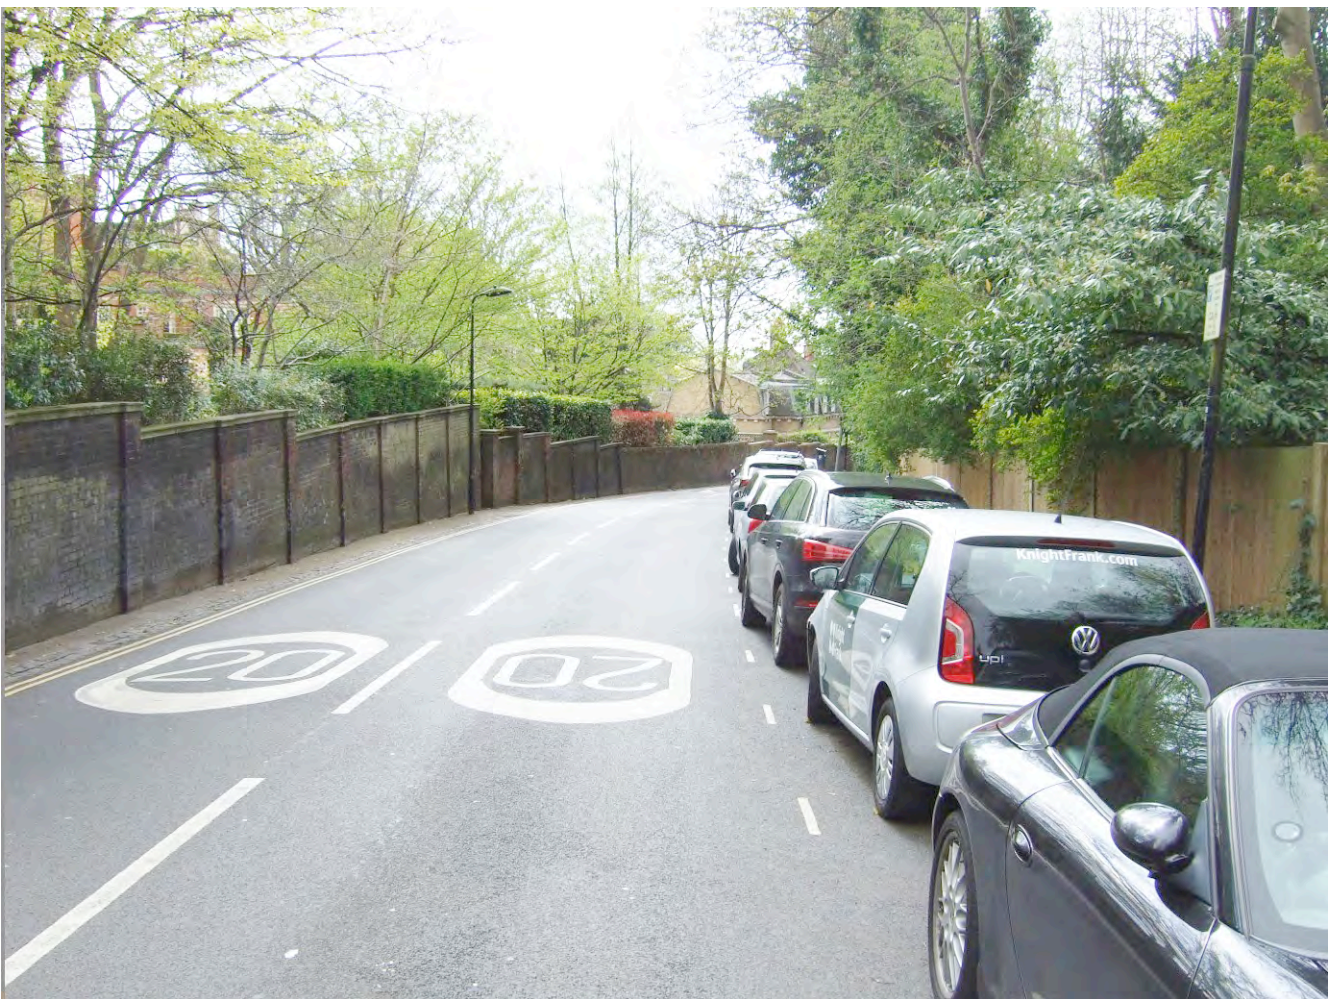
View down Froggnal with timber boarded fencing on the right and brick on the left

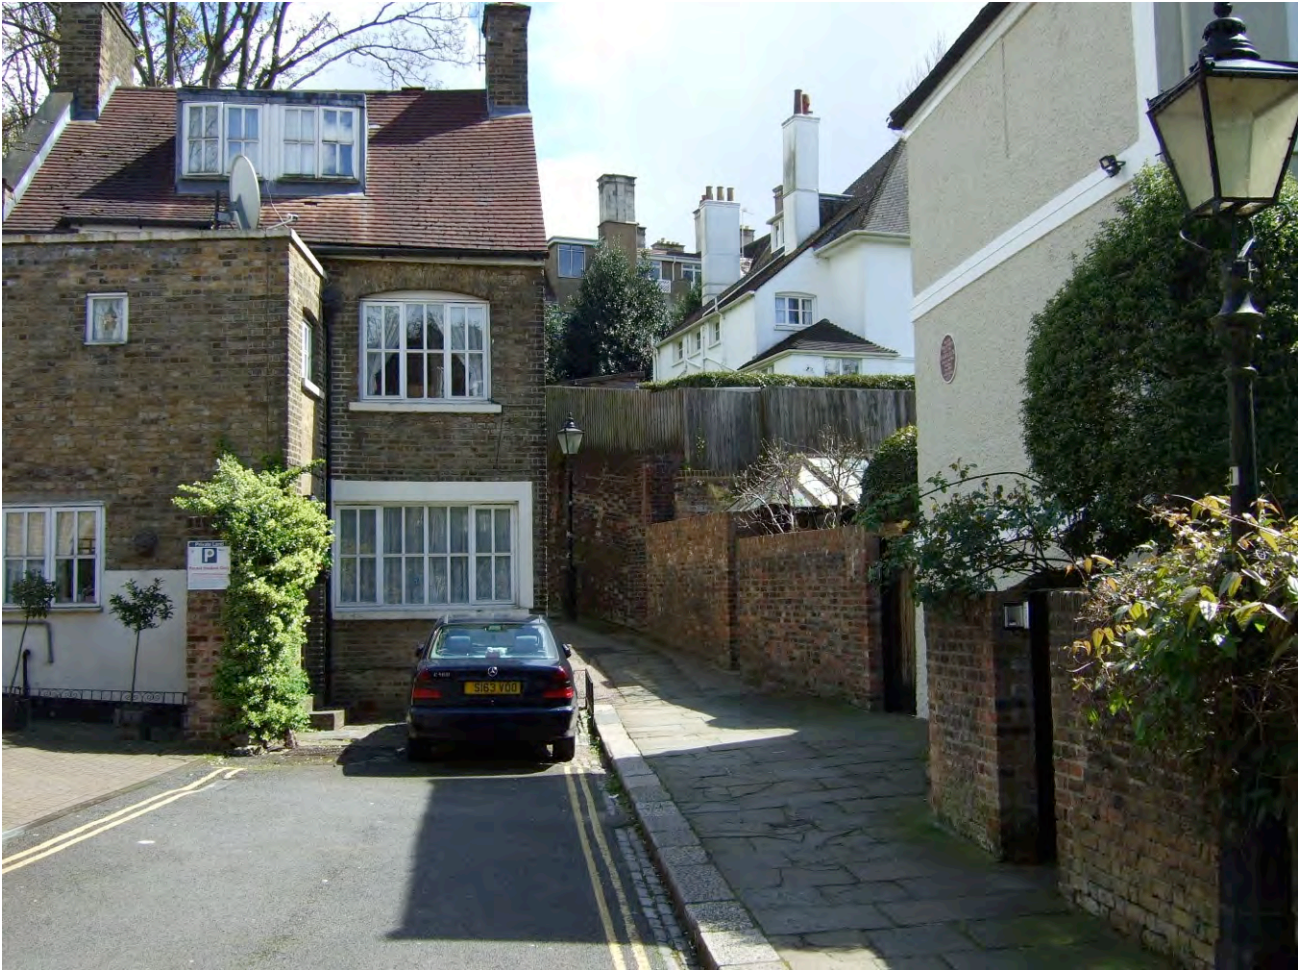
View across up Mount Vernon showing various materials heights and treatment.

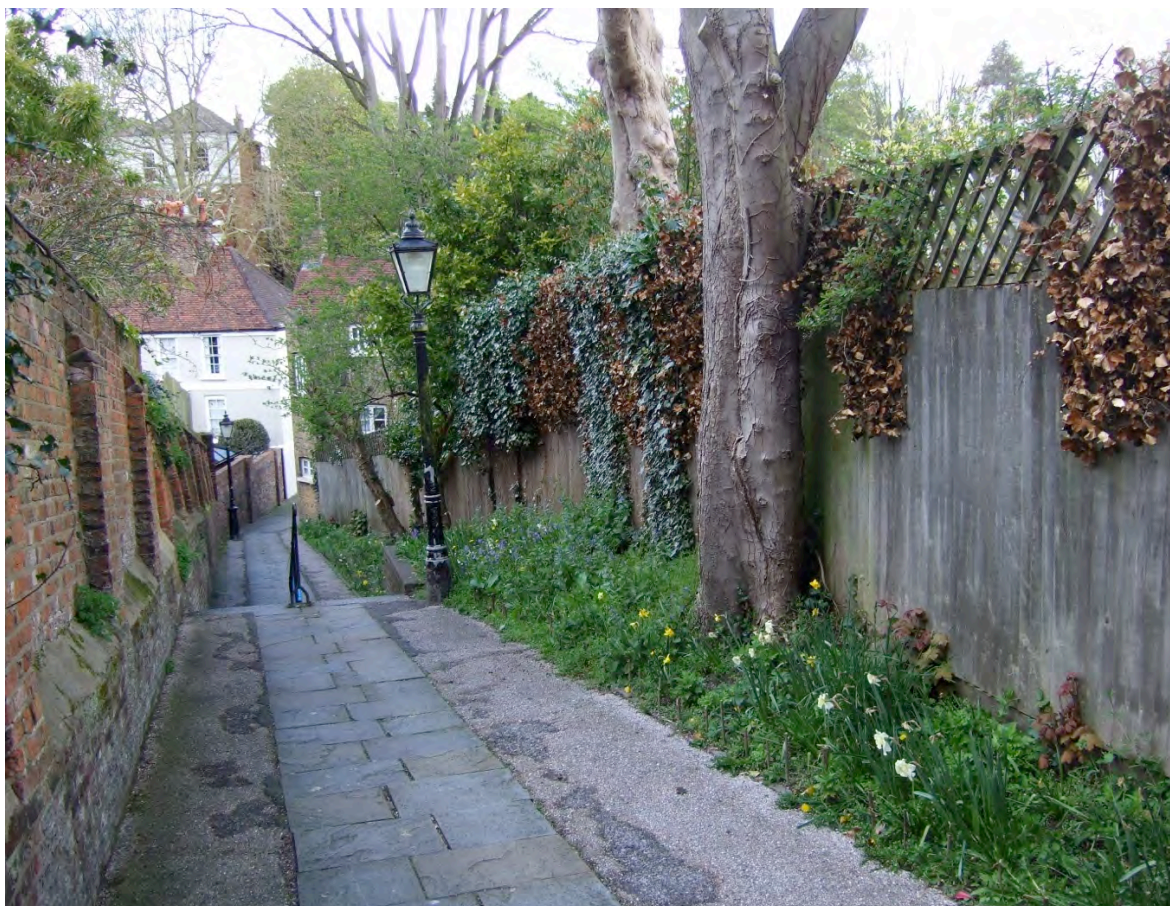
View down Mount Vernon showing trees that have been identified as a climbing risk

On the side passage, the trees make it easy to scale the fence; here additional radial trellis is proposed to inhibit this.

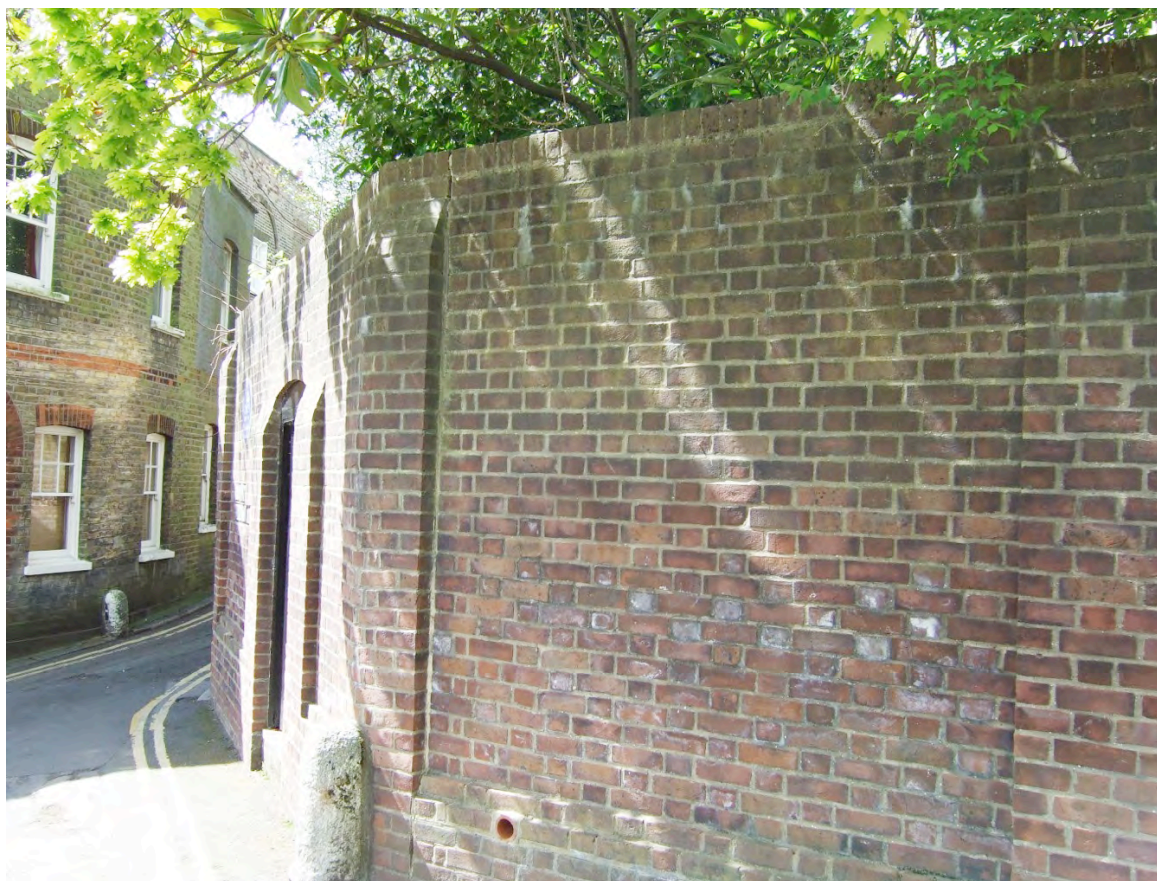
Walls at the top of Mount Vernon are much higher than the others and will not need to be improved
