Our Ref: RT-MME-123491

**Updated Bat Surveys and Nesting Bird Check – 252 Finchley Road, London.**

In September 2016 Douglas & King commissioned Middlemarch Environmental Ltd to undertake an updated Preliminary Bat Roost Assessment, a Nocturnal Emergence Survey and a Nesting Bird Check at 252 Finchley Road, London. These surveys are required to facilitate the demolition of the building and shed on site as well as vegetation clearance.

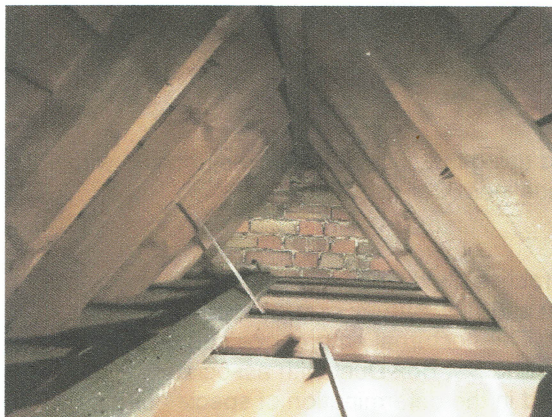
**Plate 1: Small Roof Void Left After Loft Conversion**

Internal inspection of the building revealed that the lofts have been converted leaving only small, inaccessible roof voids of approximately 1 in height and 1.2 m wide (Plate 1). No evidence of bats was found within the proximity of the entrance that was created by asbestos survey.

No evidence of roosting bats was recorded on site and no bats emerged from or re-entered any of the roosting features associated with the site. It is therefore concluded that the site does not currently support a bat roost and the demolition works can proceed as planned. If development works to the surveyed building have not commenced by March 2017 it will be essential to update the survey effort to establish if bats have colonised the building in the interim.
