100 Avenue Road, Swiss Cottage

Job No 16/2832	Date Started 11/05/16	Ground Level (mOD) 53.21	Co-Ordinates E 526715.0 N 184305.1	Final Depth 47.00m
Date Completed 13/05/16

Essential Living Ltd

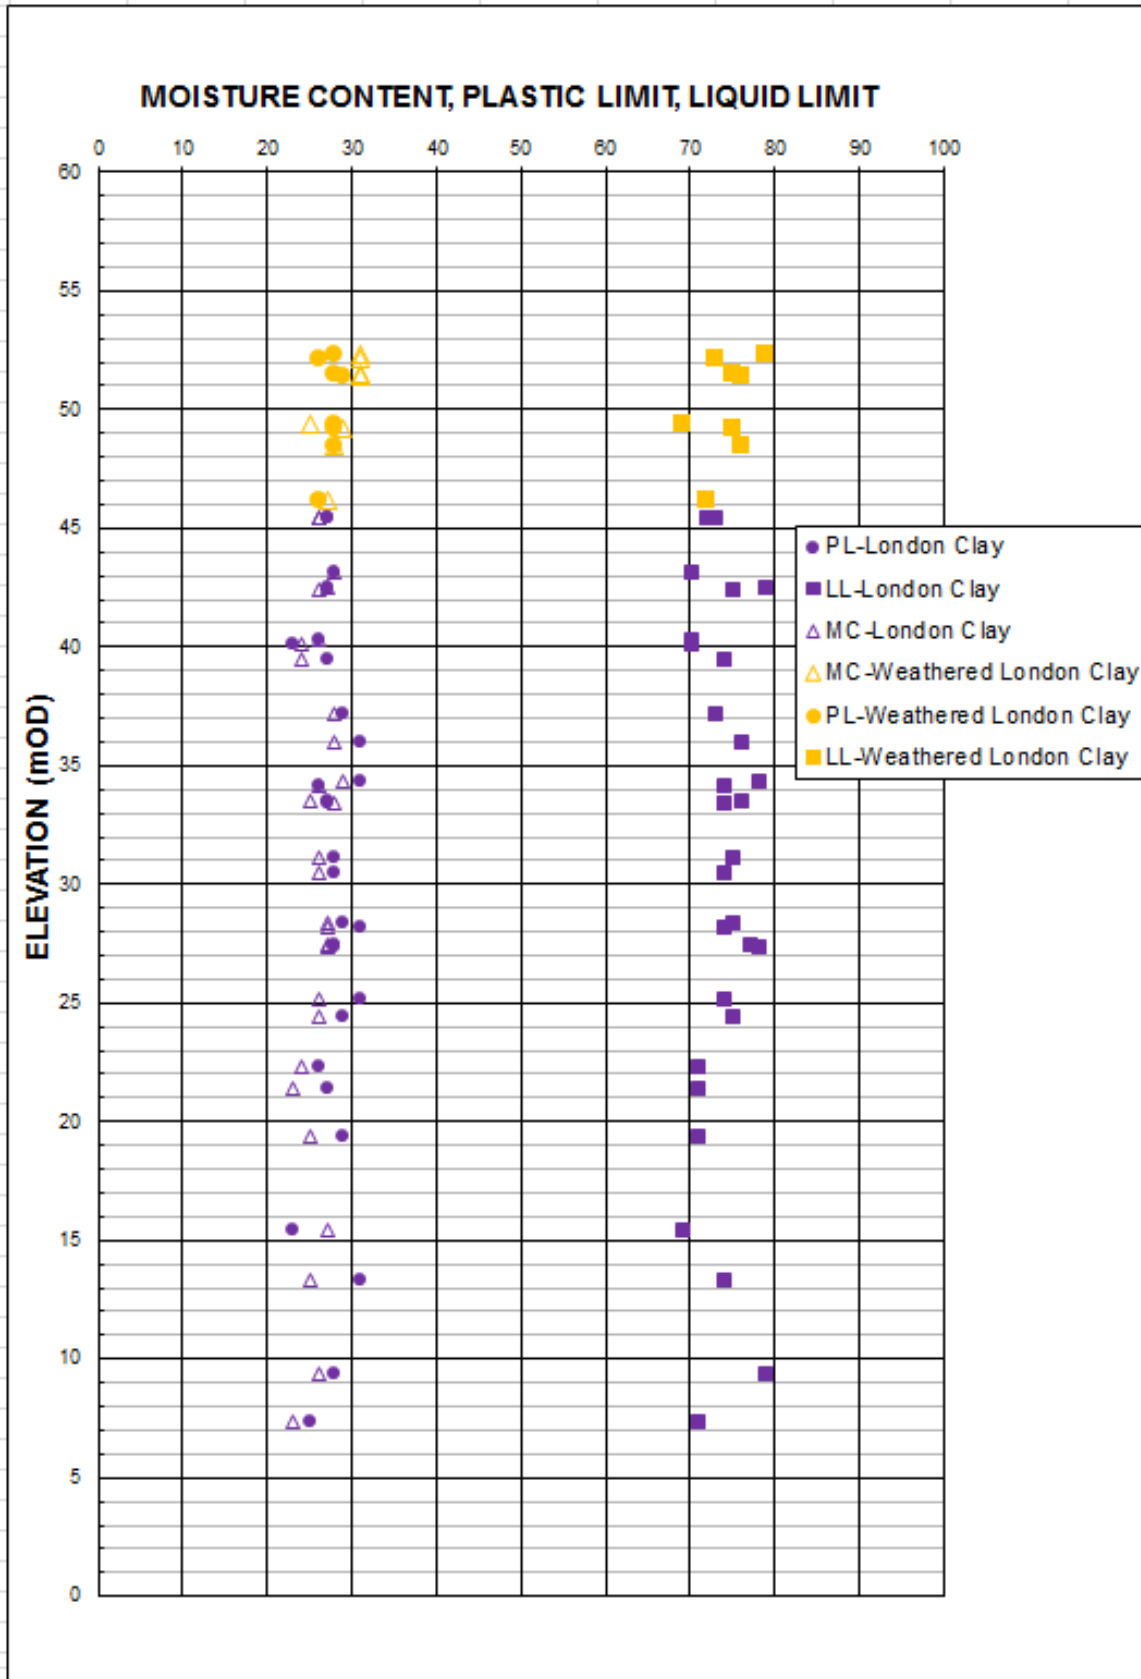
Figure 5-1: Moisture Content vs. Elevation

5.3.1 Moisture Content and Atterberg Limits

Strata	No. of Tests	NMC (%)	Liquid Limit (LL) (%)	Plastic Limit (PL) (%)	Plasticity Index (PI) (Modal Value)
Weathered London Clay Formation (division C)	8	25 to 31	69 to 79	26 to 29	41 to 52 (45)
London Clay Formation division C	20	24 to 29	70 to 79	23 to 31	41 to 52 (45)
London Clay Formation division B	9	23 to 27	69 to 79	23 to 31	41 to 52 (45)

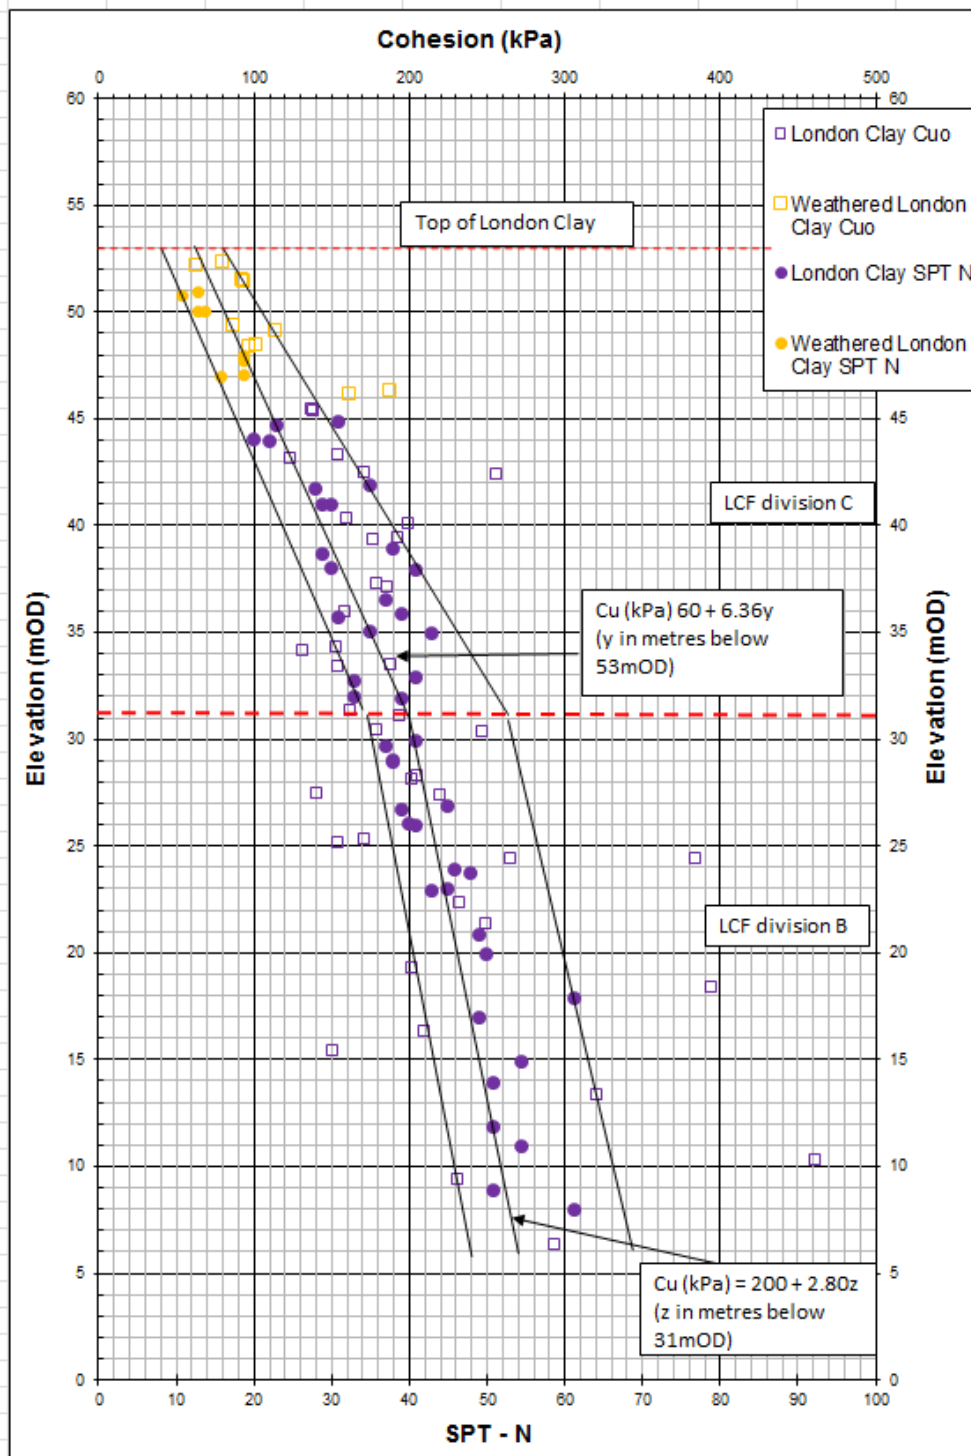
Figure 5-3: London Clay C_u vs. Elevation

- Weathered London Clay Formation (division C): C_u (kPa) = $60 + 6.36y$ (y in m below top of Weathered London Clay taken as 53mOD).
- London Clay Formation division C: C_u (kPa) = $60 + 6.36y$ (y in m below top of Weathered London Clay taken as 53mOD).
- London Clay Formation division B: C_u (kPa) = $200 + 2.80z$ (z in m below top of division B at 31mOD).
