26 Earlham Street

Historic Survey,
Design and Access Statement

Application for
planning and listed building consent
01.12.16

Gundry & Ducker

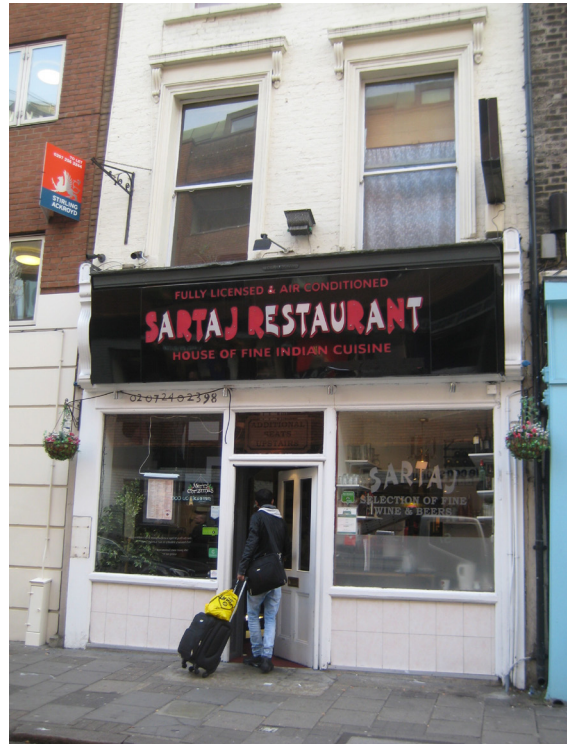
View of existing Earlham Street shopfront elevation.

The current shopfront, below fascia level, is modern (see picture circa.1974) and of poor quality, there is an inappropriate acrylic sign fixed to the original fascia. At fascia level and above, there are a pair of scrolls (the pilasters below the scrolls are missing) and there is a traditional blind box along the top of the sign, we believe these additions date from the early twentieth century.

Remove existing box sign and light fixtures etc. Remove existing shopfront below fascia level and install a completely new shopfront. The shopfront will be traditional and will comprise the following, 2no. new traditional timber box sash windows with a panelled timber stall riser below the windows. A traditional timber framed door and fan light above. The existing fascia and blindbox will be refurbished and pilasters reinstated. All timber will be painted.

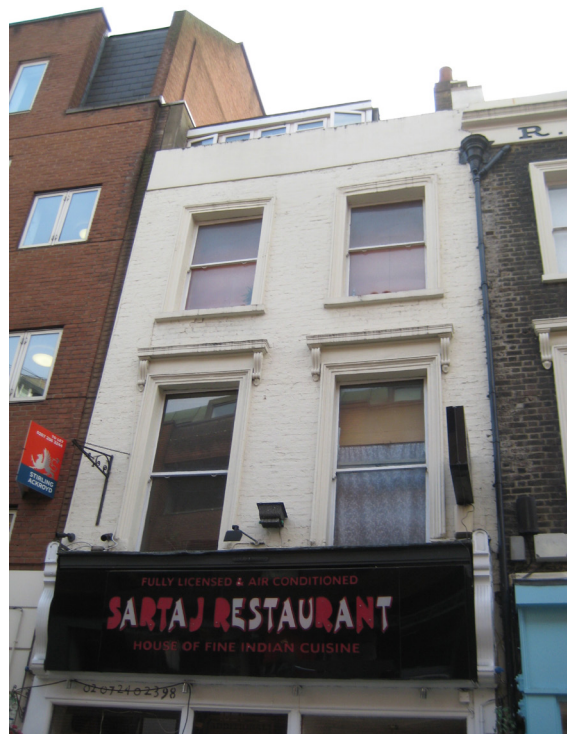
View of existing Earlham Street upper floors elevation.

Second Floor- The second floor retains a wall in the location of the original spine wall . There is a part original staircase rising from this level. There are no other visible historic features, joinery, coverings and surfaces etc are all modern. Existing sash windows to be repaired.

Third floor-The third floor retains a wall in the location of the original spine wall There is a part original staircase rising to this level and a number of modern partitions. There are no other visible historic features, joinery, coverings and surfaces etc are all modern. Existing sash windows to be repaired.

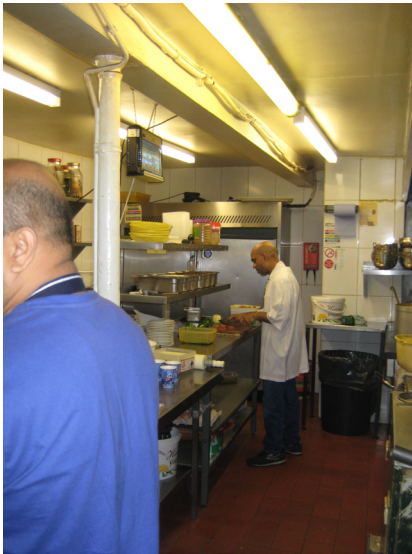
View of existing Basement kitchen

Basement Level- Other than a cast iron column there are no visible historic features. All internal walls, fixtures and fittings etc are modern. The original staircase has been lost. There is a modern staircase rising from the basement to ground level.

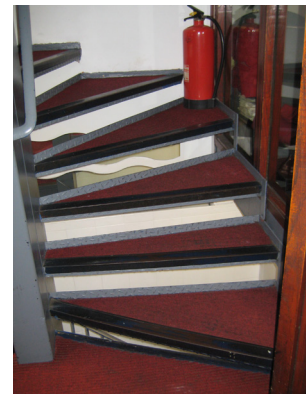
Stair to Basement and First Floor

Ground Level- There are no visible historic features, joinery, coverings and surfaces etc are all modern. There is a modern staircase rising to the first floor with modern screen partitions creating an internal lobby at the entrance.

Strip out all modern partitions, joinery, modern metal staircases wall and floor finishes through out. Install a new timber staircase to serve basement to first floor levels in original location. Install new stud walls to approximate original location to perimeter of staircase, install modern light weight partitions to form WC enclosures. Repair the fabric of the original staircase

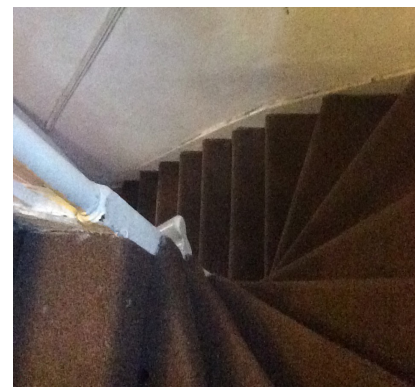
Existing original staircase to second and third floor

First Floor- The first floor retains a wall in the location of the original spine wall. There is a part original staircase rising from this level. There are no other visible historic features, coverings and surfaces etc are all modern.

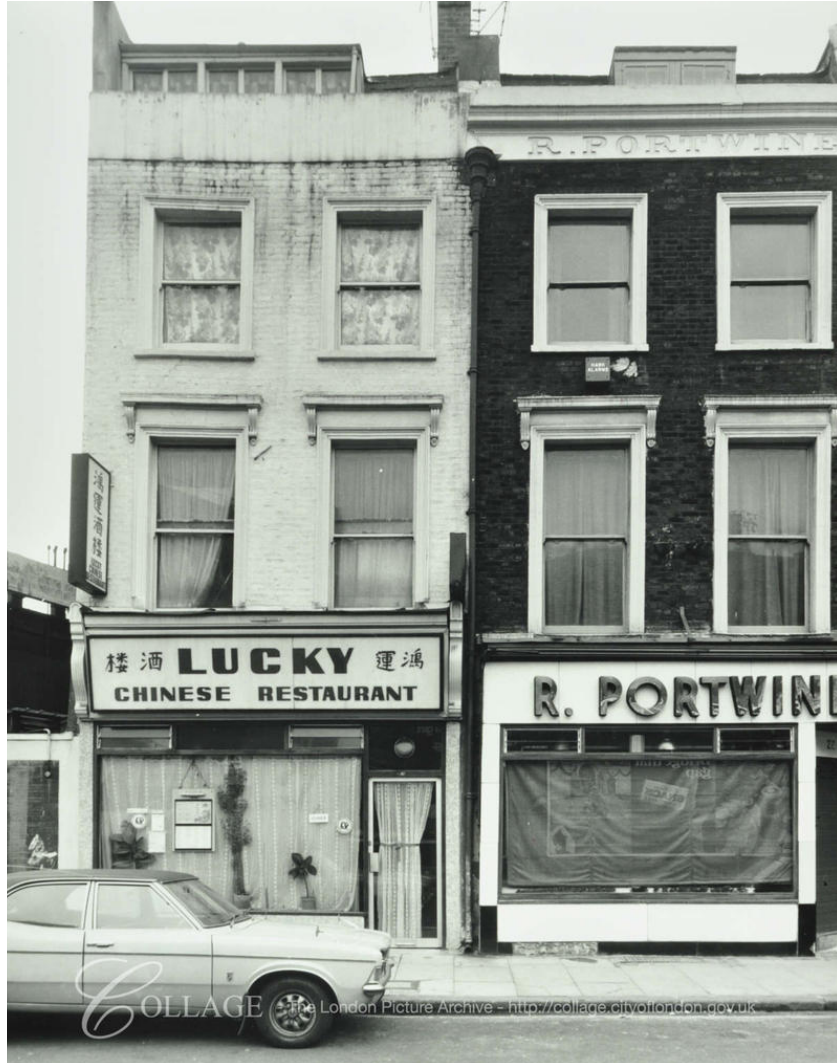
26 Earlham Street circa. 1974

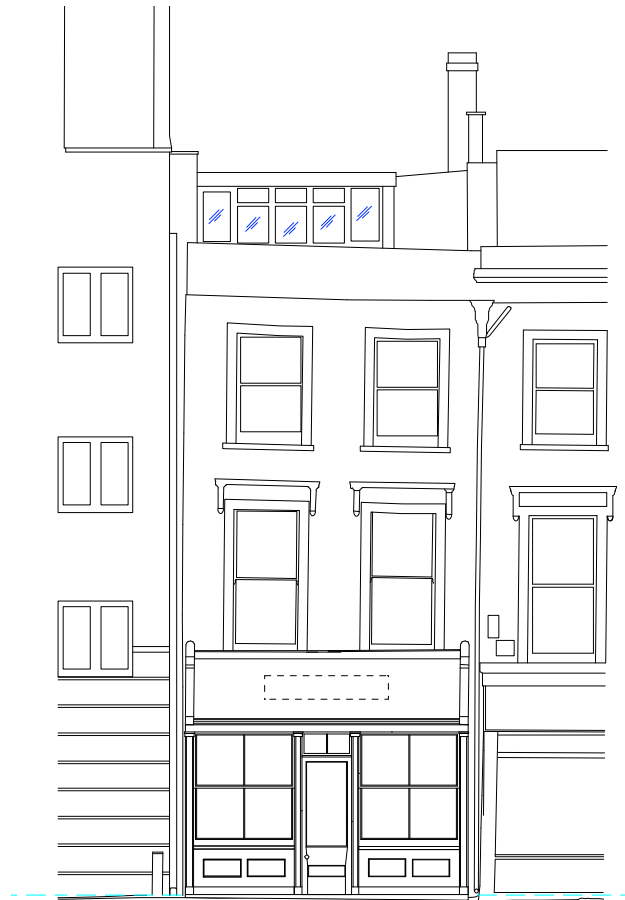
Proposed 26 Eltham Street Shop Front elevation
