Stables Market, Chalk Farm Road  
**Tack Room (Building D)**

**DESIGN AND ACCESS  
AND  
HERITAGE STATEMENT**

**FOR PROPOSED FLOOR STRENGTHENING WORKS**

**DECEMBER 2016**

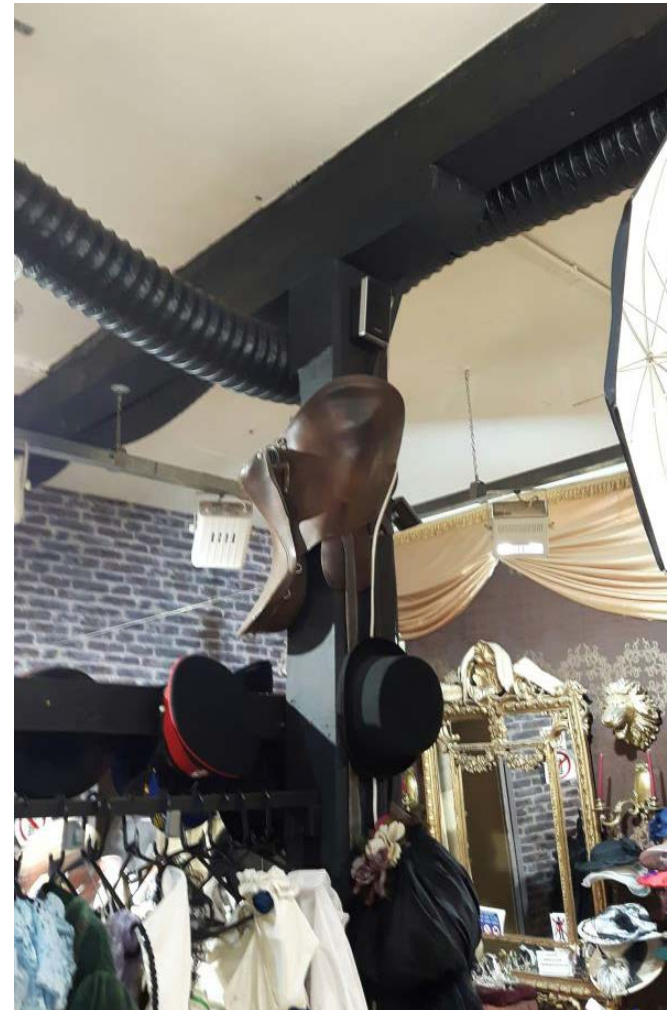
Figure 6: Tack Room: ground floor: north bay. The partitions and wall linings are modern and to be removed. The timber first floor structure and column are original.

The proposals will have minimal impact on the historic fabric of the building, as they essentially relate to joists decay repairs and floor structure strengthening. All the existing floor joists will be retained and repaired as necessary will be retained in their current state, as are all cast iron and timber columns and beams.

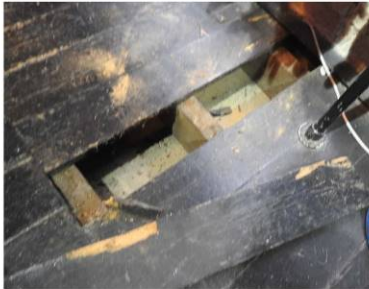
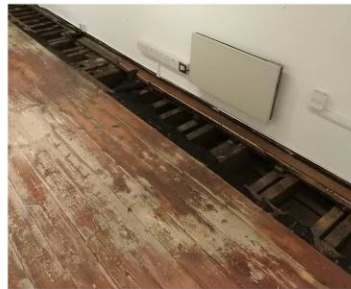
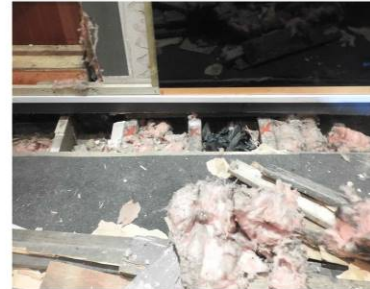
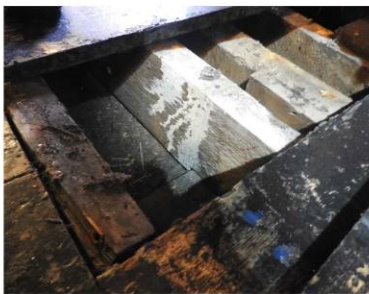
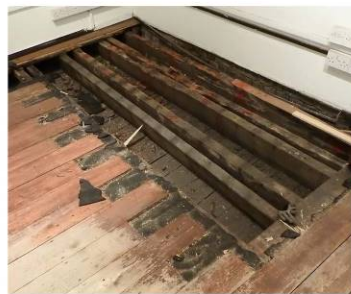
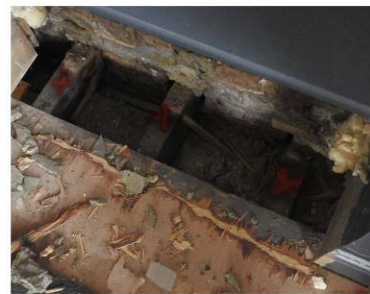
Unit 25  
Schedule of Opening-Up Works

Unit 26

Unit 27

Tack Room Units 25-27

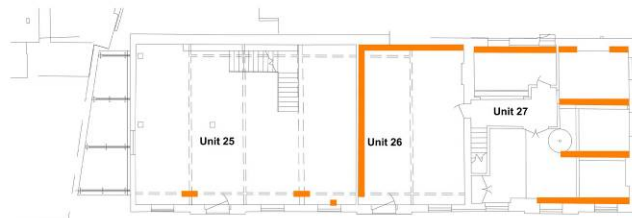
— Trial Pit Locations  
First Floor Plan
