# PICK EVERARD

SOAS Schedule of structural  
investigations  
for  
Proposed works to the Philips  
Building and Link Bridge  
SOAS, University of London

Issue Number 03  
05 December 2016

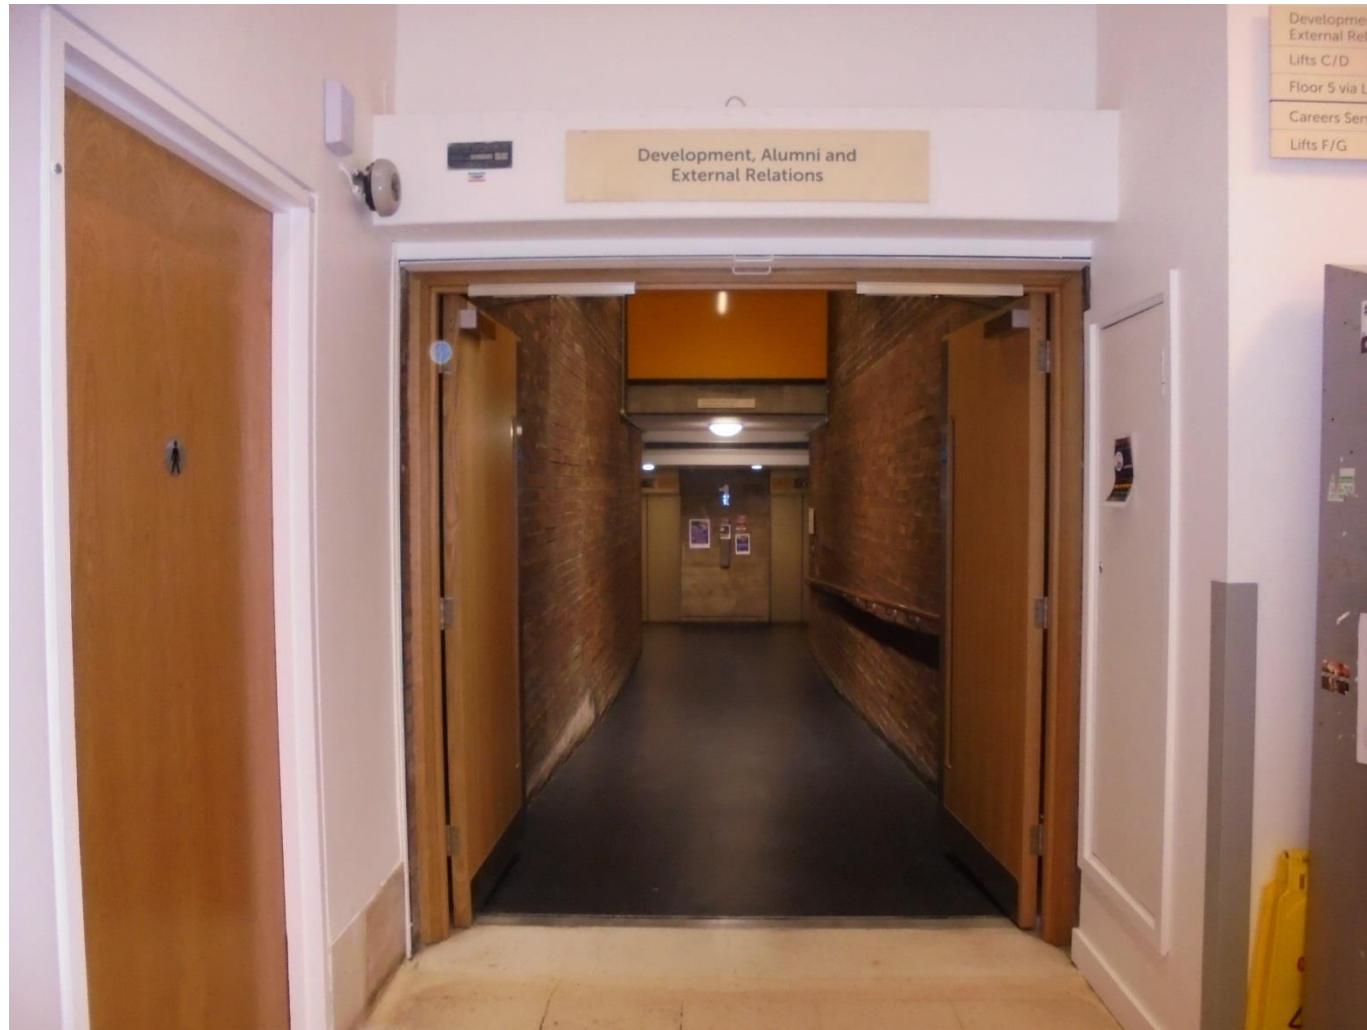
Typical internal view on Link Bridge – level I- locations for works refs 3.2.1 & 3.2.2

- Review all available archive information and asbestos registers
- Prepare further RAMS for the works
- Provide suitable safe access and protection to the works sites
- Scan proposed investigation locations for the presence of concealed services
- Locally remove previously disturbed or displaced bricks to enable access to the anticipated cavity for investigations using a borescope.
- If necessary, crate additional drilled holes through masonry bed joints to enable access to the anticipated cavity via a borescope
- Locally determine dimensions of the RC structure contained with the masonry cladding where achievable
- Make good investigation locations to match existing conditions
- Record findings and report these

- Review all available archive information and asbestos registers
- Prepare further RAMS for the works
- Provide suitable safe access and protection to the works sites
- Scan proposed investigation locations for the presence of concealed services
- Locally remove previously disturbed or displaced bricks to enable access to the anticipated cavity for investigations using a borescope.
- If necessary, crate additional drilled holes through masonry bed joints to enable access to the anticipated cavity via a borescope
- Locally determine details of masonry cladding
- Locally determine fixing details between masonry cladding and RC structure contained within the anticipate cavity
- Make good investigation locations to match existing conditions
- Record findings and report these

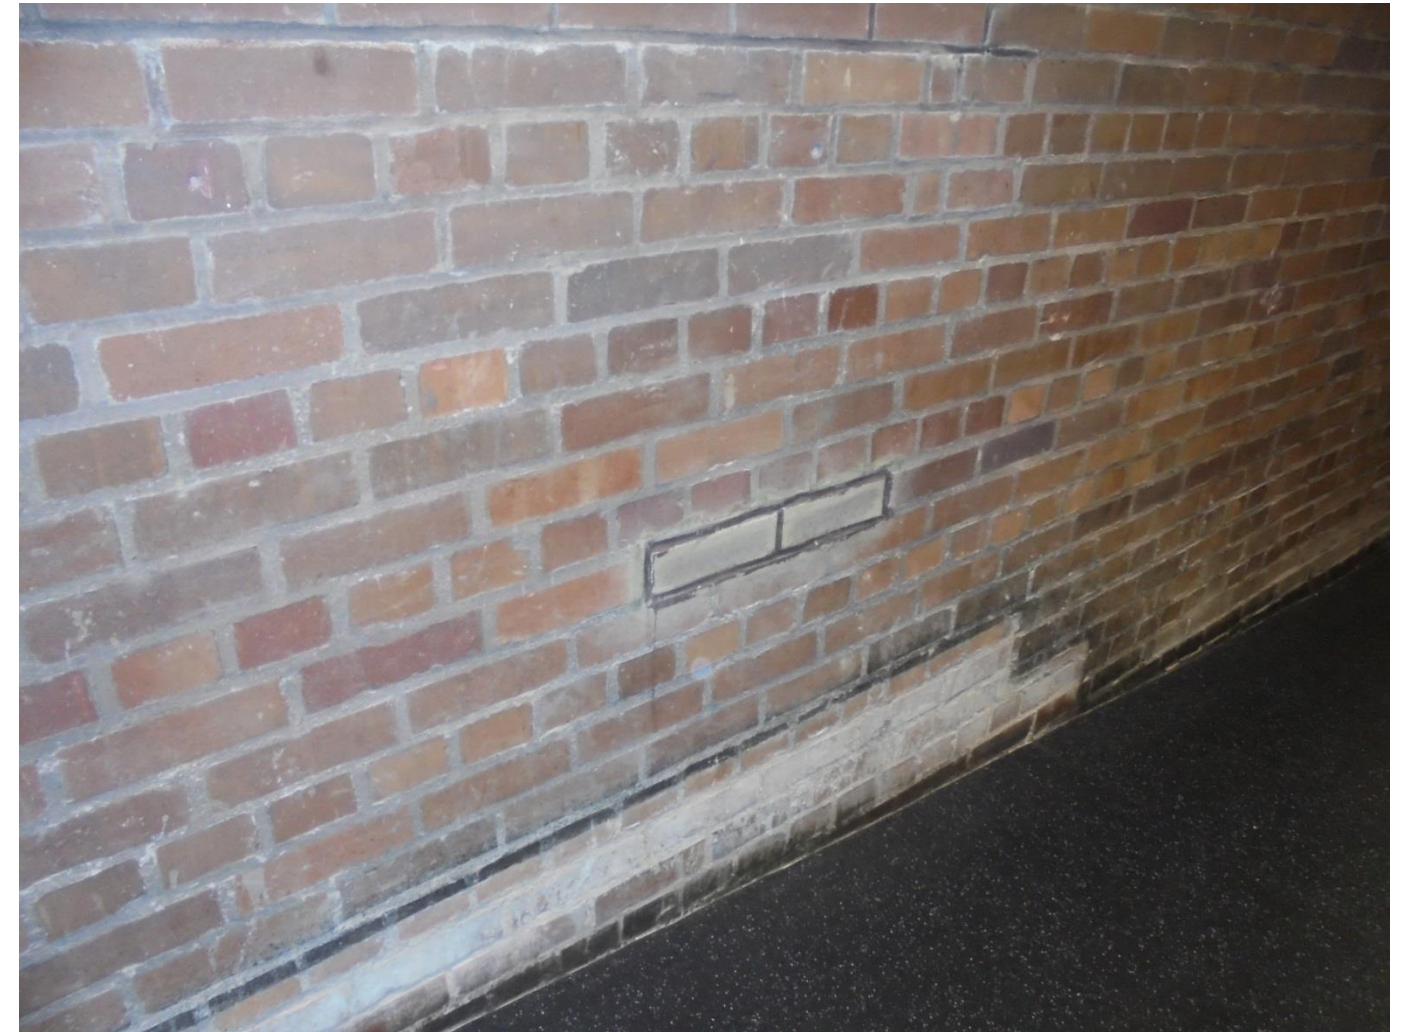
Internal face of cladding to the Link Bridge – proposed investigation through previously removed bricks – Level I – location for works refs 3.2.1 & 3.2.2

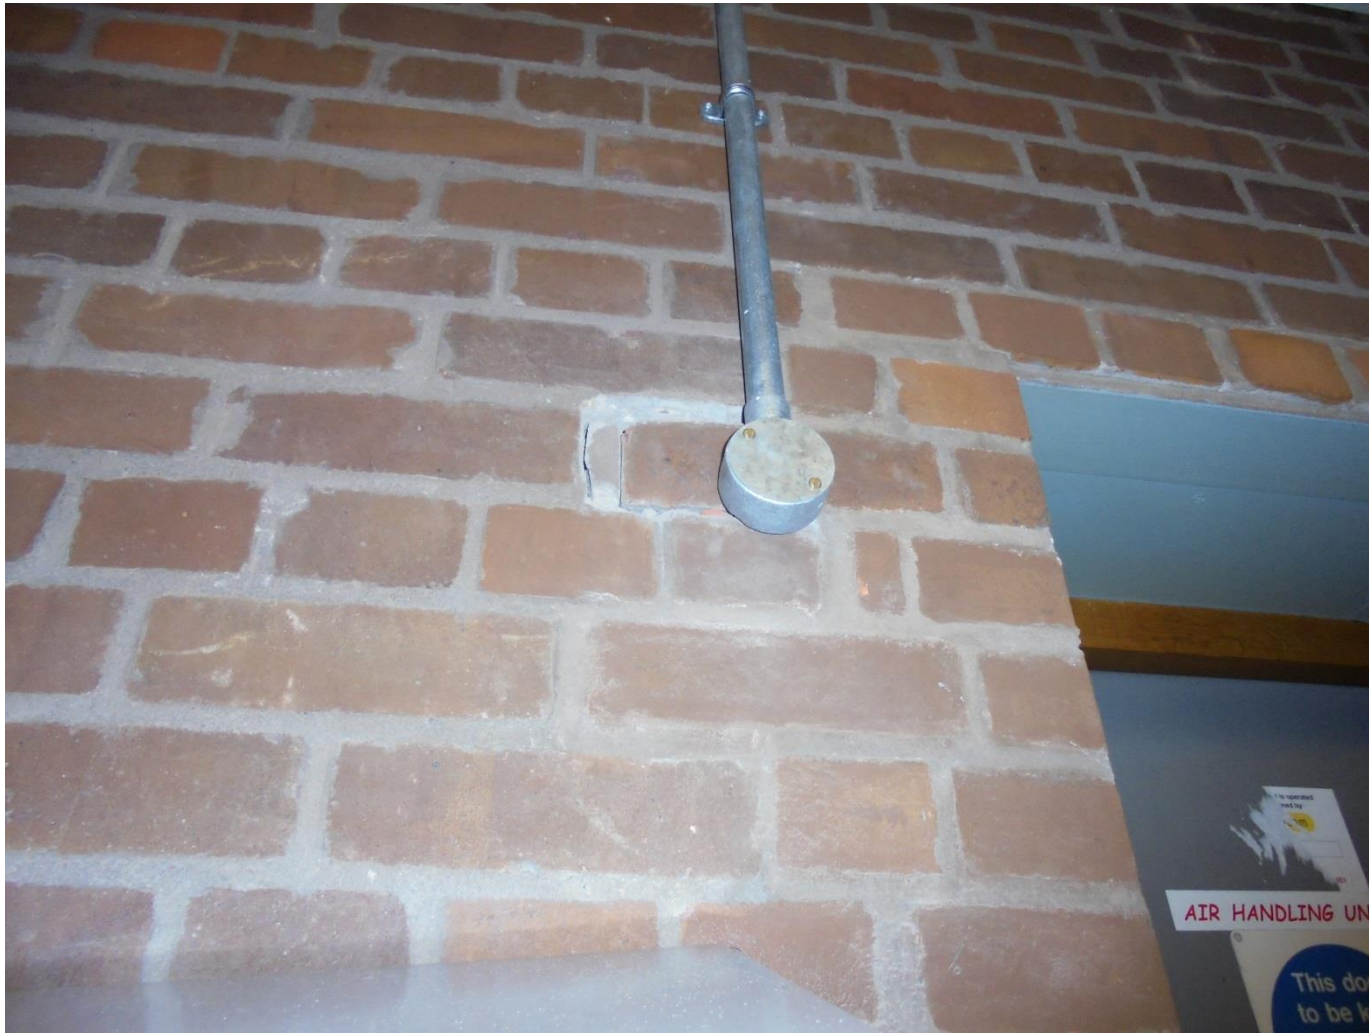
Internal face of cladding to the Link Bridge – proposed investigation through previously removed brick – Level 2 – location for works refs 3.2.1 & 3.2.2

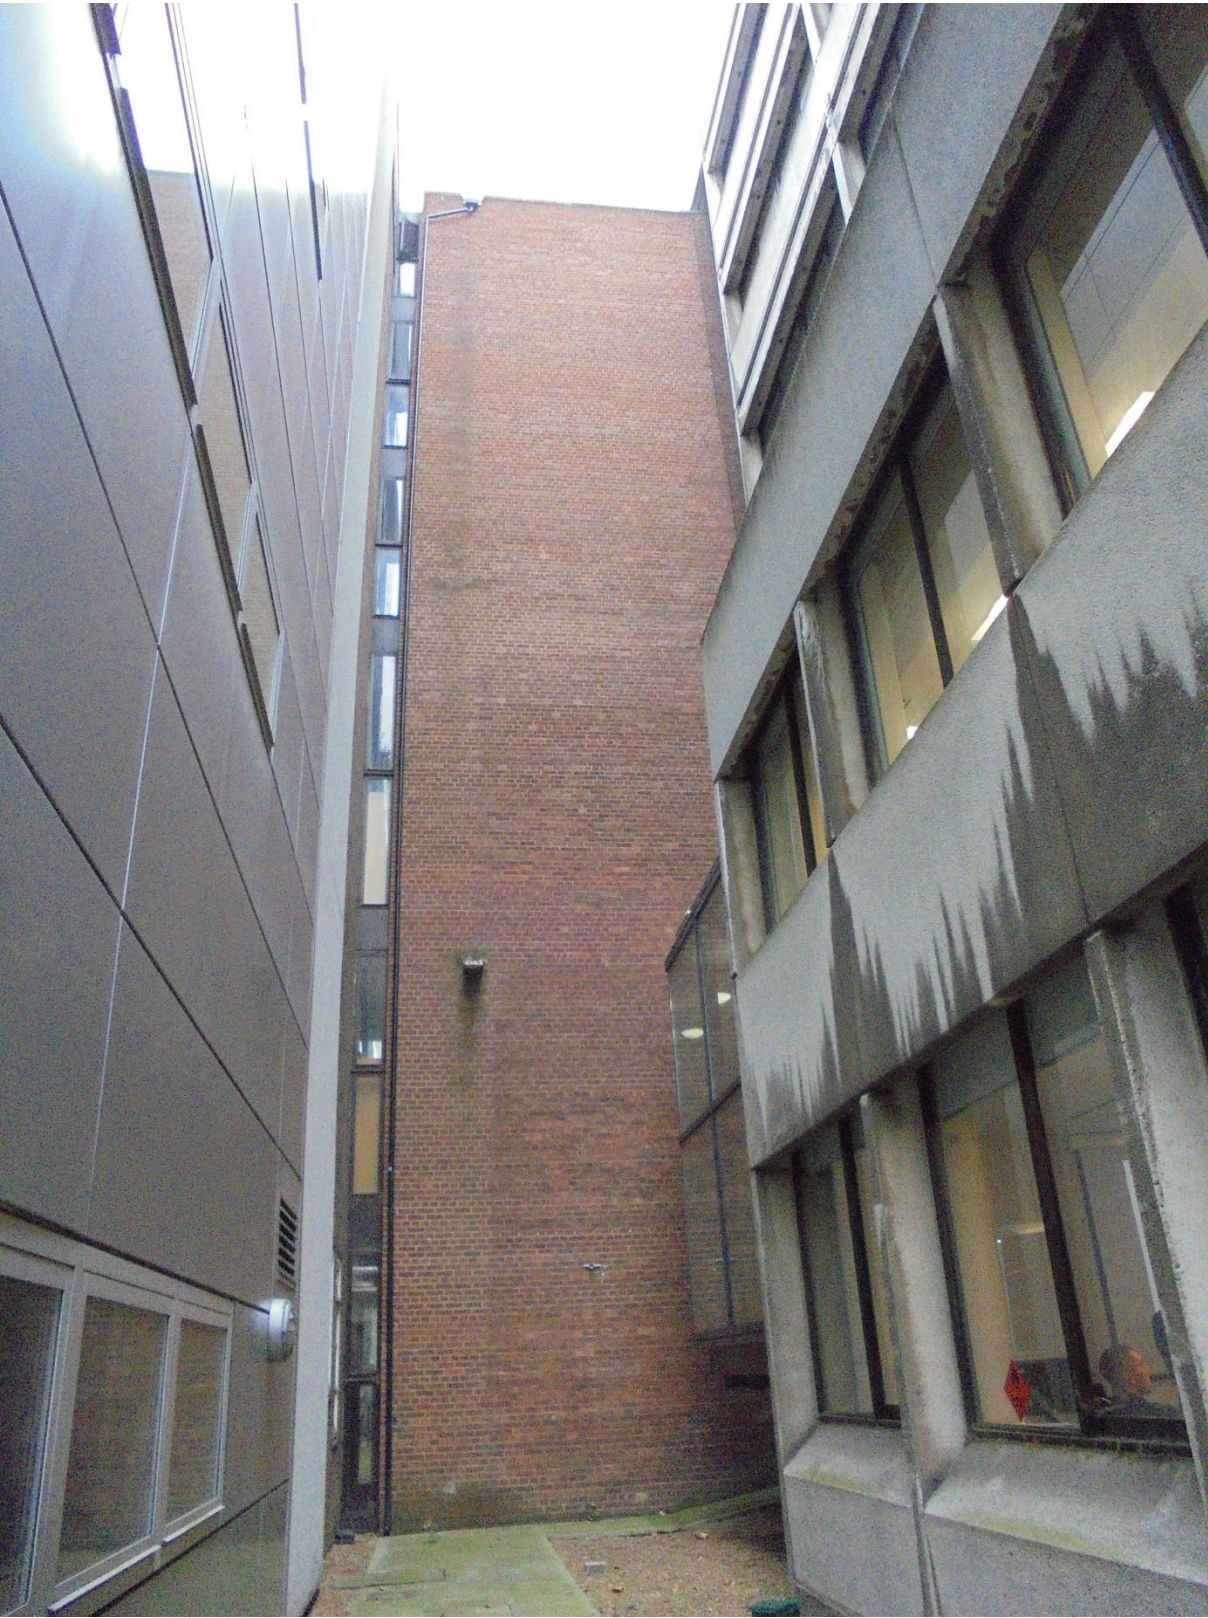
Elevation on Link Bridge – locations for works ref 3.2.3

- Review all available archive information and asbestos registers
- Prepare further RAMS for the works
- Provide suitable safe scaffold platform access and protection to the works sites
- Scan proposed investigation locations for the presence of concealed services
- Create drilled holes to enable access to the anticipated cavity via a borescope
- Locally determine details of support systems to external masonry cladding
- Make good investigation locations to match existing conditions
- Record findings and report these
