## St. Katharine's - The Danish Church in London EXTERNAL MASONRY REPAIR

St. Katharine's - The Danish Church in London  
 Rectified Return Elevations - North Tower

## St. Katharine's - The Danish Church in London

### EXTERNAL MASONRY REPAIR

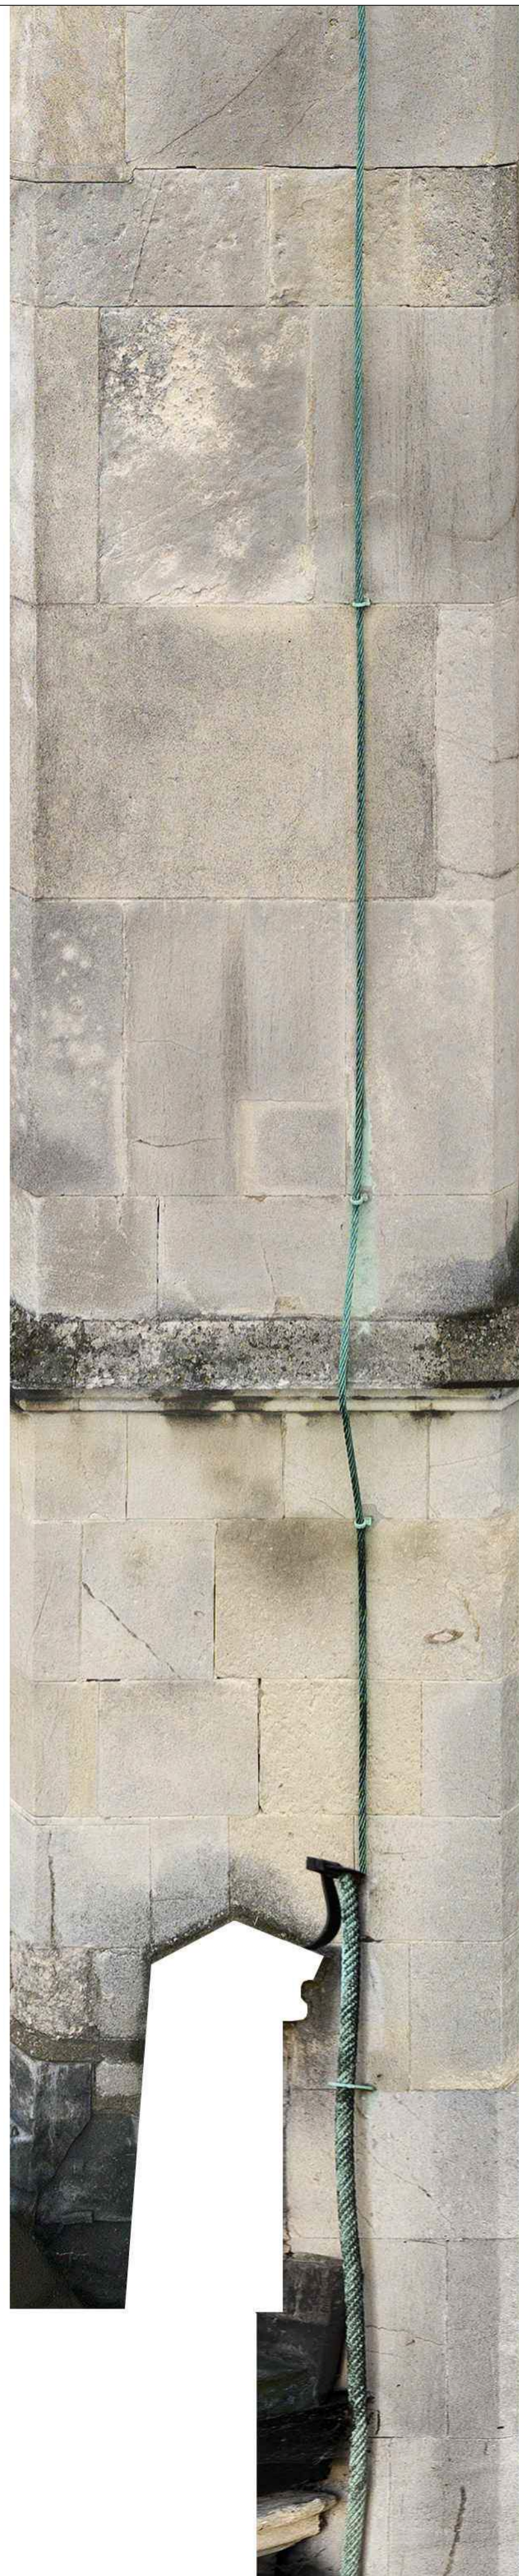
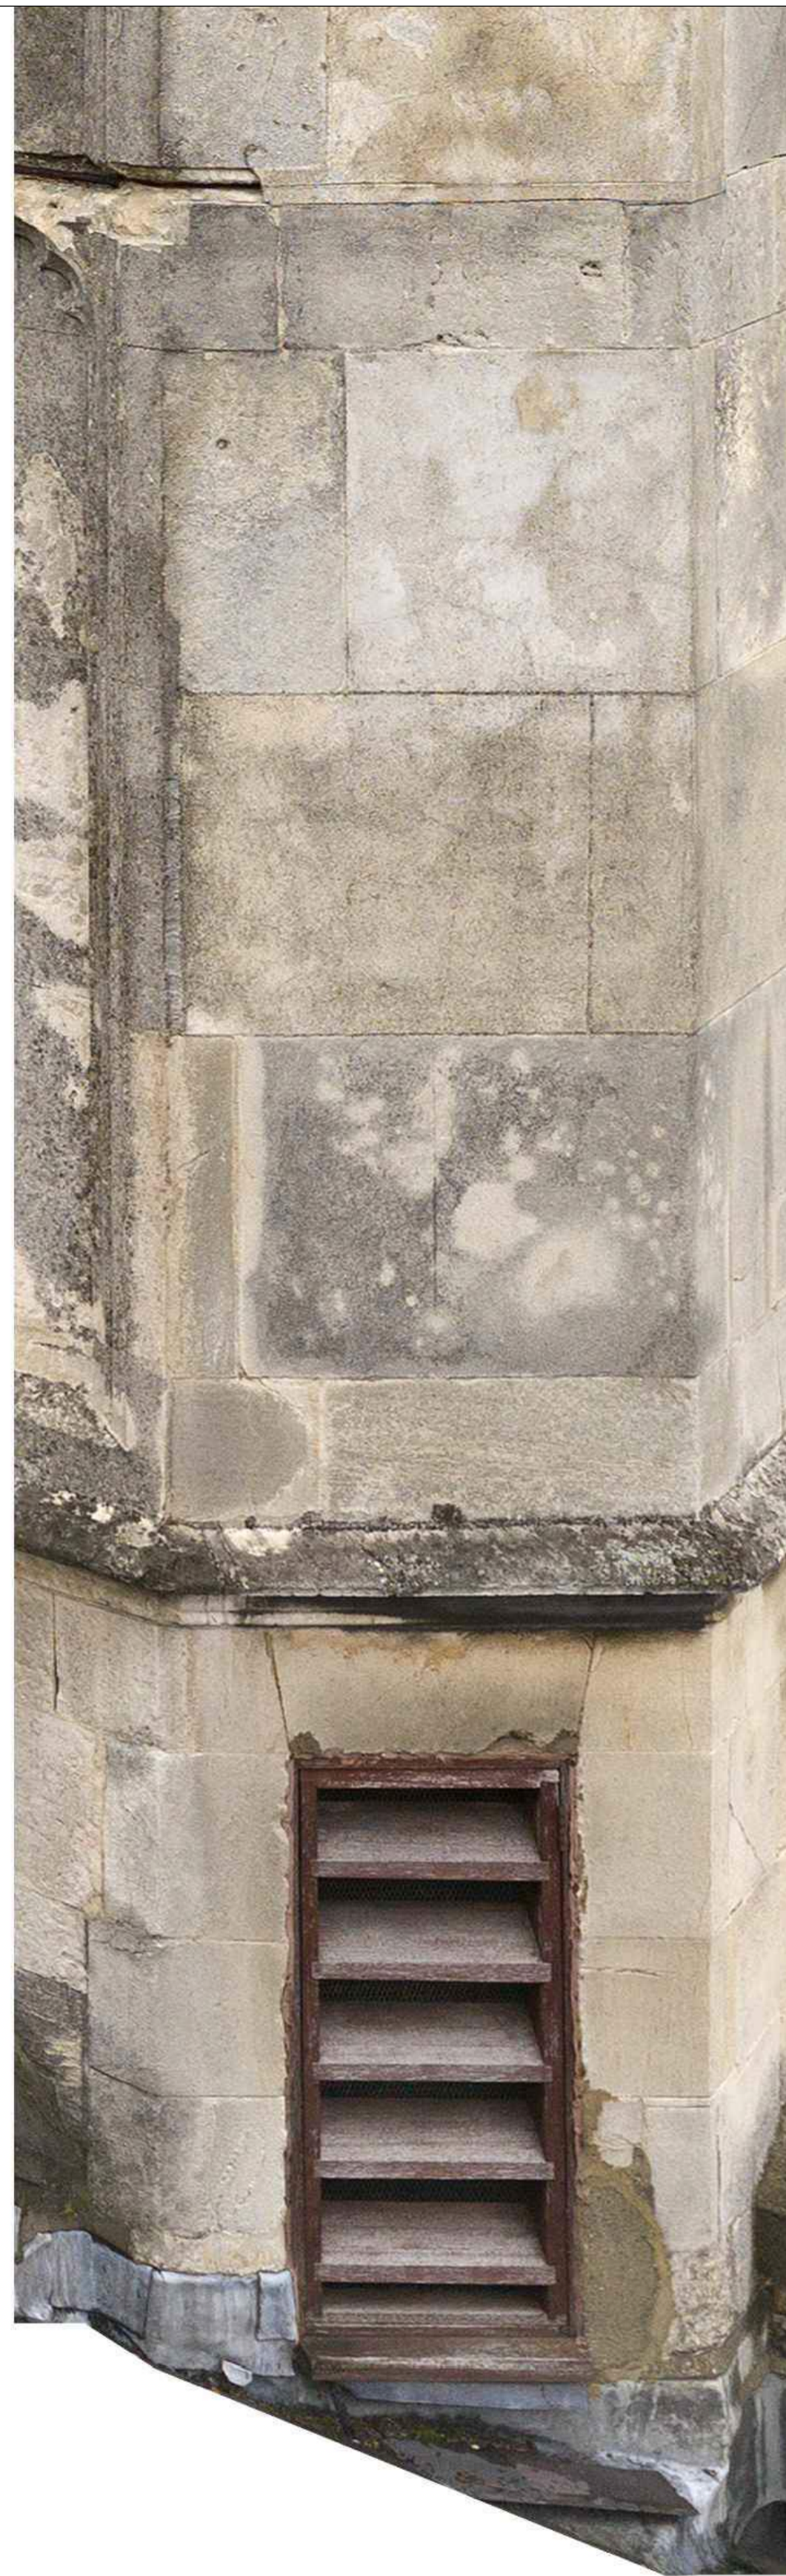
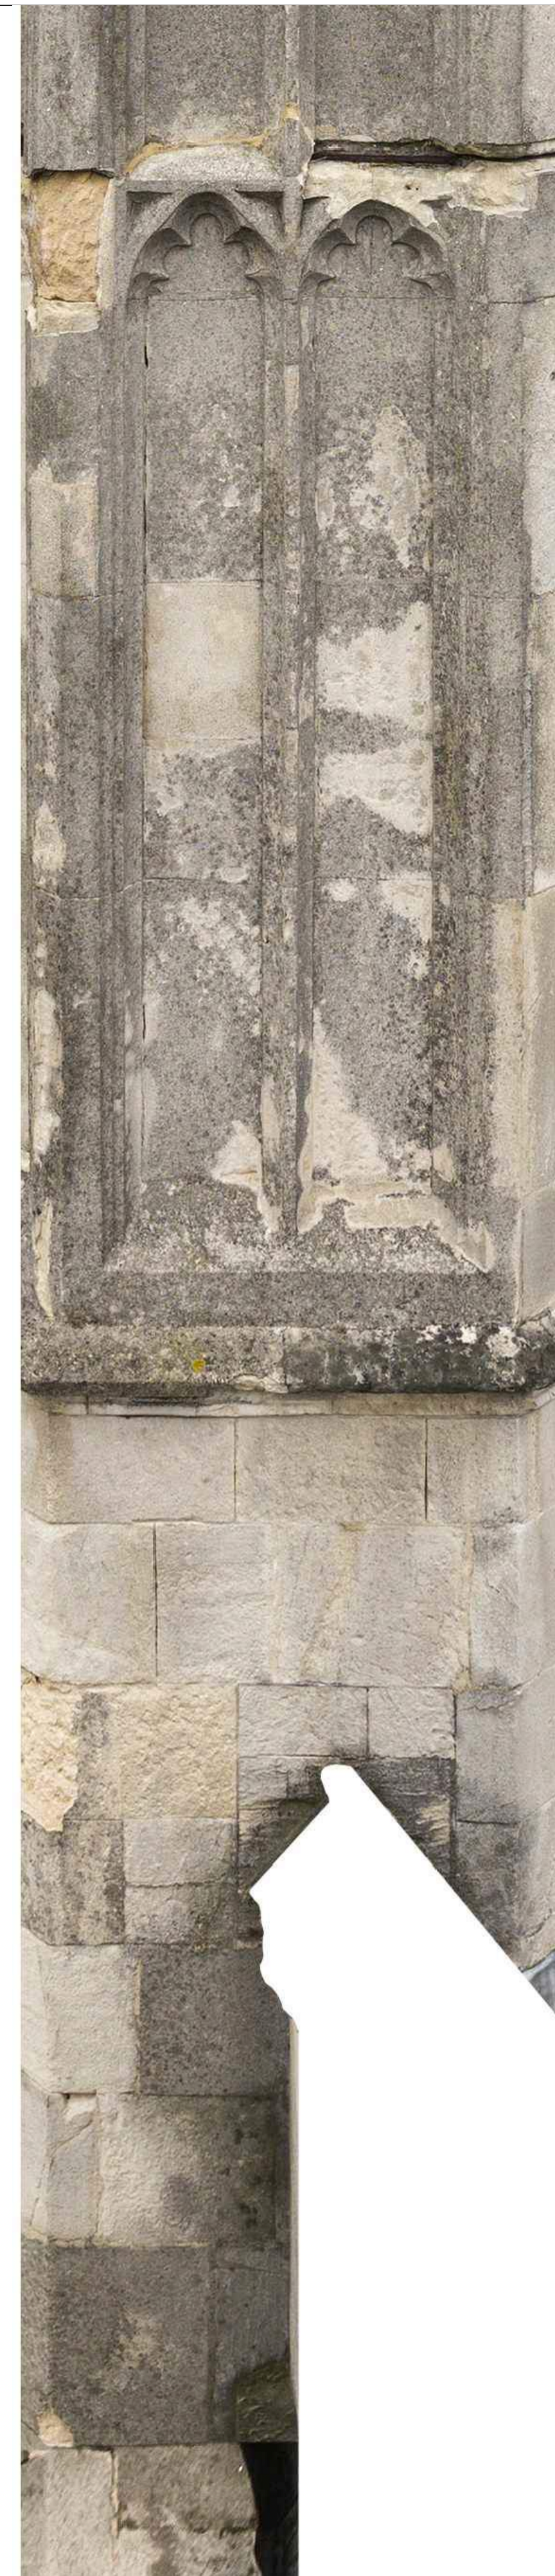
Allow for stone indent repairs and renewal as shown on drawing E4-05-02 in order to remove the ring beam in situ below, all to SE detail. Refer to Structural Engineer's drawing 1601/212/03 for suggested sequence.

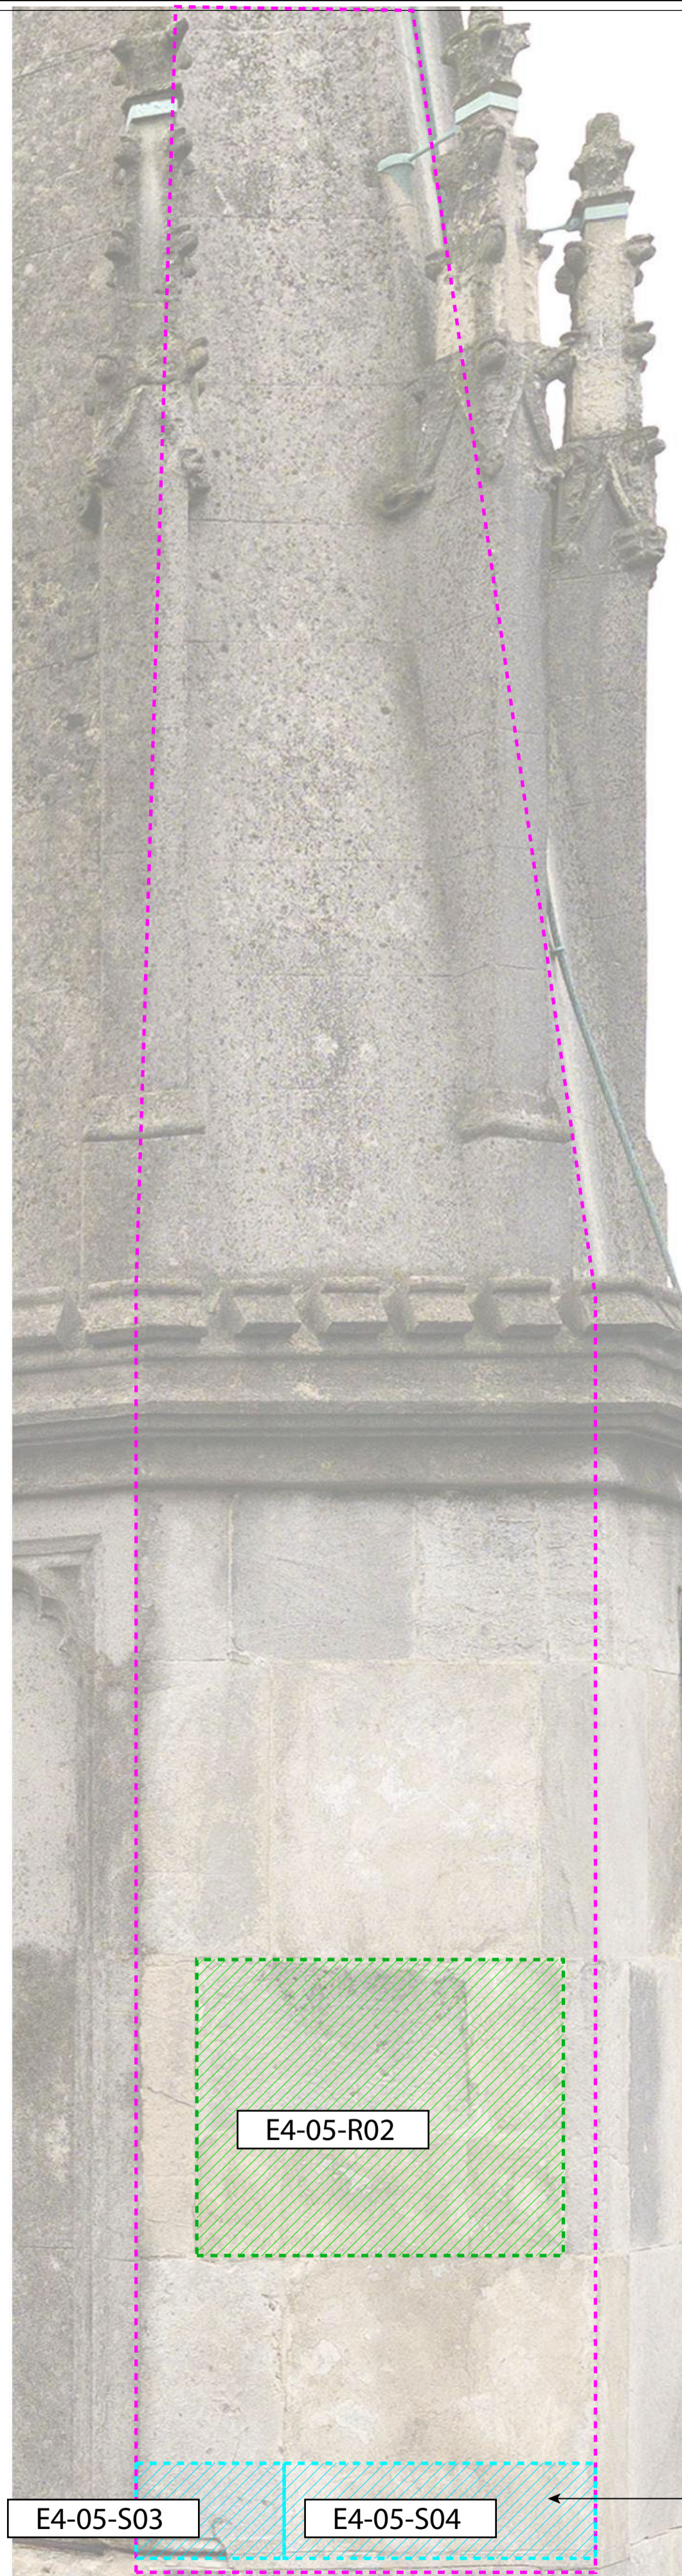
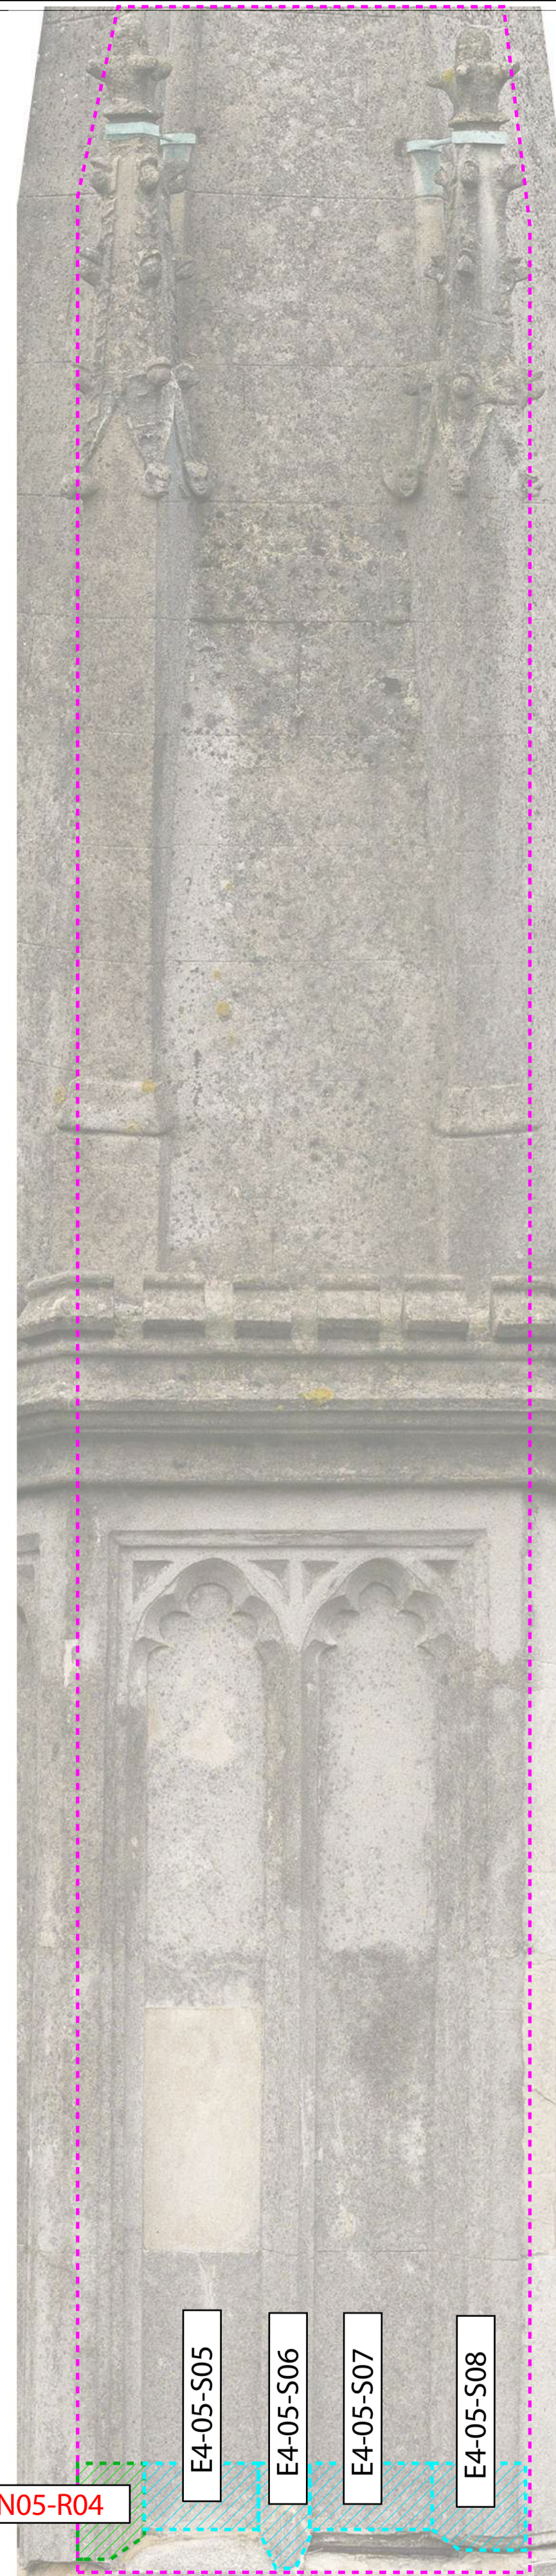
Drawing no. 043-E4-05-02  
Issue date Oct 2016  
Issue status FOR TENDER  
Scale 1:10@ A1

Refer to Structural Engineer's drawing 1601/212/03 for suggested sequence. Allow for stone indent repairs and renewal as shown in order to remove the ring beam in situ below, all to SE detail.
