### **Addendum Arboricultural Note** **In Relation to Proposed Development**

45 Flask Walk  
London  
NW3 5HH

## **1. Introduction**

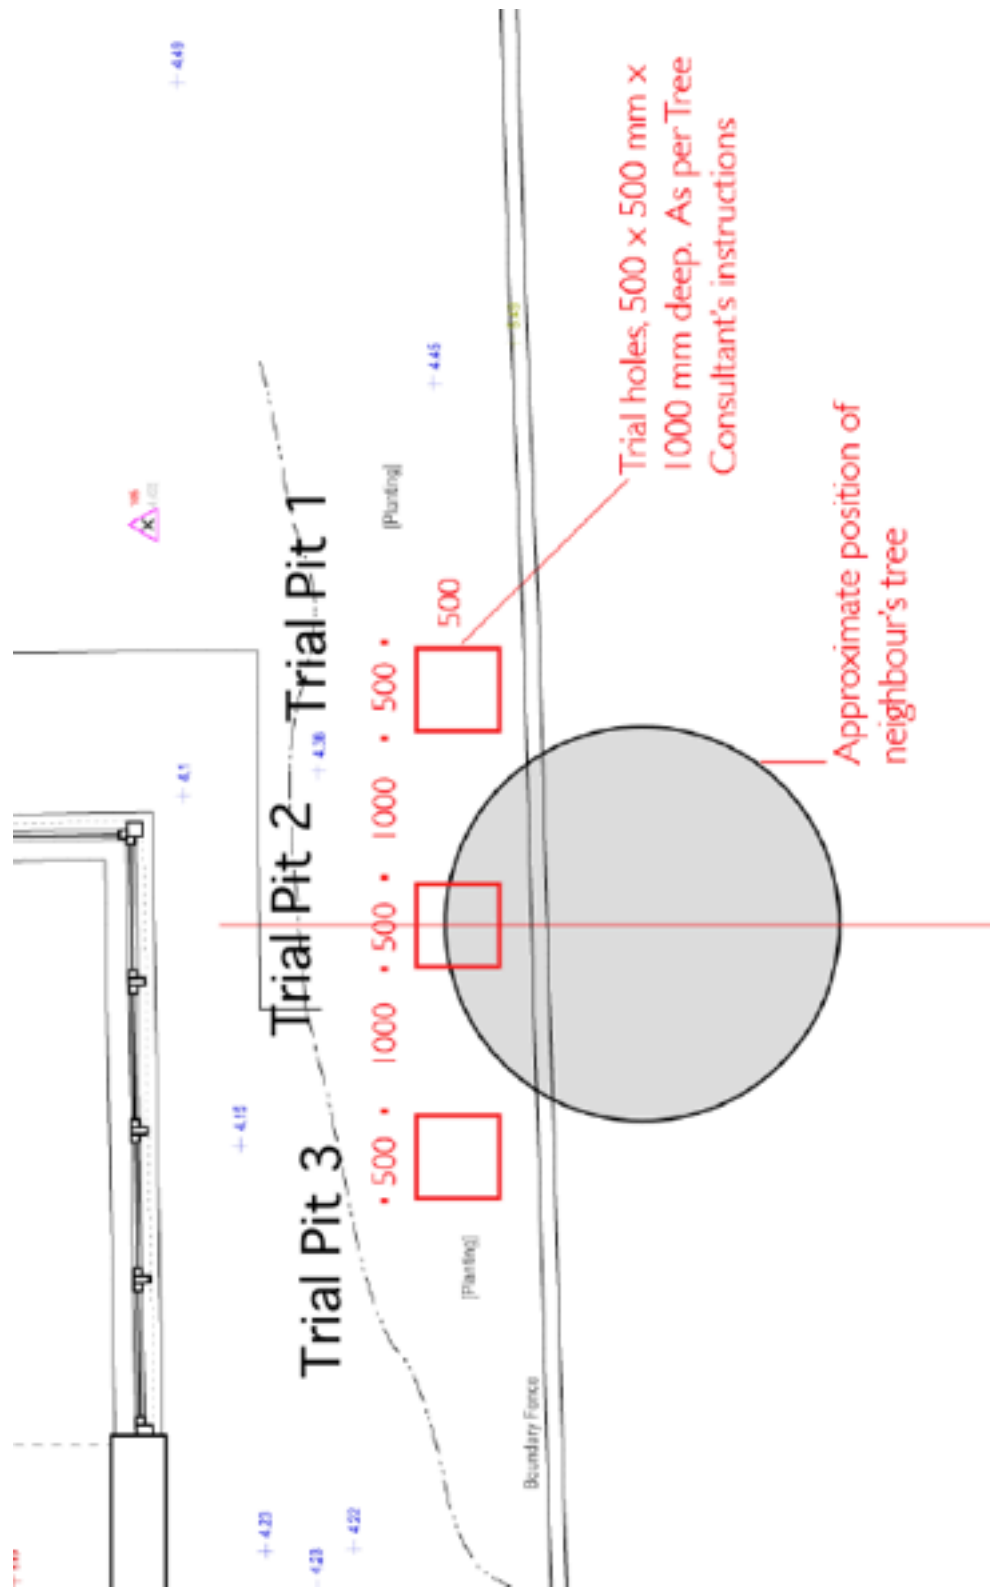
3. Trial Pit Location Site Plan - 45 Flask Walk

4.1.1 Trial pit 1 has been dug 1.5m from the outerpoint of tree T3 to the closest point of the trial pit on the south east corner of the trial pit.

4.2.1 Trial Pit 2 has been dug 1.5m from the outer point of tree T3 to the closest point of the trial pit on the north east corner of the trial pit.

4.3.1 Trial Pit 3 has been dug 3.3m from the outer point of tree T3 to the closest point of the trial pit on the north east corner of the trial pit.

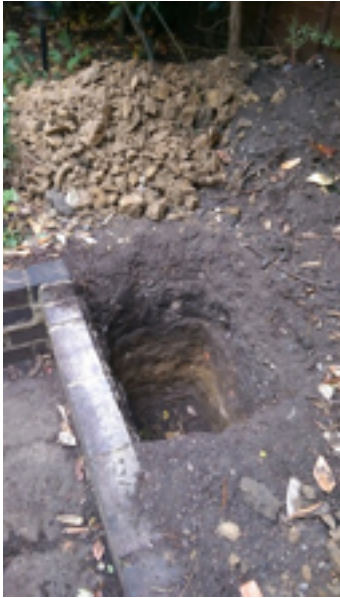
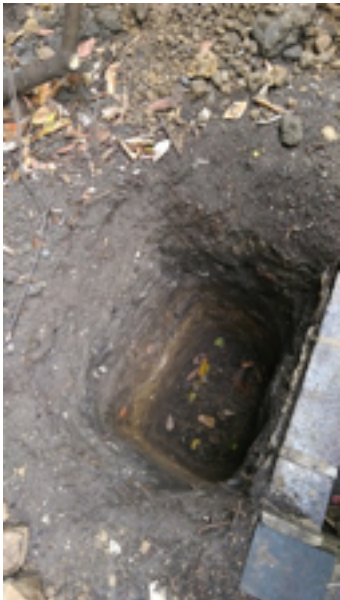
#### 4.1 Trial Pit 1 - Observations & Photographs

*As viewed in a northerly direction*

*As viewed from overhead*

4.1.3 As is evident from the site photographs very limited root activity has been encountered during the hand dug excavations for this trial pit. Even the face of within the trial pit closest to the Hawthorn tree, T3, shows minimal fibrous root growth with no larger anchorage tree roots.

5.1 The proposed development will encroach within the recommended root protection area (RPA) as discussed within the report but as is evident there is limited root activity from the neighbouring Hawthorn tree (T3) in the area directly to the west of the tree that has been discovered from the implementation of the 3 x trial pits.

5.2 It is possible that a historic boundary wall, brick built with foundations was in place during the initial development of the tree which resulted in tree root deflection, therefore affecting the overall morphology of the root system of this tree.

5.3 It is important to note that despite the findings within this Addendum, the development process would require for a flexible approach to be undertaken during the construction process, in particular for implementation of the basement and construction works / development towards the Hawthorn tree, T3.

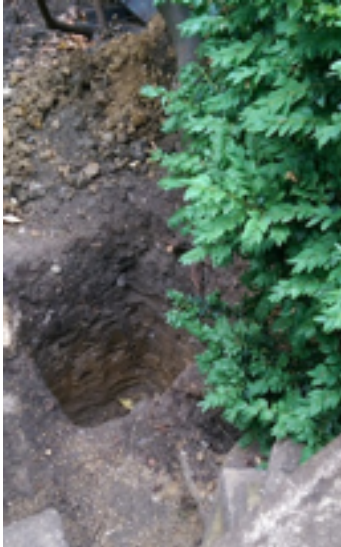
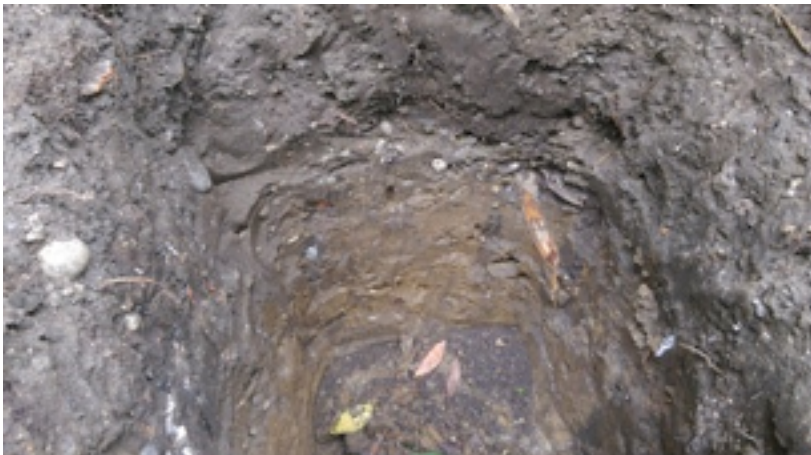
#### 4.2 Trial Pit 2 - Observations & Photographs

*As viewed in a northerly direction*

*As viewed from overhead*

4.2.3 As is evident from the site photographs very limited root activity has been encountered during the hand dug excavations for this trial pit. As with trial pit 1, the face of within the trial pit closest to the Hawthorn tree, T3, shows minimal fibrous root growth with no larger anchorage tree roots from the Hawthorn tree. It should be noted that an anchorage root approximately 30mm in diameter in the right hand corner of the photograph is from the directly adjacent Laurel (*Prunus laurocerasus*) shrub.

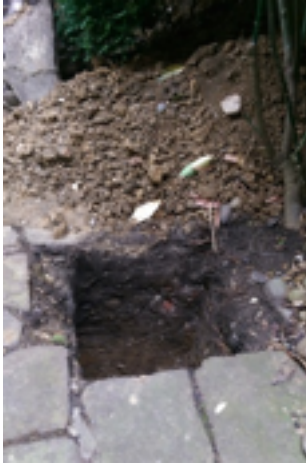
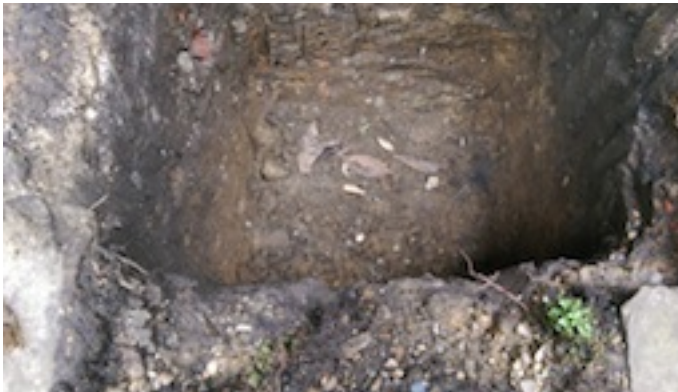
### 4.3 Trial Pit 3 - Observations & Photographs

*As viewed in a northerly direction*

*As viewed from overhead*

4.3.3 As is evident from the site photographs very limited root activity has been encountered during the hand dug excavations for this trial pit. As with trial pits 1 & 2, the face of within the trial pit closest to the Hawthorn tree, T3, shows minimal fibrous root growth with no larger anchorage tree roots. Some fibrous root activity at ground level as shown in the overhead photograph is minimal and below 10mm diameter in size.
