Arboricultural Survey (BS5837:2012) & Impact Assessment Report

45 Flask Walk
London
NW3 5HH

14th July 2015

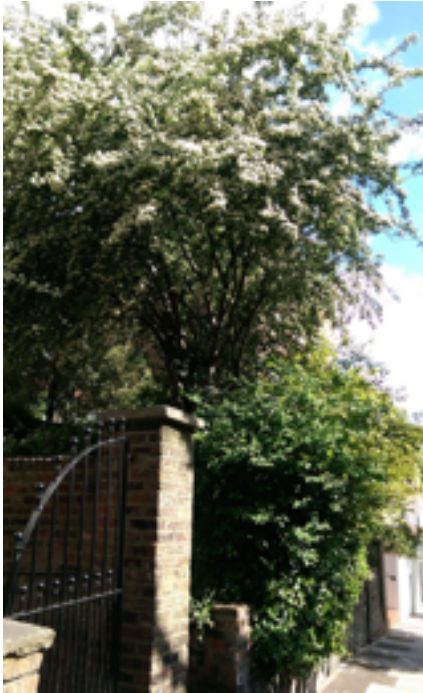
4.10 Tree T1 is a mature Hawthorn tree (*Crataegus monogyna*) which is generally structurally sound and offers good ornamental / amenity value at the front of the property. The tree is located within the raised front garden area, slightly suppressed beneath a mature Lime tree located within the public highway. The tree has good vigour with some deadwood throughout and congested form as is usual with this species. The tree is rated as 'C. 1' (BS5837:2012) taking into account the mainly ornamental value that is provided. This tree is sited within very close of potential construction site activities due to the compact nature of the proposed development site. In addition, the historic drainage system within the property may require modernisation and therefore significant excavations may be required in the front garden area close to tree T1.

C.1 Photograph of tree T1 proposed for retention at the front of the property and requiring protection - 45 Flask Walk, London, NW3 5HH; as viewed in a north easterly direction from public highway.

4.11 The tree protection for tree T1 requires realistic implementation. The recommended Root Protection Area (RPA) as outlined with BS5837:2012 is a **3.4m radius** surrounding the main stem. This is not fully achievable to the north west of the main stem within the main front garden area extending between the tree and the house. However, at least 1.5m protection distance is recommended for the tree in this direction. Taking account of the fact that protective fencing can enclose the remainder of the root plate, which is retained within the raised area of land by virtue of the front garden landscape, the overall protection for this tree is deemed appropriate.

Crown reduce height and spread 25% to give a balanced and compact shape

Crown thin 20%

Crown lift to 4m

Remove any remaining deadwood

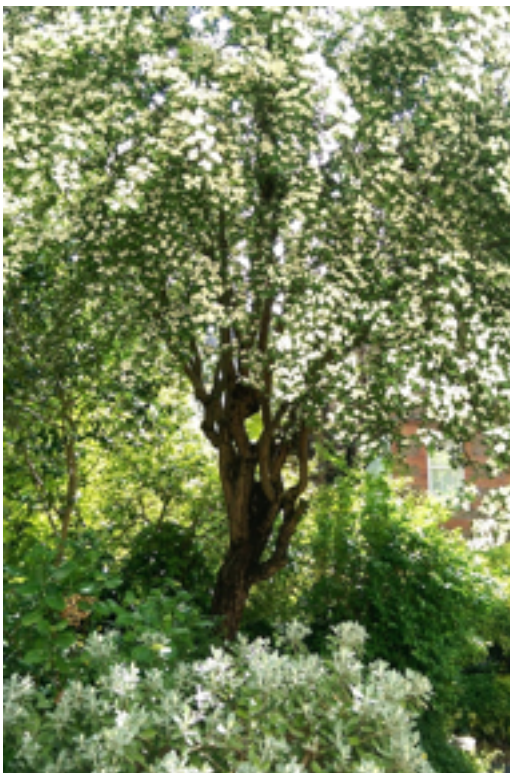
C.2 Photograph of tree T1 proposed for retention at the front of the property and requiring protection - 45 Flask Walk, London, NW3 5HH; as viewed in a westerly direction from the front garden.

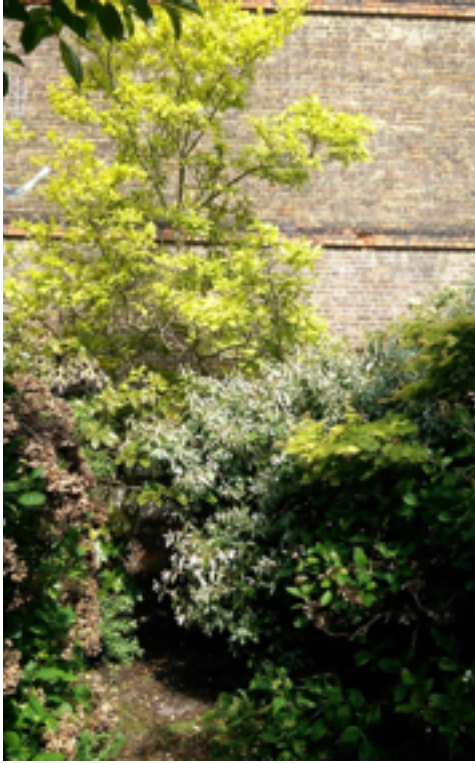
4.13 Tree T2 is an ornamental Magnolia tree sited within the rear garden of 45 Flask Walk. The tree is rated as a C.1 category specimen and is generally structurally sound. The tree offers limited amenity value within the rear garden and will be problematic in the long term as ultimately this species (*Magnolia soulangeana*) offers too broad a canopy for the location and size of the garden.

C.3 Photograph of tree T2 proposed for removal at the rear of the property - 45 Flask Walk, London, NW3 5HH; as viewed in a northerly direction..

4.14 Therefore the tree is recommended for removal within the proposed scheme with a replacement of a more suitable species to be incorporated within the re-landscaping of the rear garden. Examples of replacement trees are included within *Section 5*.

Fell to ground level and grind out stump

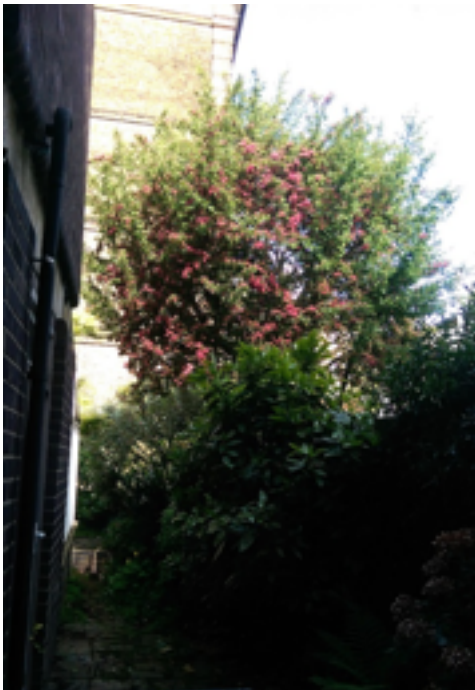
4.15 Tree T3 is a mature Hawthorn tree (*Crataegus laevigata* 'Paul's Scarlet') at the rear of the neighbouring property, 46 Flask Walk, which is adjacent to the eastern boundary fence of 45 Flask Walk, London, NW3. The tree is 7 metres in height with a spread of approximately 4-5 metres - canopy shape is relatively balanced and compact with the tree having been pruned within the past year (crown reduction and thinning works back to previous points - these works are clearly carried out on a cyclical basis); further works reducing encroachment within the rear garden of 45 Flask Walk have also been regularly undertaken. The tree is growing approximately 0.5m from the boundary between 45 and 46 Flask Walk with a wooden fence 1.2m height existing between the two rear gardens.

4.16 The tree is structurally sound at the base with significant root flare and an initially straight main stem, giving way to a relatively balanced and compact canopy shape. The epicormic growth which has resulted from recent pruning works show good vigour. With its location, age and species the tree offers some amenity value for the rear garden landscape area and is rated as 'C.1' (BS5837: 2012). The tree is therefore proposed for retention and should be protected during construction to the greatest extent possible.

C.4 Photograph of tree T3 proposed for retention and requiring protection - within the neighbouring property to the east, 46 Flask Walk, London, NW3 5HH; as viewed in a northerly direction from the rear garden.

4.17 For tree T3, the recommended root protection distances is set at a radius of **4.0 metres** (BS5837: 2012) distance. With the proposed development extending significantly within this distance to the west and north west of the main stem, it is recommended that trial pits are dug in this area in order to ascertain the extent and nature of the tree roots in this area. It should be noted that the tree root system may not be excessive due to the following factors:

Crown reduce overhanging spread 20-25% to give a balanced and compact shape and reduce encroachment within garden / proposed development site

Crown lift overhanging growth to 3.5m
