# 2.3 Heritage Statement

# 3.0 Design Analysis & Proposal

3.3.3 68 Huntley Street (Main elevation)  
Key features are:

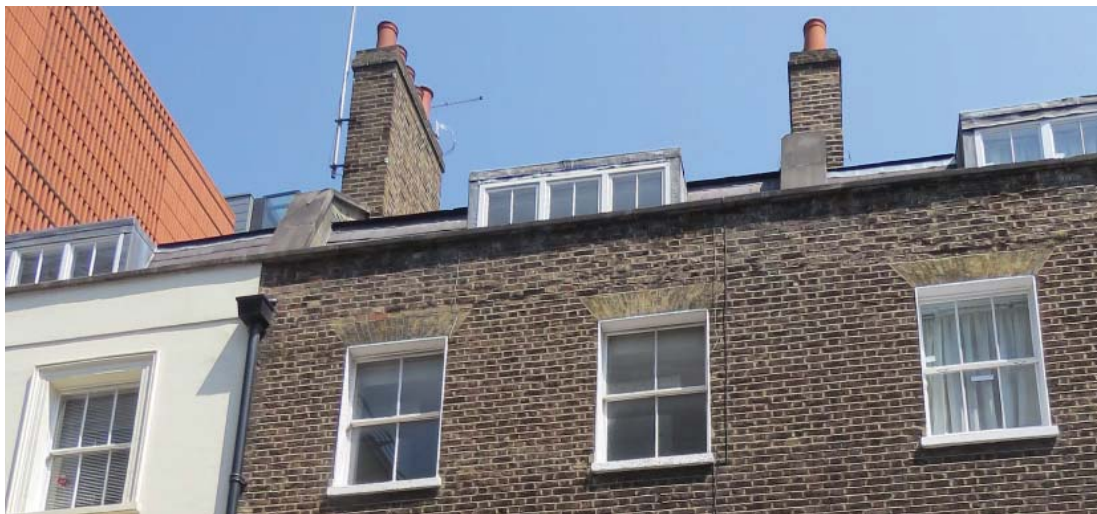
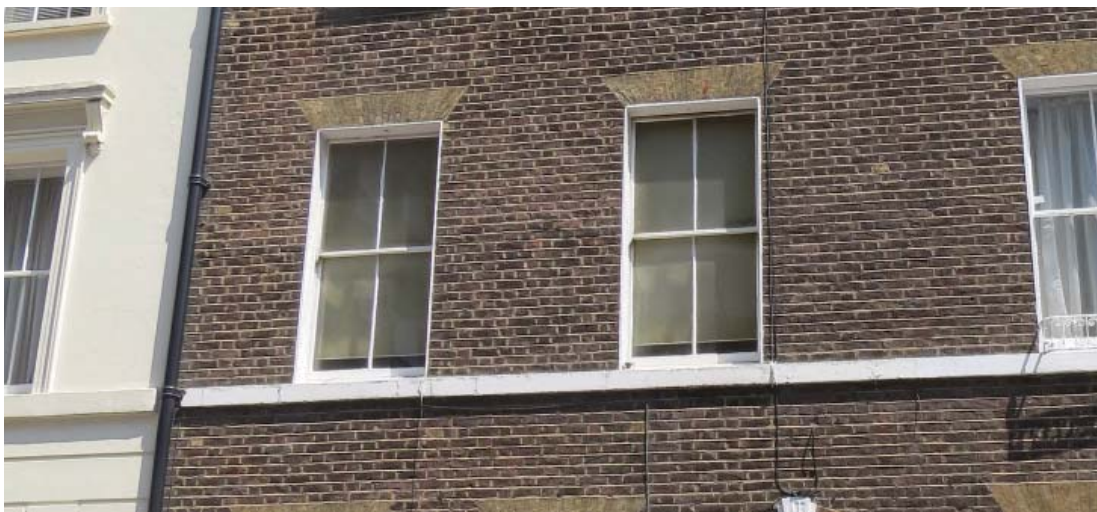
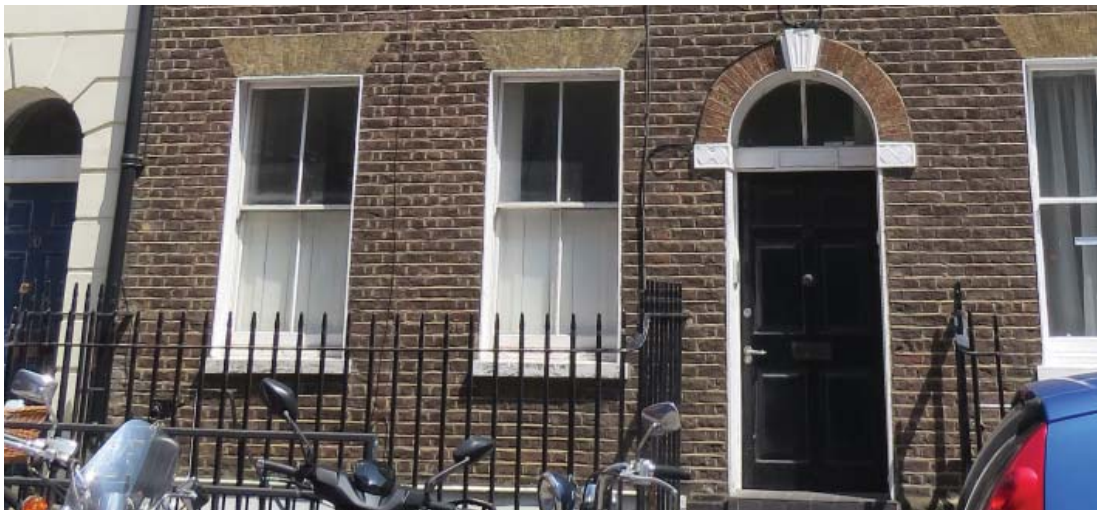
Existing Front Elevation of 68 Huntley Street

3.3.1 The key architectural features of 68 Huntley Street as illustrated in the preceding sections is the overall appearance of the terrace and its relationship as a whole entity.

3.3.2 The block elevation is modest and understated and apart from 70 Huntley street that has a complete white stucco render to Huntley street elevation. 46 - 68 Huntley street have an overall consistent character with each terrace house.

**Windows** Existing Sash windows will require to be repaired, repainted and overhauled. If windows need to be replaced these will require site measuring and made to fit existing openings and match existing windows incorporating single glazing.

Sills will need to be repaired or replaced depending on existing condition.

**External Doors** All external doors to be overhauled and made good. Replacement ironmongery will be required.

**Roof** The existing roof will be renewed. Existing tiles where sound will be replaced and lead flashings renewed to ensure a weather tight roof.
