Phase 1 Environmental Desk Study
2 Hermit Place/Rear of 246 Belsize Road

PHASE I ENVIRONMENTAL DESK STUDY

Report No. A1451/16

October 2016

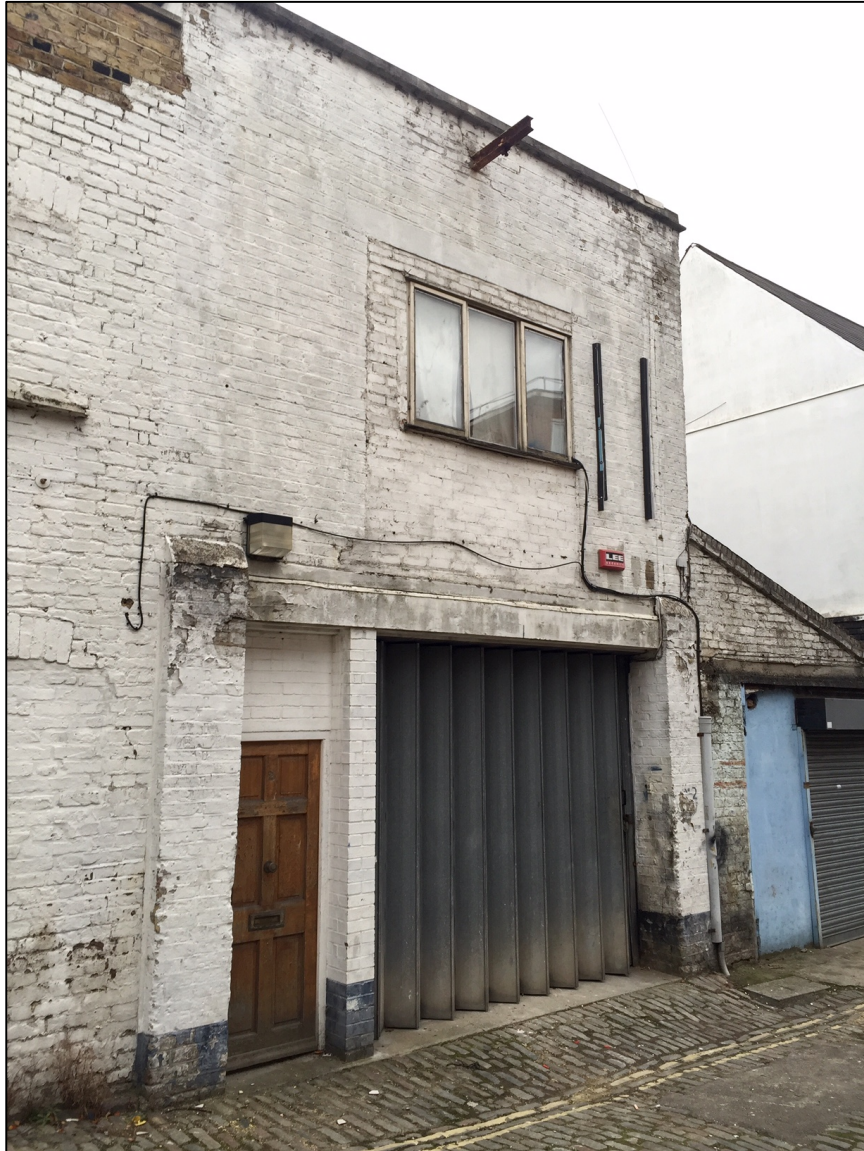
Figure 2: Existing Site Layout

2.5 An existing site layout image is shown below in Figure 2.

2.1 The site is currently an existing residential three storey property which includes a dry cleaners on the ground floor. This dry cleaners is a drop-off and collection point only, with all cleaning processes being conducted offsite.

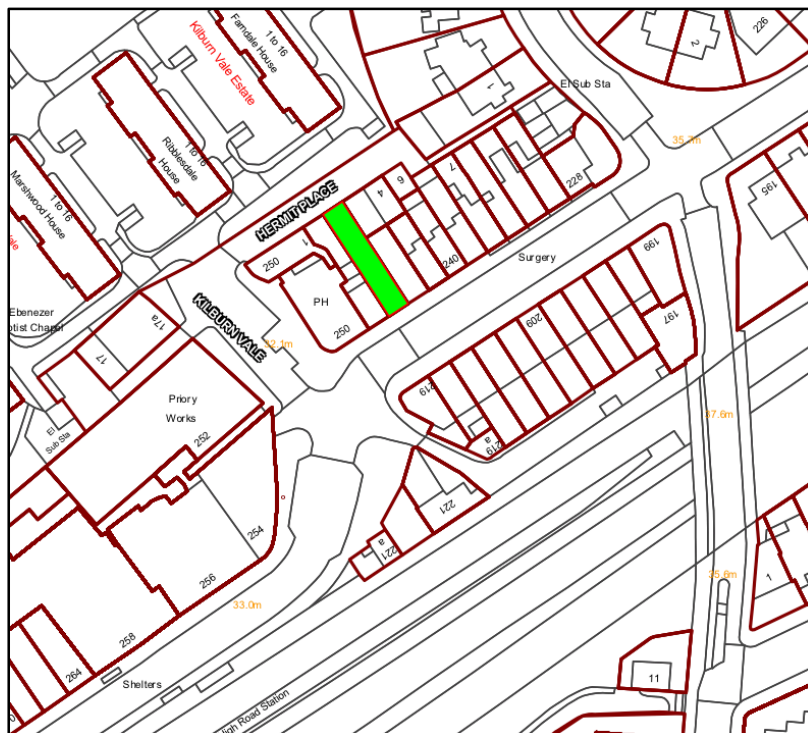
Figure 3: Site Location shown in 1850 and in 2015

4.3 Selected extracts from historical maps and aerial photographs are presented in the following figures below:

Date	Site	Surrounding Land Use
1850	Unoccupied.	Agricultural and horticultural area with some residential property. Railway line in cutting running NE-SW shown approximately 40m to the S. Residential housing to NW.
1870-1880, 1872, 1874,	Residential property appears much as it can be found today.	Significant expansion of residential properties in every direction. Recreational park 40m SW. Pond approximately 120m NW. Significant expansion of the railway line running NE-SW. Kilburn railway station approximately 50m south of site.
1874-1882	Site appears much as it can be found today.	No Change
1894	Site appears much as it can be found today.	Recreational park 40m SW is now replaced with Town Hall.
1896, 1915, 1920, 1935- 1936, 1937- 1938, 1951	Site appears much as it can be found today.	Town Hall replaced with theatre and Priory Works in 1896.
1954, 1955, 1957, 1966- 1968, 1970, 1972, 1974- 1975, 1984, 1985, 1991- 1996	Site appears much as it can be found today.	Theatre replaced with warehouse and club.

Google Earth 2015	Site appears much as it can be found today.	Area appears much as it can be found today.
