Mr Robert Hume

**13 Kylemore Road,
Camden**

*Interpretative Site Investigation and
Basement Impact Assessment
Report*

Reference	CG/18952	Revision 0	Issue Date	December 2016

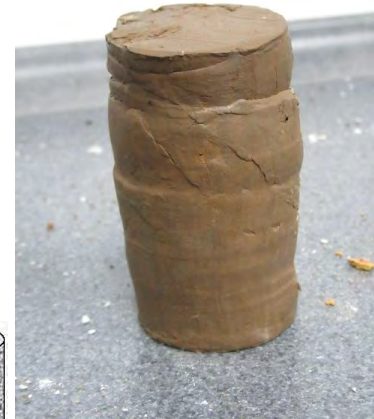
Failure Sketch
(surface inclination)

Initial Conditions			
Initial Cell Pressure	σ ₃	(kPa)	40
Strain Rate	m _s	(mm/min)	1.50380
Membrane Thickness	m _b	(mm)	0.24
Displacement Input	L _{IP}	(mm)	CH 2
Load Input	N _{IP}	(N)	CH 1
Initial Moisture	ω _i %	(%)	29
Initial Dry Density	ρ _{d0}	(Mg/m ³)	1.53
Initial Voids Ratio	e ₀	.	0.74
Initial Degree of Saturation	S _o	(%)	100

Final Conditions			
Max Deviator Stress	(σ ₁ - σ ₃) _f	(kPa)	349
Membrane Correction	m _c	(kPa)	1.673
Strain At Max Stress	ε _f %	(%)	9.74
Shear Strength	c _u	(kPa)	175
Final Moisture	ω _f %	(%)	29
Final Dry Density	ρ _{df}	(Mg/m ³)	1.52
Final Voids Ratio	e _f	.	0.74
Final Degree of Saturation	S _f	(%)	100.0

Triaxial at over bueden

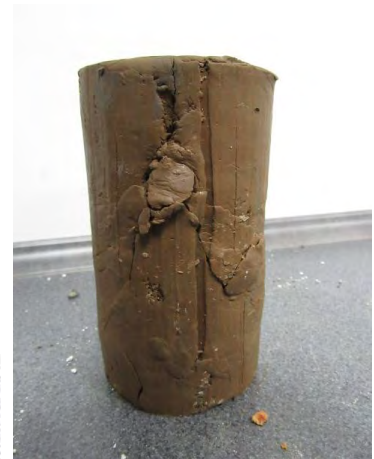
Failure Sketch
(surface inclination)

Initial Conditions			
Initial Cell Pressure	σ_3	(kPa)	60
Strain Rate	$\dot{\epsilon}_s$	(mm/min)	2.84600
Membrane Thickness	m_b	(mm)	0.24
Displacement Input	L_{IP}	(mm)	CH 2
Load Input	N_{IP}	(N)	CH 1
Initial Moisture	$\omega_i\%$	(%)	29
Initial Dry Density	ρ_{d0}	(Mg/m ³)	1.48
Initial Voids Ratio	e_0	.	0.80
Initial Degree of Saturation	S_o	(%)	98

Final Conditions			
Max Deviator Stress	$(\sigma_1 - \sigma_3)_f$	(kPa)	195
Membrane Correction	m_c	(kPa)	0.869
Strain At Max Stress	$\epsilon_f\%$	(%)	8.48
Shear Strength	c_u	(kPa)	98
Final Moisture	$\omega_f\%$	(%)	30
Final Dry Density	ρ_{df}	(Mg/m ³)	1.47
Final Voids Ratio	e_f	.	0.80
Final Degree of Saturation	S_f	(%)	98.1

Triaxial at over bueden

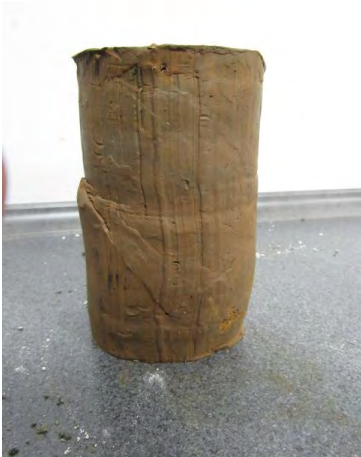
Failure Sketch	
		(surface inclination)

Initial Conditions			
Initial Cell Pressure	σ_3	(kPa)	40
Strain Rate	m_s	(mm/min)	2.83580
Membrane Thickness	m_b	(mm)	0.27
Displacement Input	L_{IP}	(mm)	CH 2
Load Input	N_{IP}	(N)	CH 1
Initial Moisture	$\omega_i\%$	(%)	37
Initial Dry Density	ρ_{d0}	(Mg/m ³)	1.38
Initial Voids Ratio	e_0	.	0.92
Initial Degree of Saturation	S_o	(%)	100

Final Conditions			
Max Deviator Stress	$(\sigma_1 - \sigma_3)_f$	(kPa)	85
Membrane Correction	m_c	(kPa)	1.191
Strain At Max Stress	$\epsilon_f\%$	(%)	11.64
Shear Strength	c_u	(kPa)	43
Final Moisture	$\omega_f\%$	(%)	37
Final Dry Density	ρ_{df}	(Mg/m ³)	1.38
Final Voids Ratio	e_f	.	0.92
Final Degree of Saturation	S_f	(%)	100.0
Notes			
Triaxial at over bueden

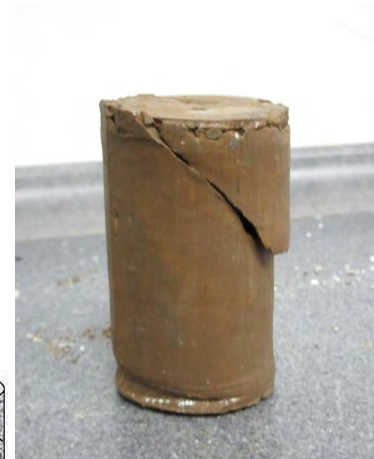
Failure Sketch
(surface inclination)

Initial Conditions			
Initial Cell Pressure	σ ₃	(kPa)	80
Strain Rate	m _s	(mm/min)	1.50800
Membrane Thickness	m _b	(mm)	0.25
Displacement Input	L _{IP}	(mm)	CH 2
Load Input	N _{IP}	(N)	CH 1
Initial Moisture	ω _i %	(%)	25
Initial Dry Density	ρ _{d0}	(Mg/m ³)	1.52
Initial Voids Ratio	e ₀	.	0.75
Initial Degree of Saturation	S _o	(%)	88

Final Conditions			
Max Deviator Stress	(σ ₁ - σ ₃) _f	(kPa)	483
Membrane Correction	m _c	(kPa)	1.586
Strain At Max Stress	ε _f %	(%)	6.14
Shear Strength	c _u	(kPa)	242
Final Moisture	ω _f %	(%)	25
Final Dry Density	ρ _{df}	(Mg/m ³)	1.52
Final Voids Ratio	e _f	.	0.75
Final Degree of Saturation	S _f	(%)	88.0

Triaxial at over bueden

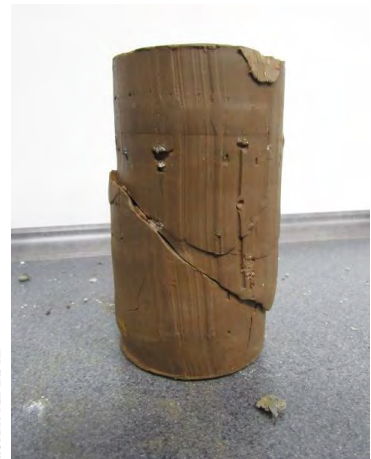
Failure Sketch
(surface inclination)

Initial Conditions			
Initial Cell Pressure	σ ₃	(kPa)	120
Strain Rate	m _s	(mm/min)	2.81640
Membrane Thickness	m _b	(mm)	0.18
Displacement Input	L _{IP}	(mm)	CH 2
Load Input	N _{IP}	(N)	CH 1
Initial Moisture	ω _i %	(%)	31
Initial Dry Density	ρ _{d0}	(Mg/m ³)	1.48
Initial Voids Ratio	e ₀	.	0.79
Initial Degree of Saturation	S _o	(%)	100

Final Conditions			
Max Deviator Stress	(σ ₁ - σ ₃) _f	(kPa)	287
Membrane Correction	m _c	(kPa)	0.599
Strain At Max Stress	ε _f %	(%)	8.29
Shear Strength	c _u	(kPa)	144
Final Moisture	ω _f %	(%)	31
Final Dry Density	ρ _{df}	(Mg/m ³)	1.48
Final Voids Ratio	e _f	.	0.79
Final Degree of Saturation	S _f	(%)	100.0

Triaxial at over bueden

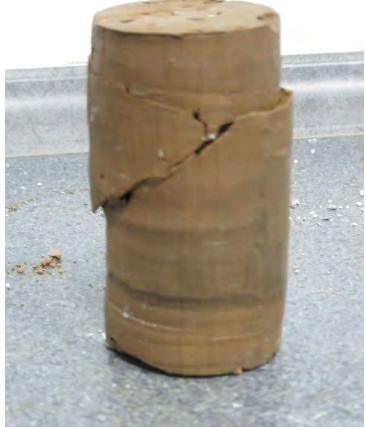
<p>Failure Sketch (surface inclination)</p>

Initial Conditions			
Initial Cell Pressure	σ_3	(kPa)	160
Strain Rate	m_s	(mm/min)	1.52200
Membrane Thickness	m_b	(mm)	0.27
Displacement Input	L_{IP}	(mm)	CH 2
Load Input	N_{IP}	(N)	CH 1
Initial Moisture	$\omega_i\%$	(%)	32
Initial Dry Density	ρ_{d0}	(Mg/m3)	1.44
Initial Voids Ratio	e_0	.	0.84
Initial Degree of Saturation	S_o	(%)	100

Final Conditions			
Max Deviator Stress	$(\sigma_1 - \sigma_3)_f$	(kPa)	422
Membrane Correction	m_c	(kPa)	1.203
Strain At Max Stress	$\epsilon_f\%$	(%)	4.97
Shear Strength	c_u	(kPa)	211
Final Moisture	$\omega_f\%$	(%)	32
Final Dry Density	ρ_{df}	(Mg/m3)	1.44
Final Voids Ratio	e_f	.	0.84
Final Degree of Saturation	S_f	(%)	100.0
Notes			
Triaxial at over bueden
