**Phase 2a Site Investigation and GQRA**

**277a Gray's Inn Road  
London  
WC1X 8QF**

**(Ref. TJ2824AR1v1.0)**

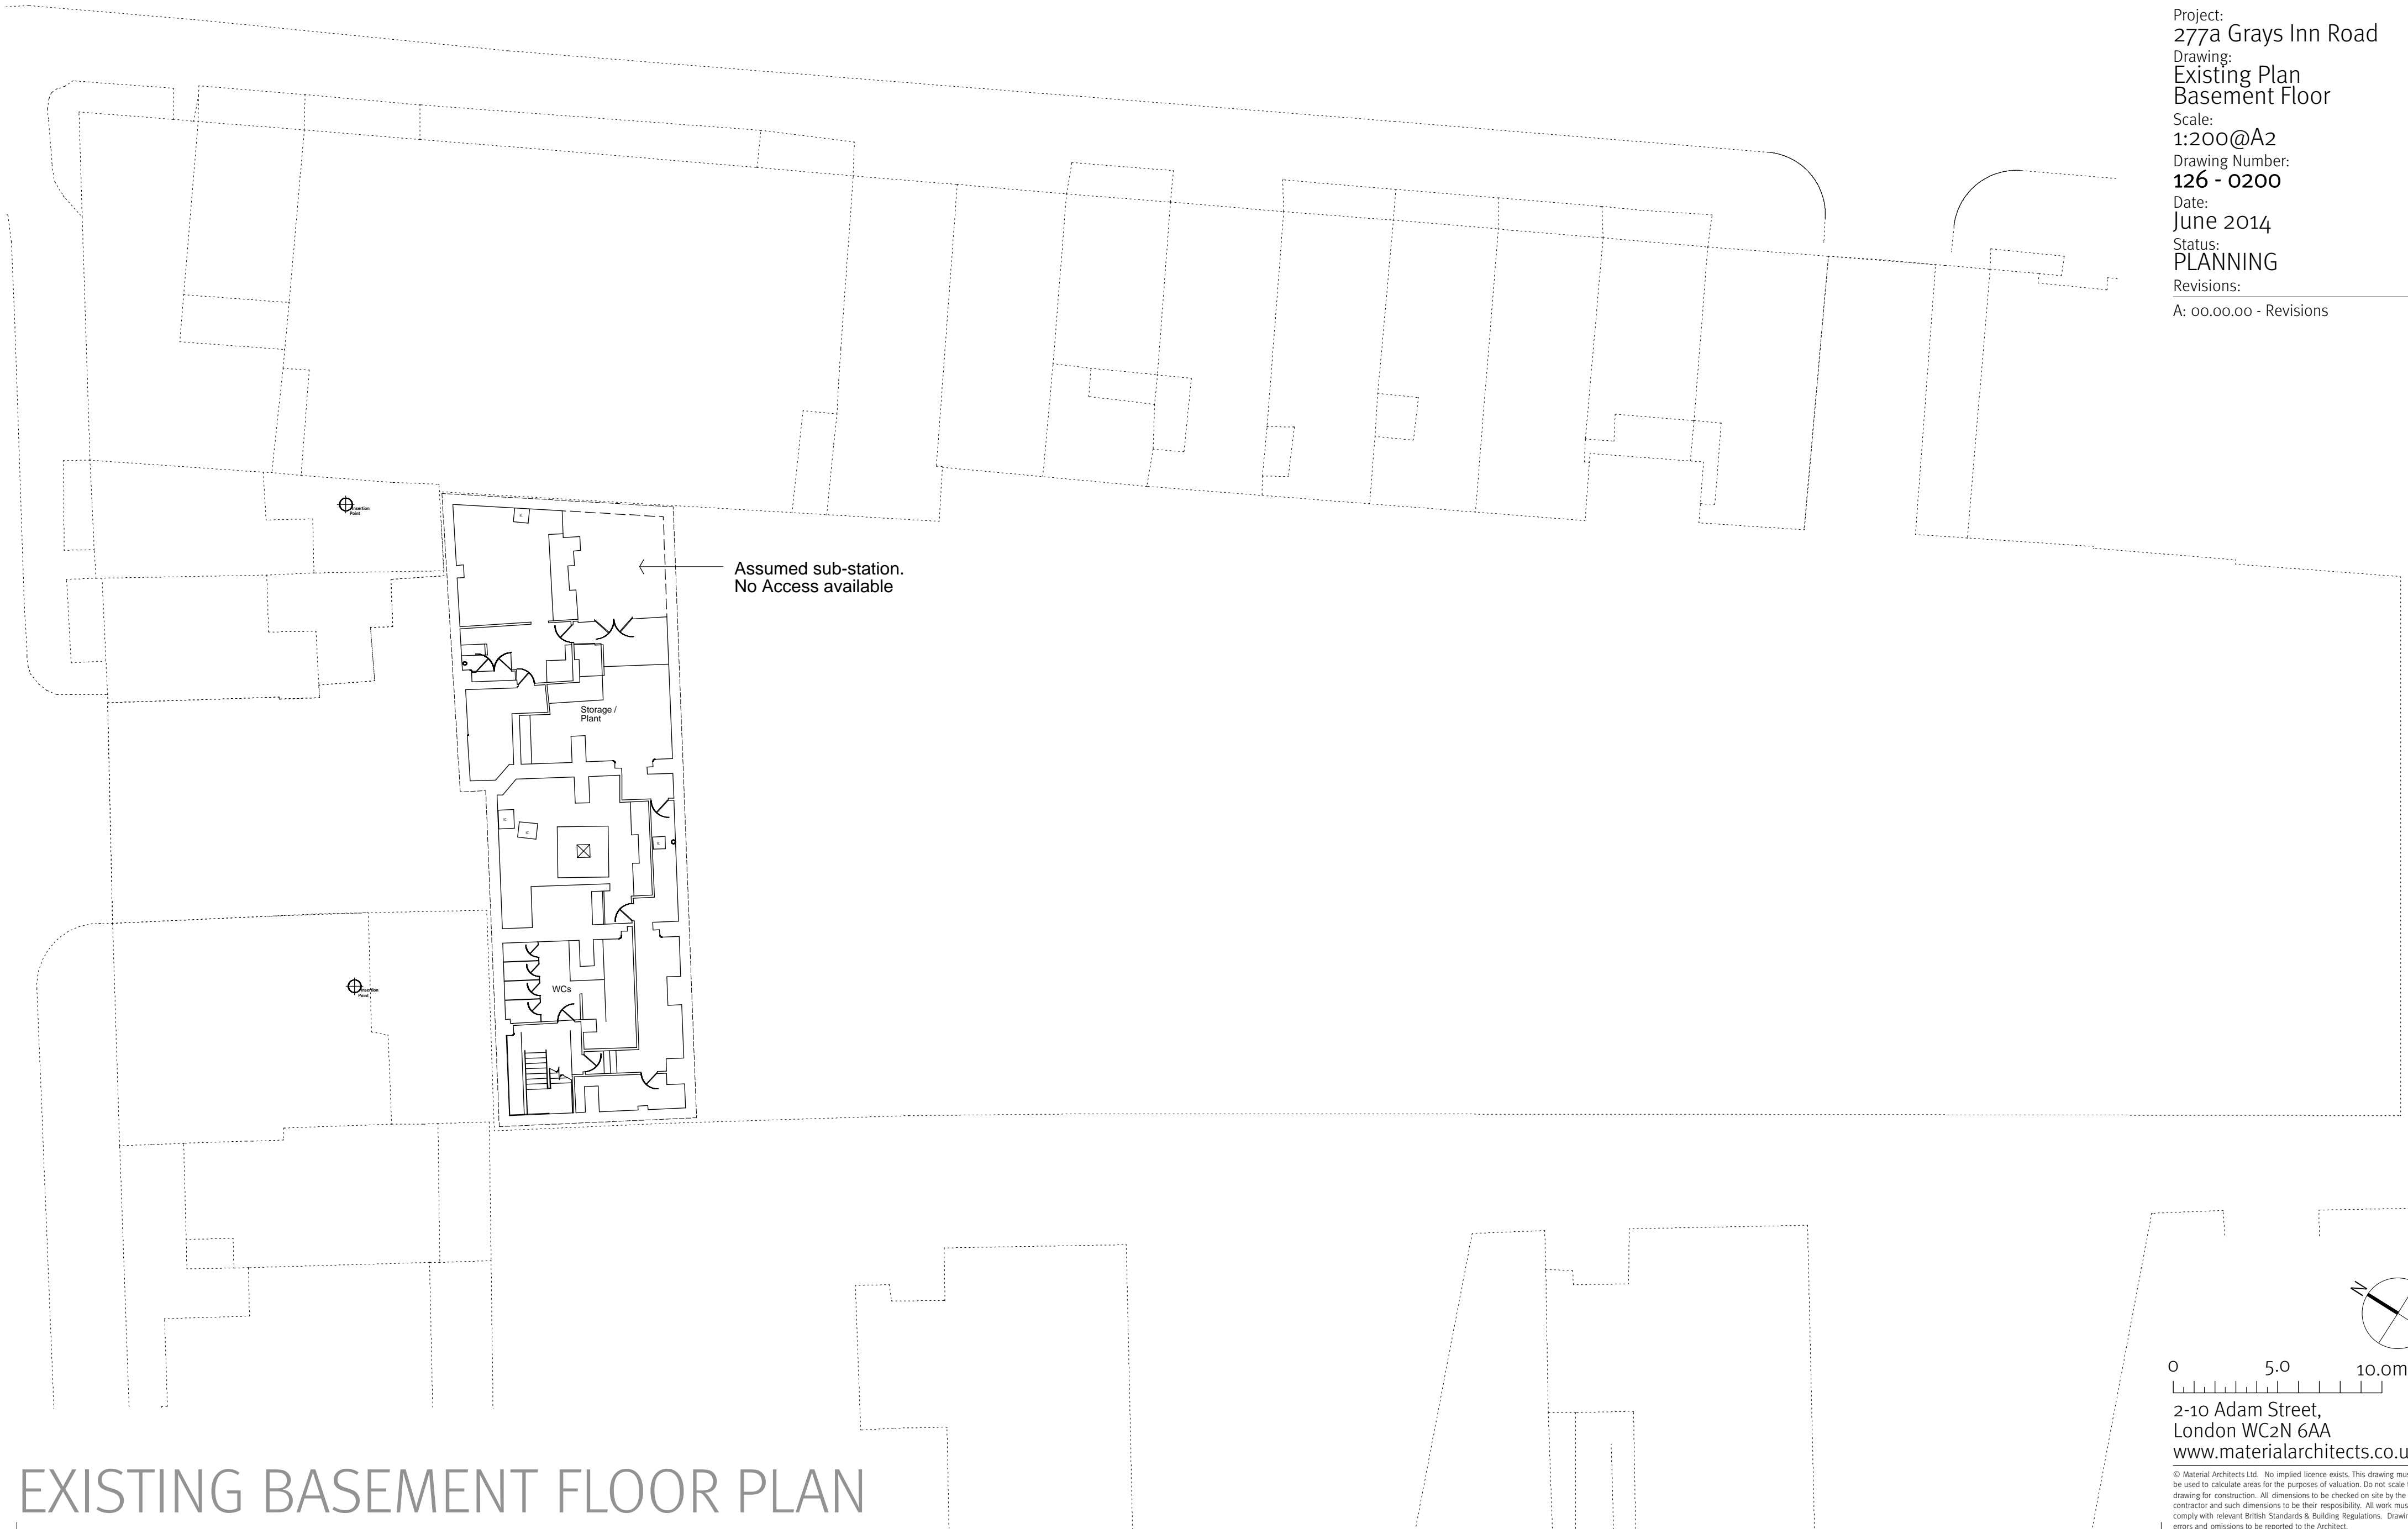
EXISTING BASEMENT FLOOR PLAN

Project:  
277a Grays Inn Road  
Drawing:  
Existing Plan  
Basement Floor  
Scale:  
1:200@A2  
Drawing Number:  
126 - 0200  
Date:  
June 2014  
Status:  
PLANNING  
Revisions:  
A: 00.00.00 - Revisions

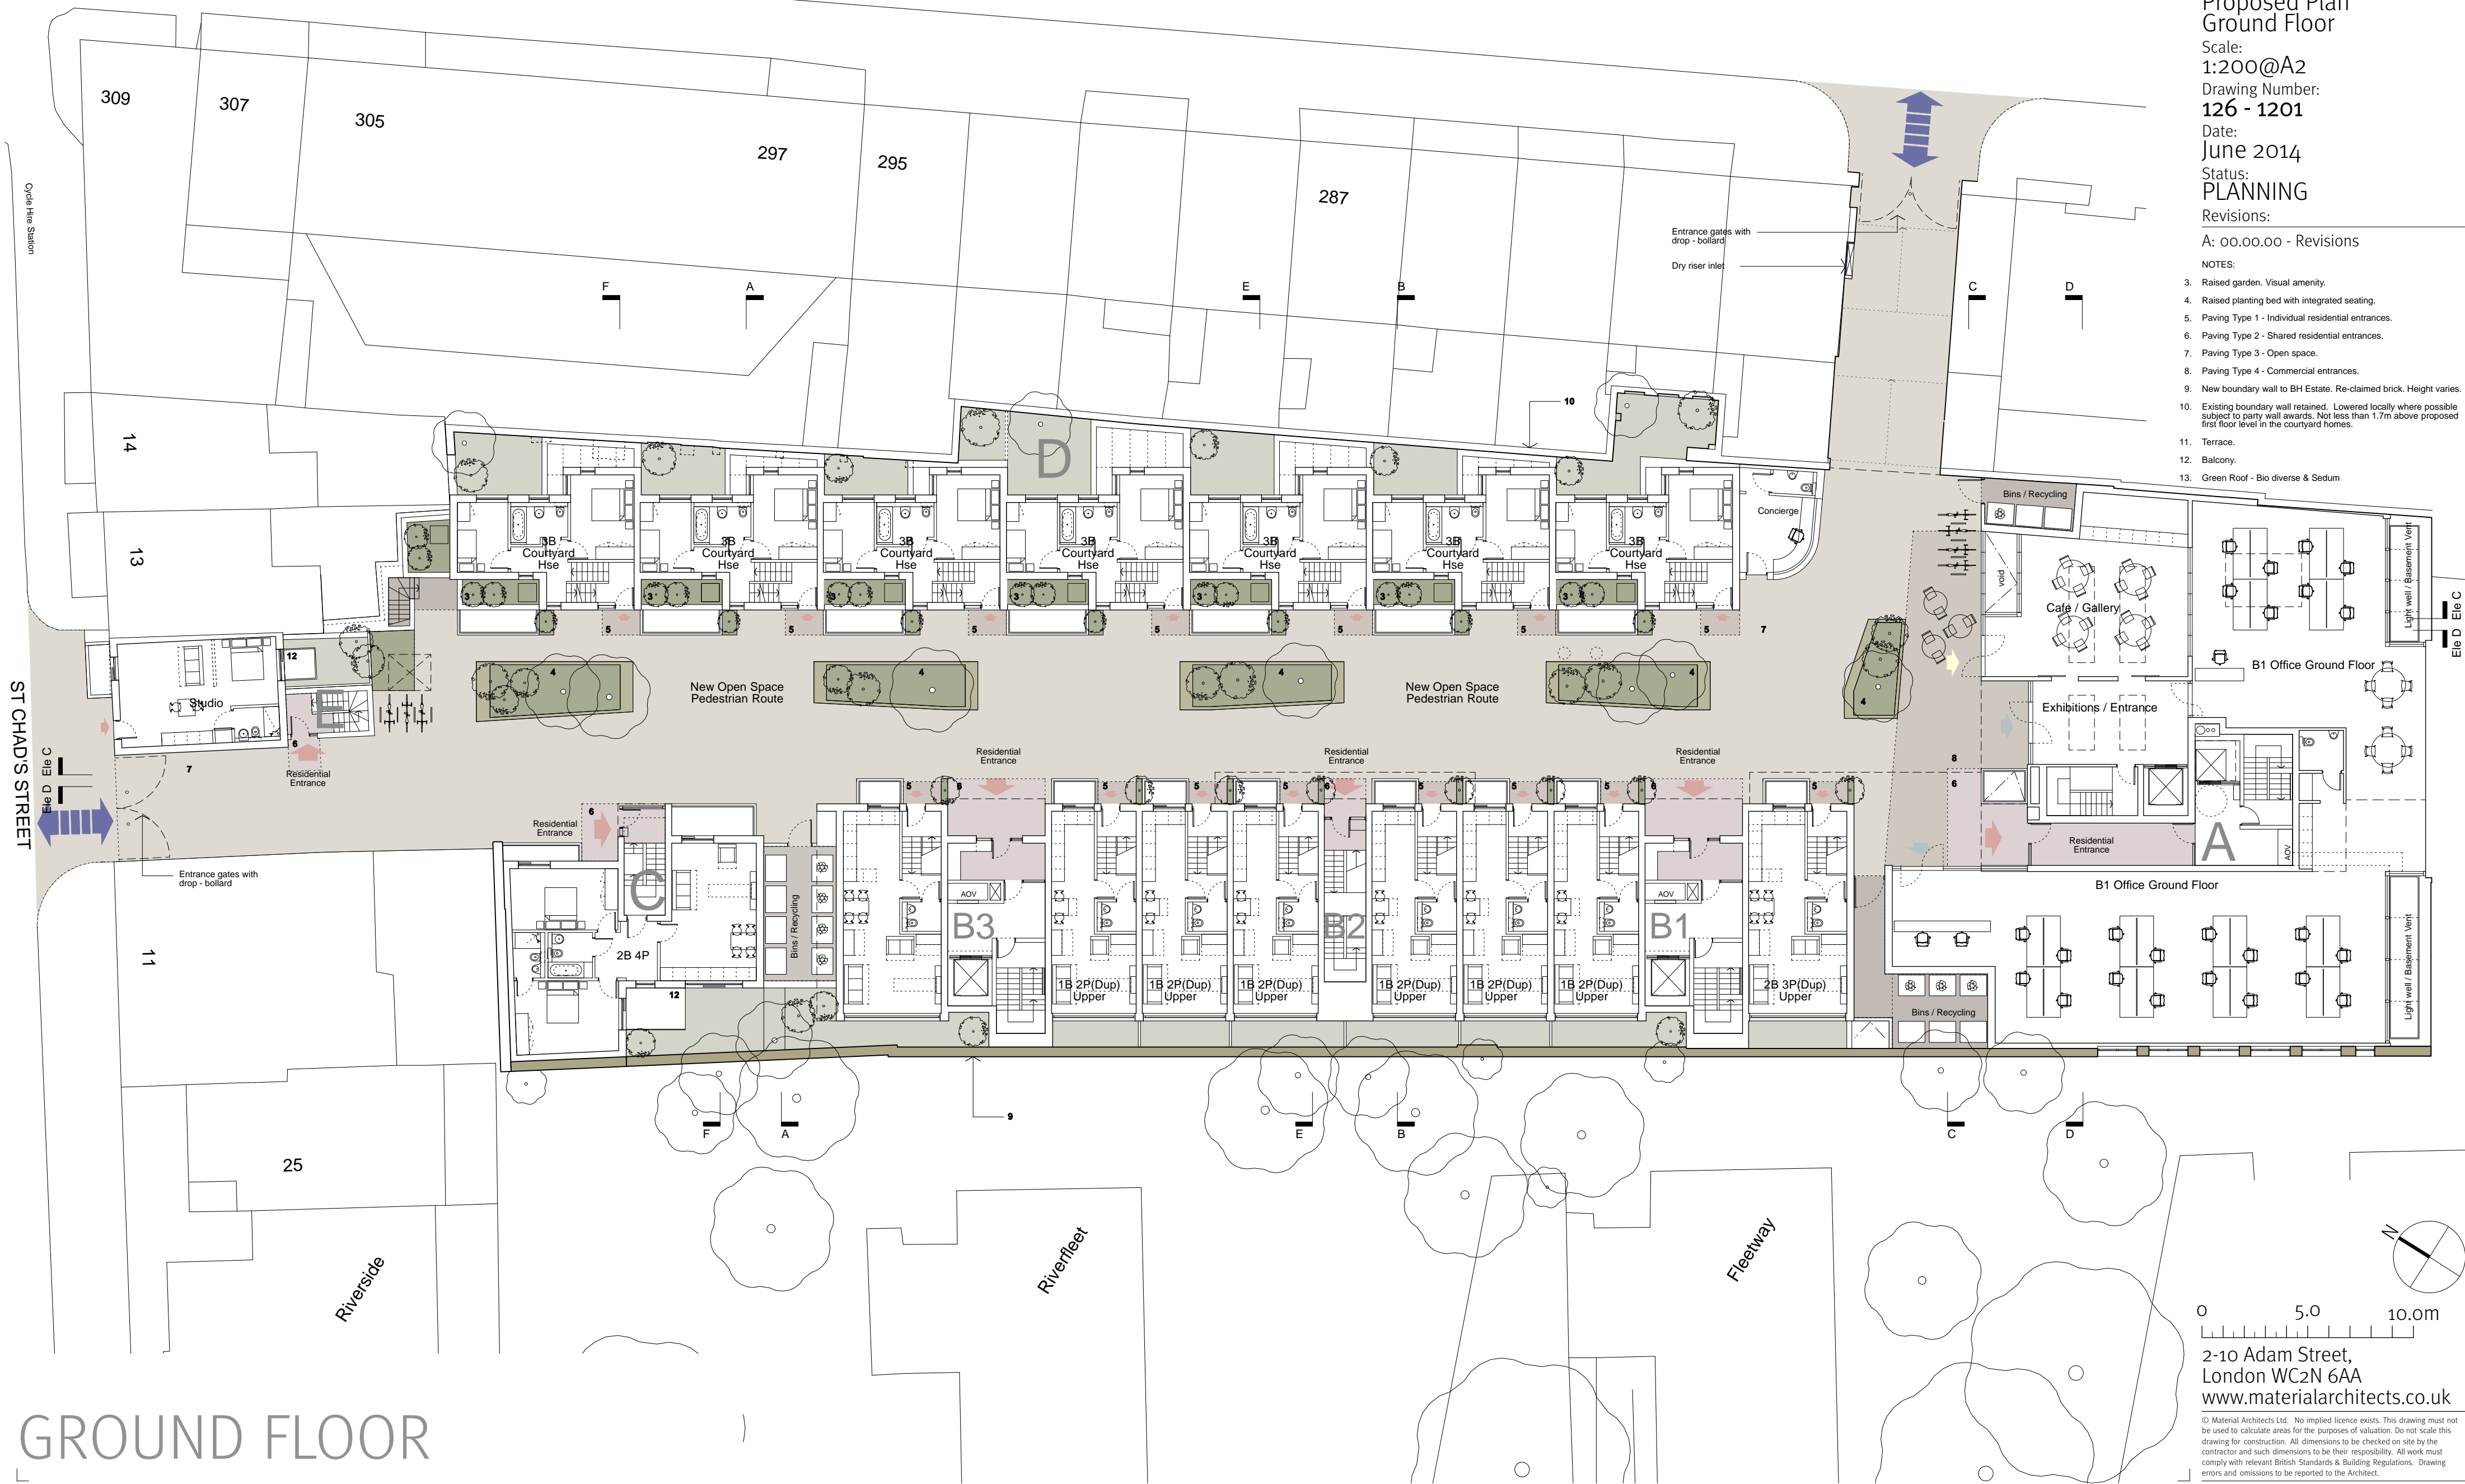
GROUND FLOOR

Project:  
277a Grays Inn Road  
Drawing:  
Proposed Plan  
Ground Floor  
Scale:  
1:200@A2  
Drawing Number:  
126 - 1201  
Date:  
June 2014  
Status:  
PLANNING  
Revisions:

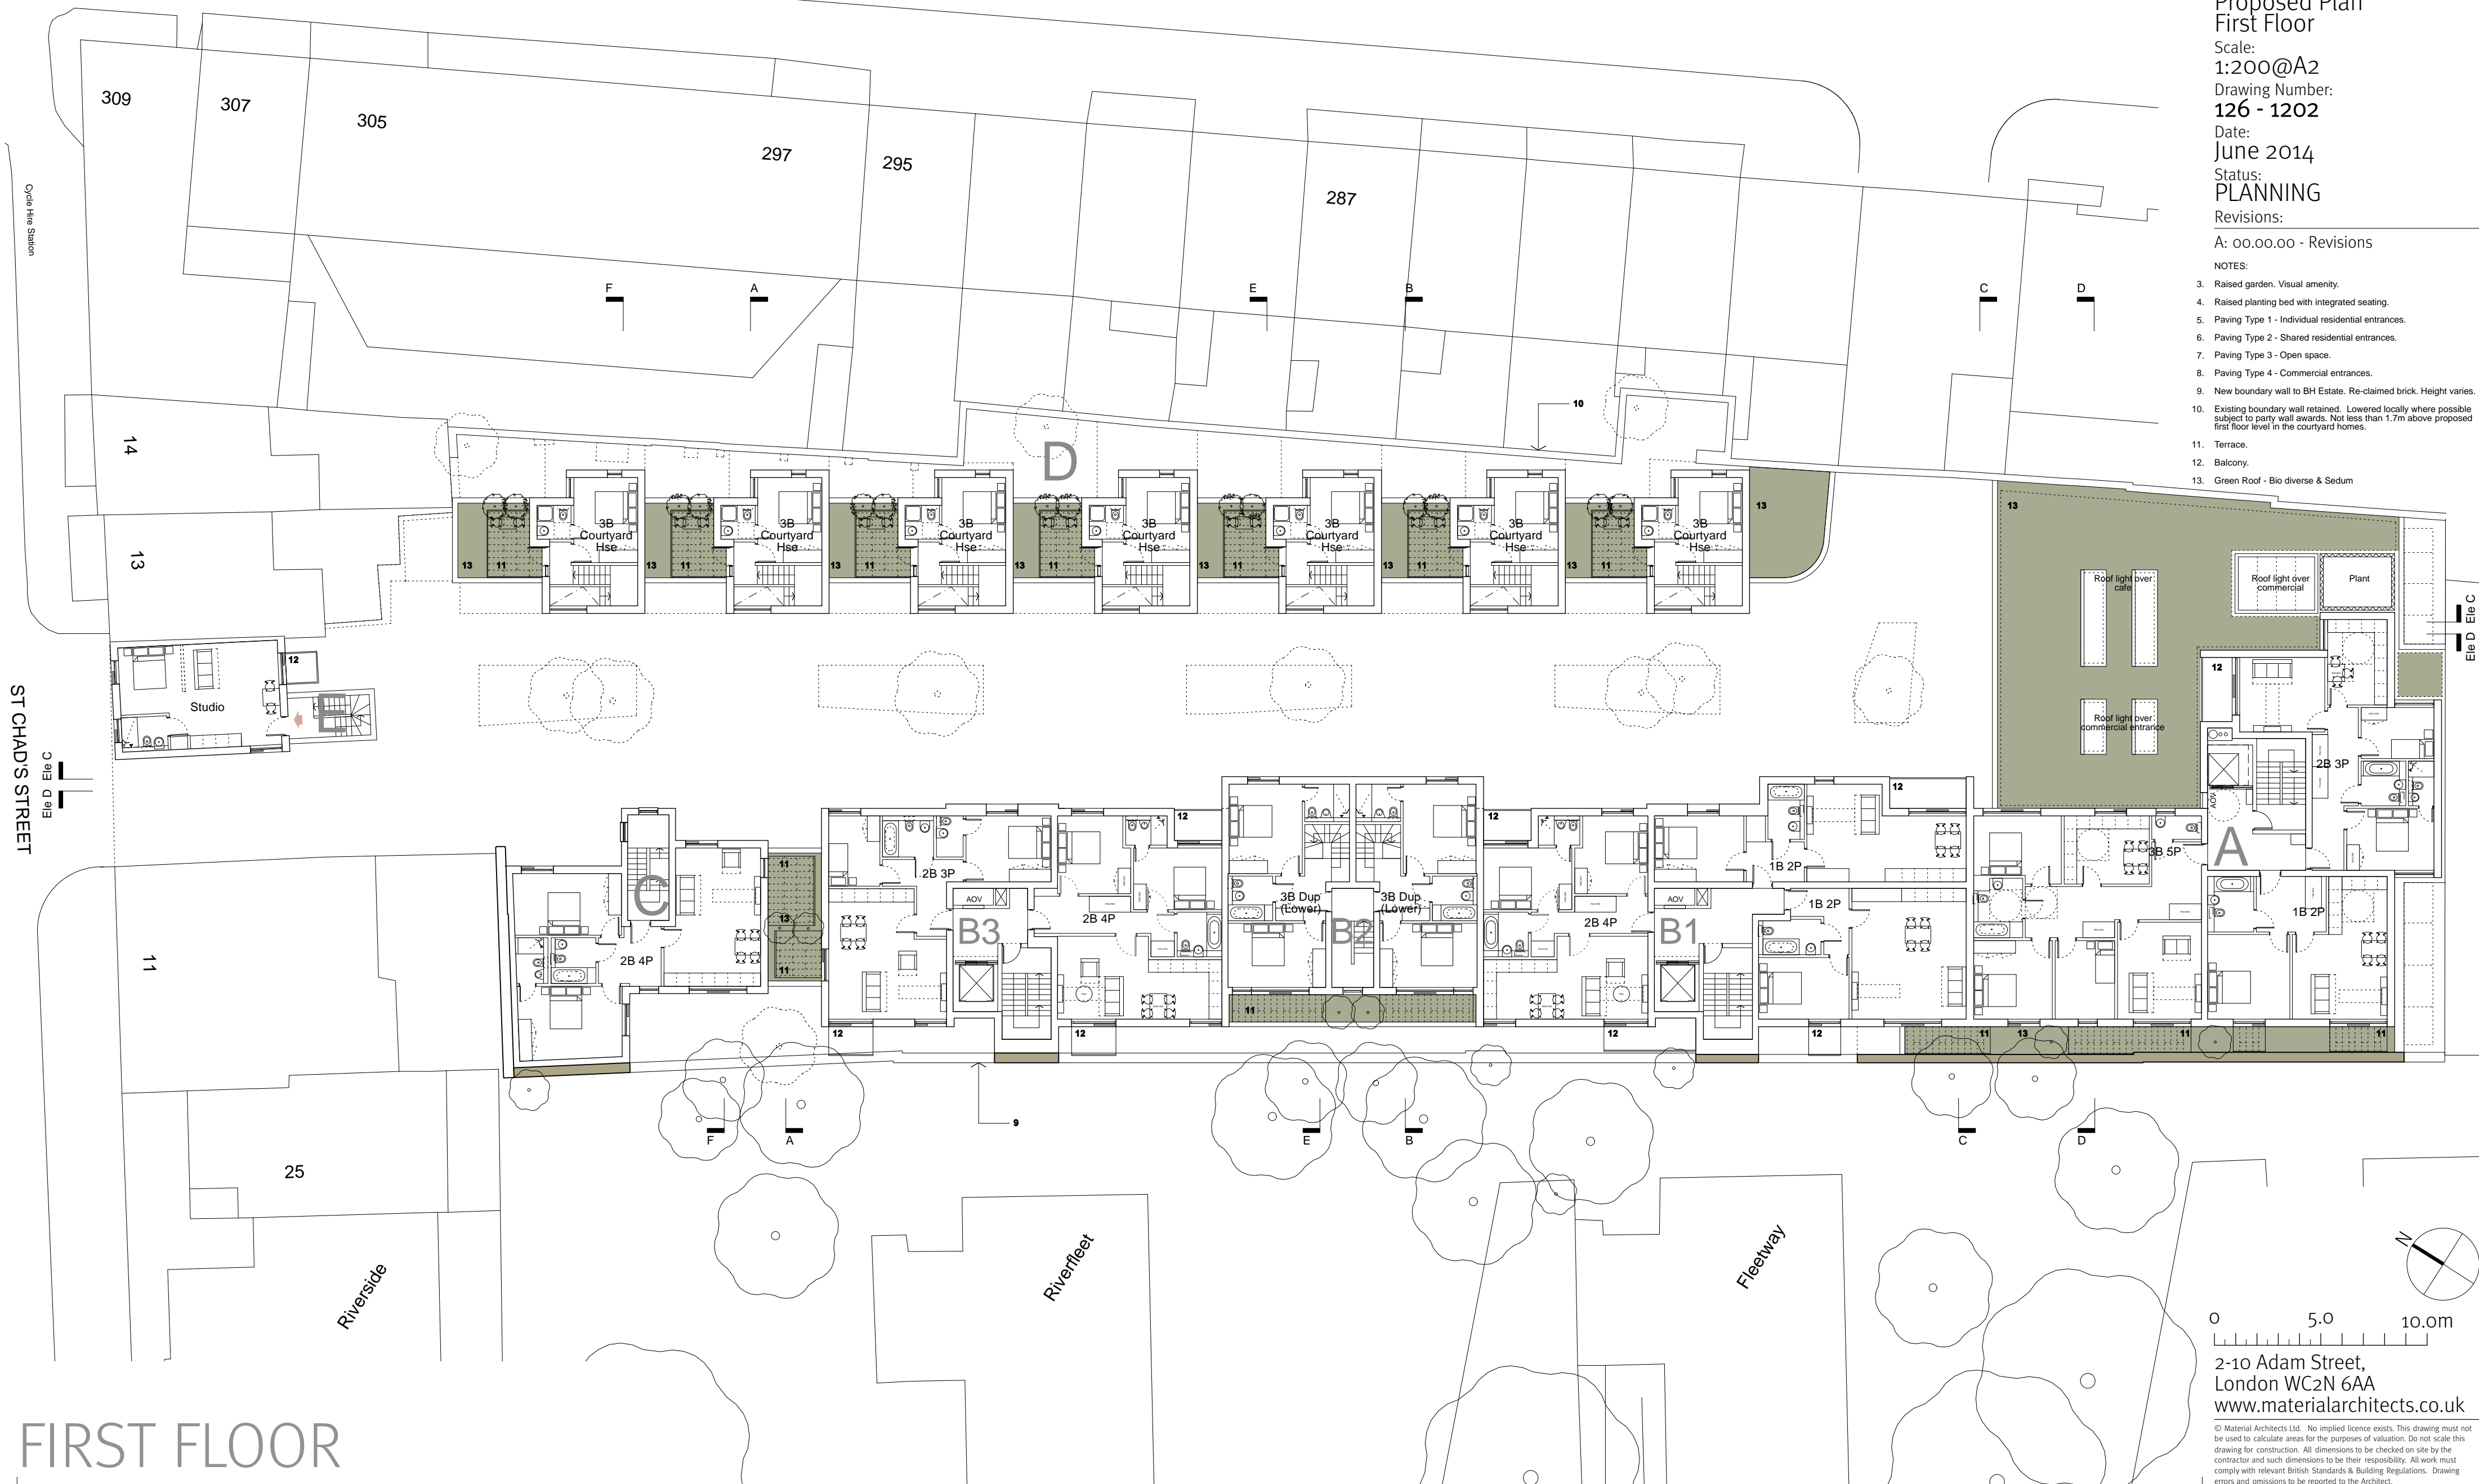
FIRST FLOOR

Project:  
277a Grays Inn Road  
Drawing:  
**Proposed Plan**  
First Floor  
Scale:  
1:200@A2  
Drawing Number:  
**126 - 1202**  
Date:  
June 2014  
Status:  
**PLANNING**  
Revisions:  
A: 00.00.00 - Revisions

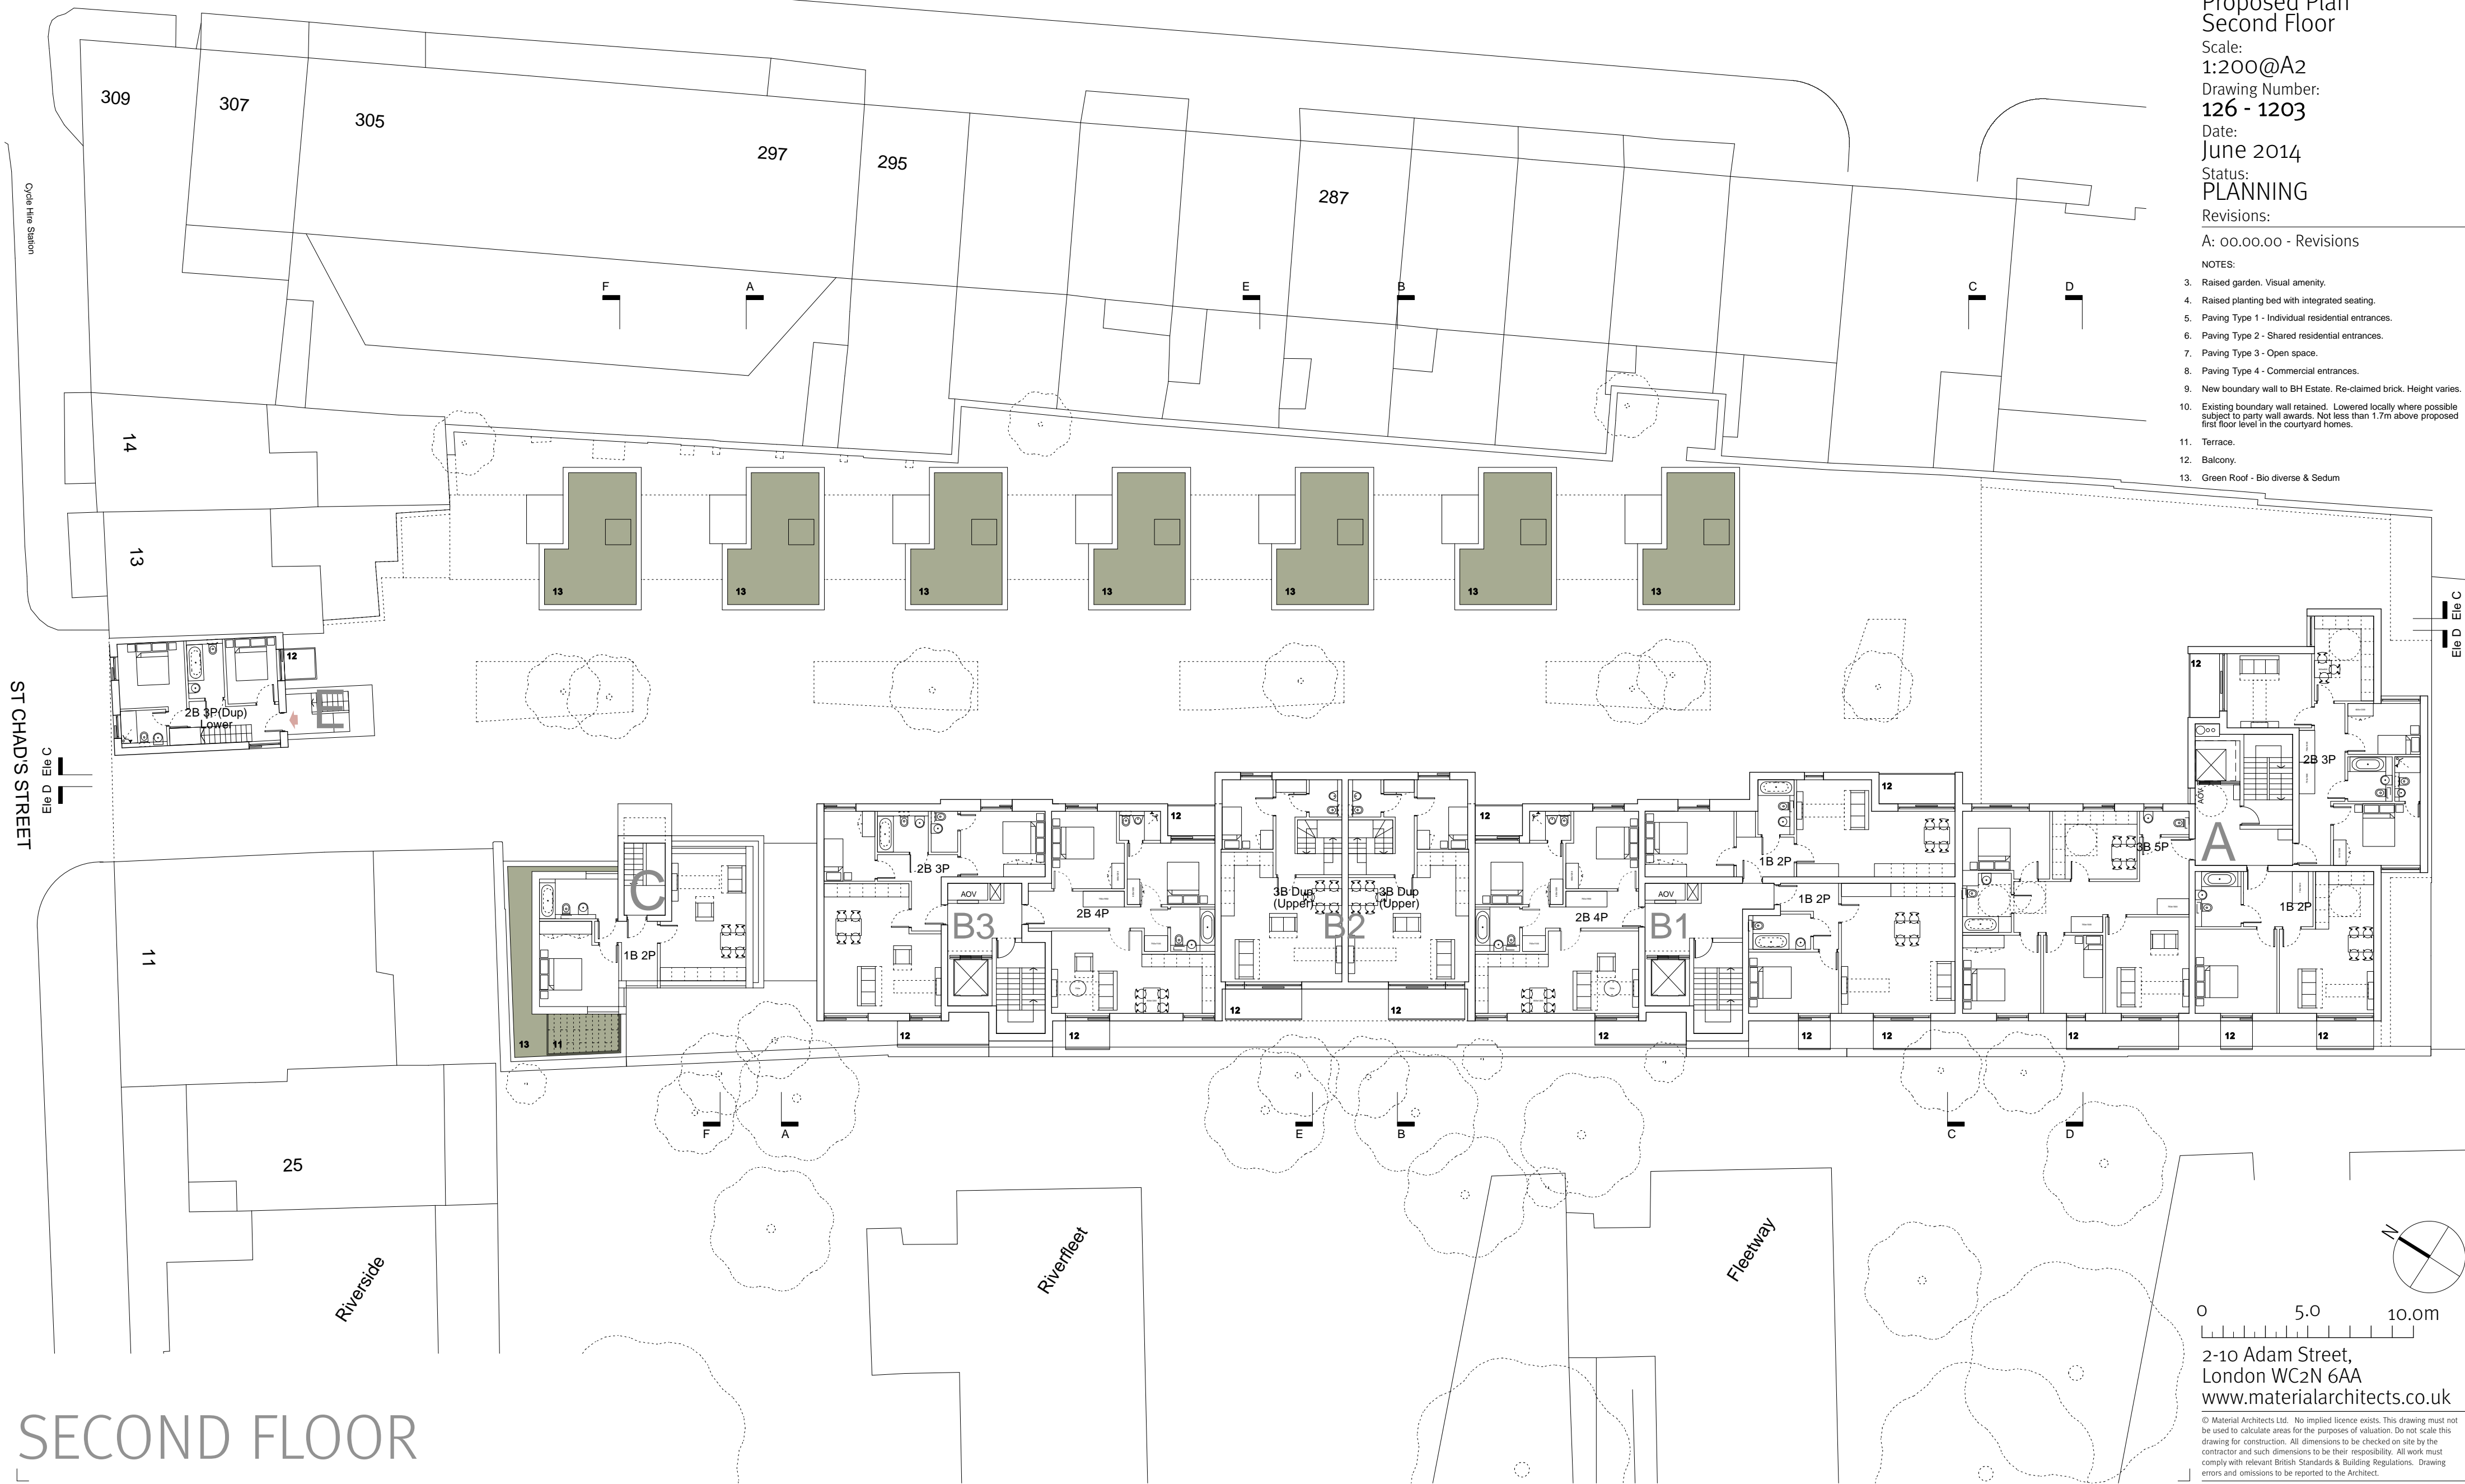
SECOND FLOOR

Project:  
277a Grays Inn Road  
Drawing:  
Proposed Plan  
Second Floor  
Scale:  
1:200@A2  
Drawing Number:  
126 - 1203  
Date:  
June 2014  
Status:  
PLANNING  
Revisions:  
A: 00.00.00 - Revisions

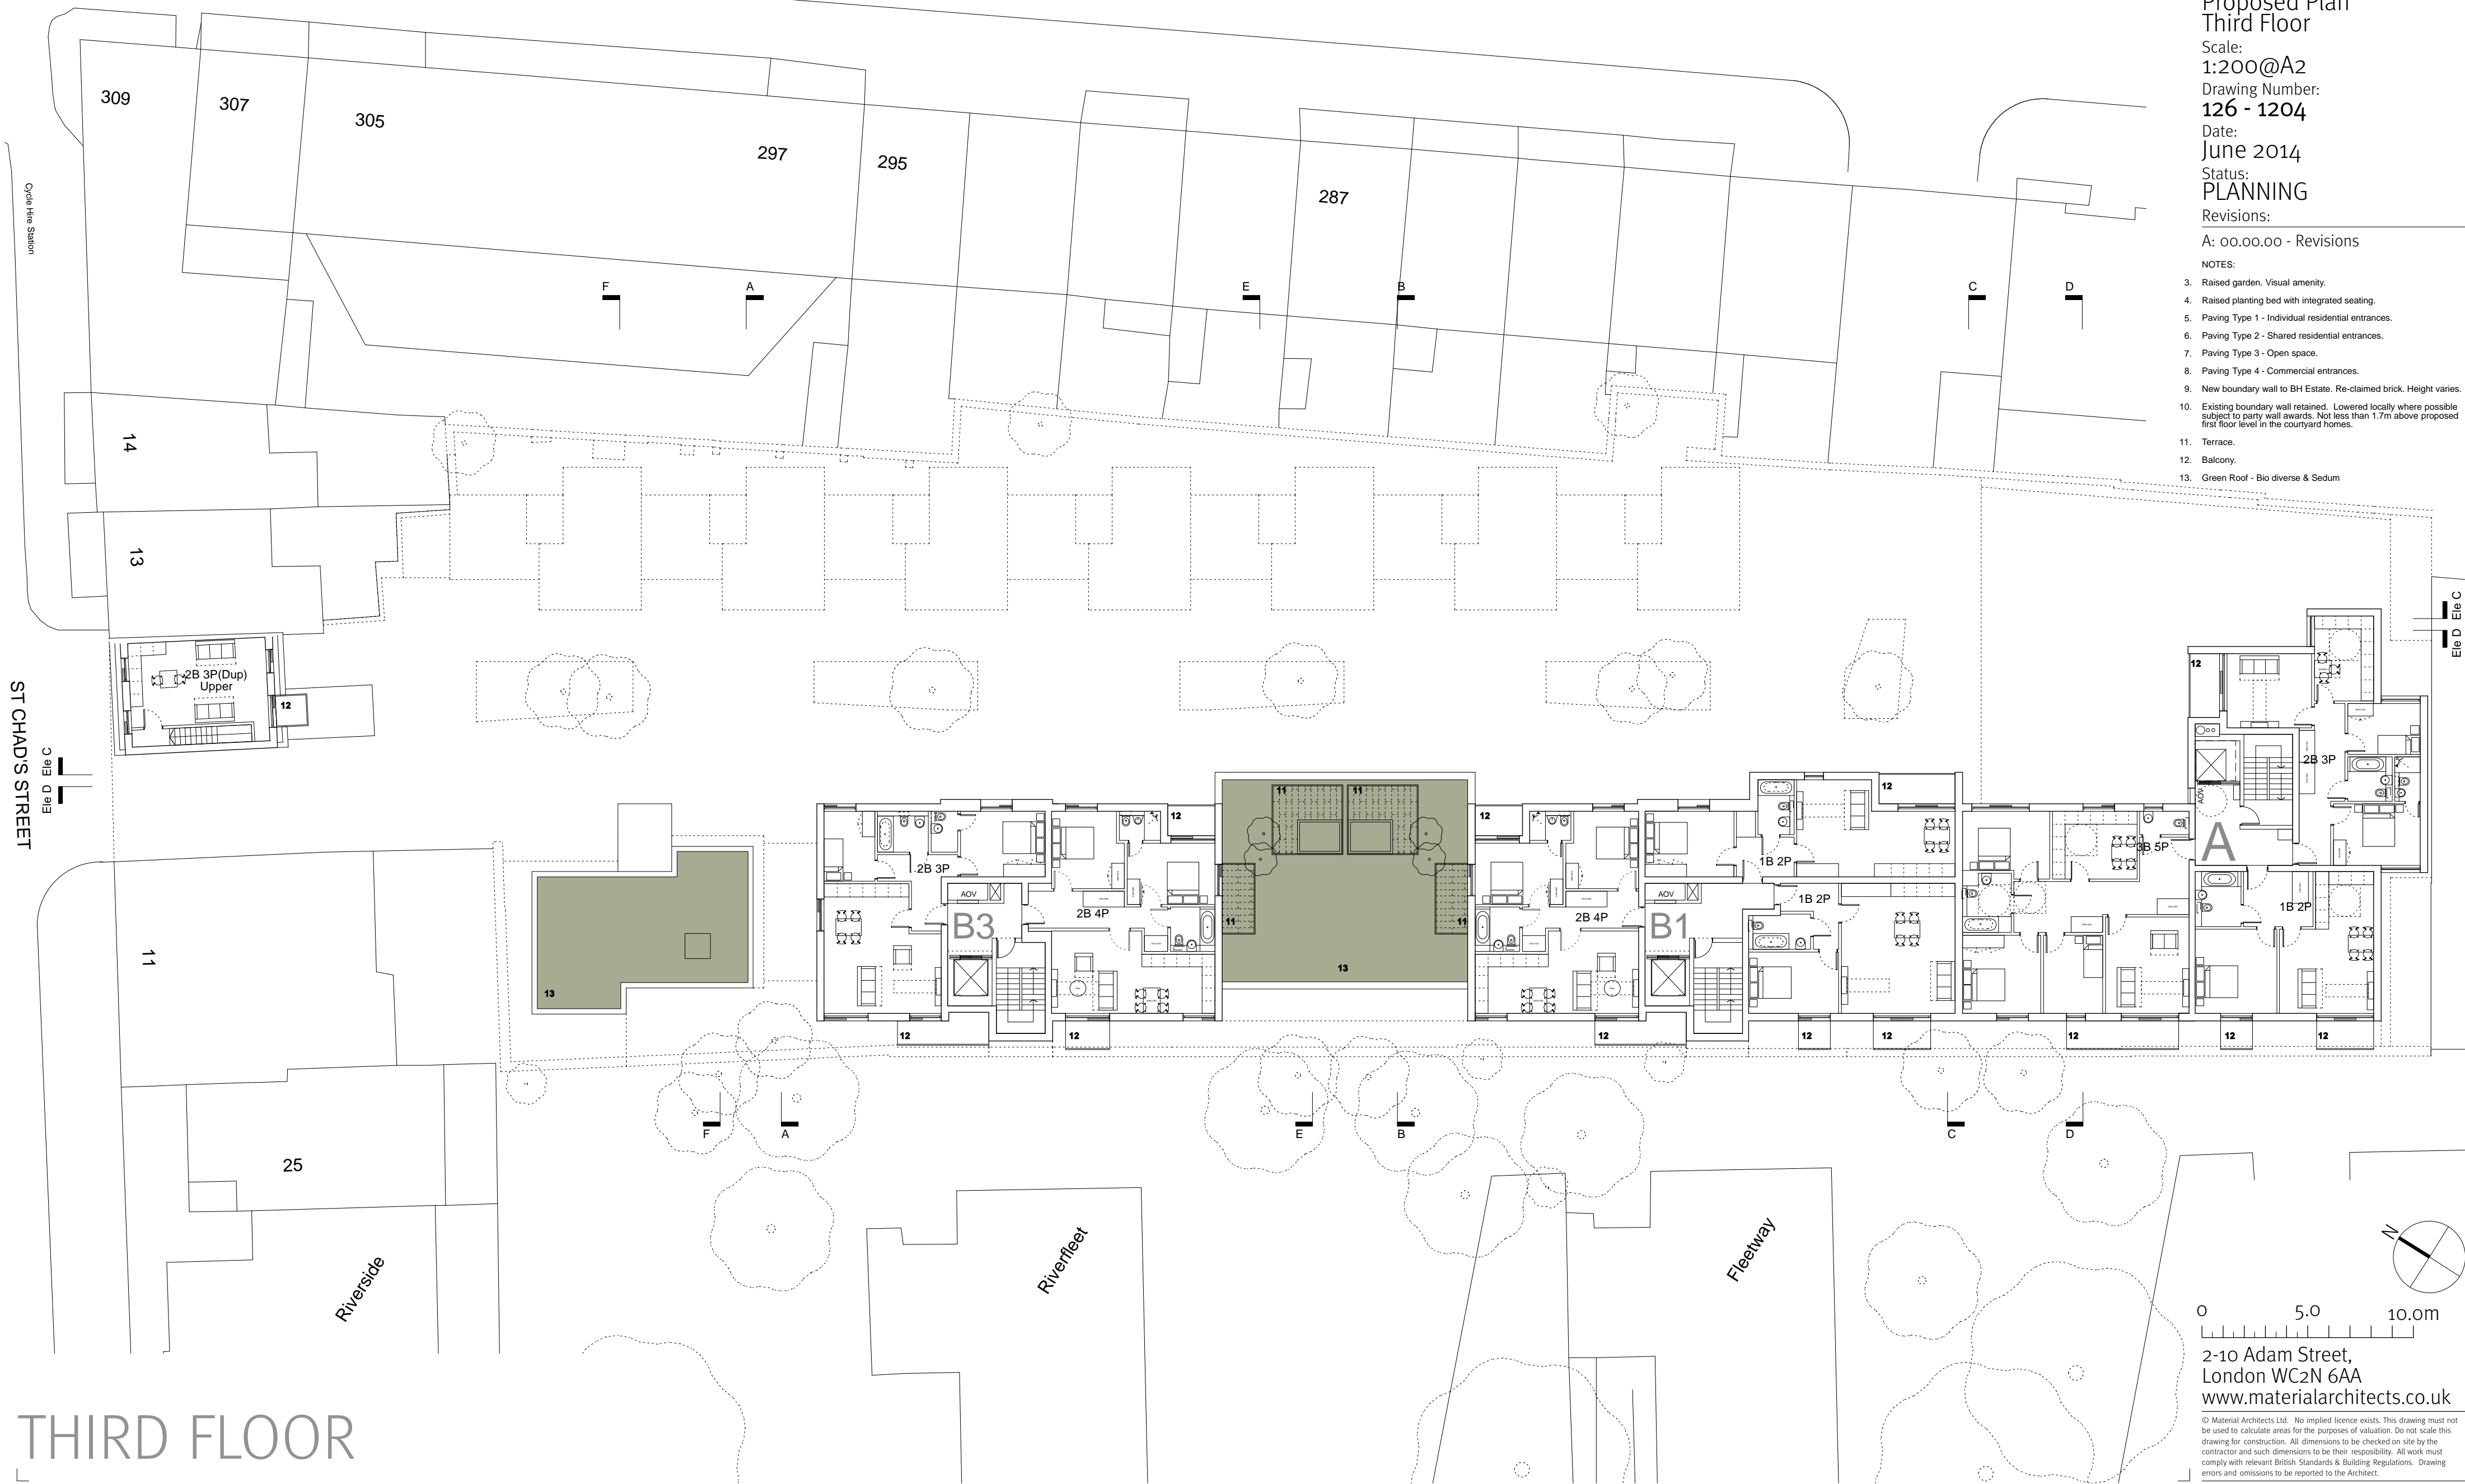
THIRD FLOOR

Project:  
 277a Grays Inn Road  
 Drawing:  
**Proposed Plan**  
**Third Floor**  
 Scale:  
 1:200@A2  
 Drawing Number:  
**126 - 1204**  
 Date:  
 June 2014  
 Status:  
**PLANNING**  
 Revisions:  
 A: 00.00.00 - Revisions

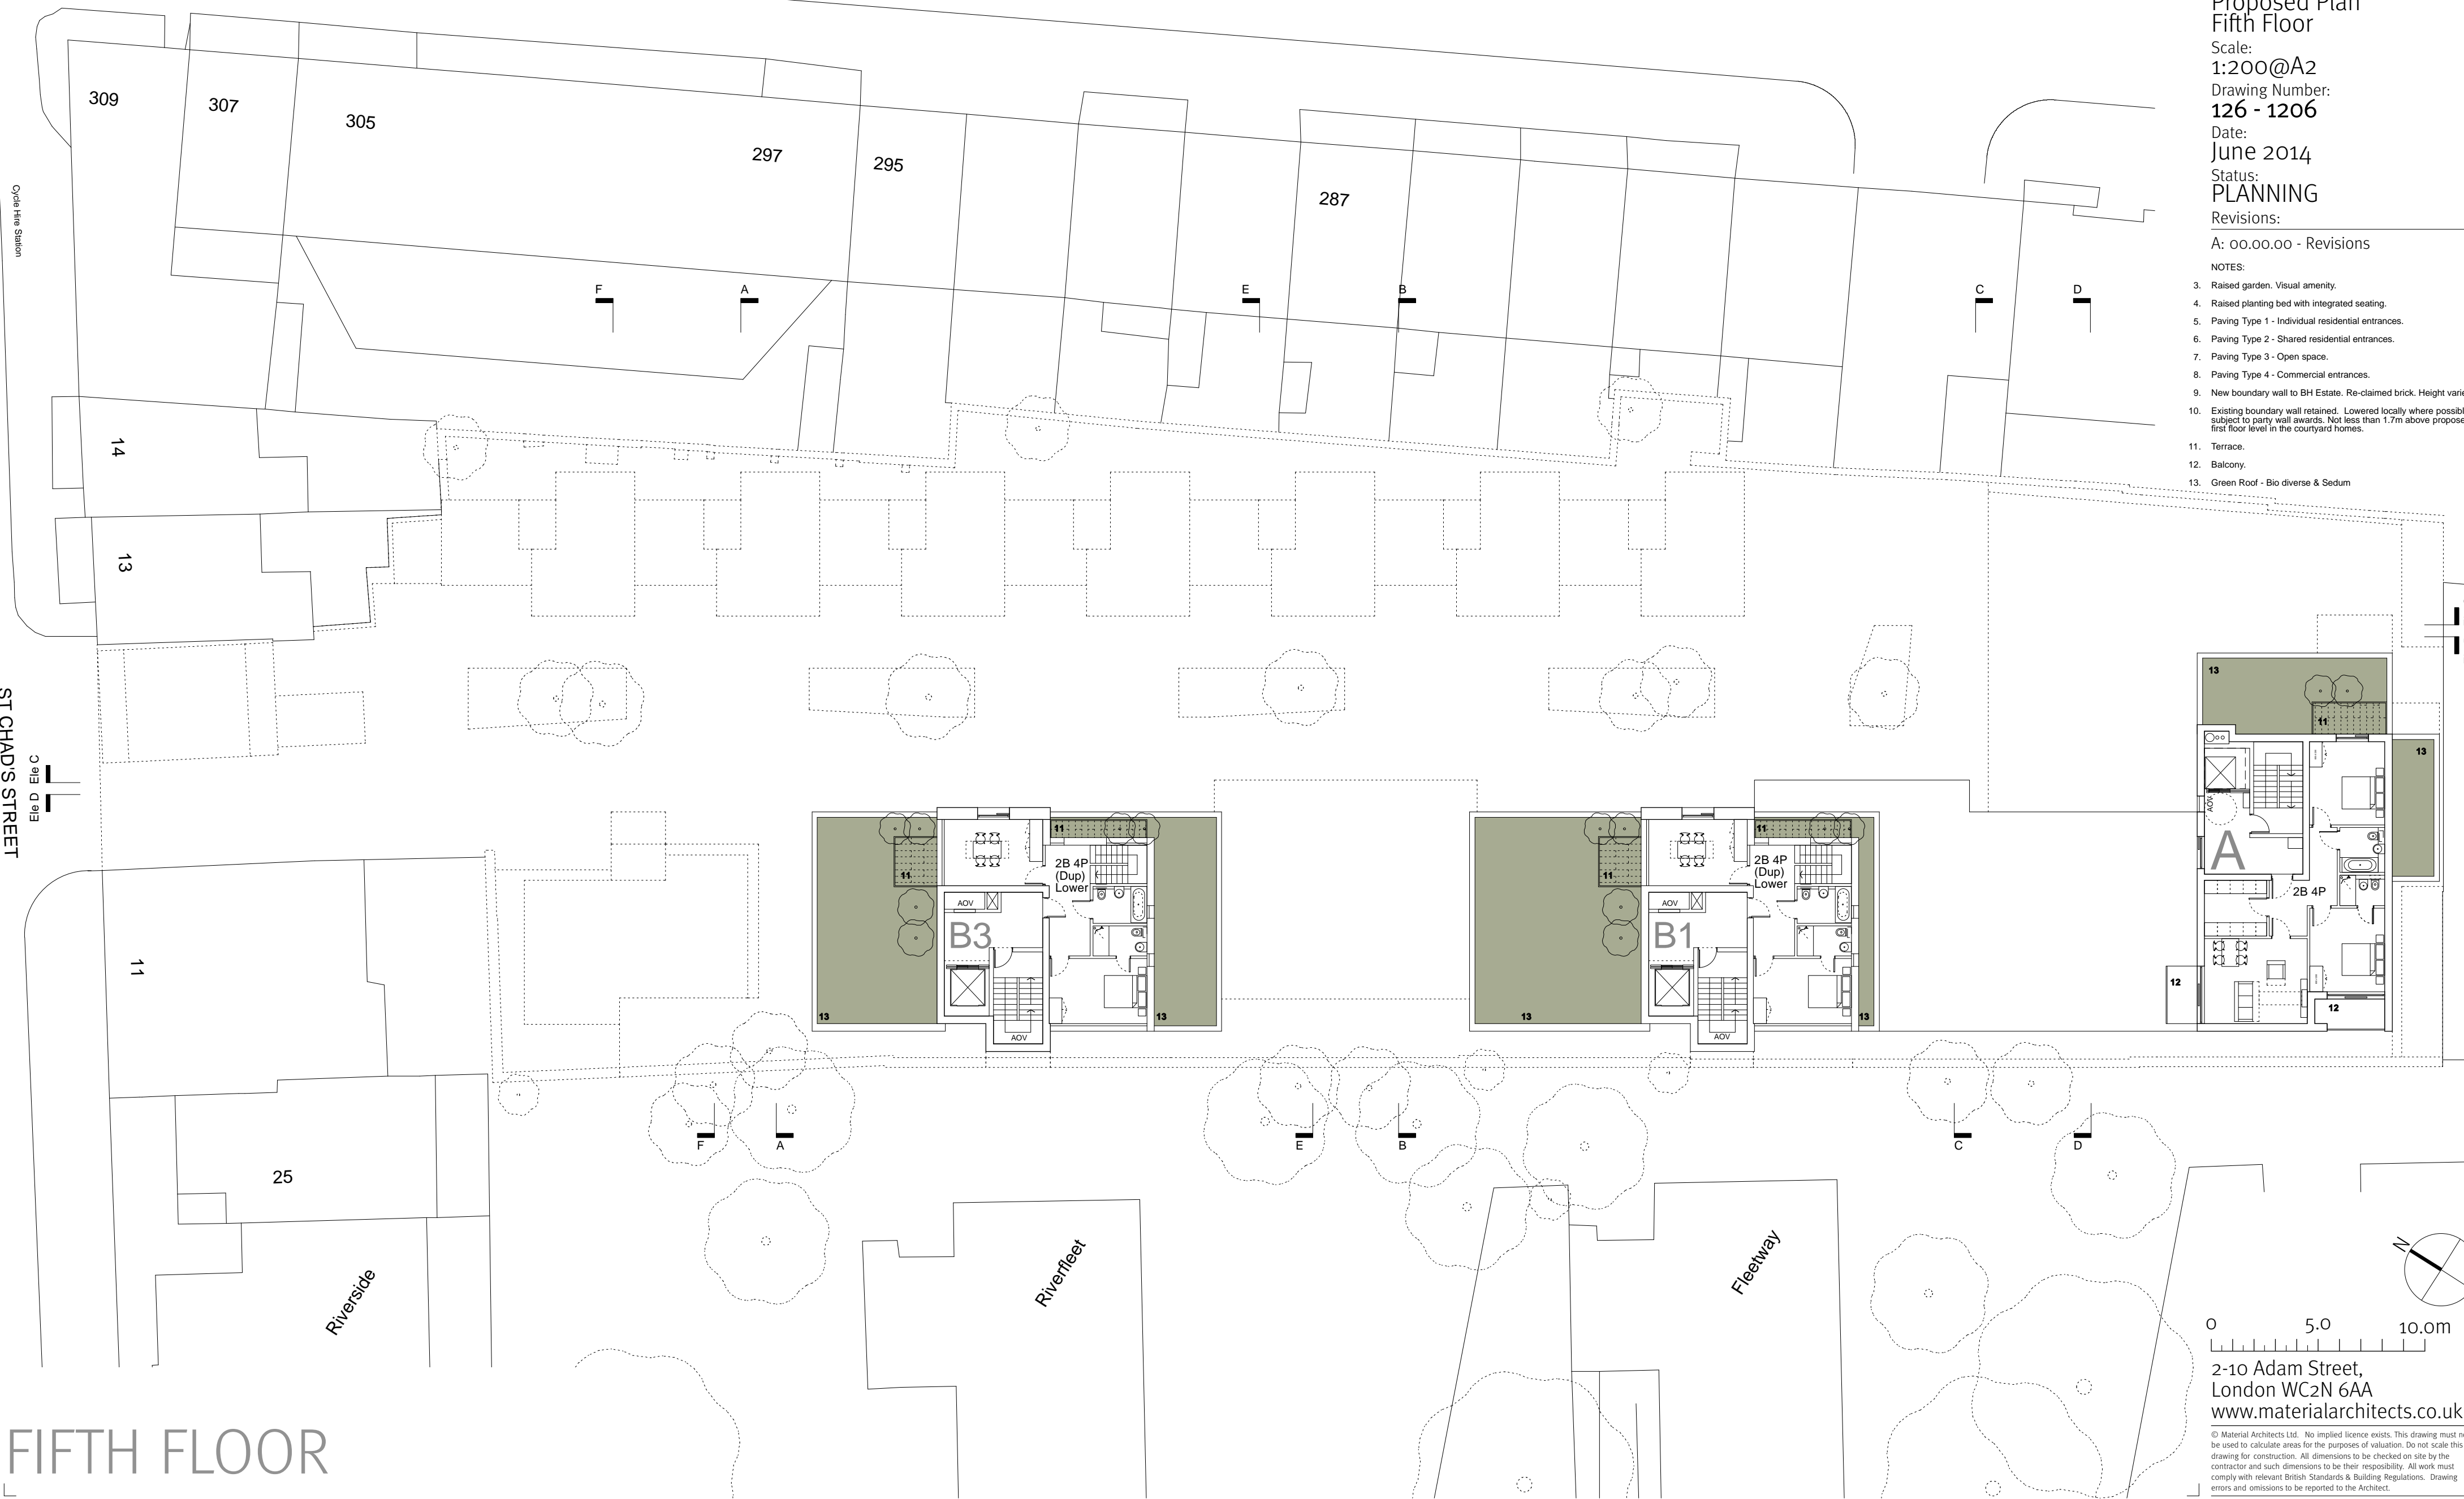
FIFTH FLOOR

Project:  
277a Grays Inn Road  
Drawing:  
Proposed Plan  
Fifth Floor  
Scale:  
1:200@A2  
Drawing Number:  
126 - 1206  
Date:  
June 2014  
Status:  
PLANNING  
Revisions:
