**Phase 2a Site Investigation and GQRA**

**277a Gray's Inn Road  
London  
WC1X 8QF**

**(Ref. TJ2824AR1v1.0)**

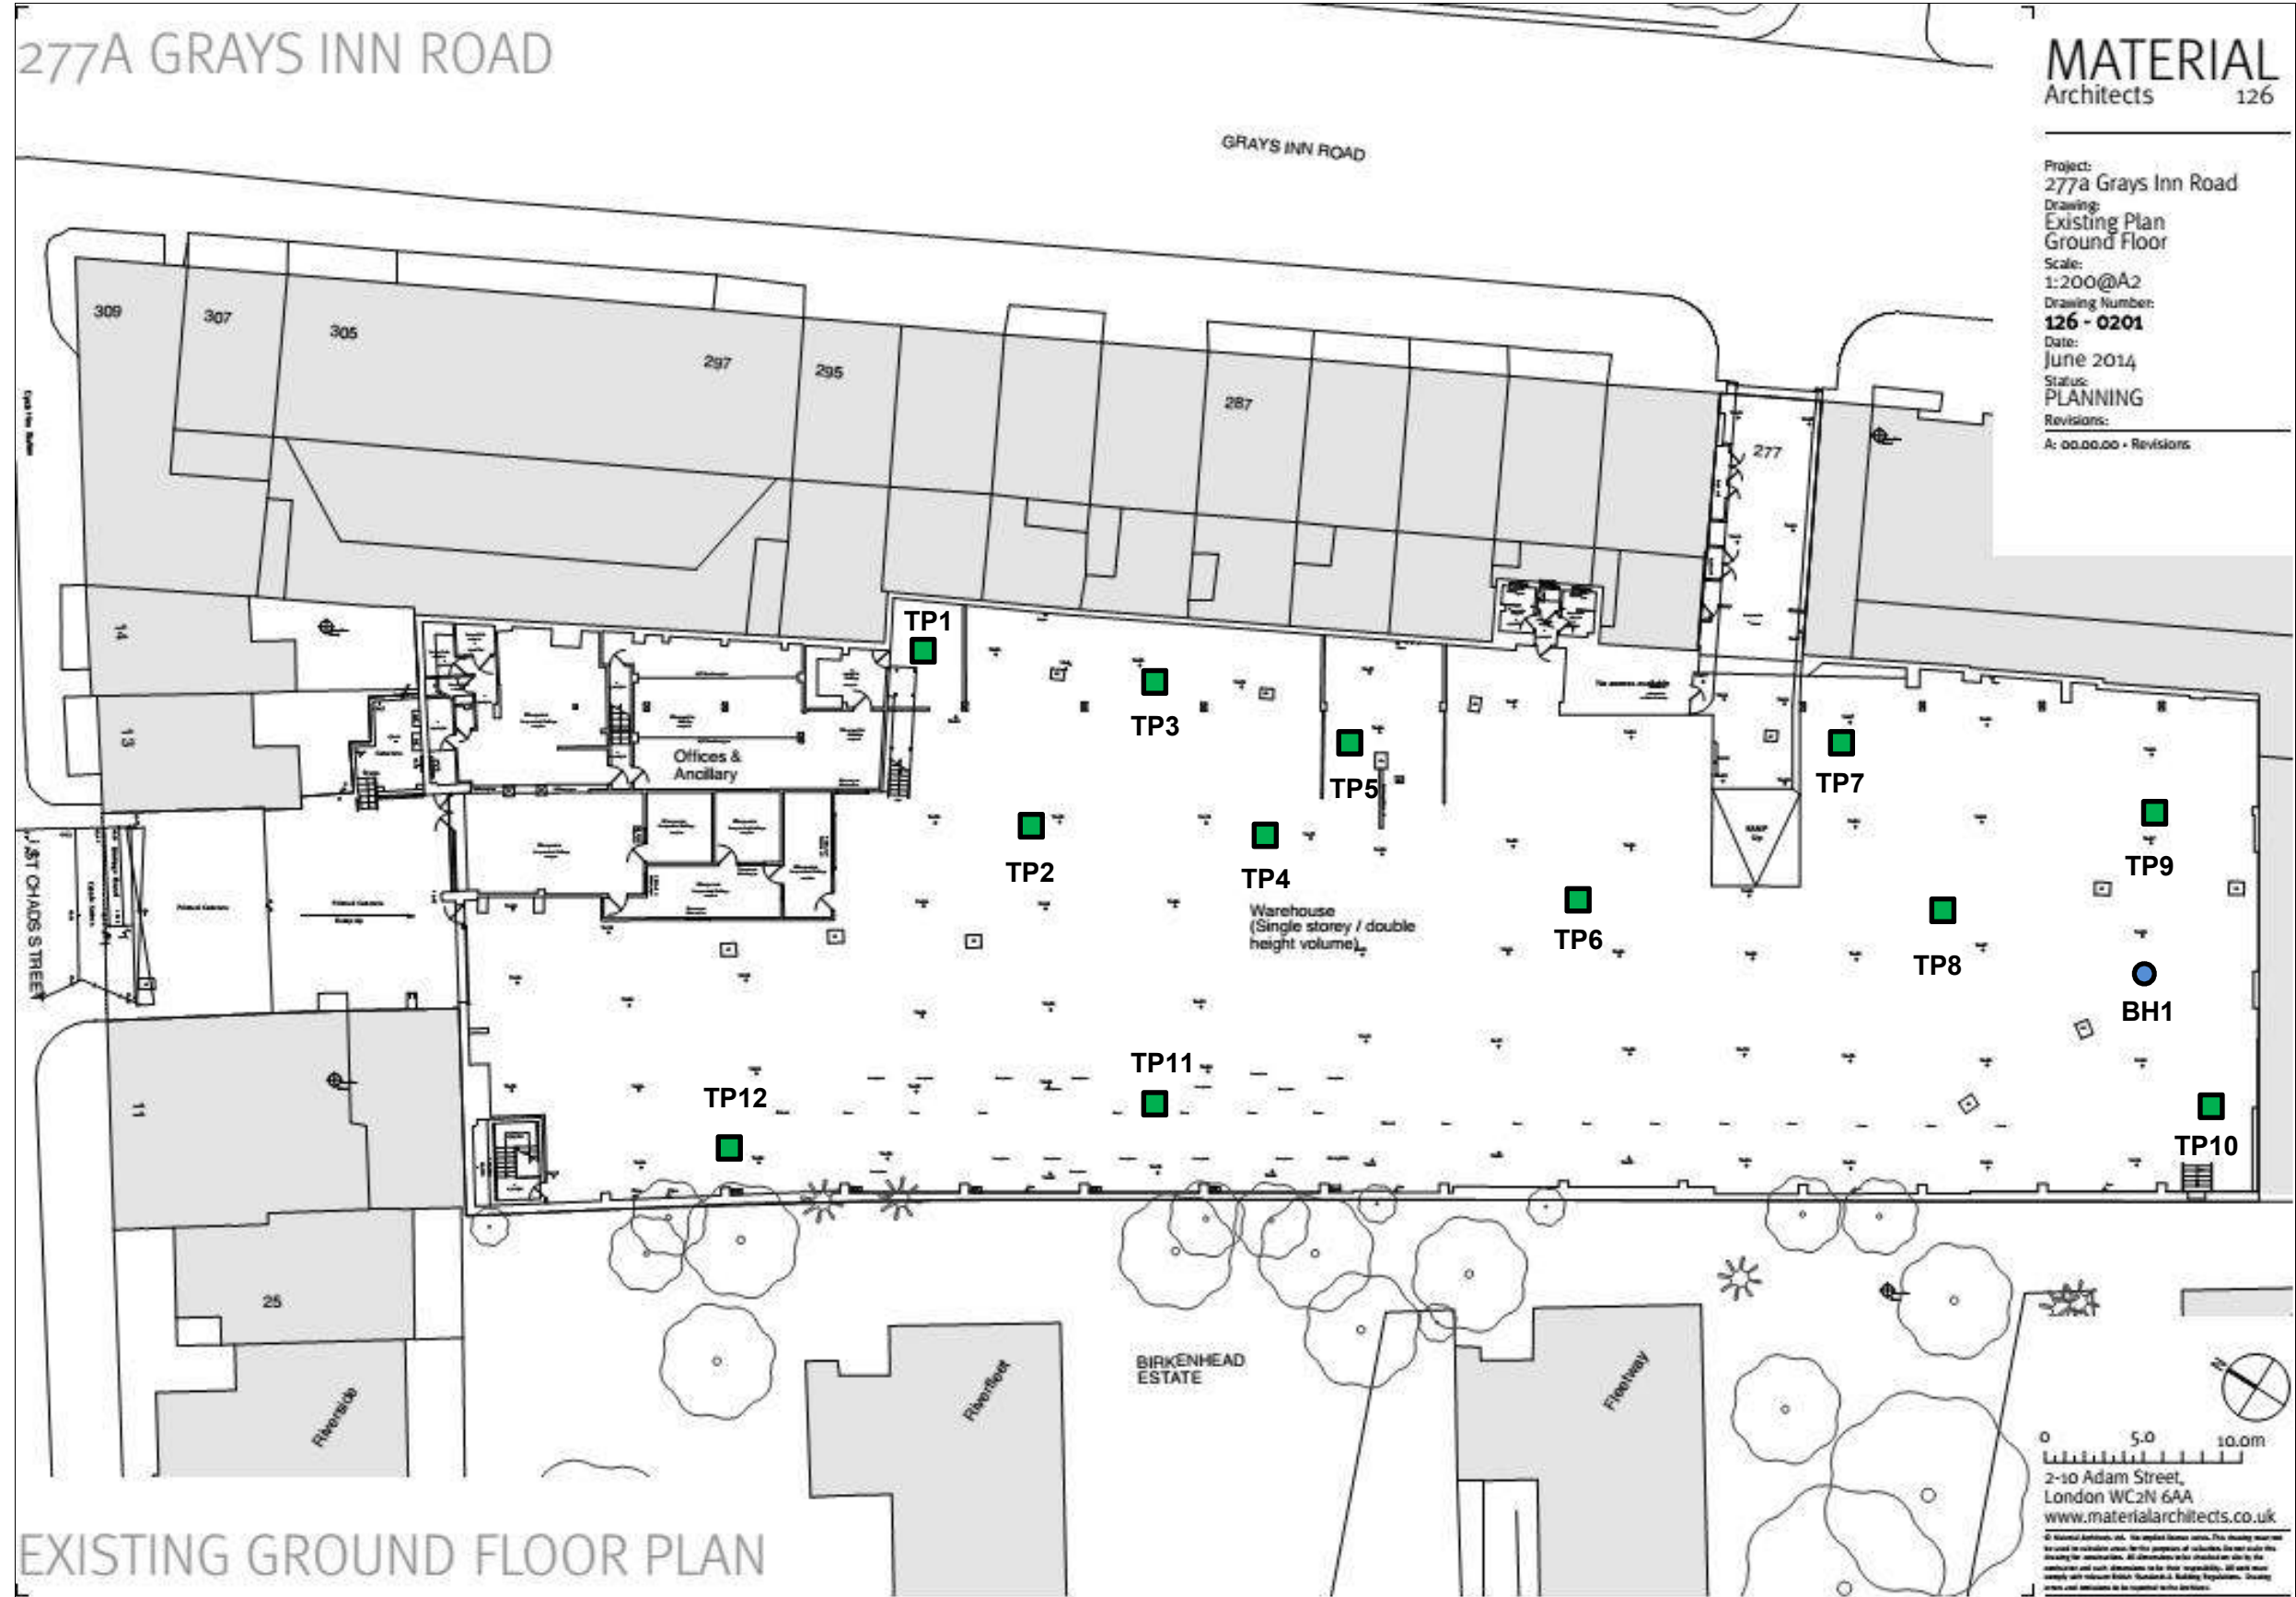
### Exploratory Hole Location Plan

The locations for the investigation were scanned with a CAT in order to minimise the risk of damage to underground services. Where necessary, the final positions of the exploratory holes were moved in order to avoid buried services. The intrusive investigation was subsequently carried out in accordance with BSI (2013b) on 09/12/2104. An annotated exploratory hole location plan is presented in Figure 3.

There was a thick layer of reinforced concrete across the entire site. The only exceptions to this were at TP8 and TP9 where the ground surface had been previously disturbed and broken out, presumably in connection with a previous investigation. Below the hardstanding was a circa 2.1m thick layer of made ground. In general, the made ground comprised a layer dominated by rubble (MG2) with a deeper layer of sandy, gravelly silt (MG3).

There was no visual or olfactory evidence of significant hydrocarbon contamination, which was corroborated by in-situ VOC headspace readings using a PID. At several locations fragments of cement bonded tile, pieces of insulation board or lagging (suspected ACM) was noted within the layer of rubble dominated made ground (MG2).
