BASEMENT IMPACT ASSESSMENT

47 DOUGHTY STREET, LONDON, WC1N 2LW

39053-01

December 2016

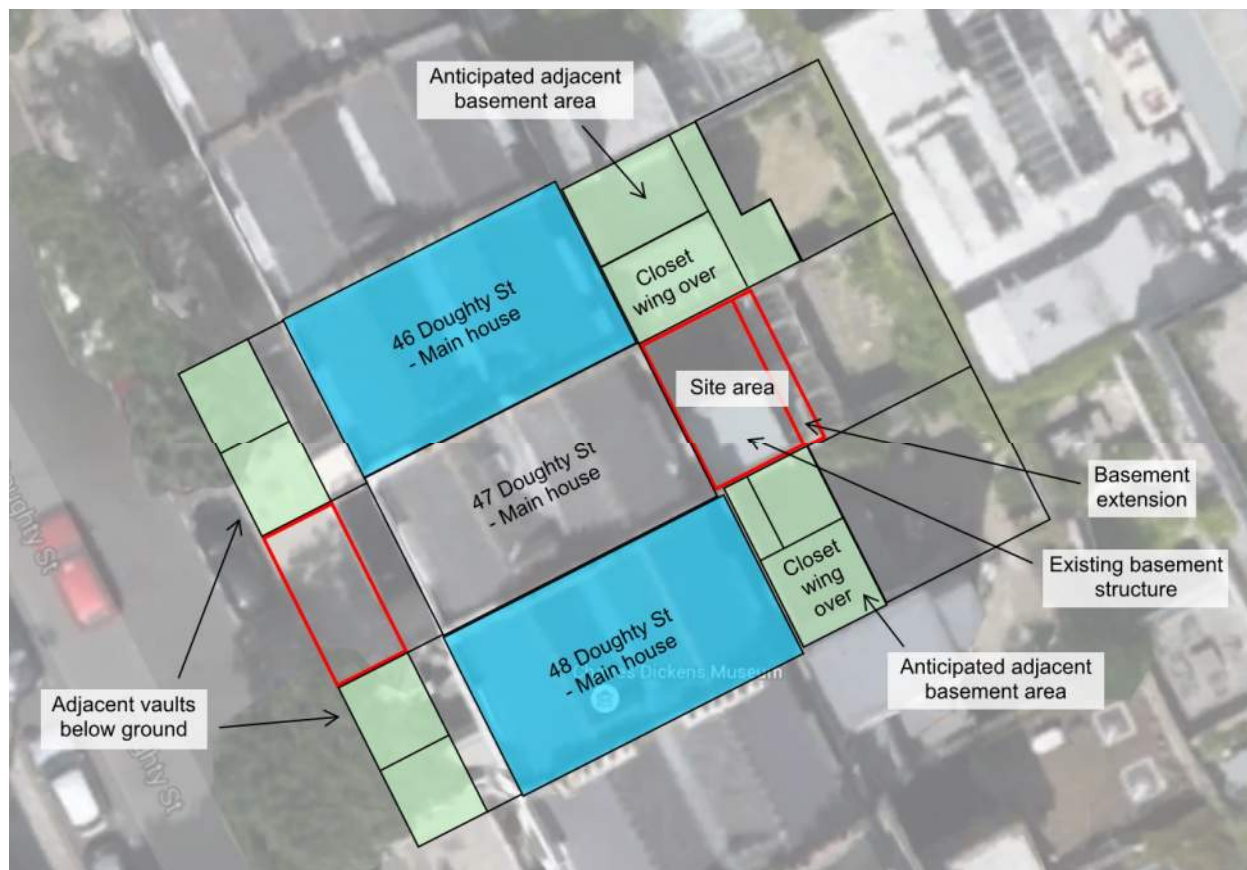
Figure 1 : Structures surrounding the site

The diagram below shows the site in the context of the surrounding structures:

The site investigation results show that the existing structures at the rear of the house are founded on Made Ground, including at least the rear wall of the main house, the closet wing, the garden walls and 21a Brownlow Mews to the rear. Despite this, no significant detriment to the structure due to ground movement was apparent on the site walk around.
