TITLE:
Generic Details for Timber Joists Vulnerable/Subject to Decay

PROJECT:
**Project No:11581
Kidderpore Avenue**

9100-DRG-00YY-DE004 B

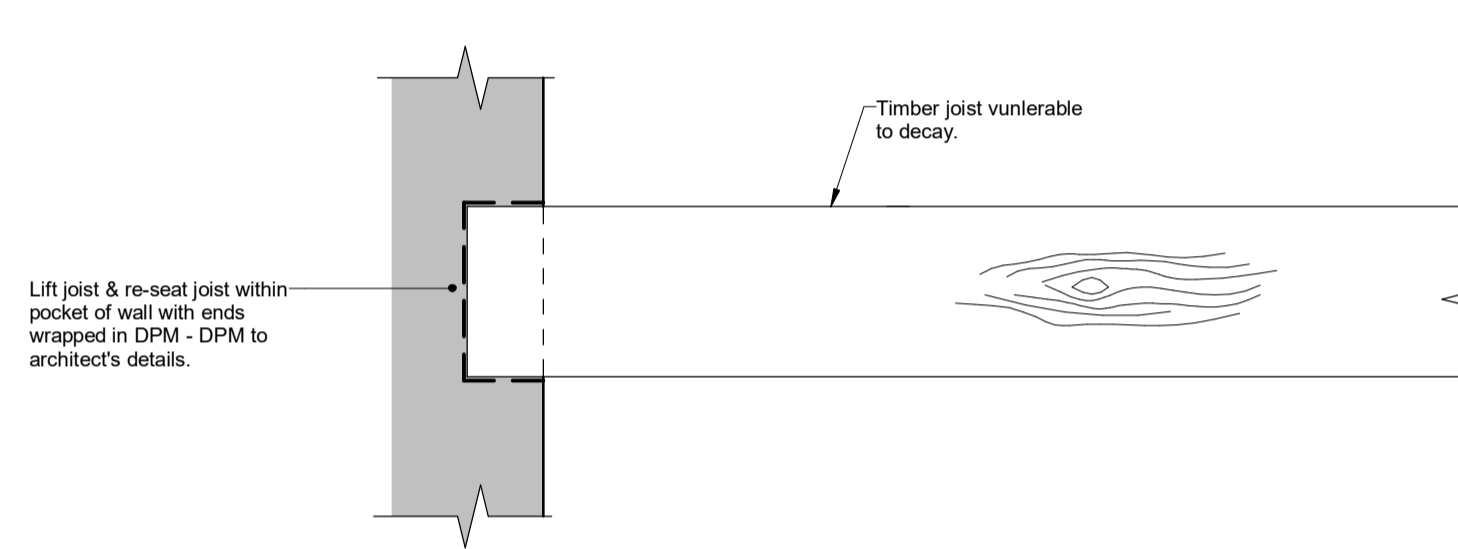
Detail 4: Protection to End of Timber Joist Where Vulnerable to Decay: Option 1
scale 1 : 10

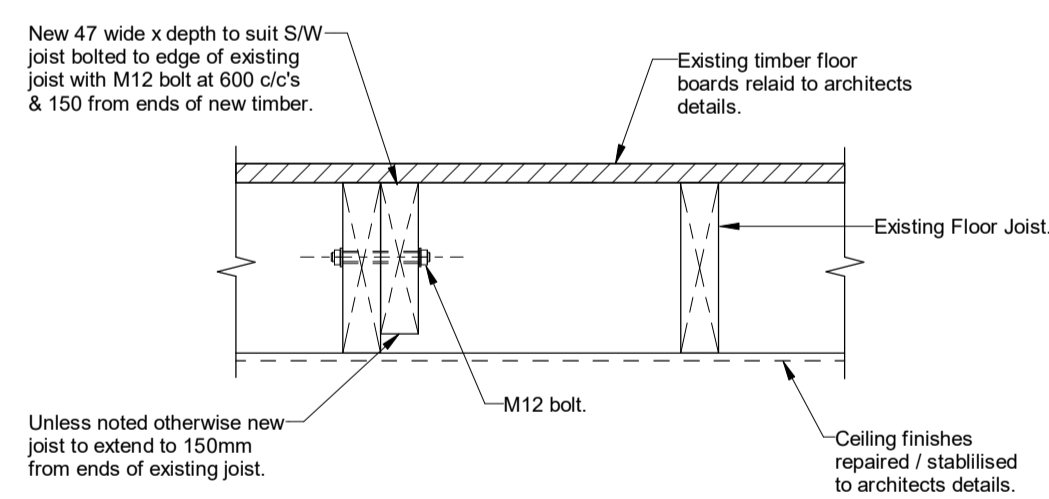
Detail 6: Double Up Floor Joists
scale 1 : 10
