2 Dormer Visibility Study
016

3 Rear Elevation
016

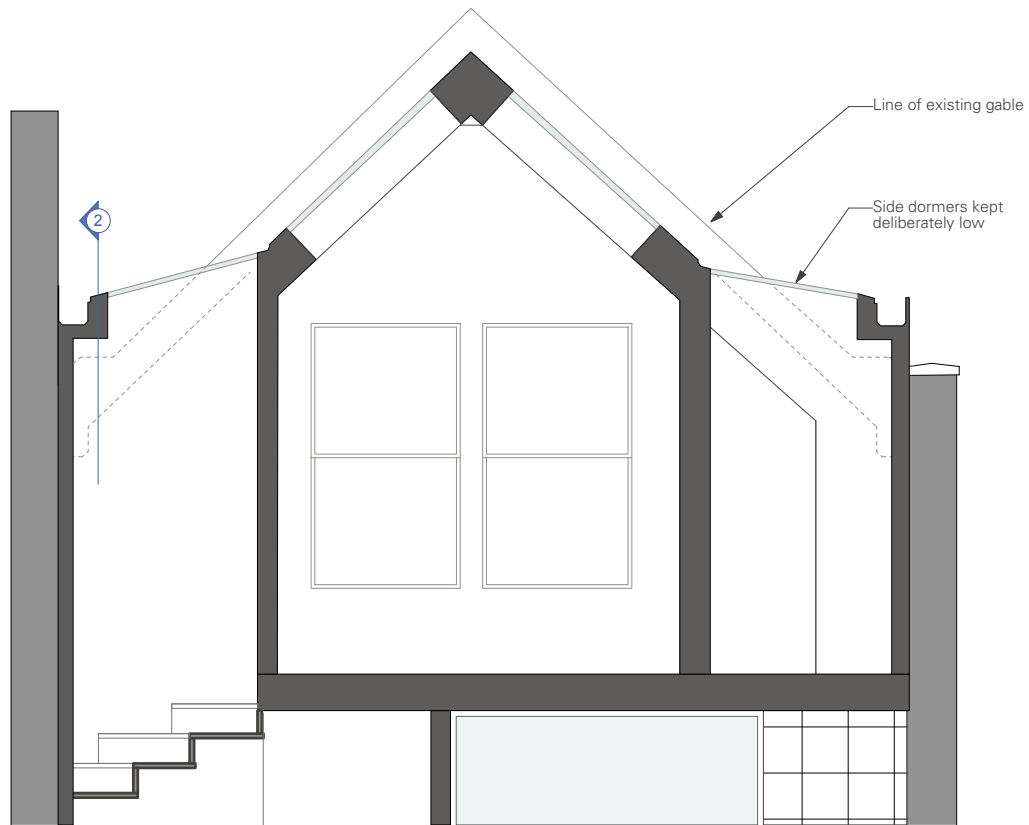
1 Rear Top Floor Section
016

NOTE
Visibility from the rear elevation is screened by the reinstated gable end to the property and the existing party wall between Hillview and Lakeview. Side dormers kept deliberately low

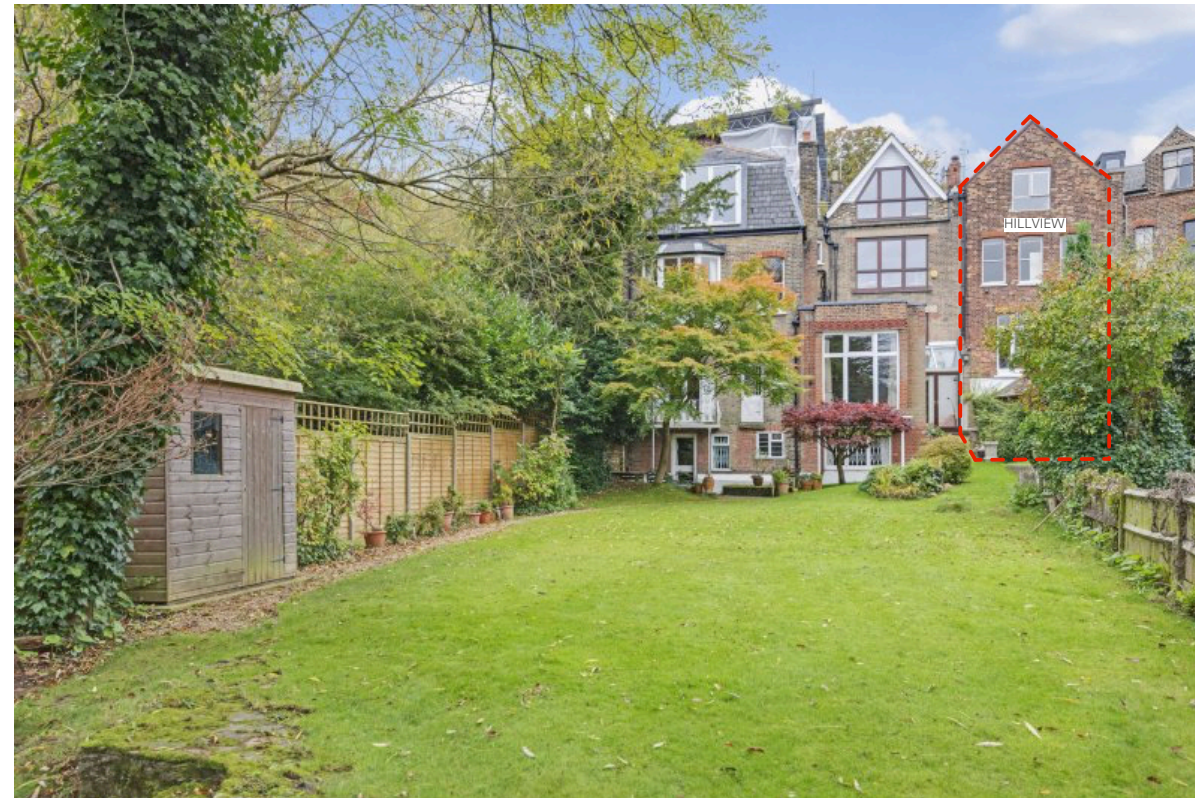
Image from property website that shows the rear elevation of the terrace properties. Note this is on adjoining property that stretches further than that of Hillview towards the pond.
