# SITE SURVEY REPORT

CLIENT: KIM ROBSON, 44 QUEENS GROVE NW8 6HH LONDON  
FRONT AND REAR GARDEN

REF: SITE PLAN - DATED 30/9/16  
REF: PRELIMINARY SERVICES PLAN DATED 6/10/16

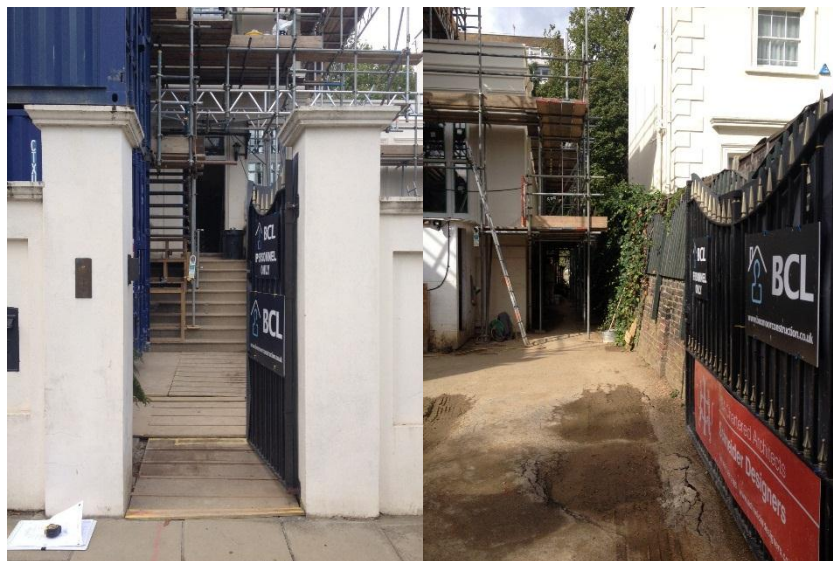
Pedestrians gate is 1160mm wide and on both side has 2.55m height pillars. Gate is metal.

Vehicular gate is metal and 3.47mm wide and also supported on 2 pillars. Gates open in single way to RHS.

Photos showing existing front gates.

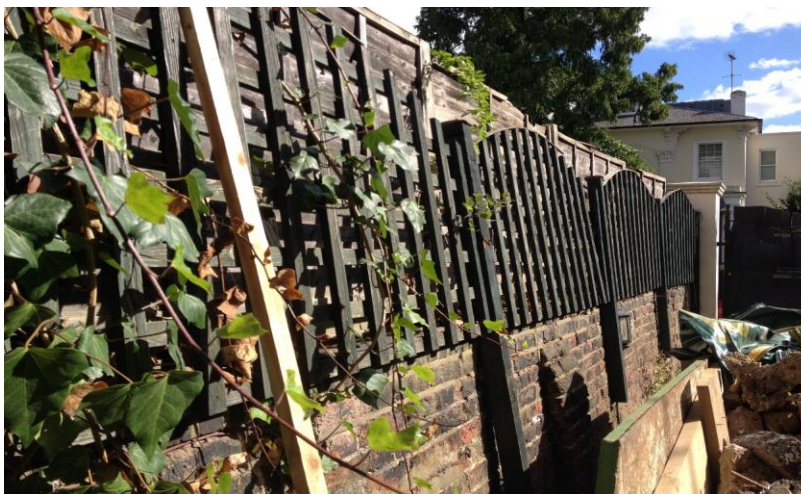
Side alley brick wall is in bad condition as well as front part. It requires immediate repairs before it will collapse and make more damage.

Picture showing existing front LHS brick wall.

Recommendations: To replace old brick wall with new one on front and side alley part to match old look.

- 4.8 To rebuild Western boundary wall with matching reclaimed bricks and bond up to rear edge of house. (A trellis would be potentially advised to sit on top of this wall to allow for climbing plants to aid seclusion and security).

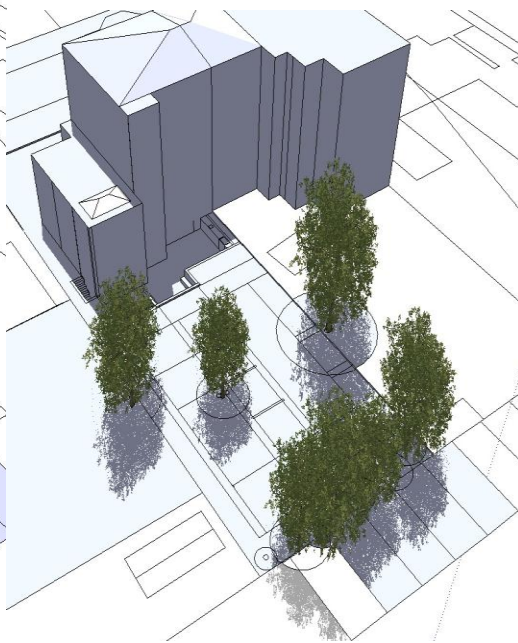
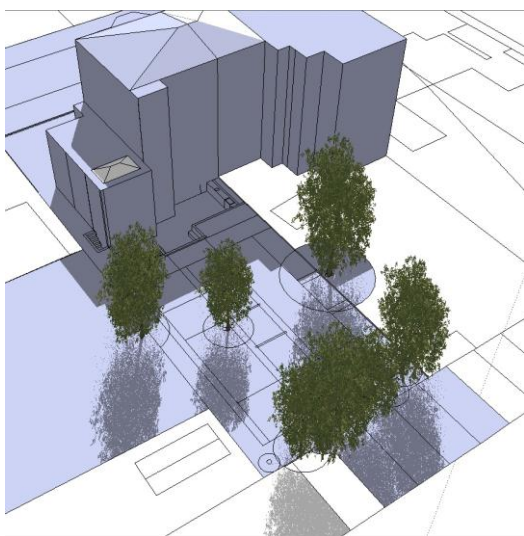
- Sun chart- rear garden

21<sup>st</sup> March at 12\_Noon.

22<sup>nd</sup> June at 12\_Noon

23<sup>rd</sup> September at 12\_Noon

22<sup>nd</sup> December at 12\_Noon
