Drawn By MBD Date	Client Mr R Harding		
June 2016 Scale 1:20	<sup>Job Title</sup> 61 Neal Street, Grd Flr Extensi London	on	
Plot Date July 2016 File Name C copyright : MD DESIGN ASSOCIATES 1998 Note:	Drawing Title First Floor Principle Front Room Existing Wall Elevations		DESIGN ASSOCIATES Architects & Designers
All dimensions must be checked on site and not scaled from this drawing.	Dwg. No. 2014211403/20	lssue	15 Swains Close Tadley, Hampshire R626 4NF Tel Nº 0118 9819631

Drawn By	MBD	
Date	June 2016	
Scale	1:20	
Plot Date	July 2016	
File Name		
Note: All dimens	ght : MD DESIGN AS ions must be checked o led from this drawing.

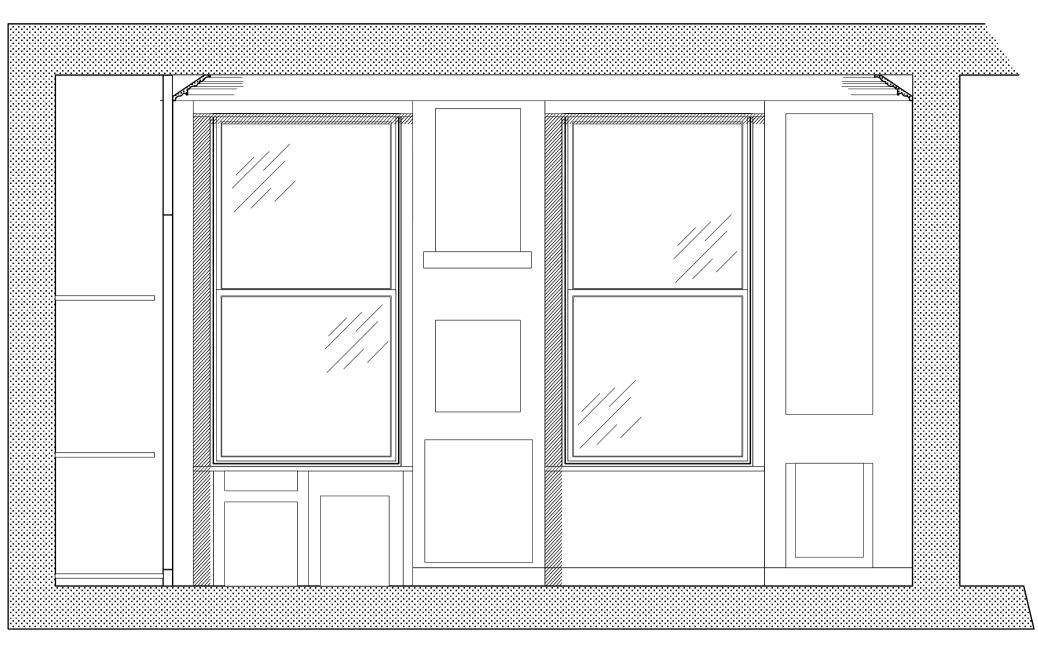
Window/Front Elevation

Original pine cupboard with timber internals
