Guildford Place - Ladies & Gents Toilets

Replacement glazed wall tiles

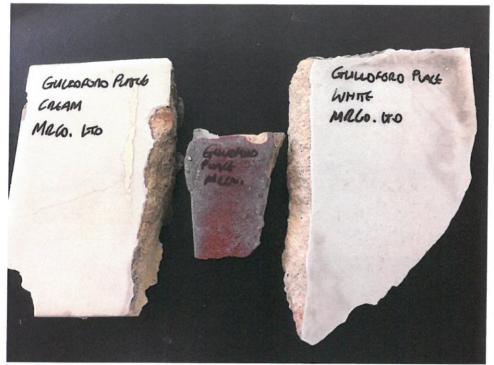
The standard tile size is 9" x 2 7/8" x <> 1" thickness. There are three colours, cream, brown and white. The thin glaze surface is on a soft biscuit base and shows signs of minimal surface crazing. The tiles do vary slightly in tone and I think if they decide to proceed, that replacements should include 3 slight tone variations of the cream and white and 2 slight tone variations of the brown.

Sample tiles enclosed

Our initial objective is to obtain costs from you to develop each of the three different coloured tiles in the 2/3 slight shade / tone variations measuring  $9 \times 27/8 \times 1/2$  inches in size, to include the  $9 \times 27/8 \times 1/2$  inch with a 2 % inch radius at one end. Could then give me a price to manufacture each tile based on a minimum order of 500 tiles in total. Schedule and quantity to be confirmed, the actual amount could be considerably more. If you could also let me know the lead-in time to specially produce the colours / moulds and then supply, much appreciated.

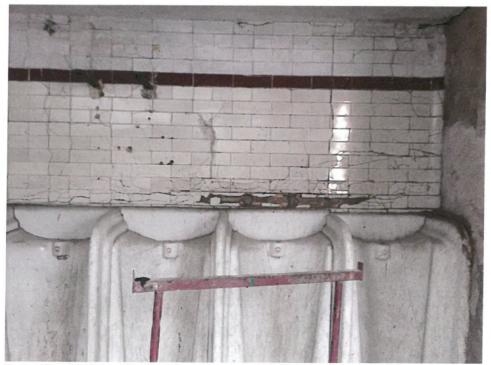
The Client is ideally looking to restore the original glazed tiling, which unfortunately are in rather poor condition as a result of severe structure failure, moisture ingress and damage.

Cream tiles for the majority of the wall areas <2.1M hieght, then a single brown tile, then white to ceiling hieght, up to 3.1m.
