Stables Market, Chalk Farm Road - Triangle Site Chalk Farm Building (Building A)

# DESIGN AND ACCESS AND HERITAGE STATEMENT

### FOR PROPOSED TENANT FITTING OUT WORKS TO UNITS 38 & 39

DECEMBER 2016

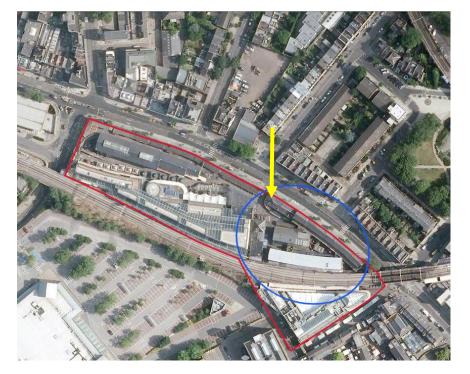
**Figure 2** The Stables Market shown within red line; the stables range circled in blue. Location of the Chalk Farm Building units 38 &39 marked with yellow arrow.

The Chalk Farm Building (Building A) lies within the triangular site described above part of the internationally recognised Stables Market, in the northwest corner of Regents Canal Conservation Area. (Fig. 1). The area is bounded to the north by Chalk Farm Road (Hampstead Road as it was known until 1862), and is separated from the former lands of the of the goods yard to the south by the railway viaducts (Fig. 2).

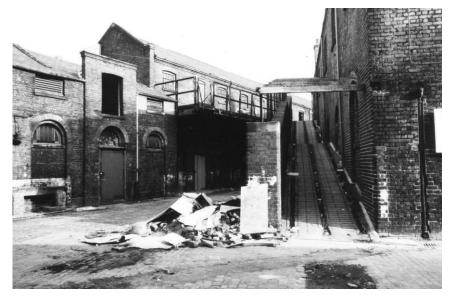
**Figure 3:** 1975 photograph looking south west towards the Chalk Farm building.

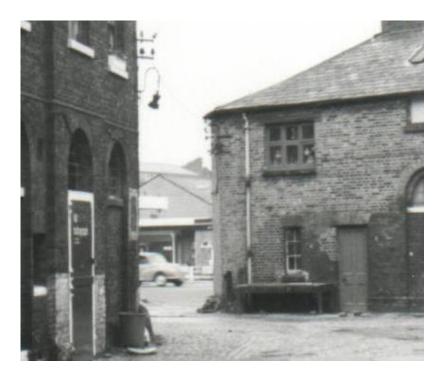
**Figure 4:** 1975 photograph looking north towards the former gatehouse end of the Chalk Farm building.

construction of the period - beyond the numerous alterations suffered through the years. The former Gate House had an altogether different character to the stables as evidenced by the fragmentary internal fireplaces, timber rafter roof structure with evidence of former plastered ceiling and mostly likely the original single panelled entrance door - extant in the 1975 photograph (fig.4).

A single external timber panelled access door will be installed to replace the existing poor quality modern door (this previously consented as part of 2015/3658/L). The new door was designed to replicate the most likely original Gate House door still extant in the 1975 photograph (fig.4).

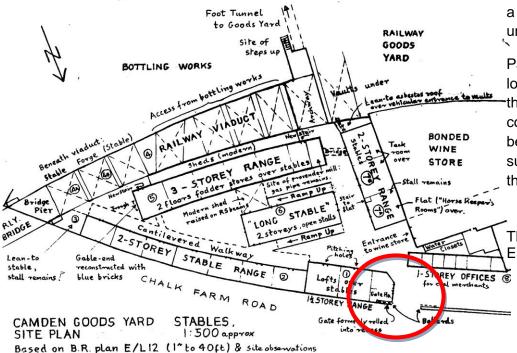
**Figure 5:** 1975 plan with 'site observations' noted. The west end of the Chalk Farm building (the subject site and highlighted in red) is noted as the Gate House and the site sliding entrance gate (which was housed within the building) is shown and noted.

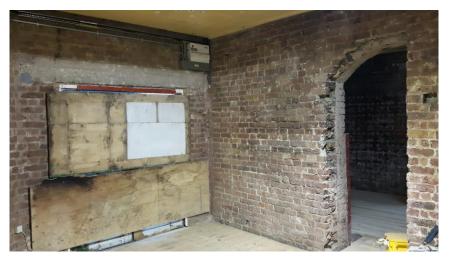
**Figure 6:** Chalk Farm Building, ground floor: view within south room (unit 38) with north room (unit 39) beyond.

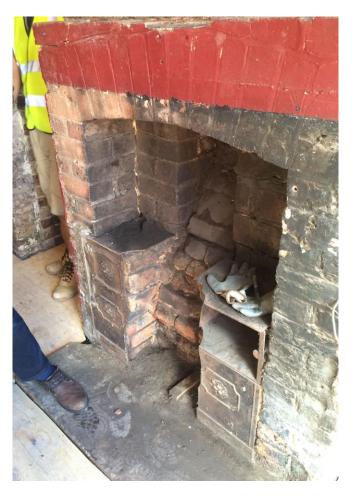
**Figure 8:** Chalk Farm Building, ground floor: north room fireplace showing fragmentary cast iron hob grate (unit 39).

The interior of the unit is currently little more than a shell, with exposed brick walls throughout and an area of rendered wall at first floor level. Three brick fire places exist – the one in unit 39 at

ground floor retaining the fragmentary remains of a cast iron hob grate. The timber staircase is wholly modern and occupies the approximate location of the original stair although of a different configuration. Existing external doors are ad hoc and very poor quality – the double doors to unit 38 being made up from a pair of old doors crudely cut to fit the aperture.

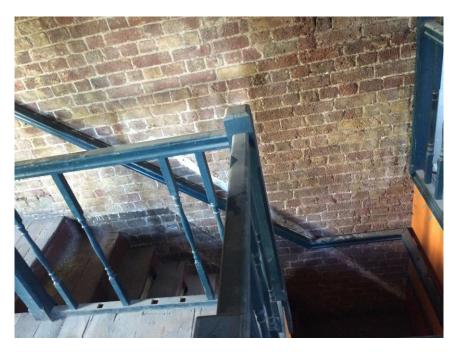
**Figure 10:** Chalk Farm Building, first floor: the timber staircase is modern. The timber joist floor has been altered and trimmed to accommodate the stair configuration.

The stair installation will require some limited trimming of the first floor structure but the floor has previously been trimmed to accommodate the existing modern stair and so will require local repair, infill and strengthening to satisfactorily make good. Existing modern ceiling/plasterboard at ground floor (Fig 13) will also be removed and replaced to fit the new stair and ceiling layout.

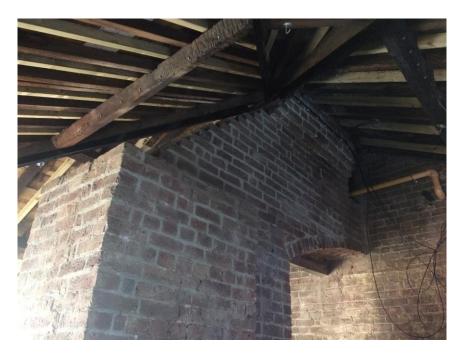
**Figure 11:** Chalk Farm Building, first floor: view from south room (unit 38) showing repaired roof structure. A plaster finish ceiling sloping soffit will be reintroduced to the joist underside.

Structural examination of the timber roof structure has identified a number of necessary repairs to wall plates and hip rafters (refer to Appendix III for details). The exposed rafters of the roof will be lined on their undersides with plasterboard and skim to create a sloping soffit ceiling (the existence of the original plastered ceiling can be evidenced by the lath and plaster staining to the undersides of the original joists).

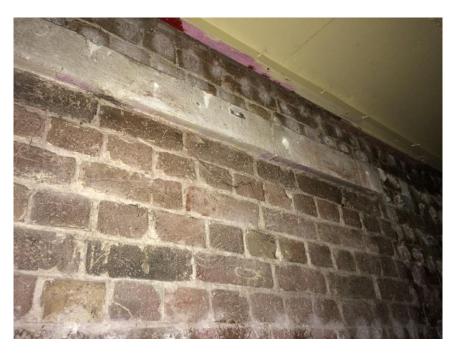
**Figure 12:** Chalk Farm Building, ground floor: view of north wall high level (unit 39) showing the projecting horizontal stone course the purpose of which was to provide for sufficient fixing for the rolling/sliding external site entrance gate (refer to fig.5).

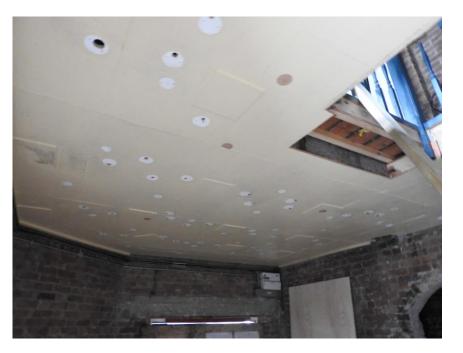
**Figure 13:** Chalk Farm Building, ground floor: existing modern ceiling – modern, poor quality plasterboard, with marks and holes from the previous tenant.

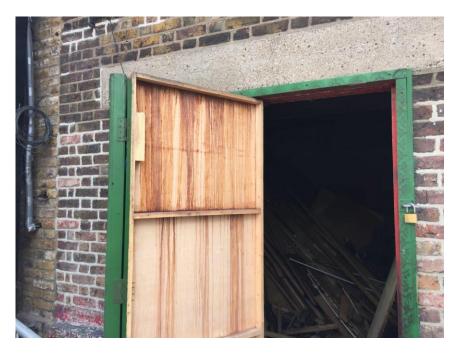
**Figure 14**: Chalk Farm Building, west elevation, external folding door to left hand side: the doors are modern poor quality plywood.

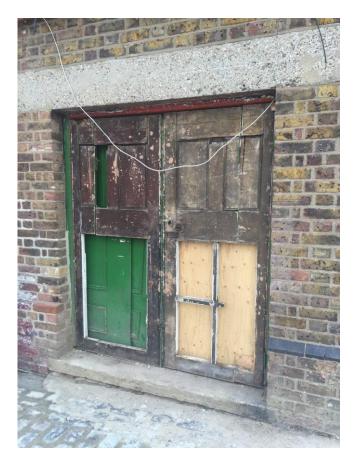
**Figure 15**: Chalk Farm Building, west elevation, external folding door to right hand side: the doors are of some age, but reused from elsewhere, cut a quarter in down their length and hinged, turned upside down and then lined each side with odd facings.
