**Phase II Ground Investigation Report**

**77-79 Charlotte Street, London W1T 4PW**

**Charlotte Street Property Ltd**

**REPORT 14653/GIR**

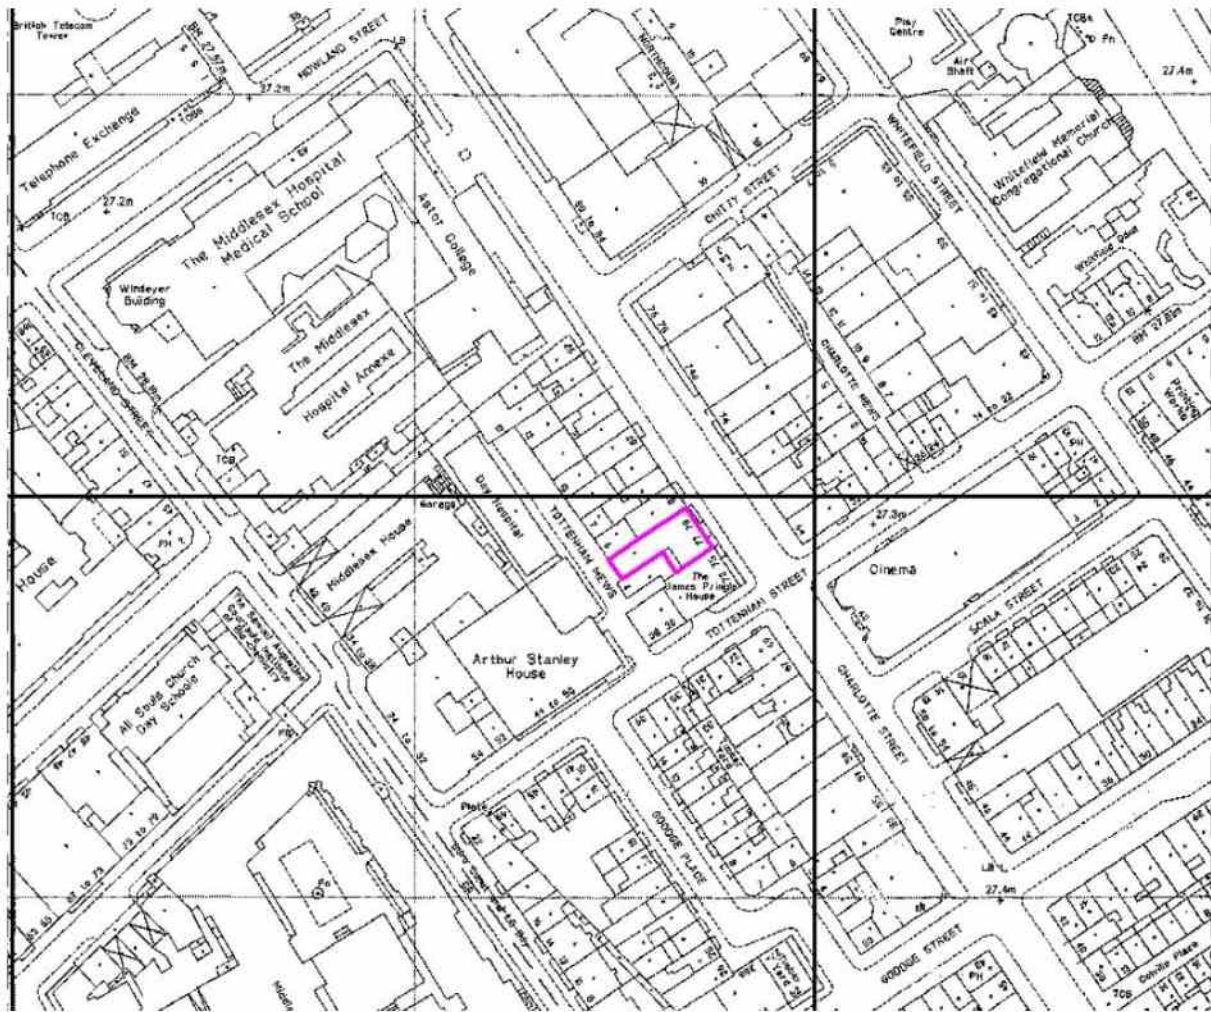
**Figure 2.2 Site Location Plan**

The site area is 0.03ha. It is situated at 77-79 Charlotte Street, London W1T 4PW, at O.S. National Grid Reference of TQ 29354 81787. The site location map and plan are presented in Figures 2.1 and 2.2, the details of the conditions of site can be obtained from the Site Walkover within the 14653/DS section 3.1.

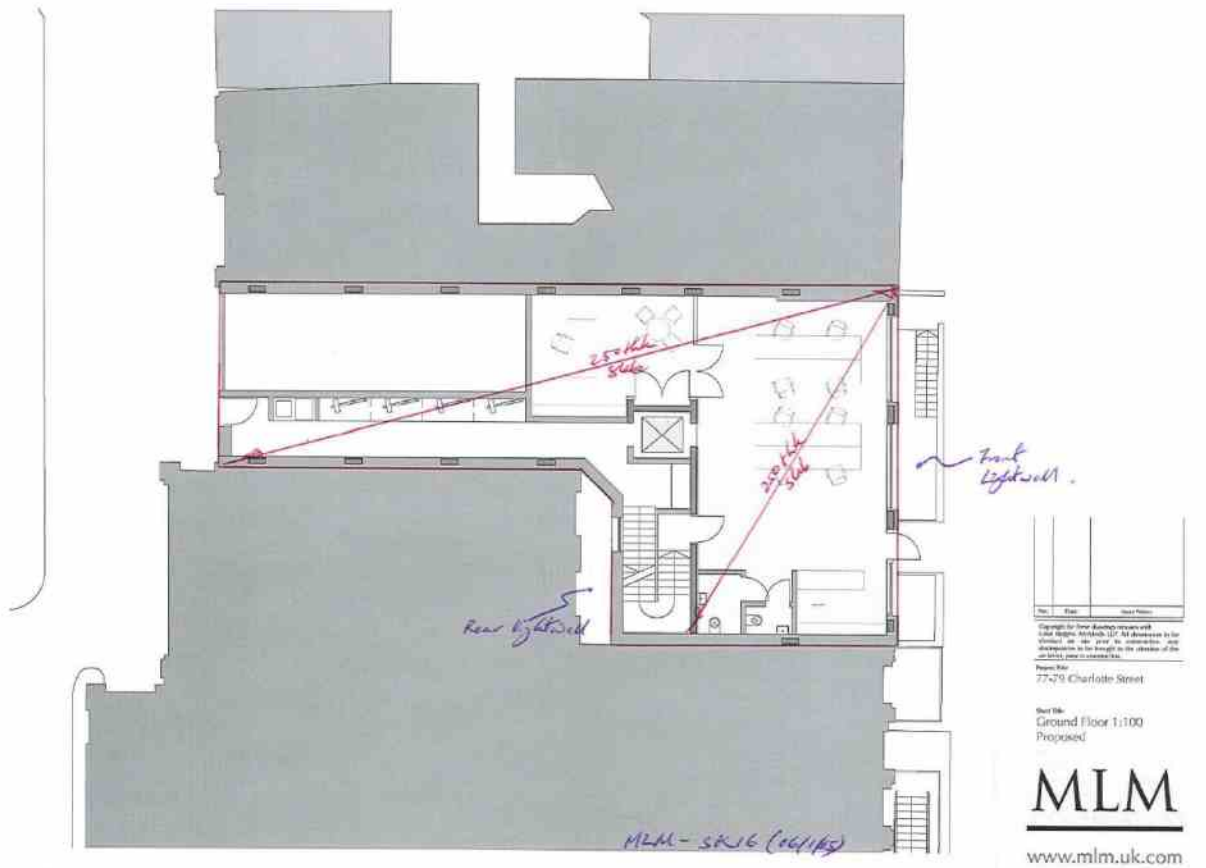
Figure 2.3 Proposed Ground Floor Plan

by MLM without numbers and dates. Any change or deviation from the scheme outlined in the drawing could invalidate the recommendations presented within this report. Soils Limited must be notified about any such changes. The proposed layout and the sections are given on Figures 2.3-2.6.

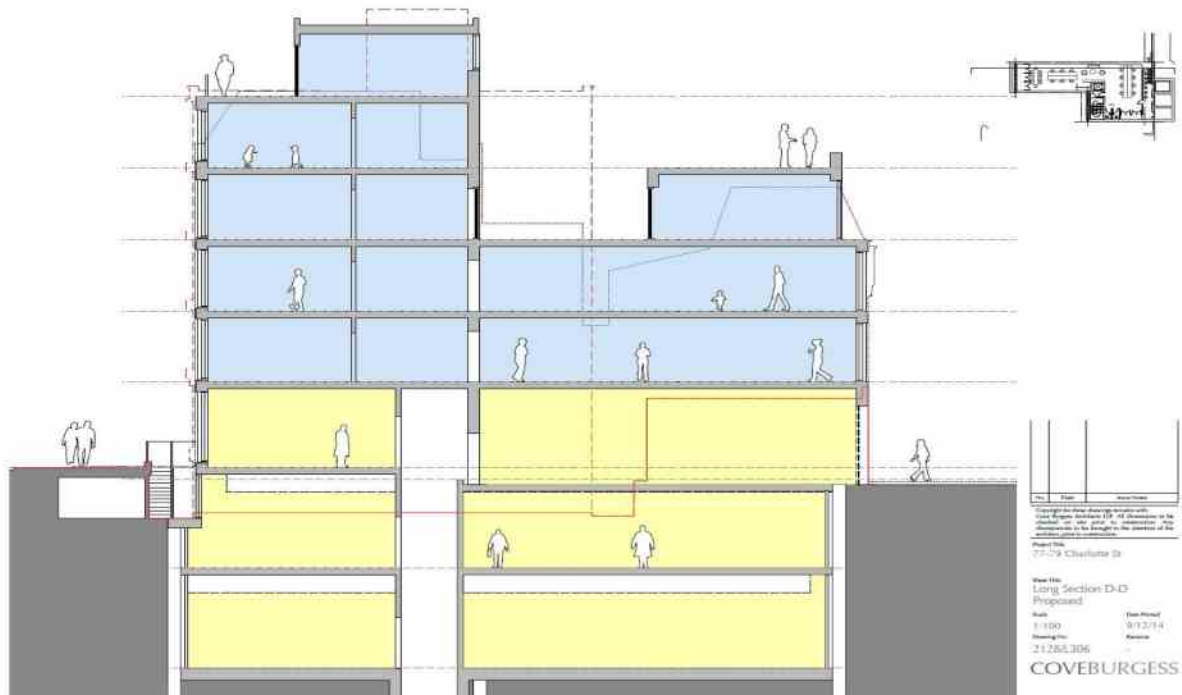
Figure 2.6 Proposed Section

The proposed development comprises the demolition of the existing building and construction of a new six storey building with a two level basement. The basement level is to be approximately 8m below existing ground (street) level. The current proposal for the new building is to construct a concrete frame from the first floor slab down to the basement and a lightweight steel framed structure from first to roof level. It was intended to be of mix usage; with upper floors from roof to second for residential and first floor to basement for commercial/office usage, with no areas of soft landscaping.

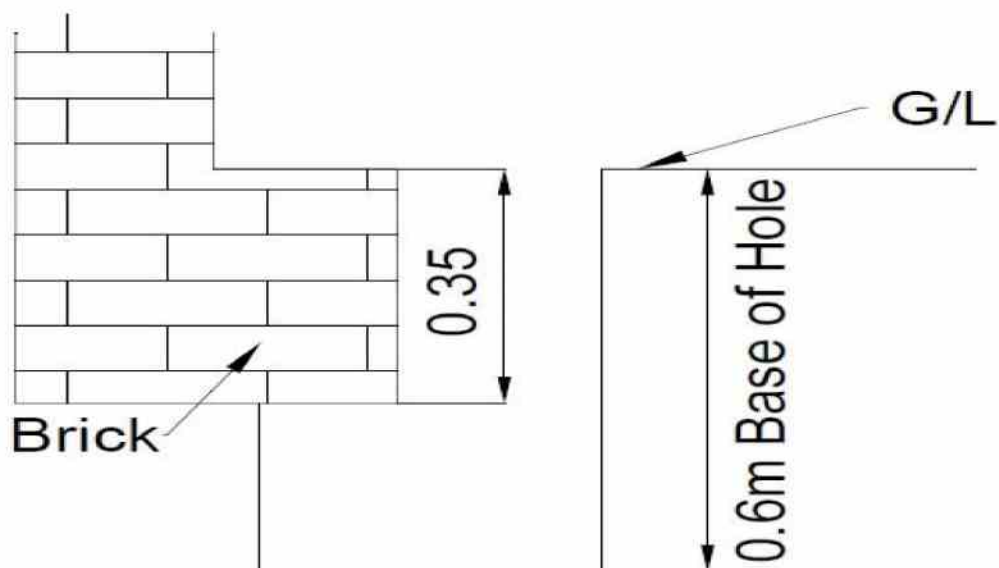
Figure 3.2 – Foundation Section (TP1)

3No trial pits (TP1-TP3) were hand excavated to enable the recording of the foundation configurations of the existing building and walls on site.

The foundation sections for TP1-TP3 are given in Figures 3.2-3.4 respectively. The dimensions are in metres.
