Design, Access and Heritage Statement

Facade works to 43 Flask Walk, London, NW3 1HH

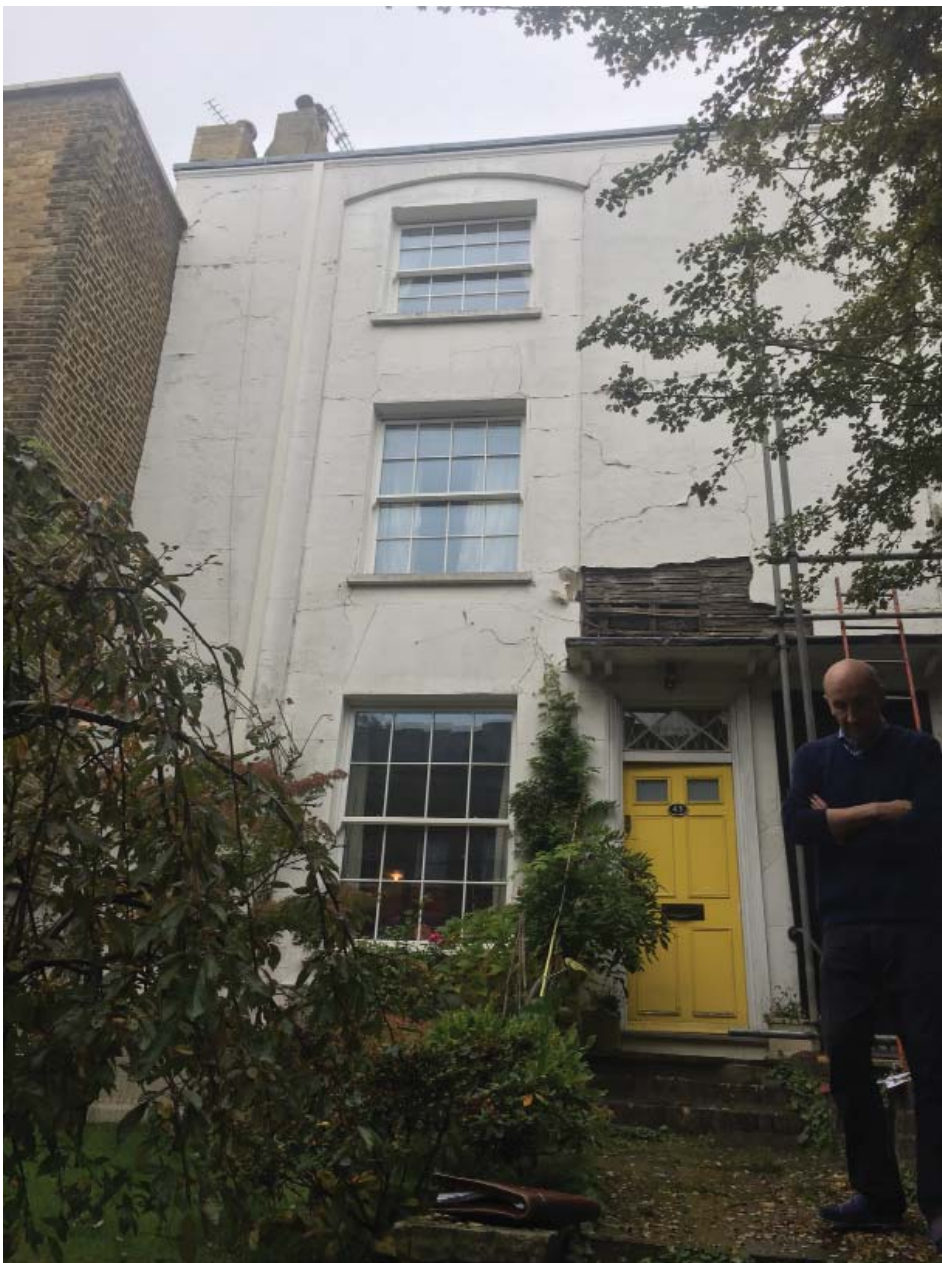
Photos of condition prior to repairs:

The existing building has a painted sand and cement render facade on metal lath. This is not the original historic finish as it is clear from the existing metal lath and cement based render that it was installed at some point in the last 30 to 50 years.

Over time the render has de-bonded and has fallen into disrepair. The property was served with a dangerous structures notice as sections of the render had fallen off causing a hazard to the occupants and passers by.

The current owner undertook urgent repairs to stabilize the substrate and wishes to apply a new lime based render finish which is the subject of this application.

The intention is to create a matching painted render finish to replicate the original facade but using a traditional lime render in keeping with the historic fabric of the building. Given the deterioration of the facade and current exposure to the elements it is urgent that the works be carried out to preserve the fabric of this heritage asset.

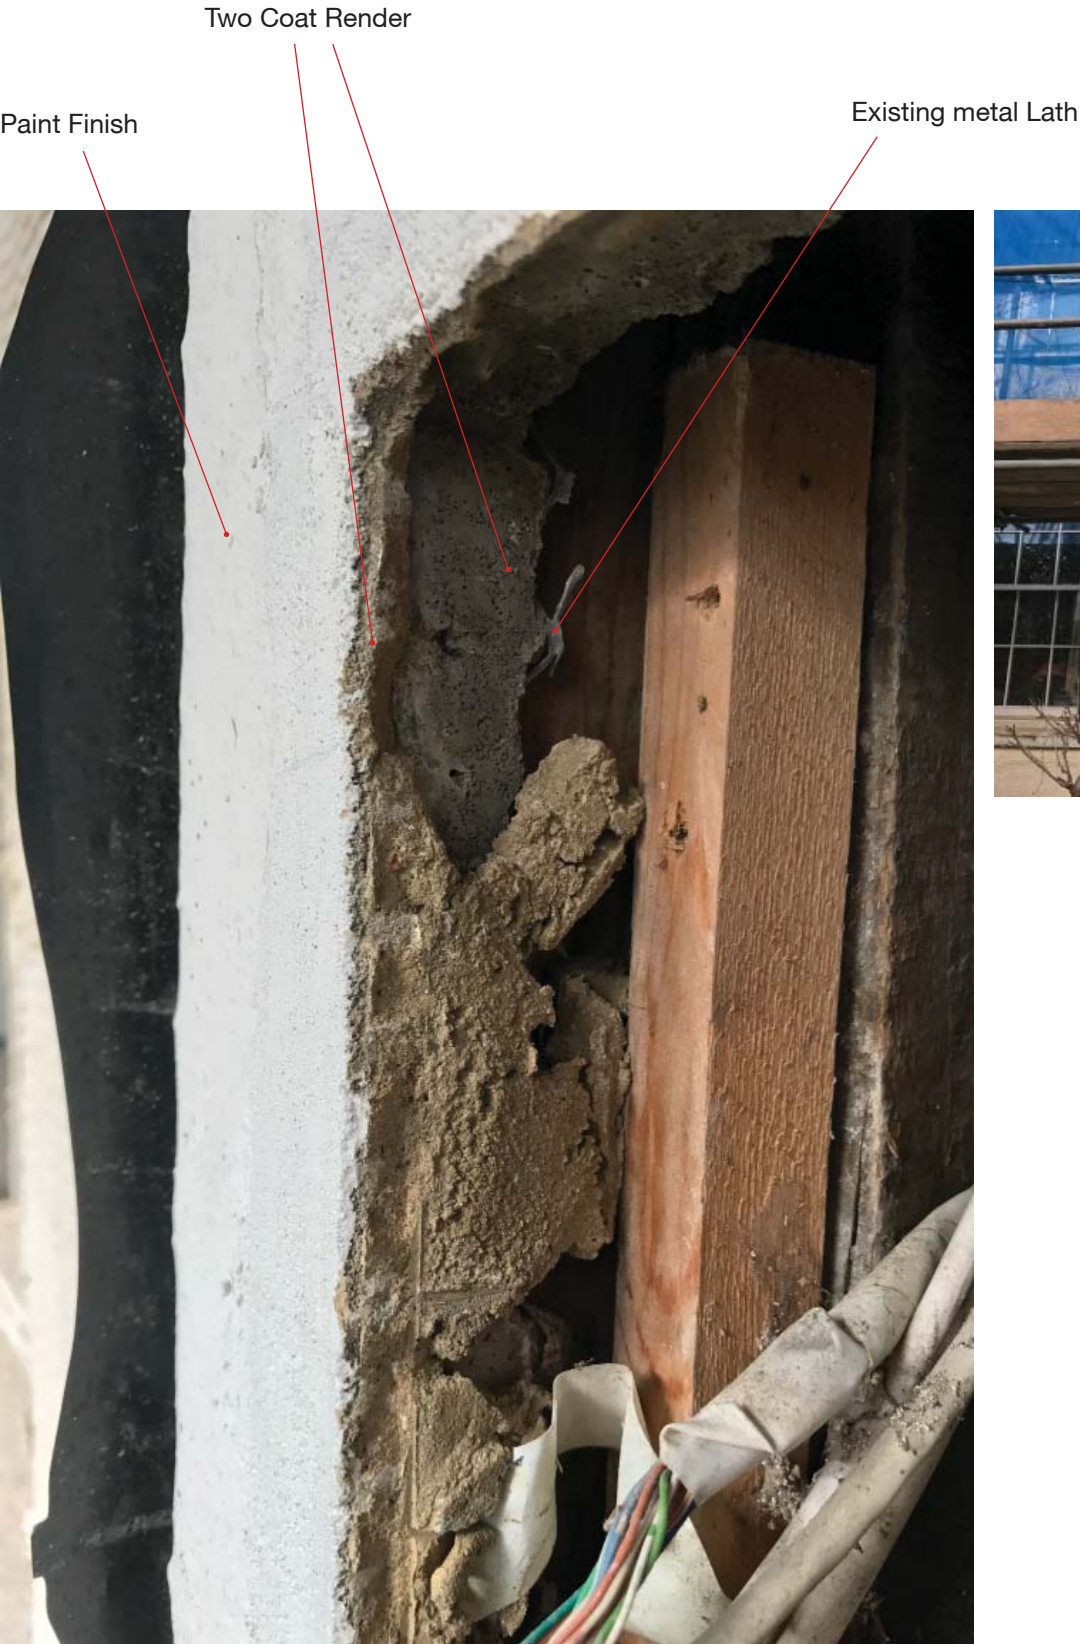
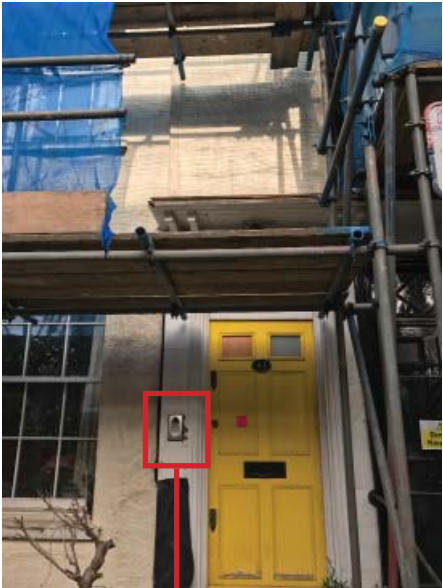
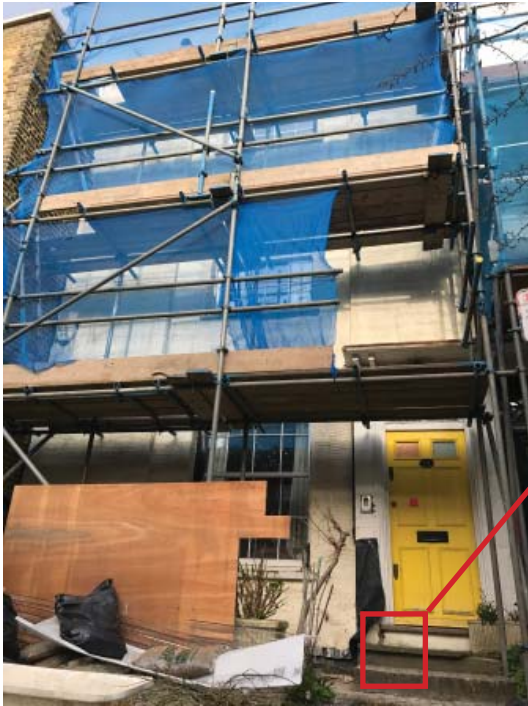
Sample Location

The existing facade build up is not original and can be seen in the following photographs. It comprises a two layer cementitious render onto expanded metal lath.

Existing Cut Out At Entry Phone

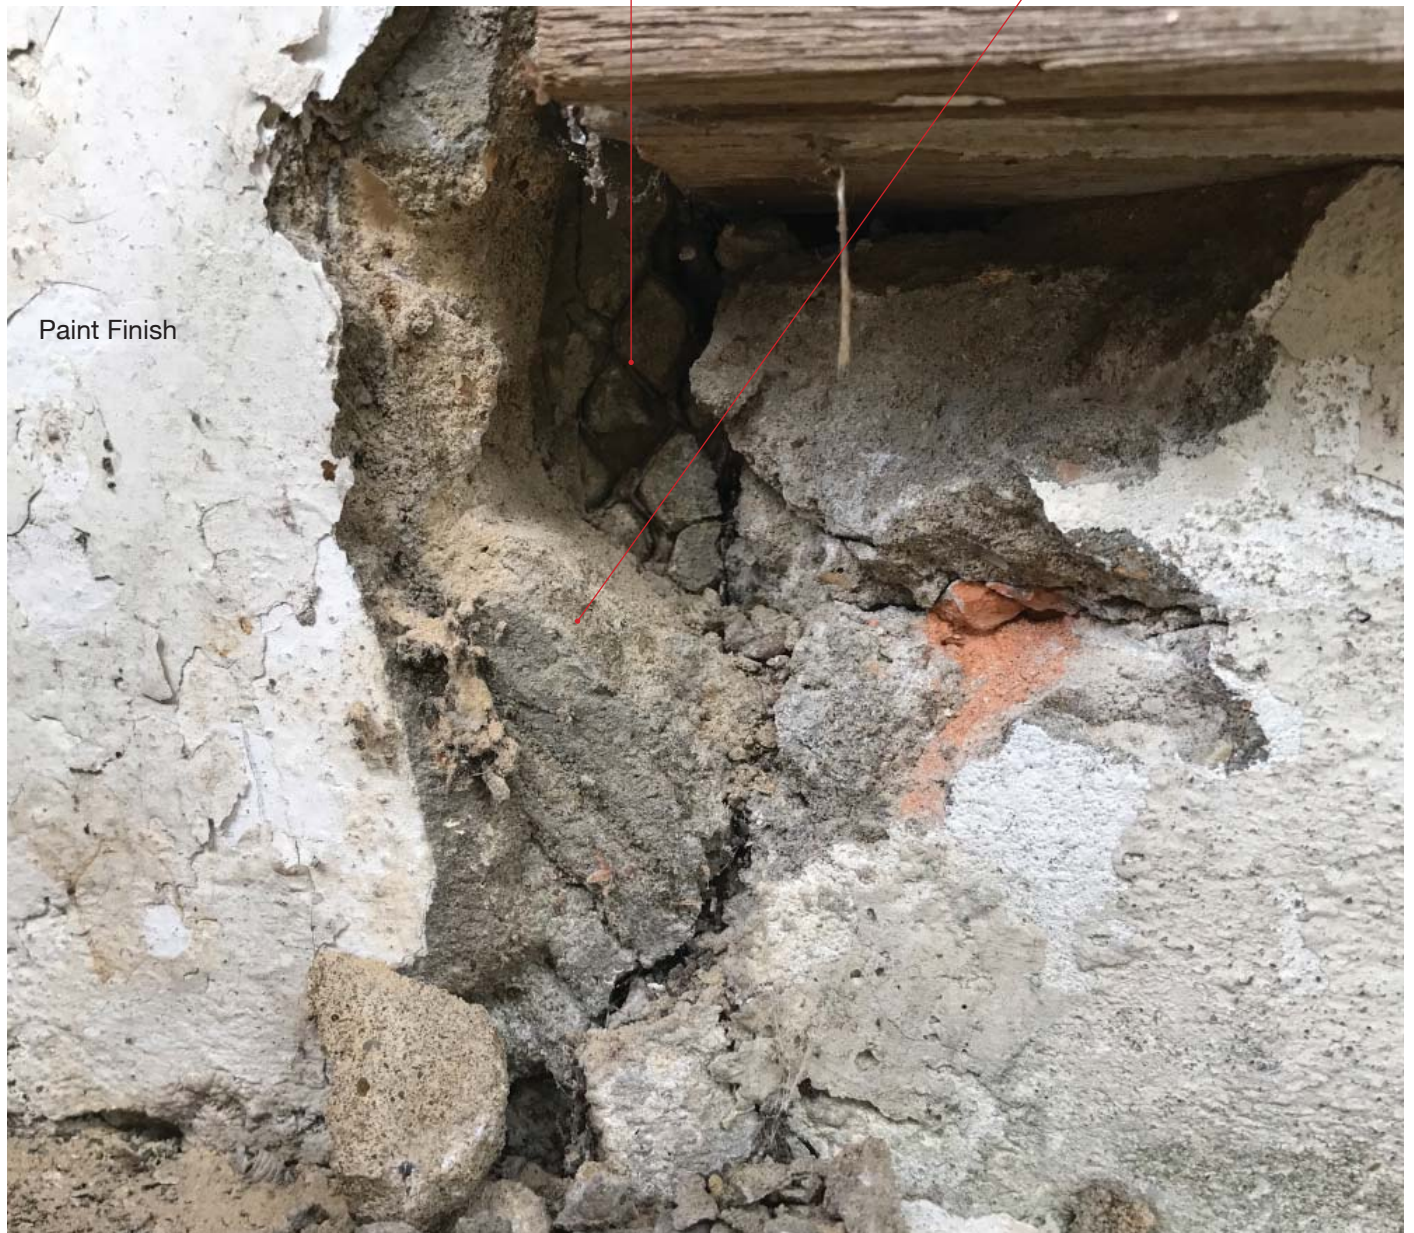
Sample Location

Existing metal Lath

Two Coat Render

Paint Finish

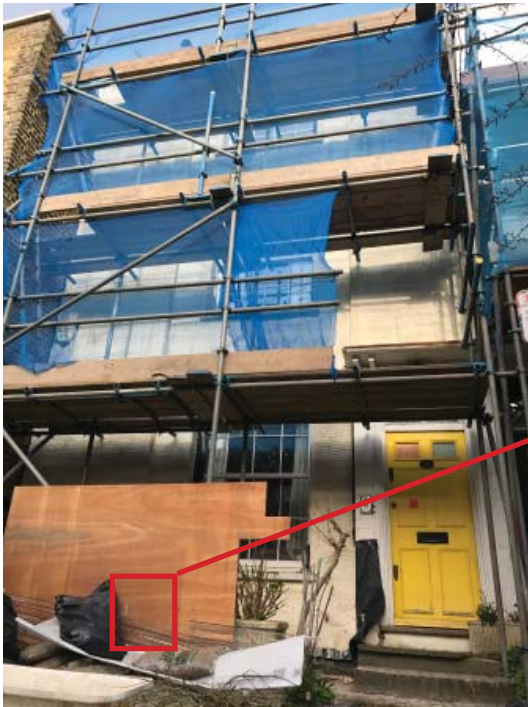
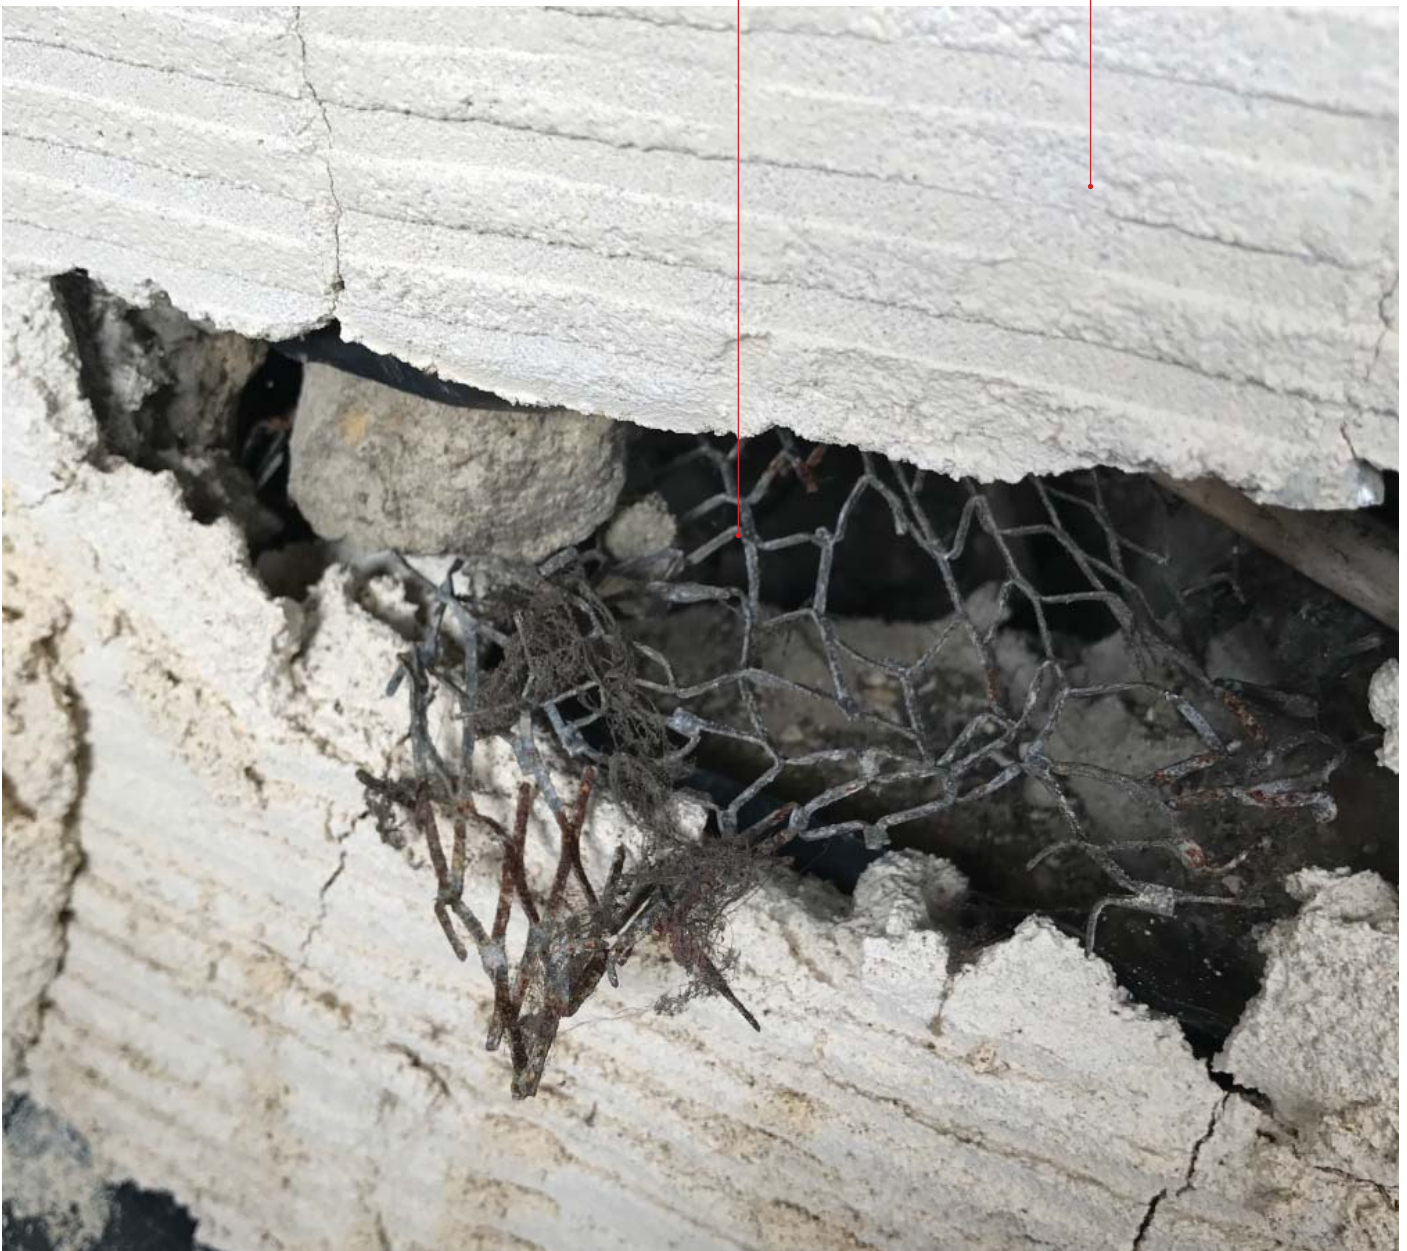
Sample Location

New Stabilising Render Base Coat

Existing metal Lath

We propose fixing a membrane with stainless steel rib lath fixed with stainless steel screws and washers. This will enable the structure to move independently without cracking or disturbing the new repairs. This would be followed by a lime render consisting of 2 part lime and 3 parts washed sharp sand with zone two aggregates. Once cured and set, a final coat of 1 part lime and 3 parts washed sharp sand with zone two aggregates floated to a smooth finish and block and lined as was faintly showering on the existing.

The lime render coat would be totally breathable and the membrane would stop moisture reaching the old cracked sand and cement render. This would give the façade the original look in the original lime render.

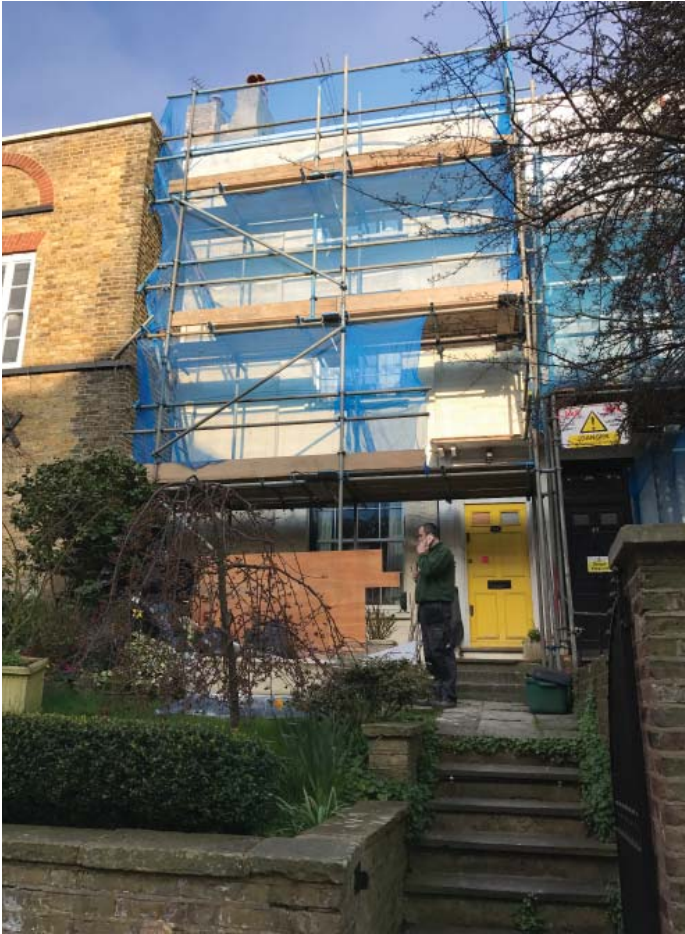
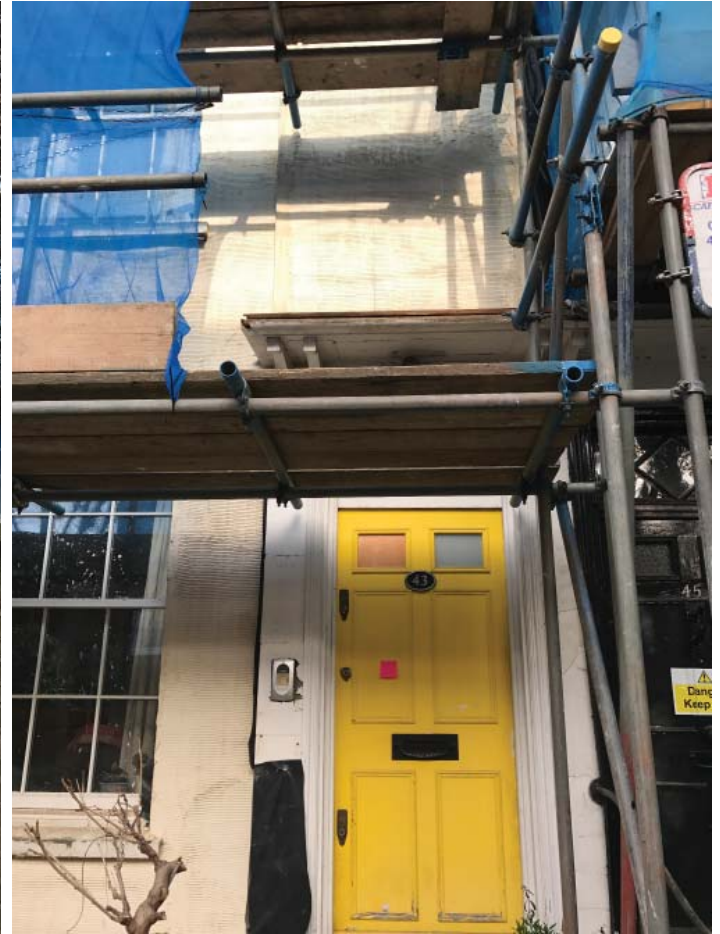
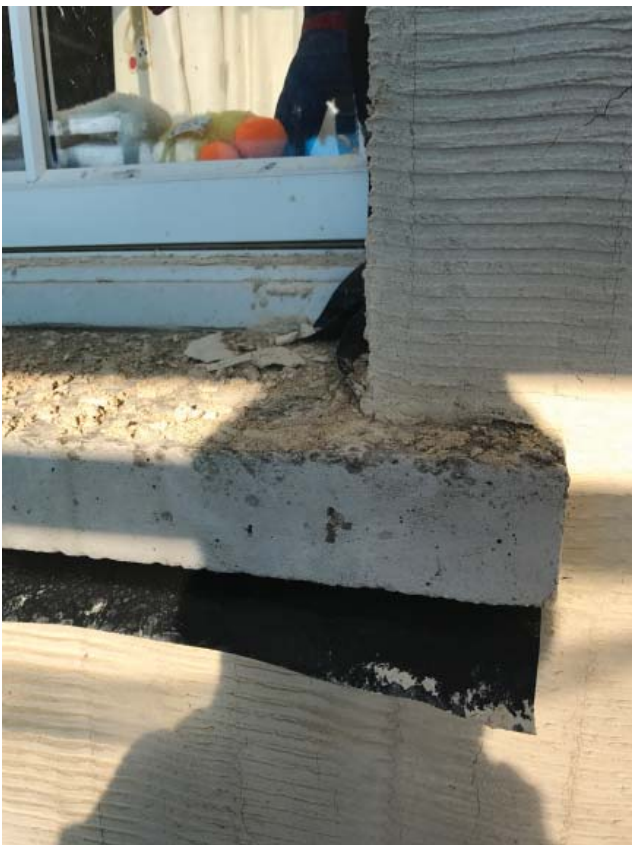
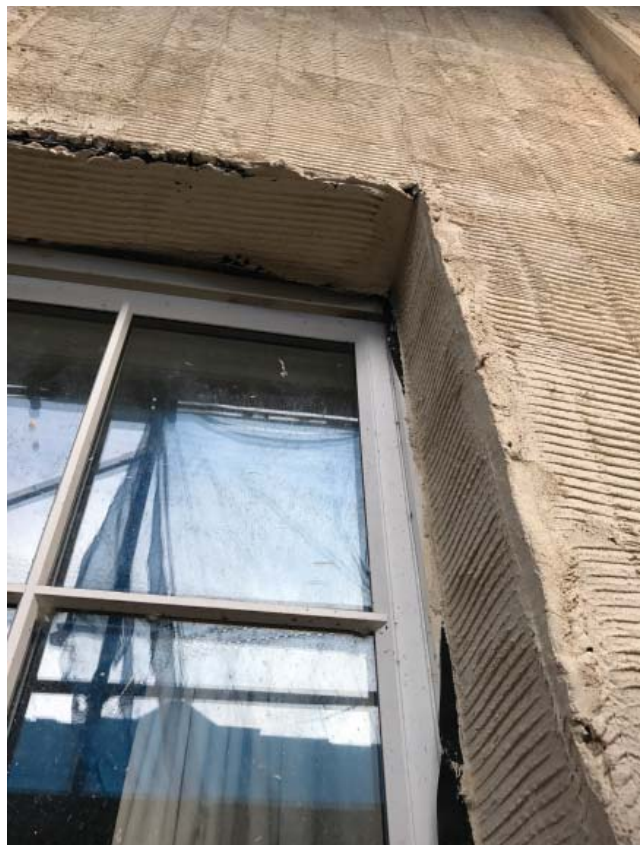
Photos of current condition:

When investigating the front façade we found that from small patch above the front entrance was missing, which we believe was a bad repair with a strong sand and cement mix applied directly onto the laths, the remainder was solid and hard. We took off small patches and found that there was expanding metal lathing under many coats of sand and cement render, none of which was in any way original. To remove this would cause major damage to the timber structure.

This would be followed by a breathable lime wash or alternative paint with the same properties. We would remove the obsolete air conditioning pipework, boxing, condenser unit, wiring and cables.

The main front step is flat paving, not original. This is damaged and would be replaced with a bespoke quarried bullnose York Sand stone step with 65mm overhang.
