ST GILES CIRCUS

BASEMENT CONSTRUCTION PLAN ZONES 1 & 2

029-Z1-REP-011
Rev 01

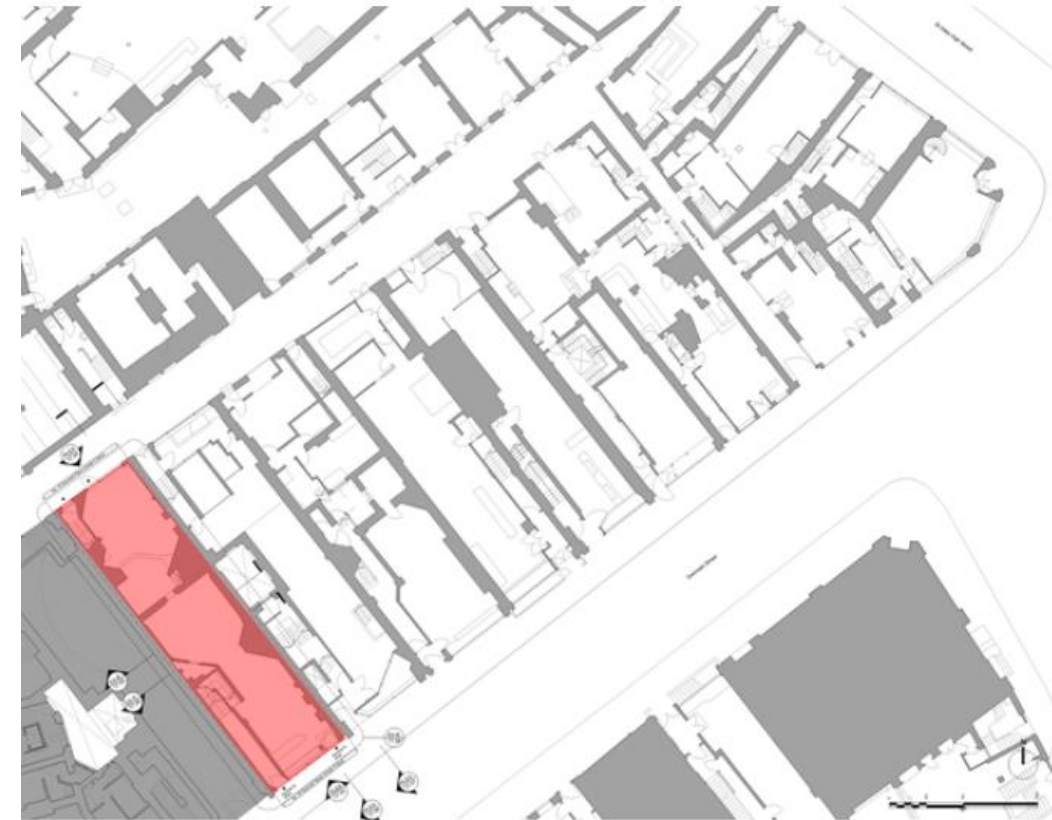
Figure 5.1: Location of No 20 Denmark Street / 16 Denmark Place

- 5.1.6 The front wall is of masonry construction with 3 openings per floor. At the rear a later extension for toilets/bathrooms has been connected to the half landing and a single wider window is provided to the rear room. The rear extension for toilets/bathrooms is generally in a poor condition, with cracking to the base and walls.

- 5.1.7 The party walls are of masonry construction with two chimney breasts on the party wall to No. 21 that extend the full height of the building.
- 5.1.8 A partial inspection of the floor plates has been undertaken, at third floor the floor boards were observed to run perpendicular to the front facade in both the front and rear rooms, indicating that the joists span parallel to the front facade. At second floor the floor boards in the rear room run the same way, however the floor boards in the front room run parallel to the front facade. This could indicate that the floor boards are finishes applied to a lower floor structure below.

- 5.1.9 Internal load bearing stud walls surround and support the stair structure and also pick up the floors to the rear rooms.
- 5.1.10 The original masonry front facade has been removed at ground floor level, together with the internal stud wall that separates the front and rear rooms to create a shop. Although no cracking evident to the main structure, there is evidence of cracking in the adjoining bathroom extension.
- 5.1.11 At lower ground floor level the wall around the stairs is constructed from masonry and a steel frame with column supports the ground floor along the approximate line of the dividing wall between the front and rear rooms.

5.1.13 The floor structures observed at second and third floor were level and felt solid. Internally some movement had occurred to the internal stud wall, particularly between the stair wall and the rear masonry wall. The rear masonry wall has experienced previous movement, particularly around the larger window openings which have moved considerably. Although no recent cracking is evident any alterations to the windows could adversely affect the masonry around the window. Water ingress was observed to the rear wall at third floor.

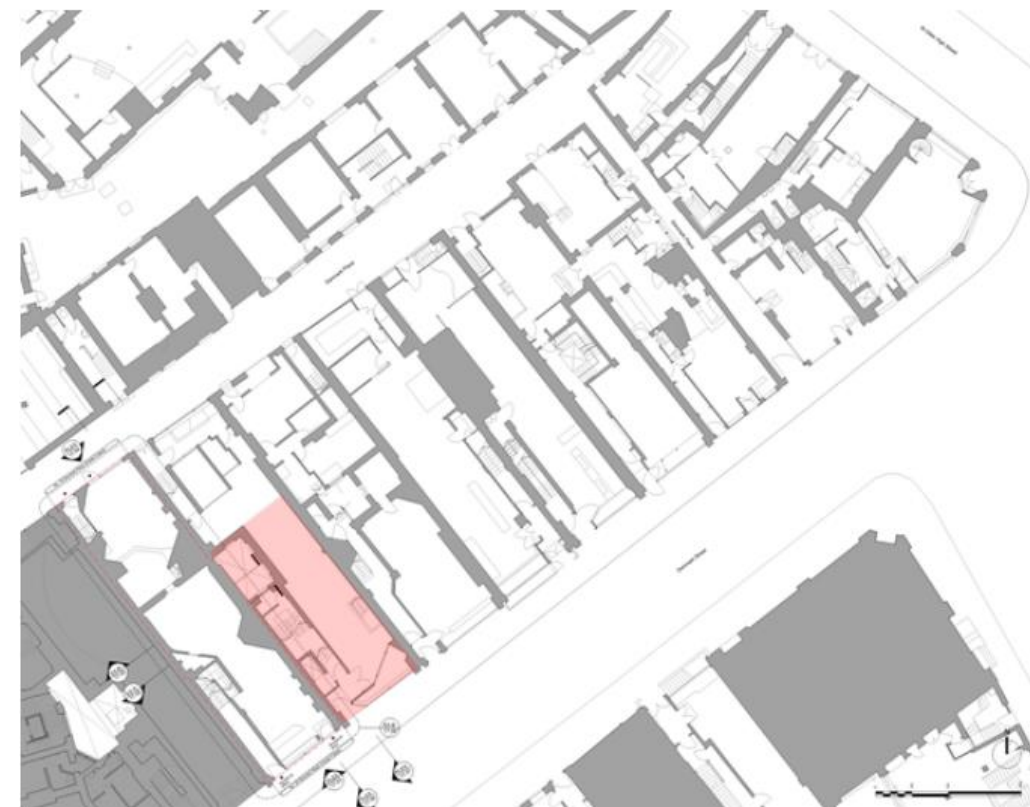
Figure 5.3: Location of No 21 Denmark Street

- 5.2.4 The existing building is formed of masonry walls, steel beams with concrete filler joist floors spanning between the beams. The filler joist slab is approximately 180-200mm thick with a 30 mm lightweight screed zone over, that appears to be a "Magnesite" floor of wood flour and cement.
- 5.2.5 Generally, the Steel "filler joists" were measured as 44-63mm wide, 100-125mm deep at 660-770mm ctc, increasing to 880mm in the rear area (to be demolished). Samples taken from the Magnesite floor have been tested for asbestos and found to be negative.
- 5.2.6 If the full 1.0kPa super imposed deadload allowance is to be utilised entirely for new finishes and architectural build-ups, the magnesite screed (along with any cement render to ceilings) must be removed.

- 5.2.7 Main steel beams were measured at 457mm deep with steel angles fixed to the web to support the filler joists. Walls were observed to be masonry. Wall thickness is thought to be 215mm to the Party Walls. Alcoves have been created within the wall lines to allow a 105mm recess by means of a 230mm steel beam encased in concrete within the wall as a lintel.

- 5.2.8 The roof construction was opened up and proven to be a similar filler joist construction to the floors, with an increased 100mm screed zone above the filler joists, and a thin hessian bed before a 20mm tar/bitumous waterproofing layer.

- 5.2.9 The general condition of the building was good. Local corrosion of the steelwork within the floor was noticeable adjacent to water sources and in the front corners of the building. Cracking of the parapets between properties was also evident and visible within the buildings. The front floor light beneath the pavement shows signs of heavy corrosion and will need to be replaced with a new concrete slab to ensure it is fully trafficable.

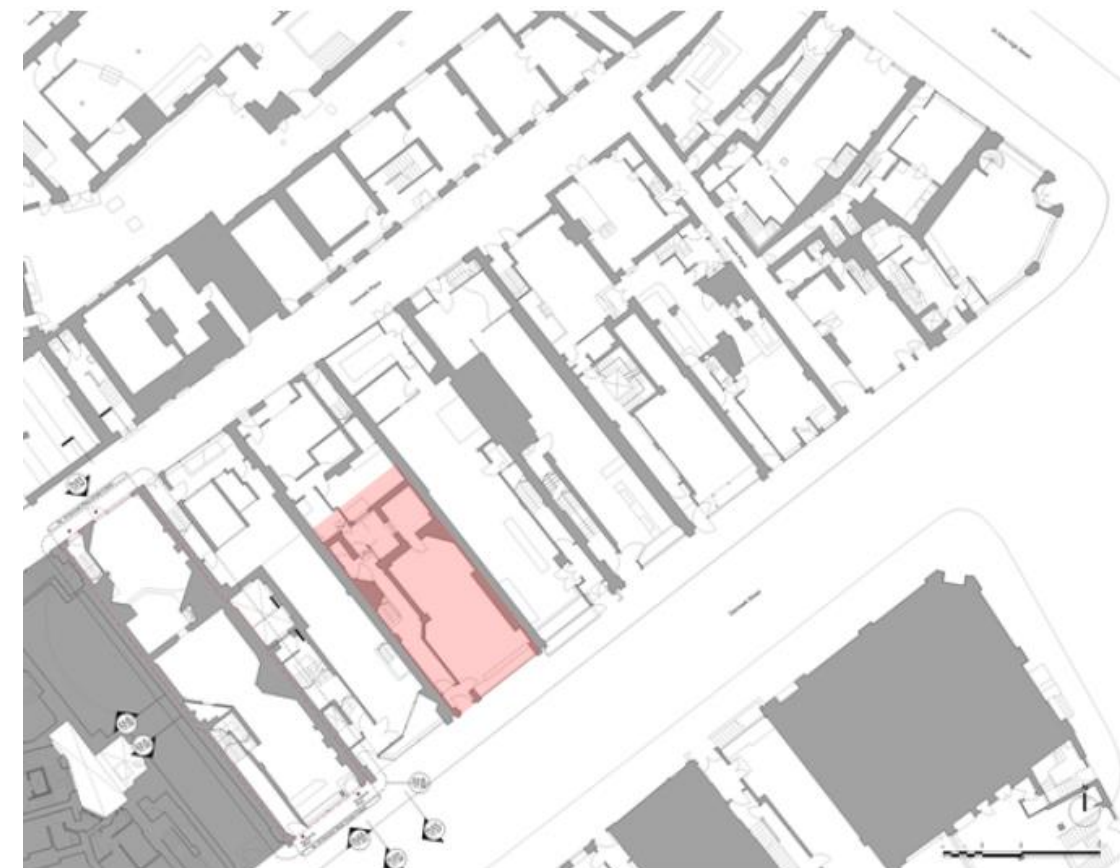
Figure 5.5: Location of No 22 Denmark Street

- 5.3.5 The party walls are of masonry construction with two chimney breasts on the party wall to No. 23 that extend the full height of the building. The existing building is of masonry construction with timber joist floors on steel beams. At ground to third floor level the front room is believed to be subdivided by a beam running from the front façade to a steel beam that spans between Party Walls on the former spine wall line. A masonry pier is evident at each end of the beam. At second floor this has not been directly observed due to lack of access.

- 5.3.6 At fourth floor level the floor joists span front-back to the spine beam between Party Walls. At roof level timber fitch beams are used to support the flat roof, spanning between piers built in to Party Walls. The roof is of timber joisted construction (150x50 at 350 ctc recorded) with boards over and a 20mm tar/bitumous layer. The general condition of the building was good. Local corrosion of the steelwork within the floor was noticeable adjacent to water sources. The front façade shows signs of sever corrosion and weathering especially to cills and copings.

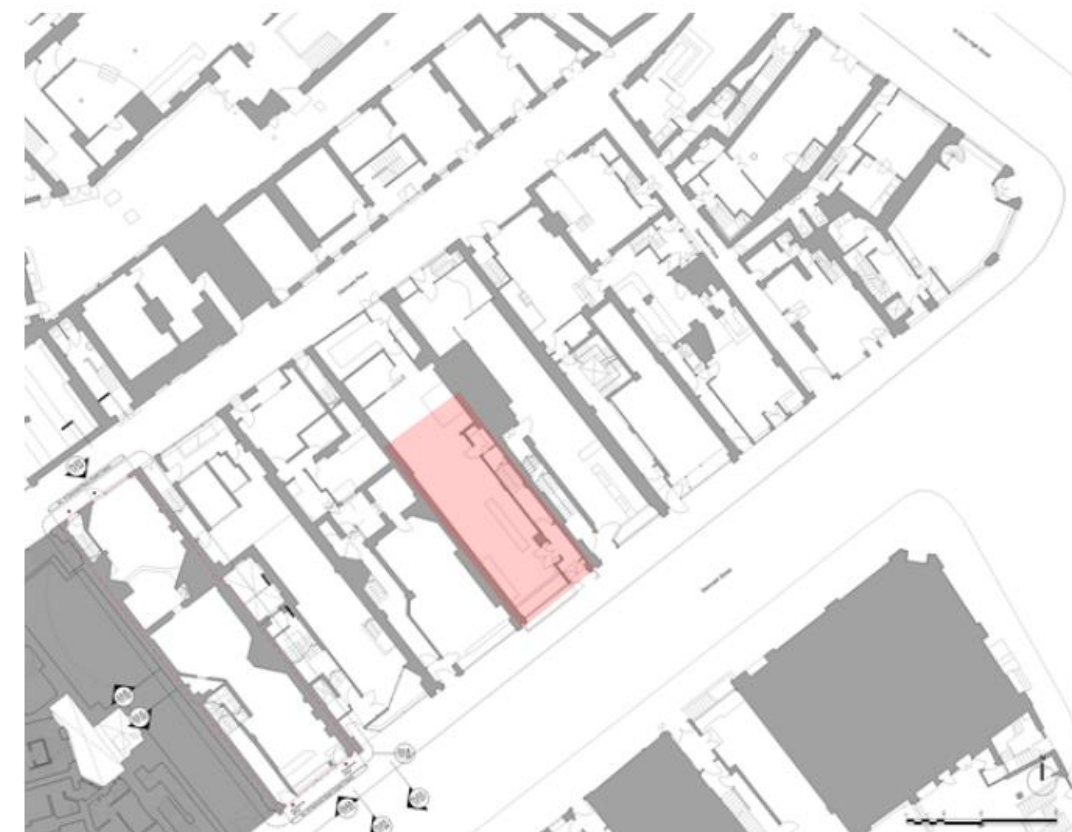
Figure 5.7: Location of No 23 Denmark Street

- 5.4.5 Stairs through the building appear to be cast in situ reinforced concrete off similar floor support steelwork. Main steel beams to the basement were measured at 470mm deep. Walls were observed to be masonry. At first floor level a plate girder transfers the masonry wall above to the Party Walls allowing the full width of the building to be open in the shop below.

- 5.4.6 The roof is of similar filler joist and concrete construction with 110mm of concrete above the filler joists and a 20mm tar/bitumous waterproofing layer over. The general condition of the building was good. Local corrosion of the steelwork within the floor was noticeable adjacent to water sources.

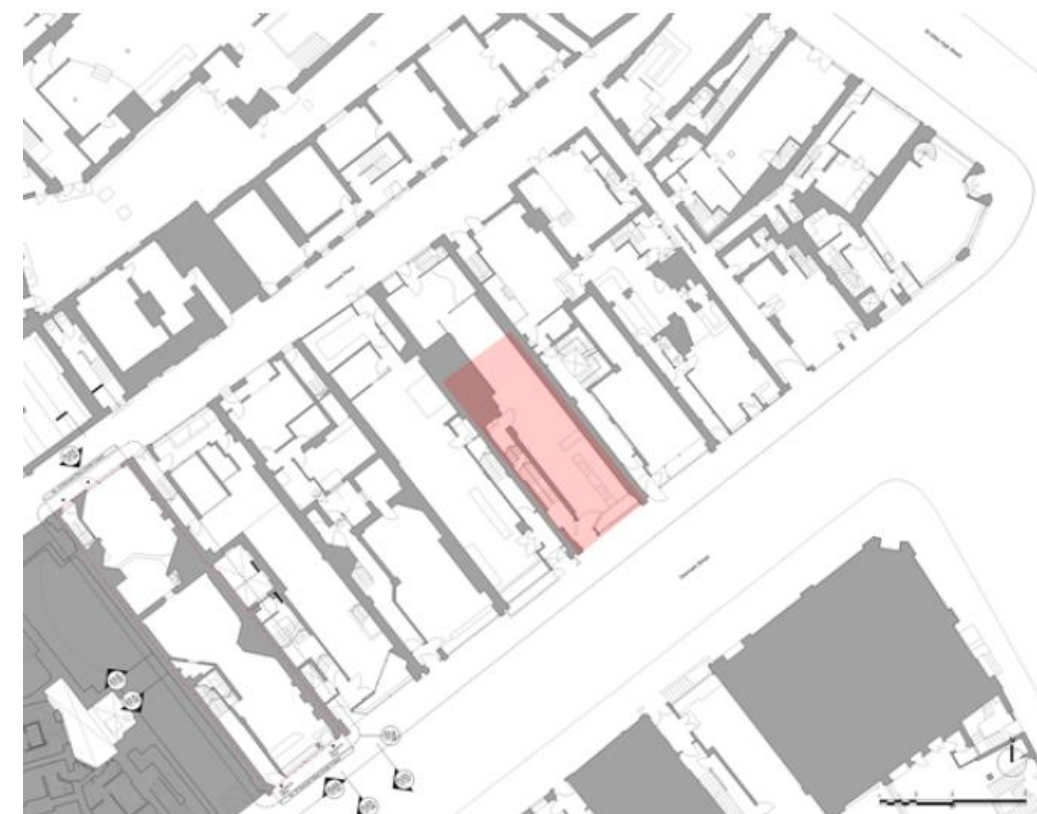
Figure 5.9: Location of No 24 Denmark Street

- 5.5.4 The existing building is of load bearing masonry construction with concrete hollowpot floor slabs spanning between steels embedded within the slab. The hollow pots are typically "3 pots high" with the reinforced ribs between. Main beams span between Party Walls and are embedded within the slab depths. Walls were observed to be masonry.

- 5.5.5 Floors have a similar 30mm Magnesite floor a screed covering to the other 1920's buildings. The roof construction was opened up and shown to be similar hollow pot construction with 90 mm of concrete above the hollow pots with a 20mm tar/bitumous waterproofing layer over. The general condition of the building was good. Local corrosion of the steelwork within the floor was noticeable adjacent to water sources.

- 5.5.6 Significant damp was evident adjacent to the front parapet. Externally it was noted that the side wall parapets were also cracked and had open perpend and loose coping stones. As with 21 & 23 DMS, if the full 1.0kPa super imposed deadload allowance is to be utilised entirely for new finishes and architectural build-ups, any magnesite screed (along with any cement render to ceilings) must be removed.

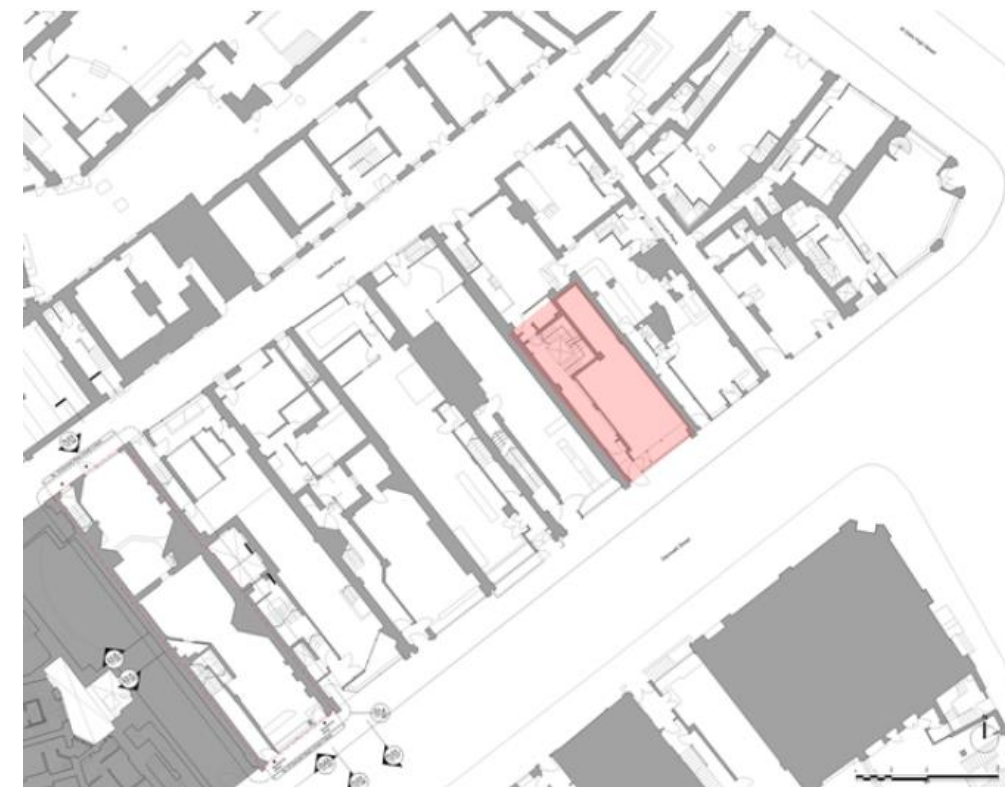
Figure 5.11 Location of No 25 Denmark Street

- 5.6.5 Walls were observed to be masonry built tight around steelwork. Floors have a similar 30mm Magnesite floor a screed covering to the other 1920's buildings. The roof was opened up and 110mm of concrete measured above the Primary steel line. 20mm of bitumous / tar was found as the waterproofing to the slab.

- 5.6.6 The general condition of the building was good. Areas to the internal lightwell showed signs of damp that will have to be addressed. As with 21, 23 & 24 DMS, if the full 1.0kPa super imposed deadload allowance is to be utilised entirely for new finishes and architectural build-ups, the magnesite screed (along with any cement render to ceilings) must be removed.

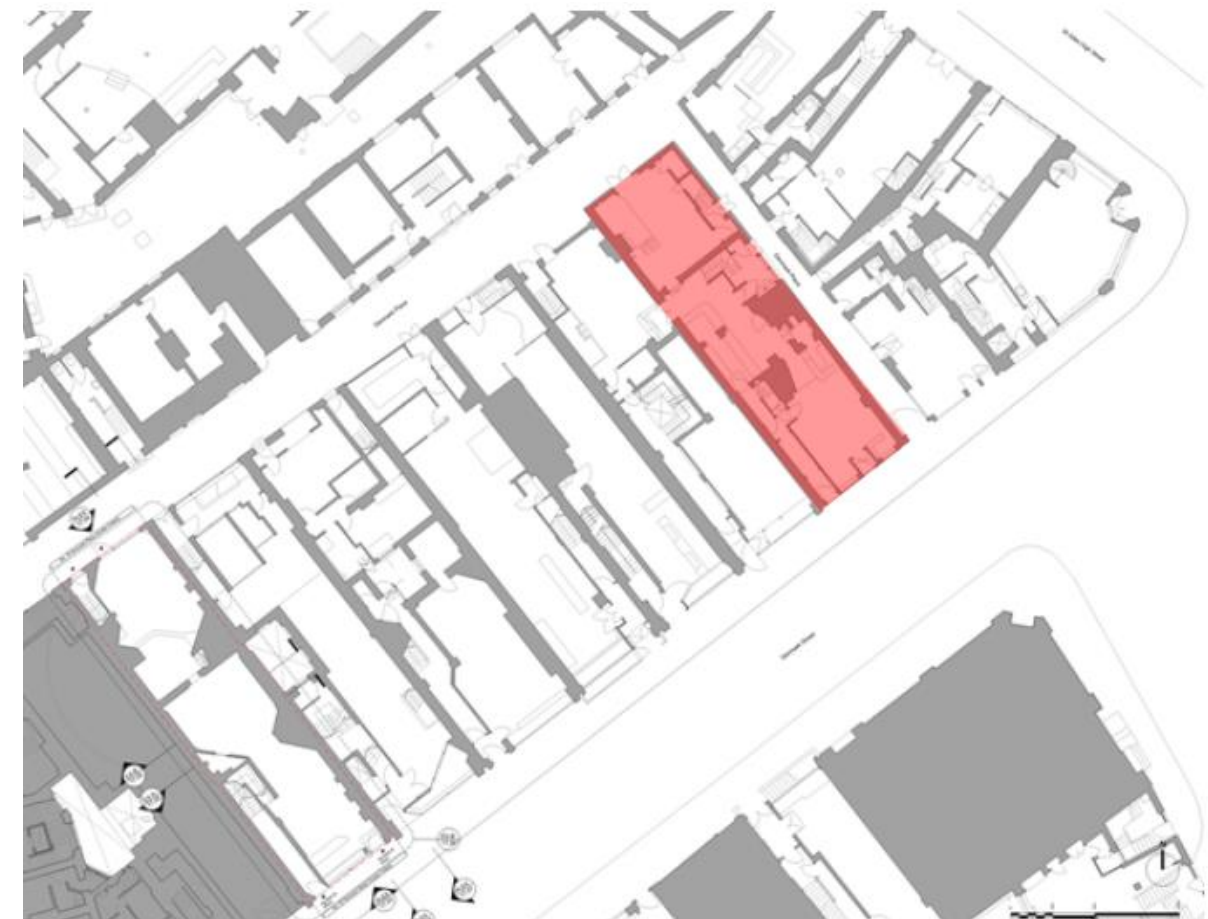
Figure 5.13: Location of No 26 Denmark Street

- 5.7.9 The condition of the listed building at 26 Denmark Street has been identified as a cause for concern and the building has been placed on the English Heritage at risk register of listed buildings. It is apparent that the structure has experienced significant differential settlement and that the on-going cracking within the building was reported by the facilities manager in 2012. Movement monitoring has been installed in this area and since May 2014 there has been little sign of further movement.

- 5.7.10 The external masonry walls of the 18th Century house have experienced considerable movement with the front facade having settled considerably on the side adjacent to No. 27. This has resulted in some cracking around the windows as was observed in the second floor flat. Internally the spandrel panels have visibly moved and large cracks are evident.

- 5.7.12 Similar cracking was observed in the rear masonry wall around the stairs with the cracks consistent with settlement on the side adjacent to No 27. A shear crack is visible on the rear façade adjacent to the No. 25 Party wall showing cracking directly through brickwork. Significant settlement of the internal wall around the stairs was also noted which has resulted in a significant fall across the landings and half landings between the party wall and the internal wall.

- 5.7.15 The building settlement appears to be the result of more significant foundation settlement on the No. 27 side of the site compared to the No.25 side of the site. It is further noted that the passageway between 26 and 27 has experienced more movement at the Denmark Street end.

- 5.7.16 Where the masonry side wall to the adjacent alley joins with 23 Denmark Place a large crack is visible for the height of the building indicating differential movement. There are a number of possible causes for the differential settlement, these include:

- 5.7.13 **In order to arrest further movement and allow the construction of the proposed lower ground floor on the site of 23 Denmark Place, it is proposed to underpin the rear wall of No 26 Denmark Street. Trial pits have confirmed that this rear wall has shallower foundations than the other walls (including the chimney) in No 26, therefore underpinning is proposed to increase the bearing capacity and width of the existing footing.**

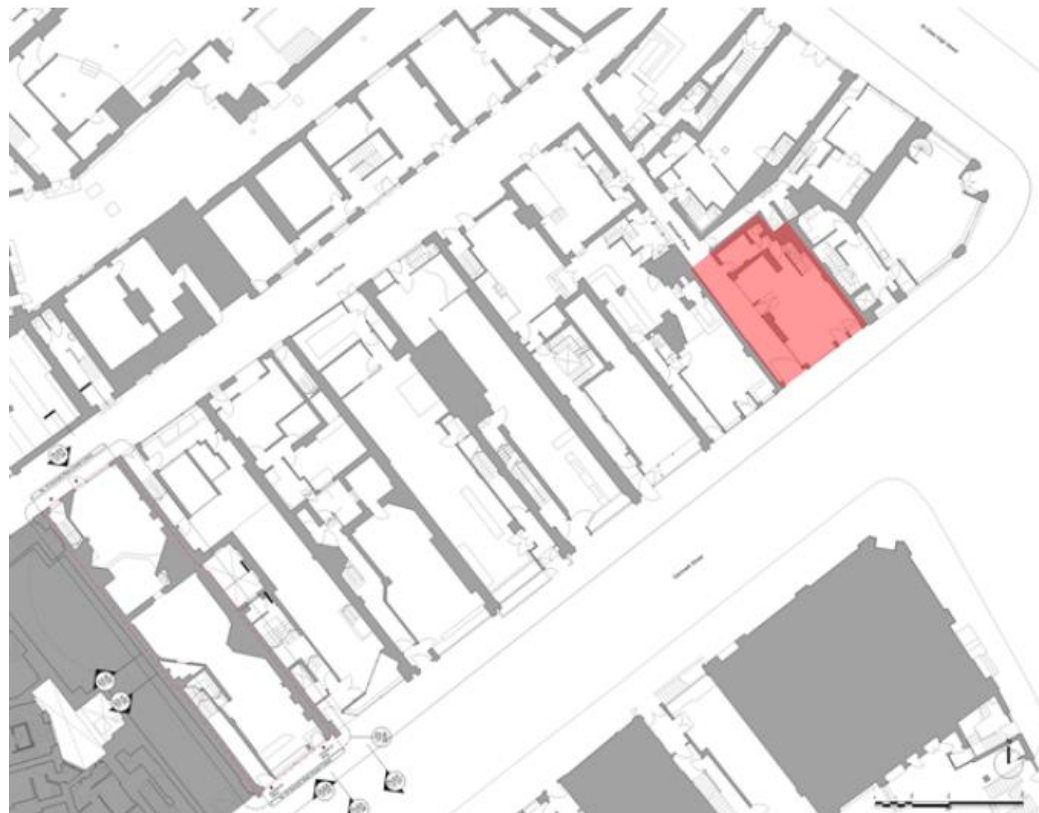
Figure 5.16: Location of No 27 Denmark Street

- 5.8.3 The floors are of timber construction with the floor boards at third floor level running perpendicular to the front facade, indicating that the joists would span parallel to the front facade. A large chimney breast is located in the centre of the floor at first, second and third floor levels.
- 5.8.4 At ground floor level this is located in the wall to the ginnel and is considerably smaller than on the upper floors, the eccentric loading from the chimney above is supported by a first floor beam that spans across to party wall. At first and second floor, the floors have been finished with later floor boards to provide a level floor structure, the facilities manager reported that this was done around 2011.

- 5.8.5 It is not possible to confirm either the direction of the floor span, or if the floor structures have been replaced during the levelling exercise. The original London valley roof has been replaced with a flat roof with asphalt finishes.

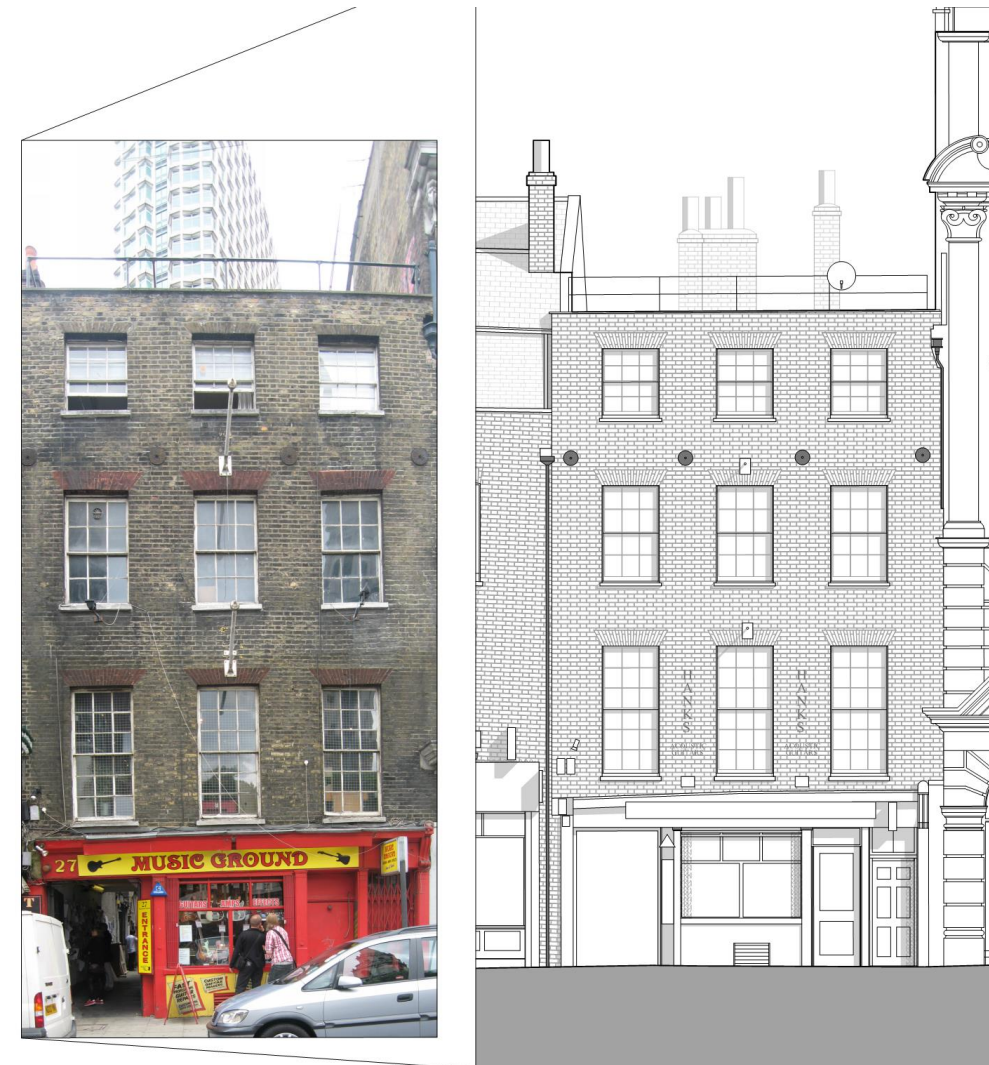
Figure 5.17: Front Elevation

- 5.8.8 The property has experienced some movement, particularly adjacent to No 26 where there is some settlement however this is less than at No. 26. As a result of this movement some minor cracking in internal finishes to the front facade was noted at third floor level. These finishes are old so it was not possible to determine how recent this movement was. Movement monitoring of the Denmark Street façade installed in February 2015 has shown no significant further movement.

- 5.8.9 The rear façade shows evidence of historic movement and rebuilding at high level. The floor structures at ground, first and second floor have been re-levelled and are in reasonable condition. The floor structure at third floor is much older and has sagged noticeably and is more mobile than the other floors.

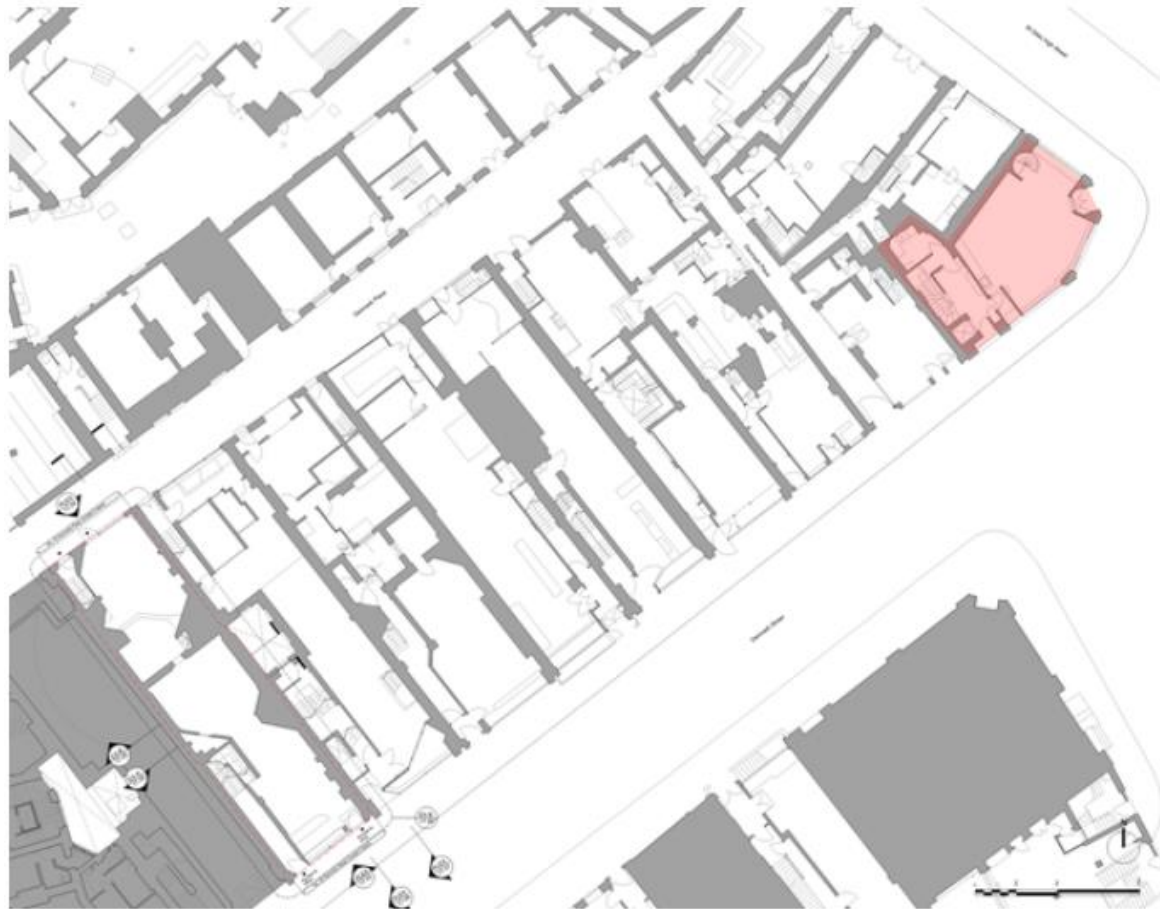
**Figure 5.18: Location of No 28 Denmark Street**

- 5.9.1 No. 28 Denmark Street is a 5 storey plus lower ground floor building, believed to have been built early in the 20th century. The building occupies the corner site of Denmark Street and St Giles High Street. The building is abutted on both sides by listed buildings. A high degree of fenestration is apparent on the façade.
- 5.9.2 The building is currently retail use at lower ground and ground floor levels and office use from first to fourth floor level. The lower ground floor of the building is to be adapted to accommodate a UK Power Networks (UKPN) Switch room. This room is to meet UKPN infrastructure requirements, which includes increased loading, head heights and fire protection. The above floors are to be retained in their current use.

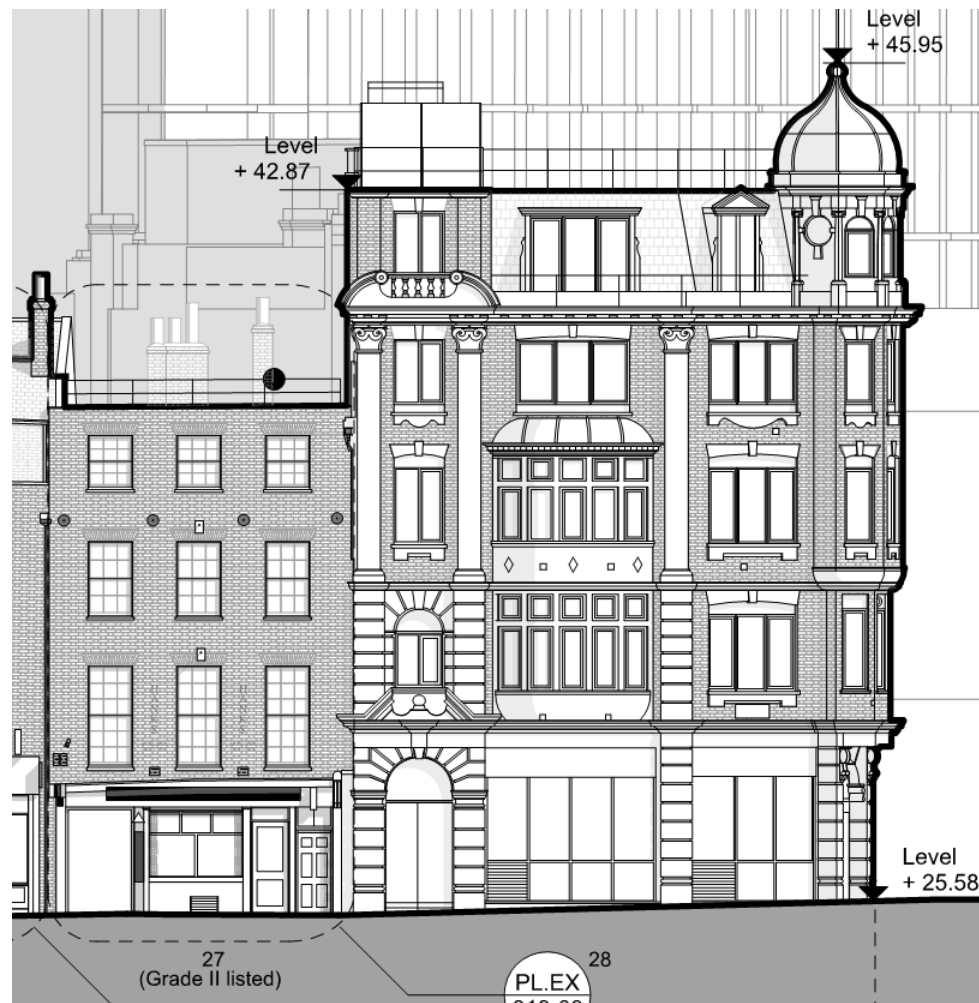
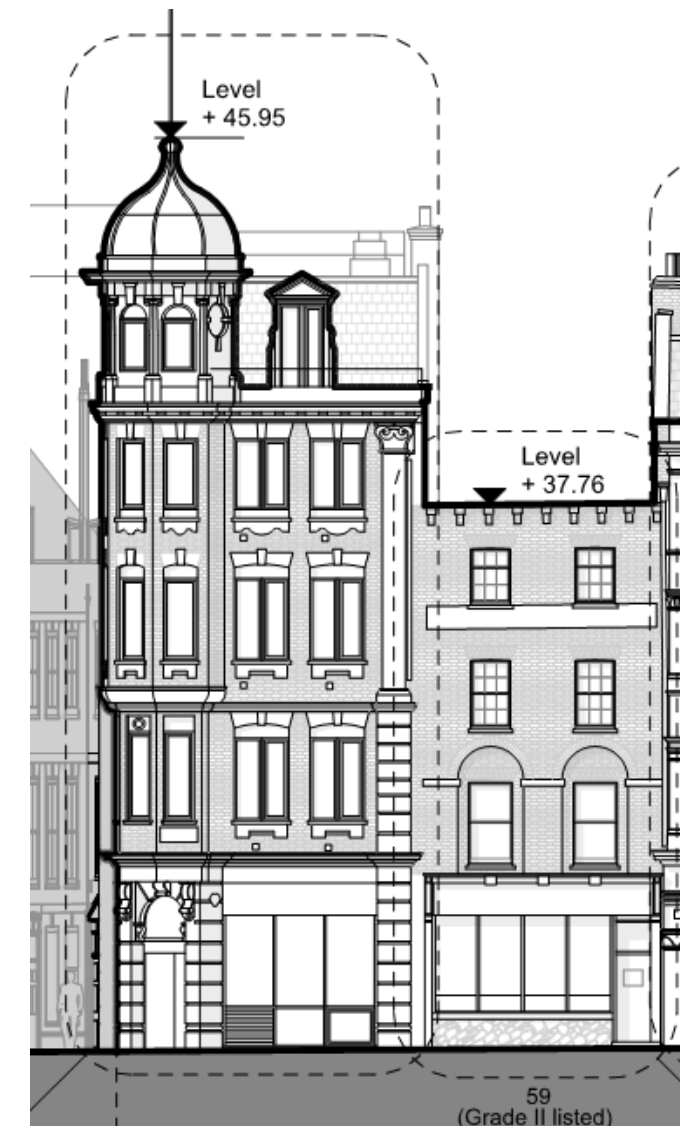
Figure 5.19: Front Elevation – Denmark Street

Figure 5.20: Front Elevation – St Giles High Street

- 5.9.3 The existing building is steel framed with concrete filler joist floors and masonry infill within the frame. The building has filler joist floors that span between the facade on St Giles High Street, a central steel spine beam, and the party wall to 27 Denmark Street. The central spine beam is supported by a steel column in the Denmark Street facade and it is believed a similar column exists in the party wall to 59 St Giles High Street. The lower ground floor has a ground bearing concrete slab and the building is founded on mass concrete footings that have been proved to extend at least 0.8m below the existing floor level.

- 5.9.4 The filler joist slab is of an unknown depth, and is observed to be in a poor condition at underside of ground floor slab level. The general condition of the building elsewhere was good. Local corrosion of the steelwork within the floor was noticeable adjacent to water sources.

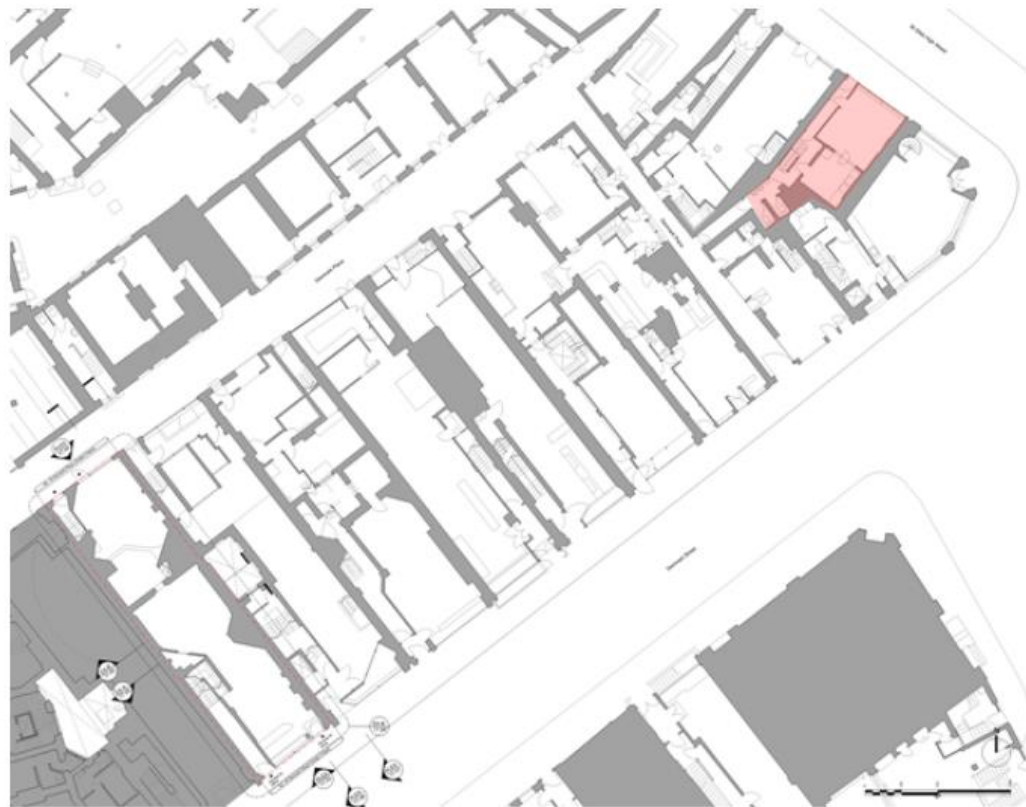
Figure 5.21: Location of No 59 St Giles High Street

- 5.10.1 The property is a four storey masonry building with mansard roof to the rear, which the Camden listed building register dates from the early 19th Century. The top floor of the front facade is of slightly later masonry construction than the floors below. There are two windows in the front facade. The original masonry front facade has been removed at ground floor level and replaced with steel beam and column.

- 5.10.2 Modern floor finishes on the upper floors meant that it was not possible to confirm the direction of the span of the floor, however from the deflected shape of the floor it is likely that the first floor spans between the masonry party walls and is trimmed around the chimney breasts that are retained on the party wall to No. 28 Denmark Street. The mansard roof has a central valley that runs from the front facade to the rear where it drains to a gutter behind a parapet. The timber stud wall around the stairs supports the rear portion of the upper floors and extends down to ground floor level. This wall is removed at lower ground floor level where a masonry wall is provided adjacent to the stairs. At lower ground floor level a masonry spine wall separated the front and rear portions of the building. In front of the building there is a former light-well that has been covered with a concrete slab supported by a steel beam to form the pavement above.

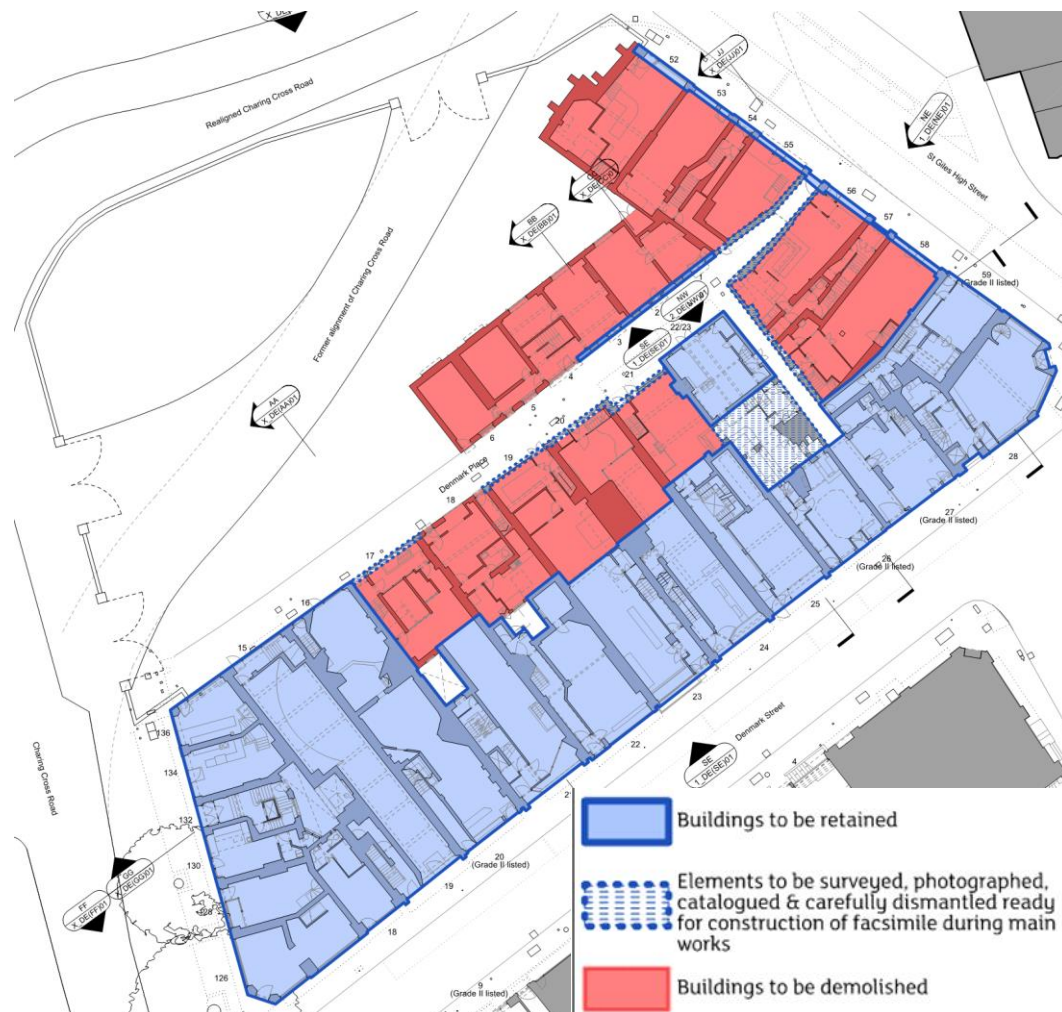
8.2.1 The site encompasses a range of different buildings with varying levels of demolition required (see figure 8.1), these include:

Figure 8.1: Extent of demolitions.

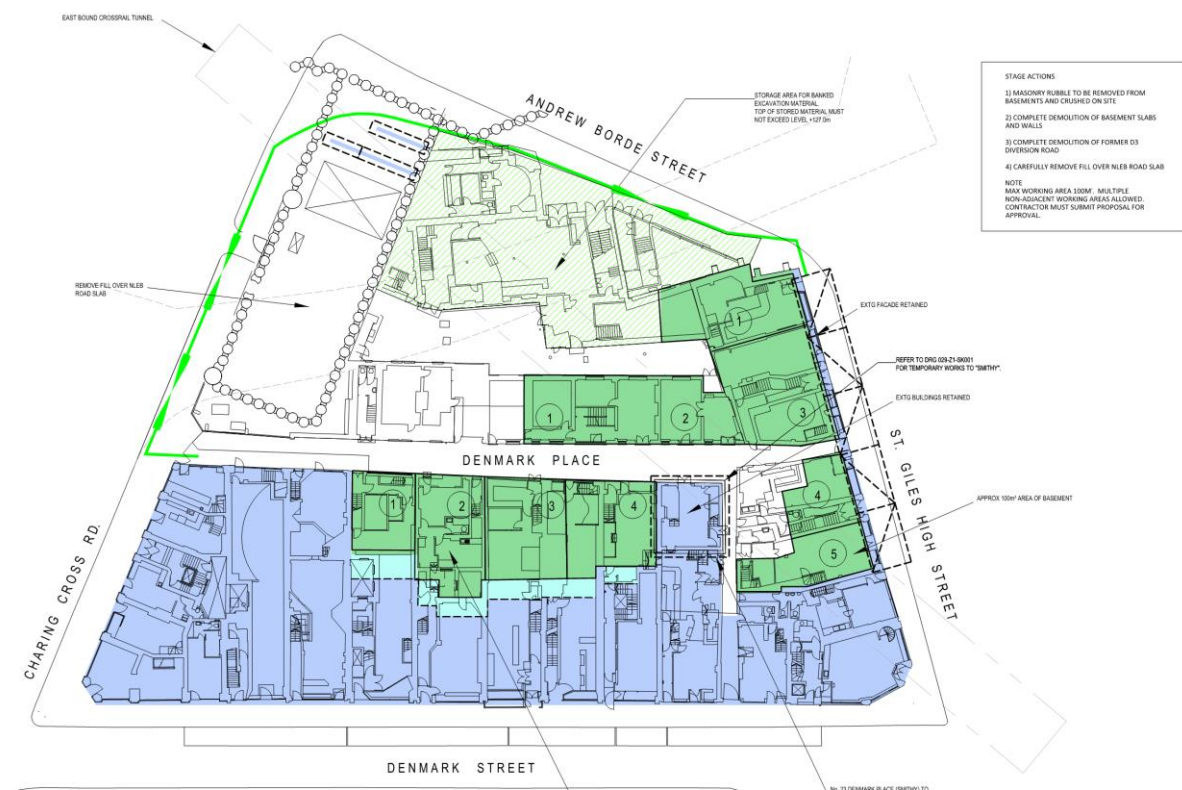
Figure 8.3: Breaking out of basements to be conducted in hit and miss arrangement.

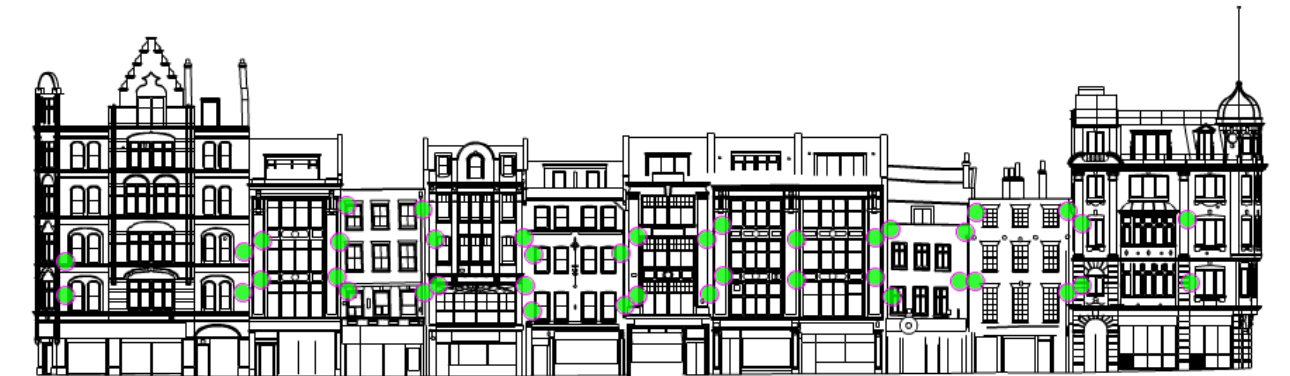
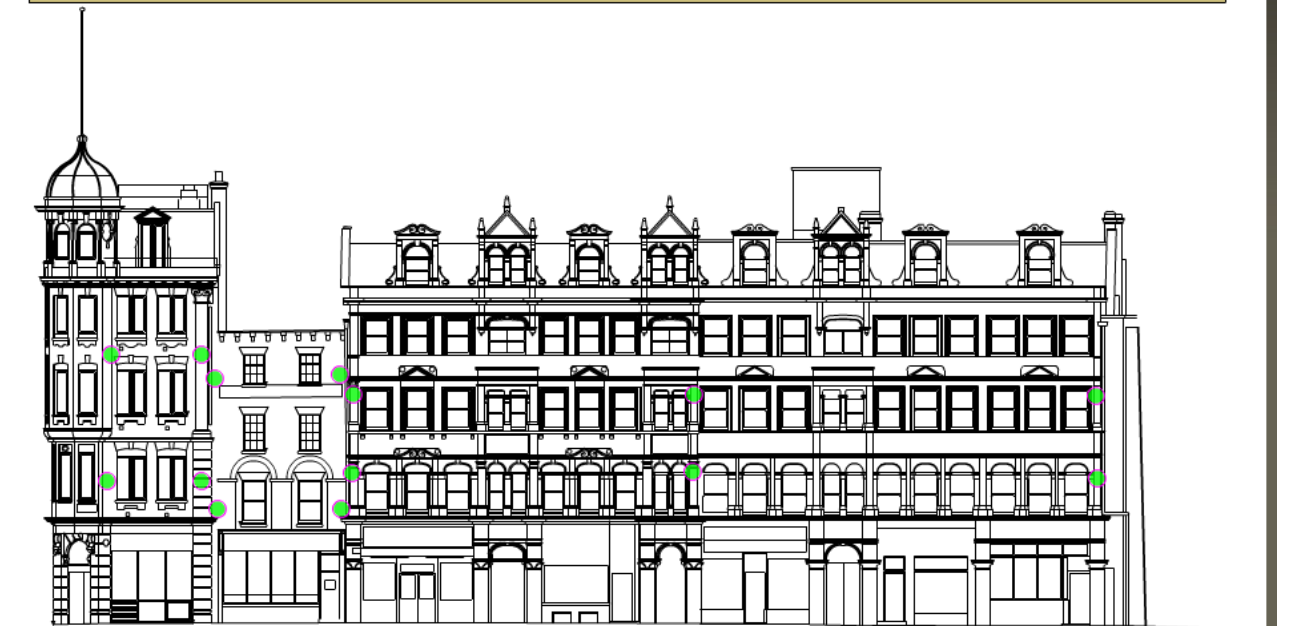
11.1.3 The majority of the prisms and ATS support brackets were originally installed for LUL/Crossrail as part of the Tottenham Court Road Station Upgrade Works, these were then purchased by the client and new ATS installed to commence monitoring in February 2015. Additional prisms have been installed on the rear façade of the Denmark Street properties (shown purple in figure 11.1). Initially it was not possible to sight these prisms from the ATS due to the mews buildings on Denmark Place so manual surveying was required during the demolition works, but now that these have been demolished these prisms will be added to the automatically monitored system. Figure 11.2 shows the prisms installed on the adjacent building elevations.

Figure 11.2: Denmark Street (north) and St Giles High Street façade monitoring (from SES website)
