## BIRKENHEAD BOUNDARY WALL

277A Gray's Inn Road, London  
December 2016

## **277A GRAY'S INN ROAD**

**ADDITIONAL INFO - WALL AND LIGHTWELLS TO  
BIRKENHEAD ESTATE**

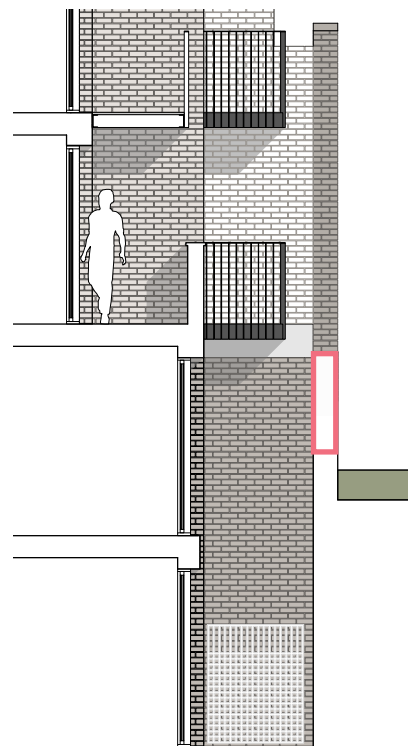
Consented 'Hit and Miss' brickwork  
proximity to private terrace / balcony

Annotated drawings highlighting the proximity to private residential balconies, which poses an obvious security risk.

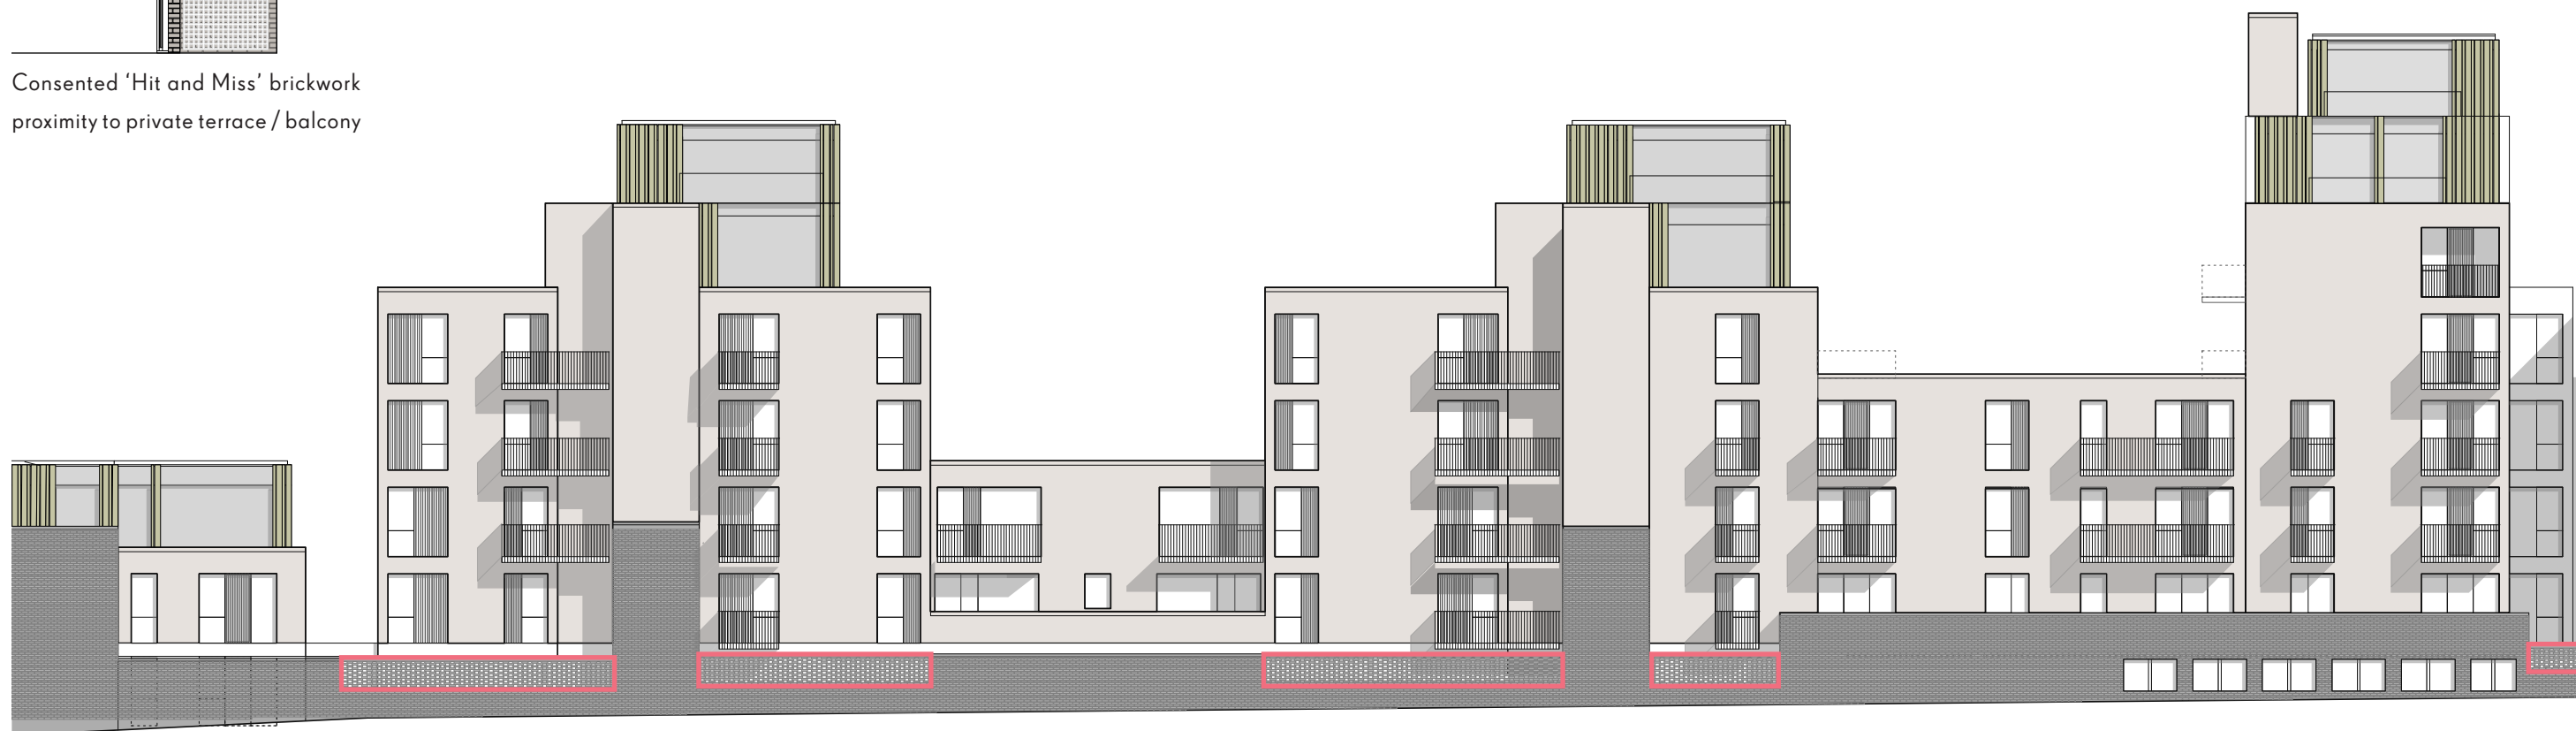
Consented areas of 'Hit and Miss' brickwork along the Birkenhead boundary wall.

Drawing extract from the original planning document showing the Birkenhead boundary wall, and the extent of the 'hit and miss' brickwork and where it occurs along the boundary.

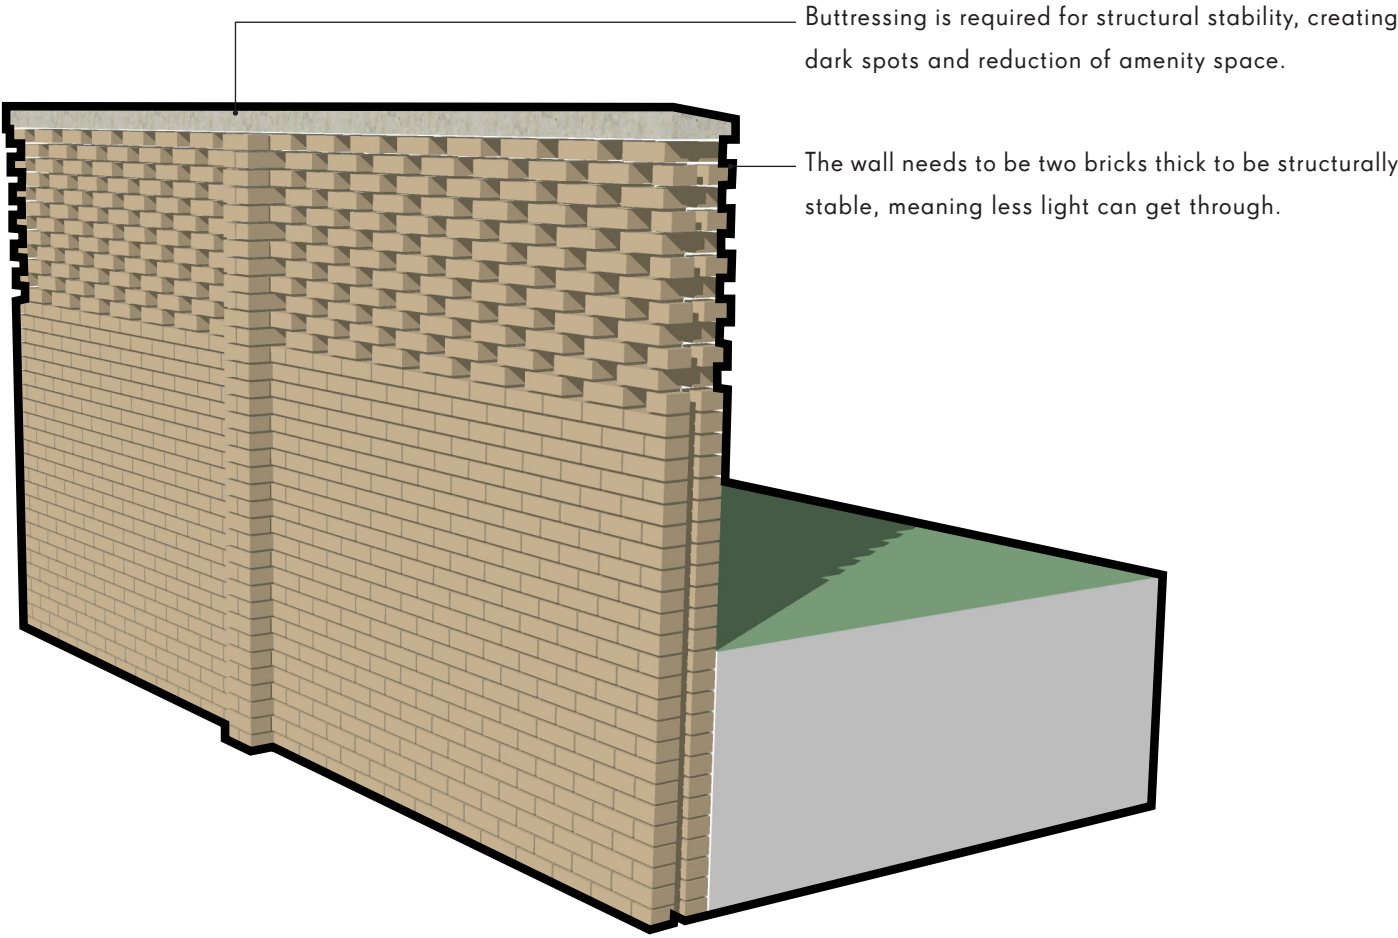
Consented wall as viewed from proposal side.

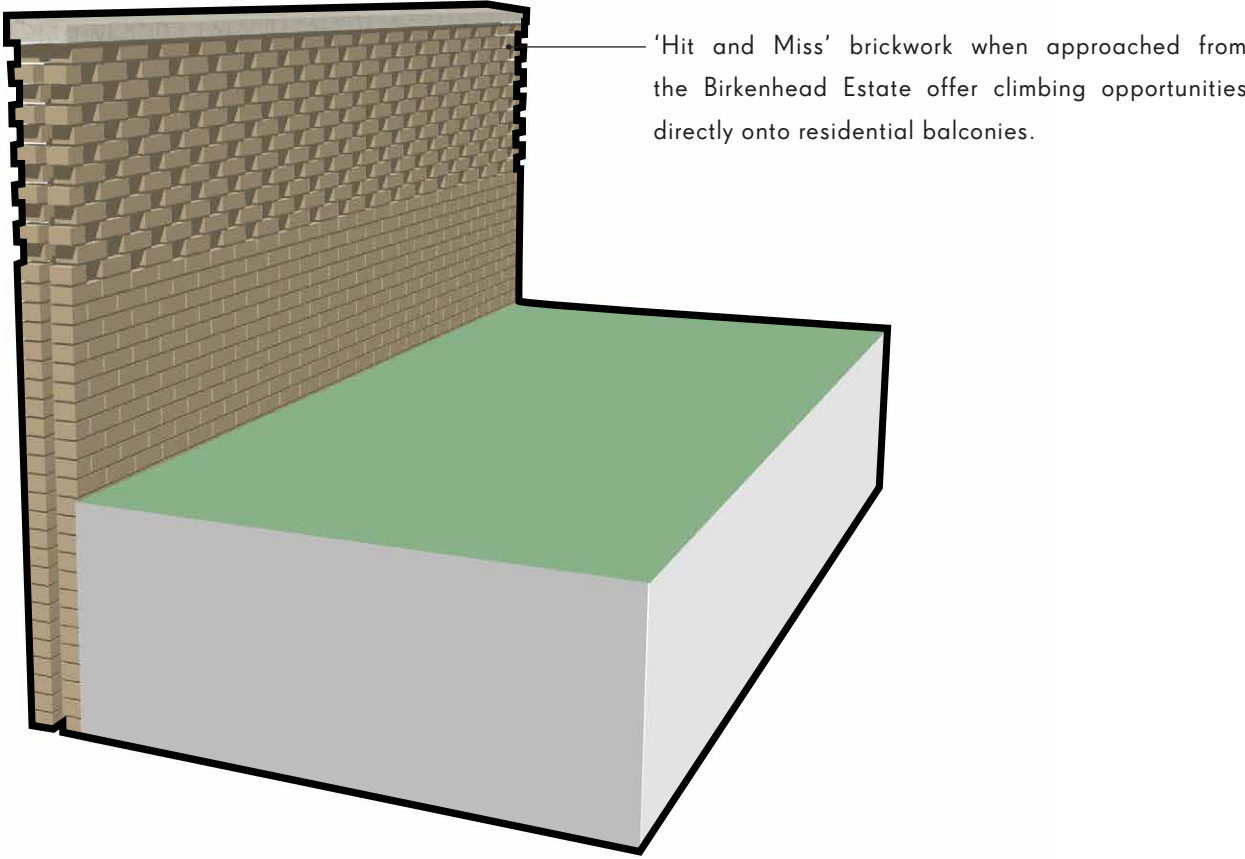
Consented wall as viewed form Birkenhead Estate.

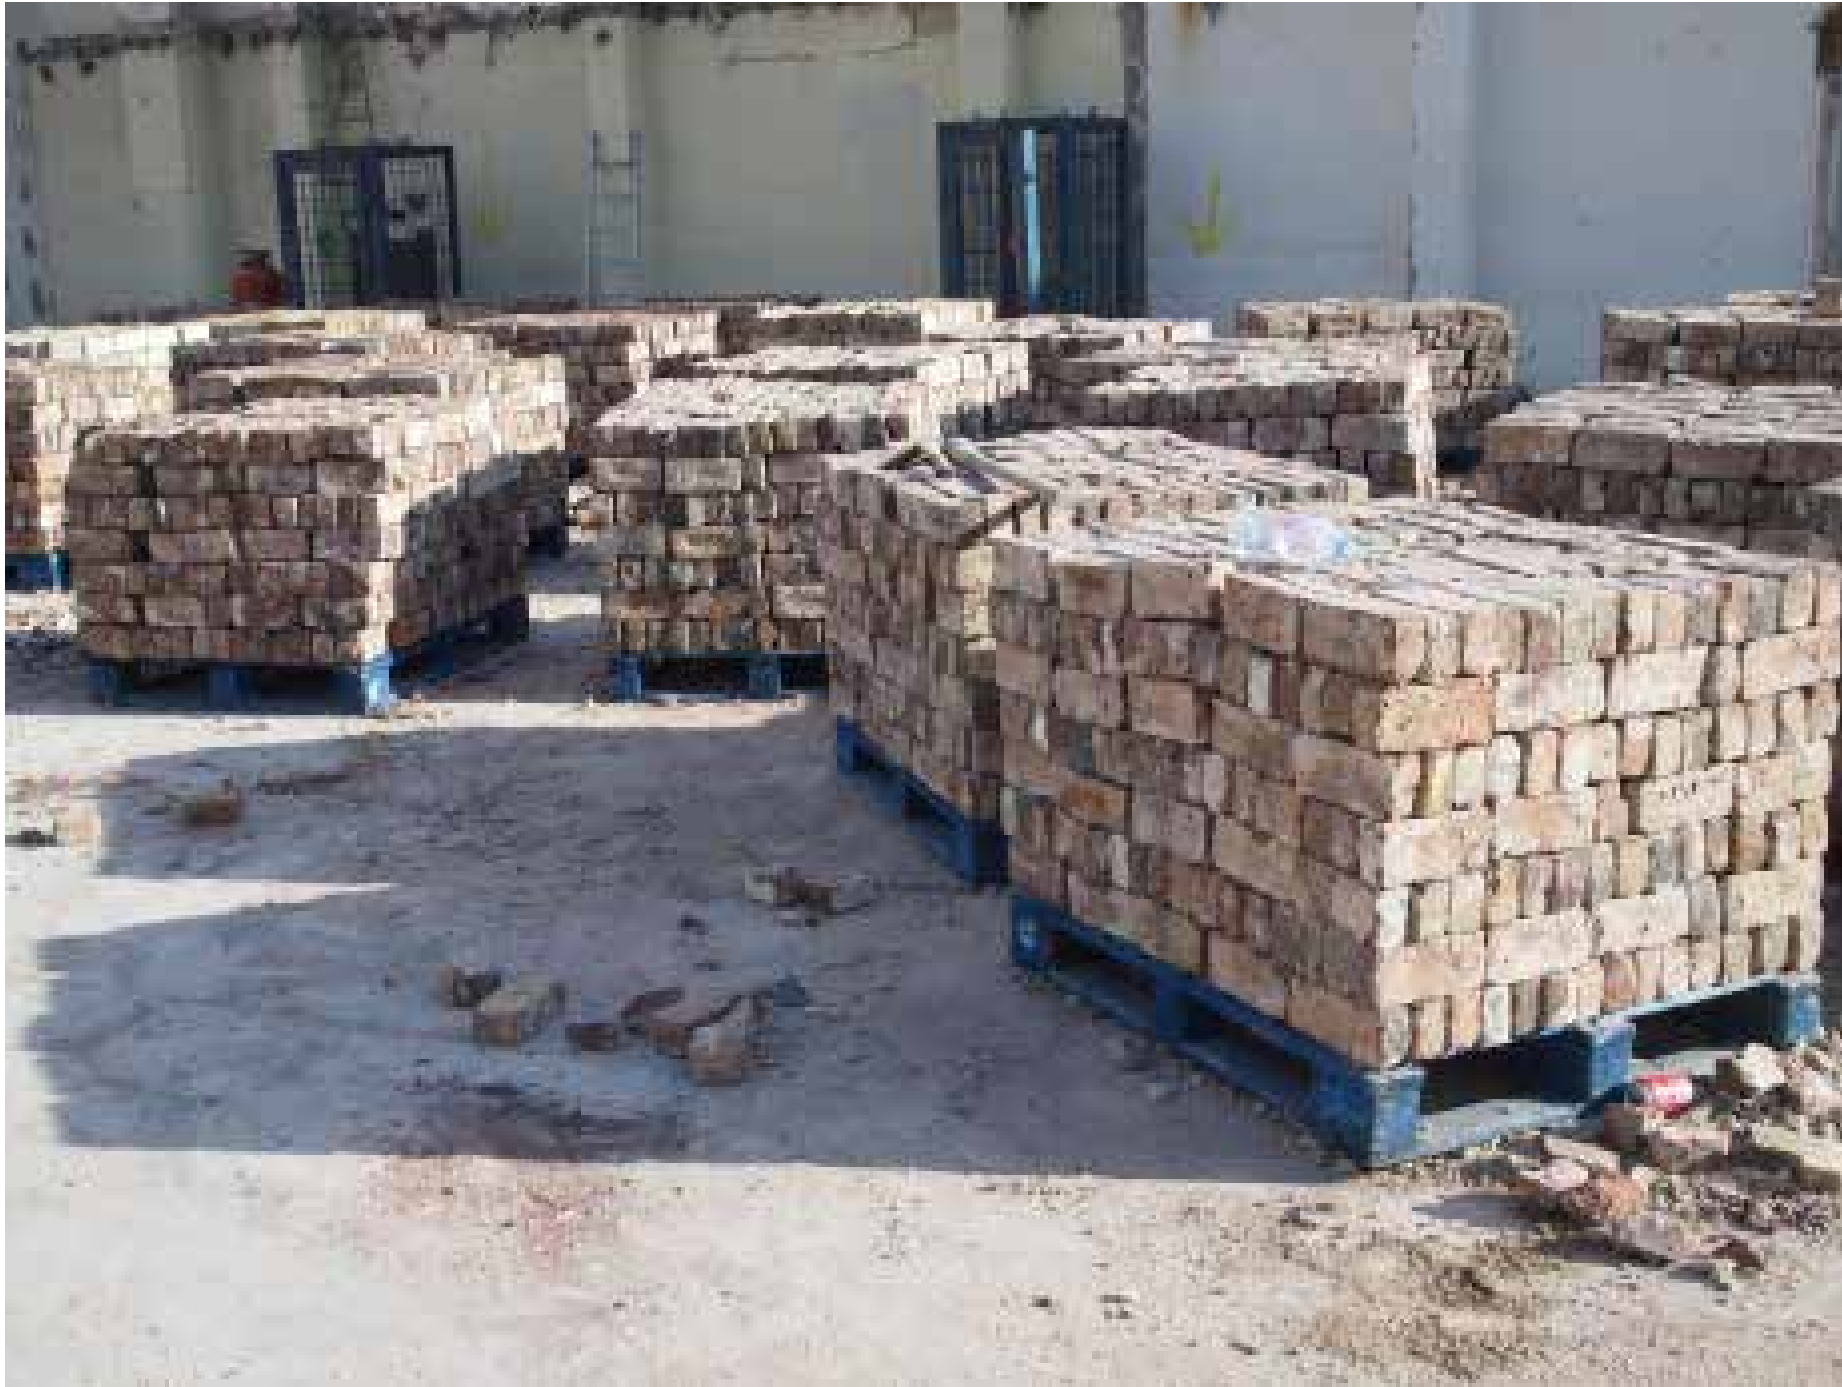
The bricks from the existing warehouse were reclaimed at the time of demolition and sent for storage off site at the demolition contractors yard.

The bricks organised ready for collection can be seen in the image to the left.

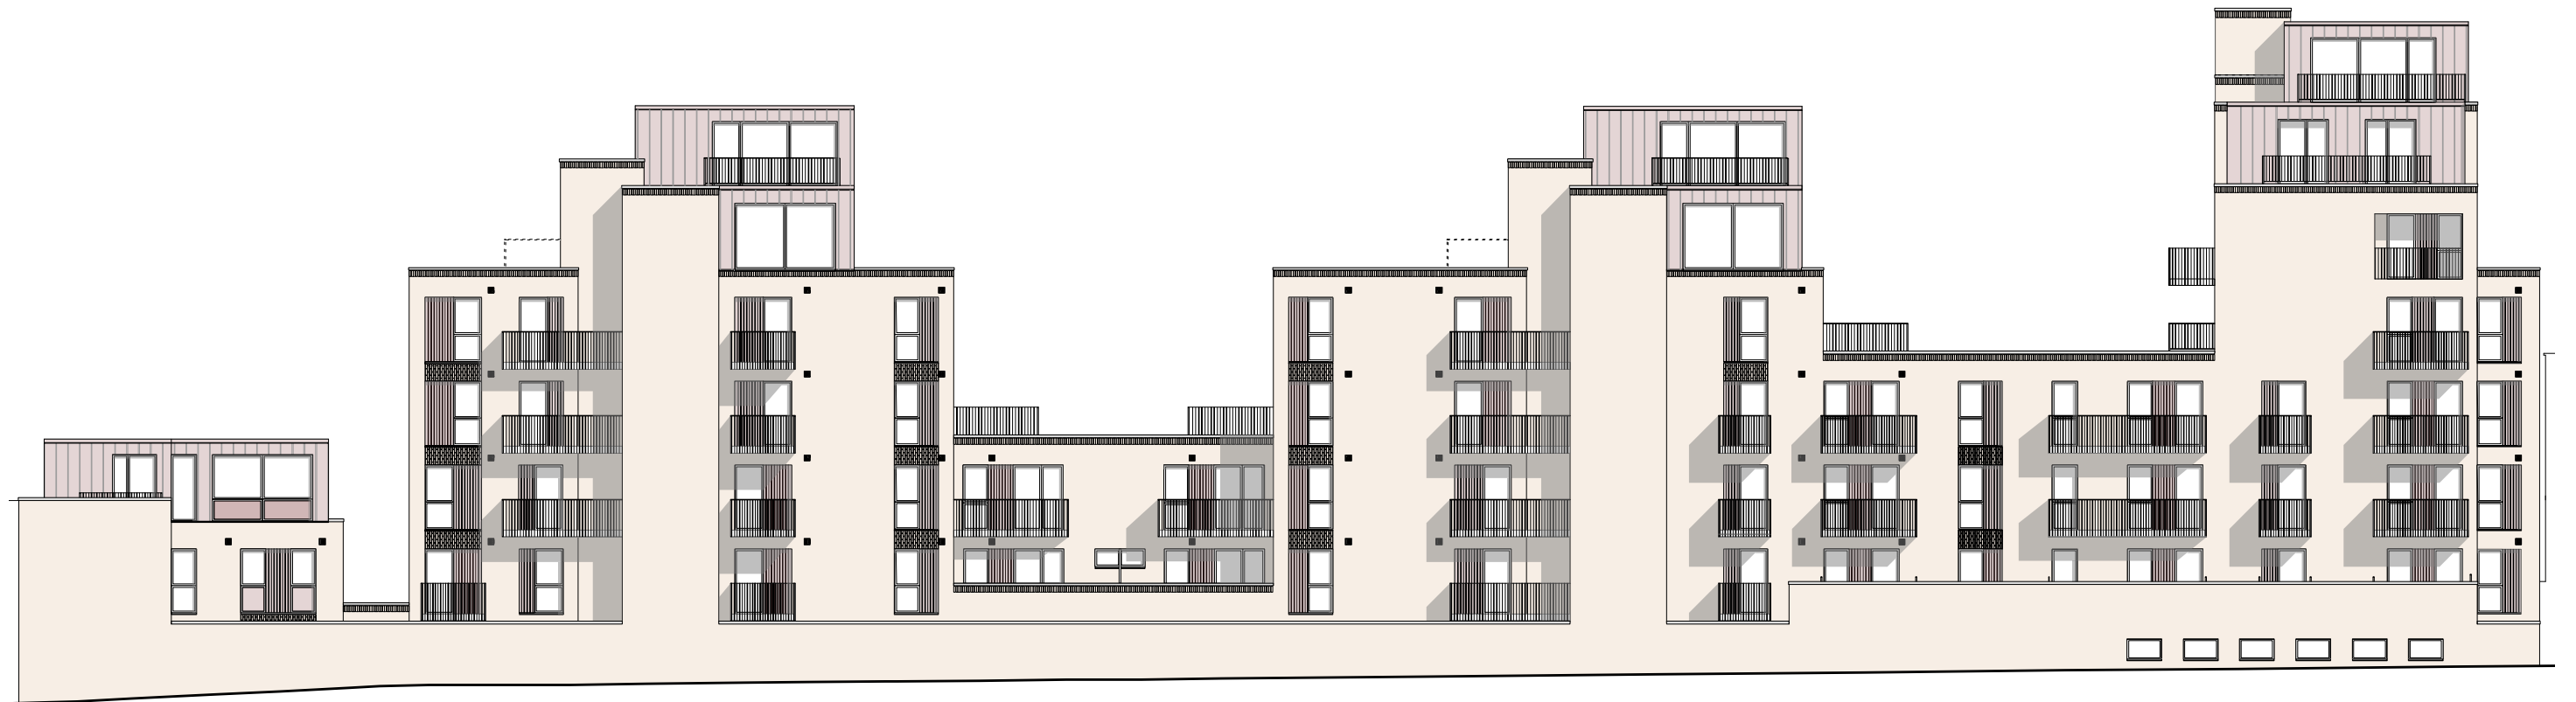
Due to the issues highlighted previously with the consented 'Hit and Miss' brickwork wall, we are proposing a solid brickwork wall to the Birkenhead boundary.

The proposed solid brickwork wall will alleviate any security risks whilst the matching brickwork will complement the scheme beyond.

Proposed solid brickwork wall to the Birkenhead boundary wall.

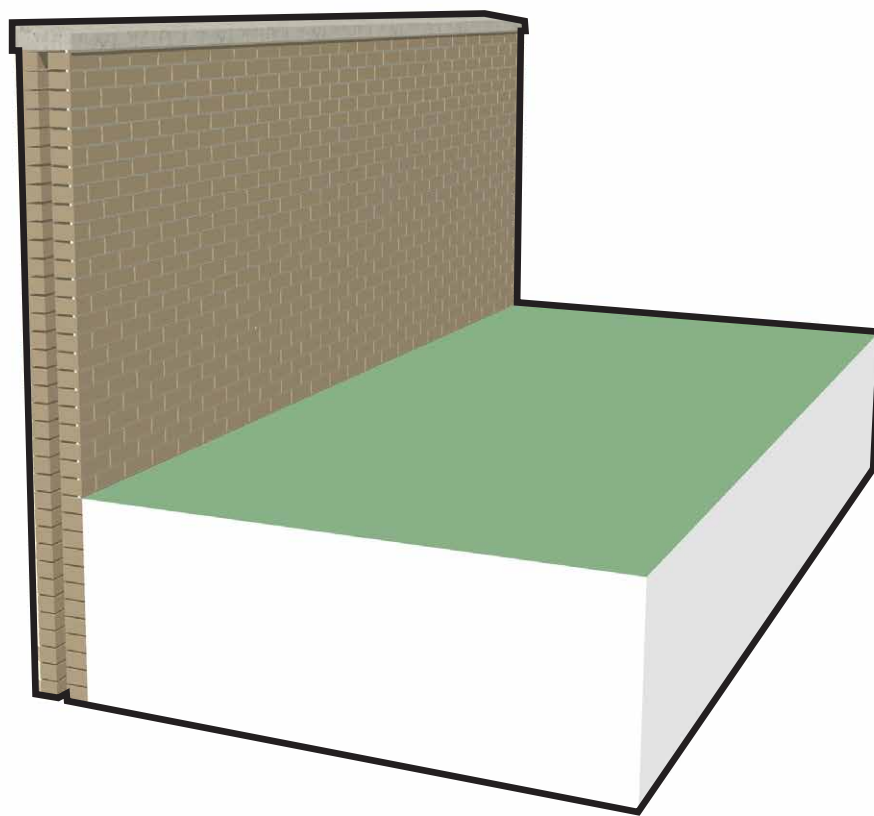
Detail section of the solid brickwork wall as viewed from the Birkenhead estate, and development side of the scheme.

Solid brickwork to the Birkenhead boundary wall.

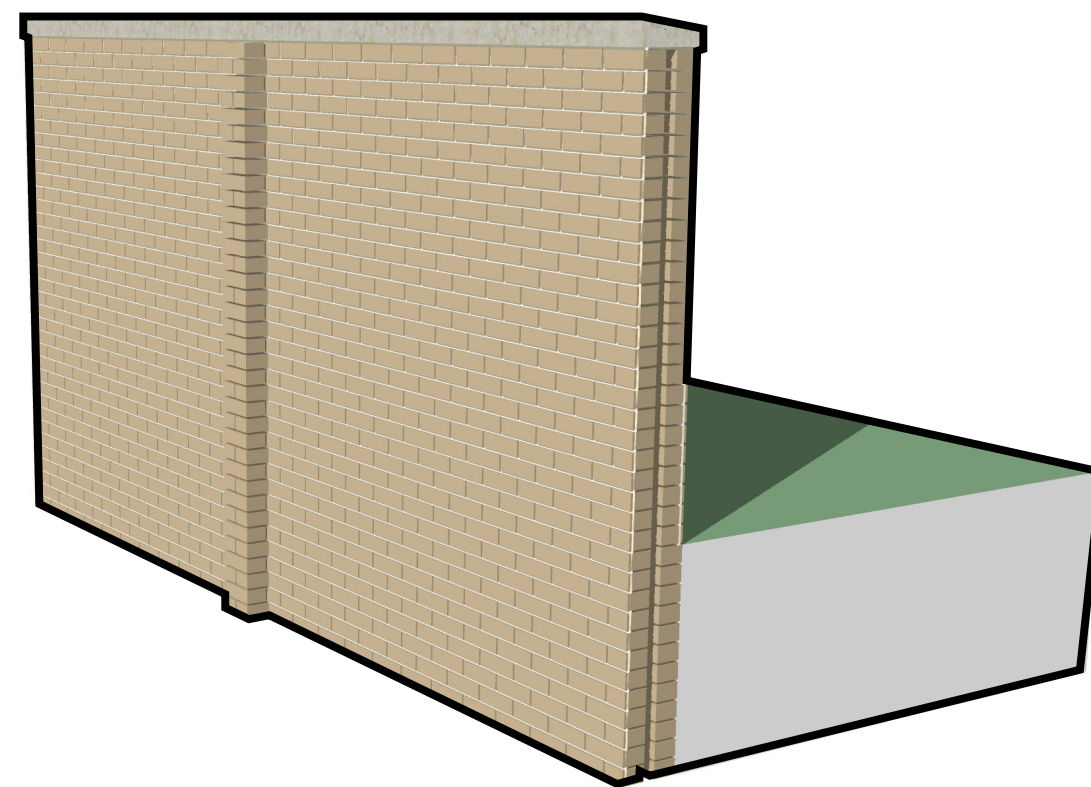
Solid brickwork as viewed from development side.
