# EMIL EVE ARCHITECTS

45 and 46 Red Lion Street, London, WC1R 4PF

## HERITAGE REPORT and DESIGN AND ACCESS STATEMENT

PLANNING APPLICATION SUBMISSION

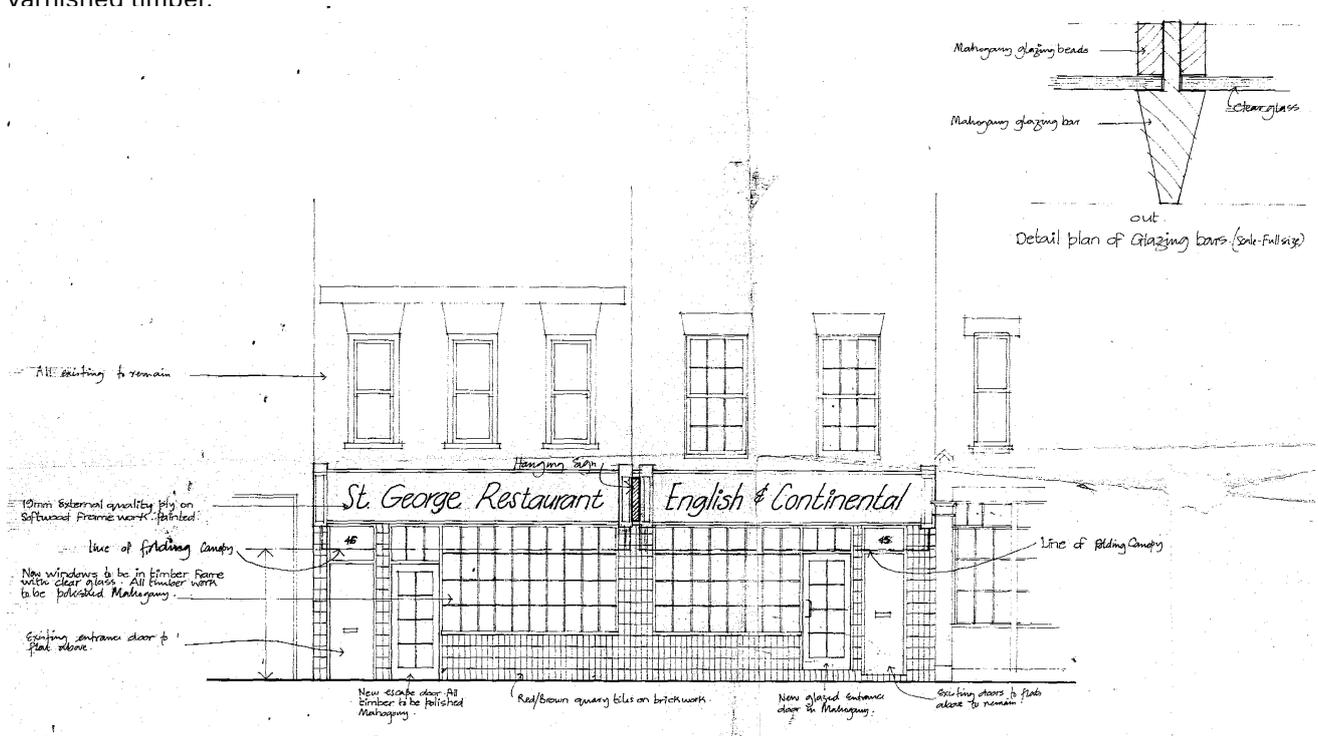
Planning drawing showing proposed works to restaurant facade, 1984

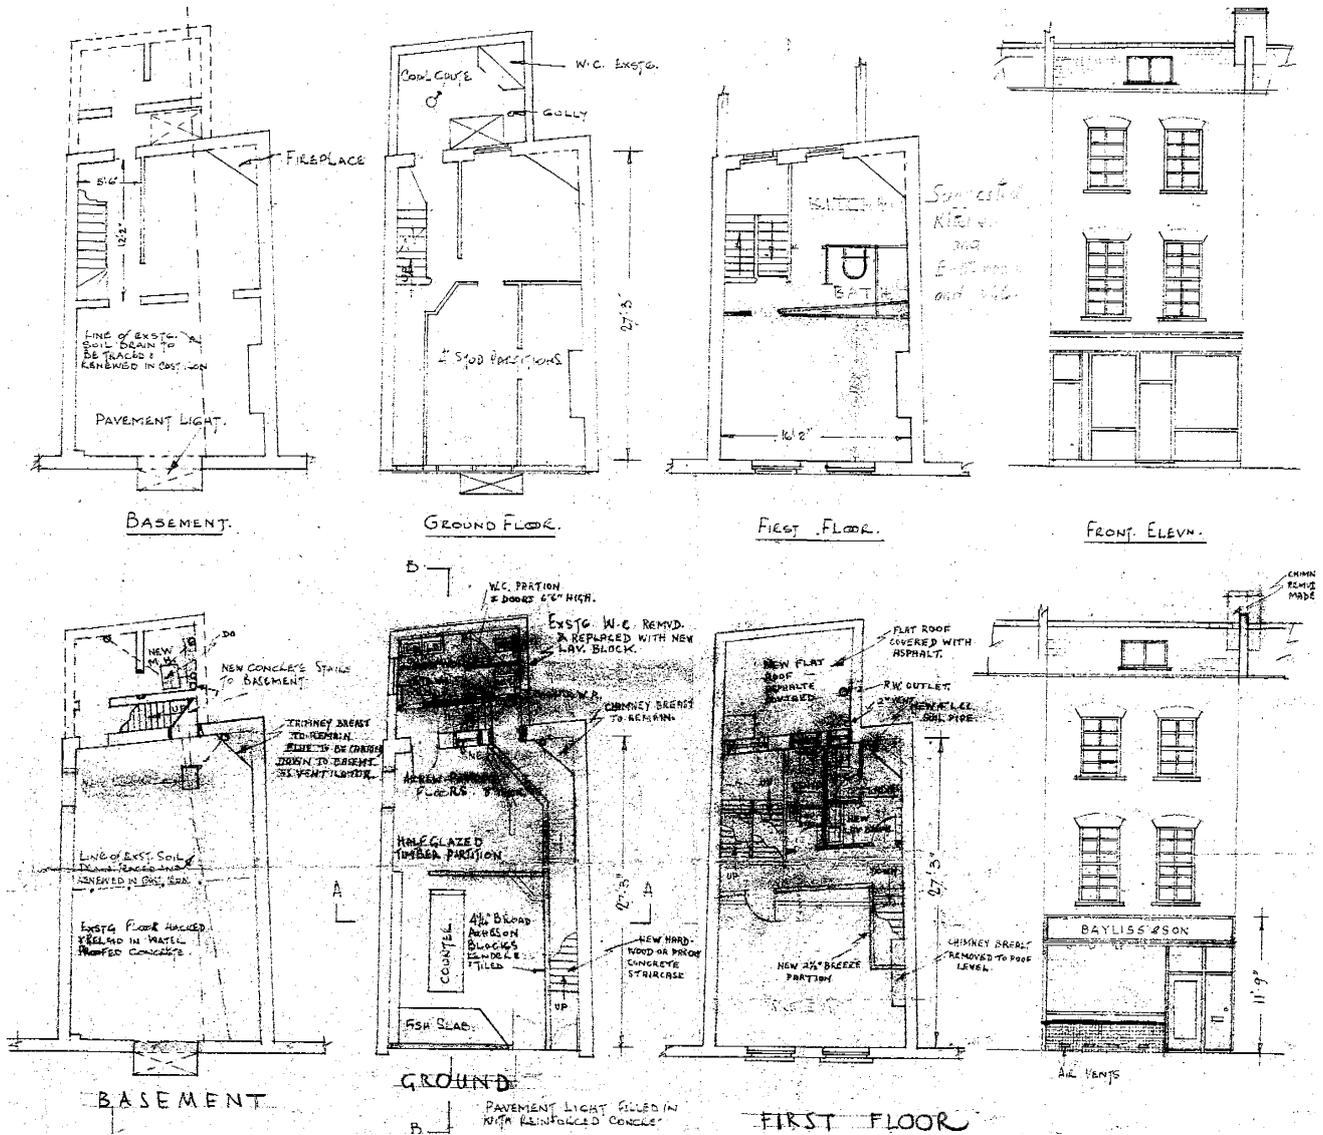
Planning drawing showing proposed works to property including repositioning stairs, 1959

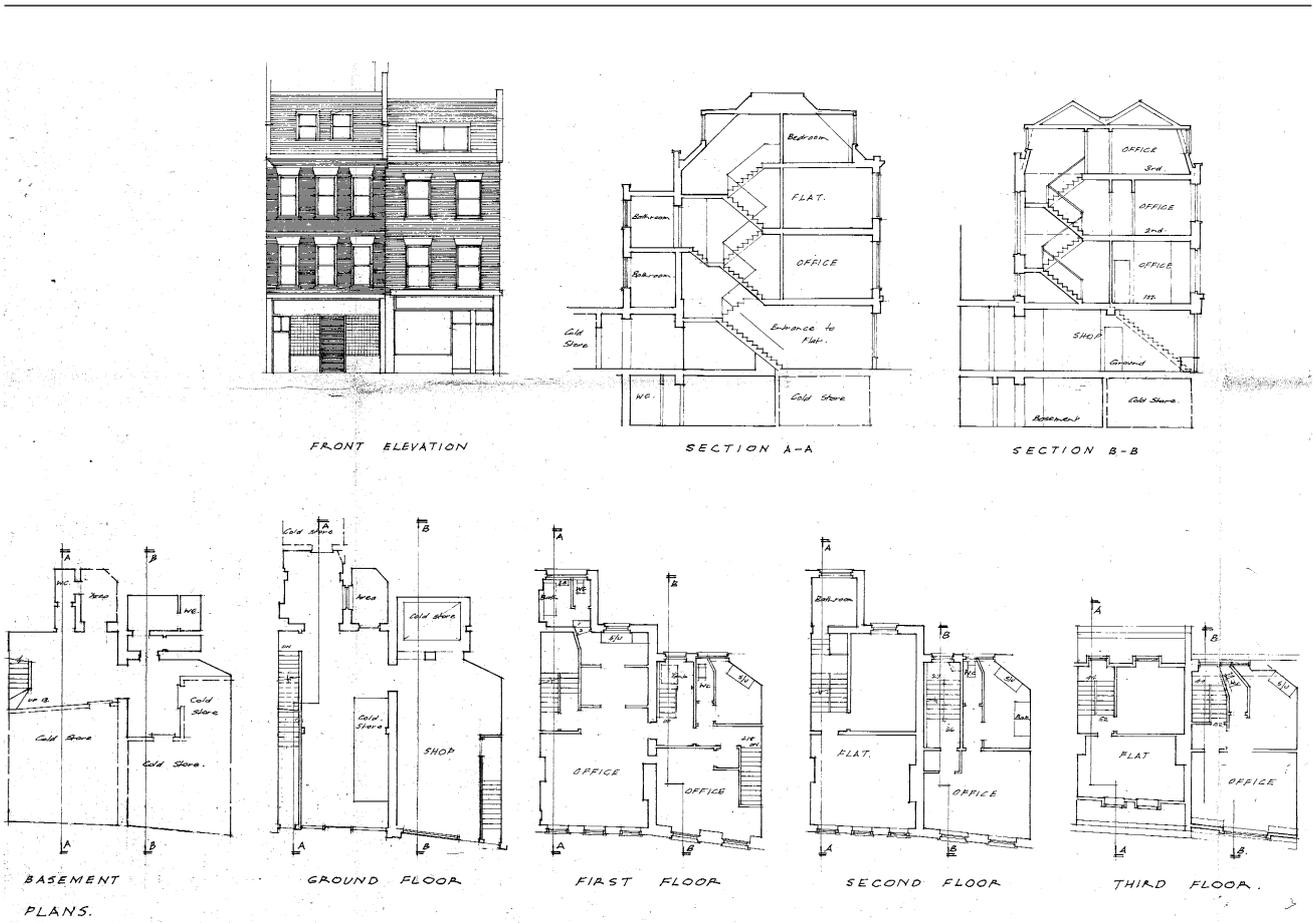
Planning drawing for change of basement and ground floor to restaurant, 1982

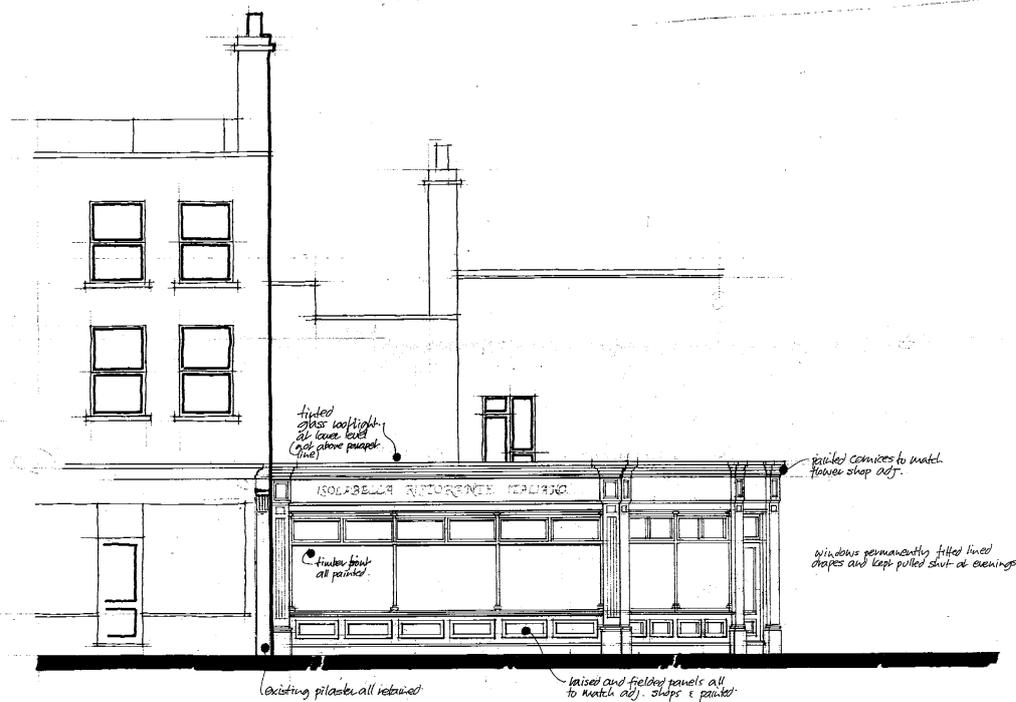
Planning drawing single storey rear extension, 1993

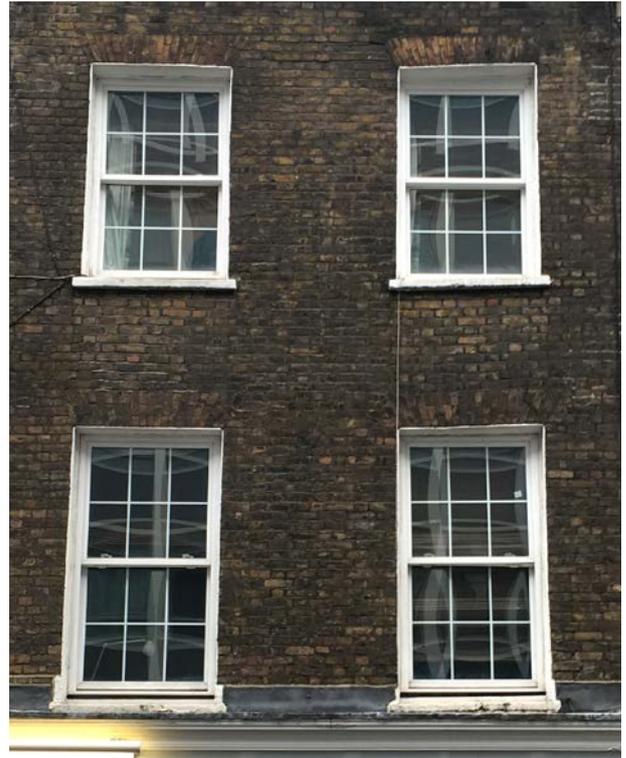
No 45: gauged yellow stock brick flat arches to recessed sashes

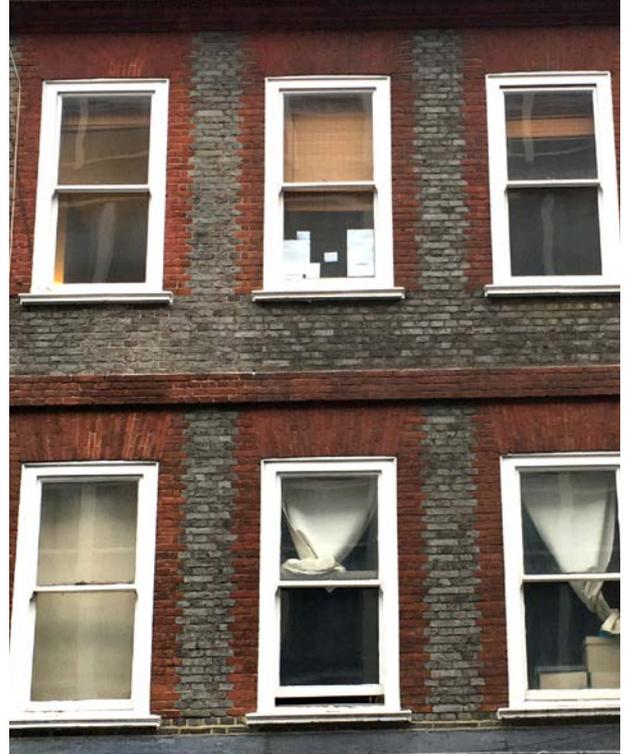
No 46: gauged red brick flat arches and red brick banding

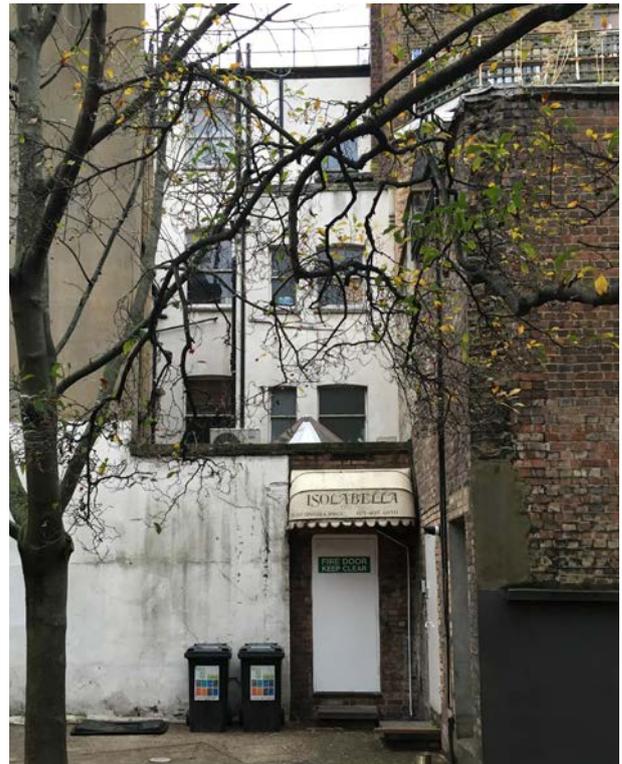
The rear facades of no's 45 and 46 are currently in a very poor state of repair. Concrete render is weathered and cracked and has been badly patched around window openings and service penetrations.

Rear elevation in poor state of repair

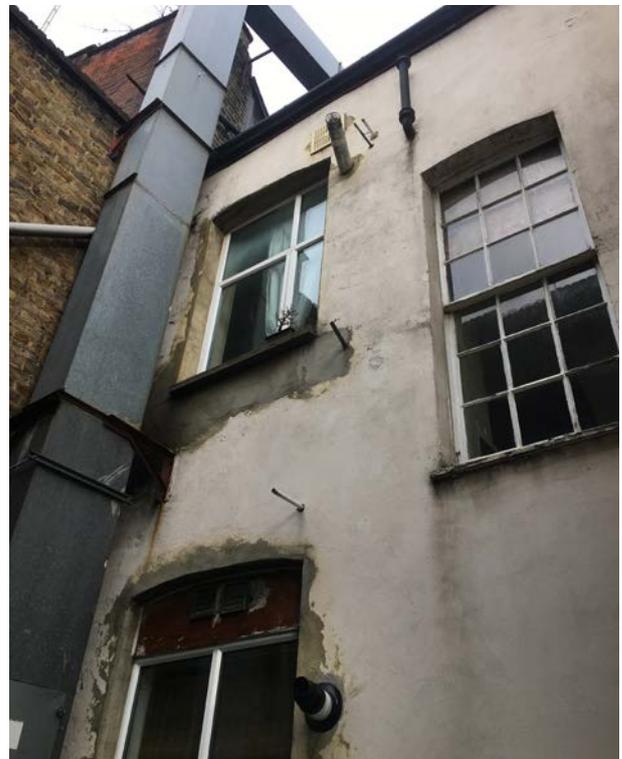
Unpainted and poorly executed render around windows and service penetrations

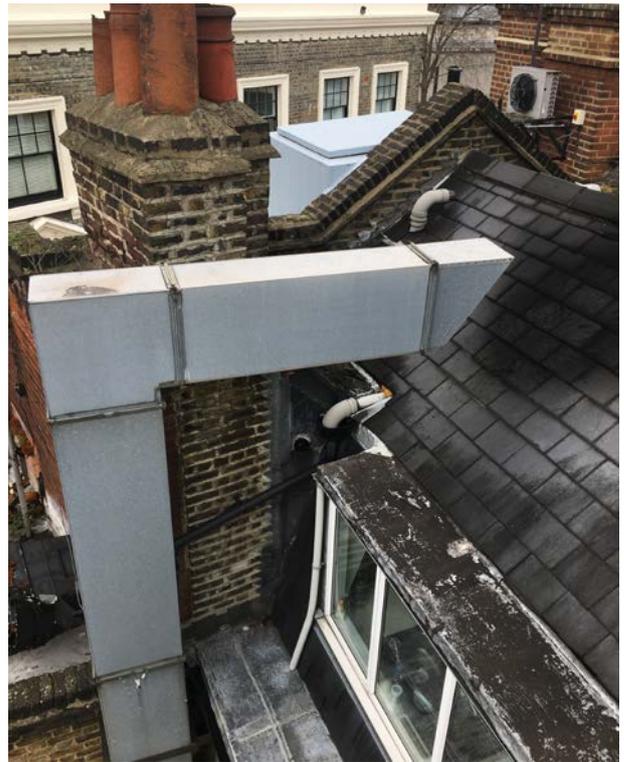
Vent extract from ground floor restaurant terminates towards rear roof slope

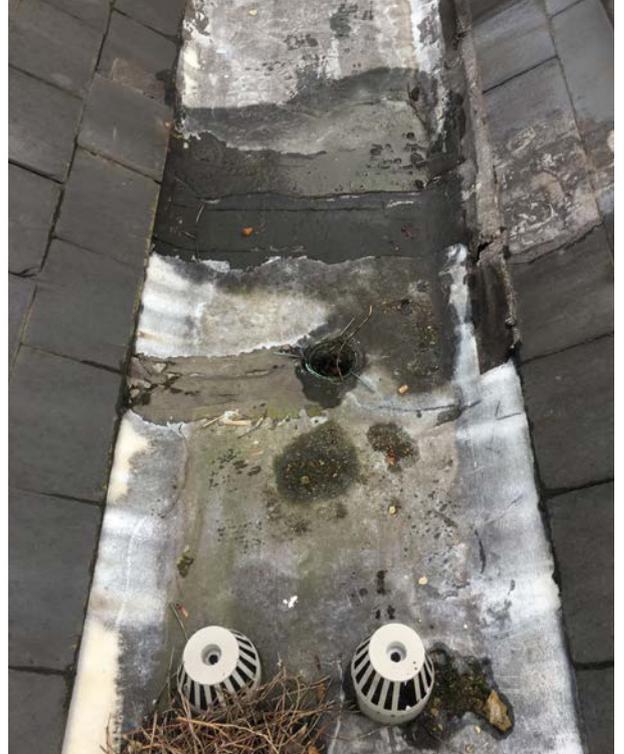
Poor quality lead valley which suffers often from flooding

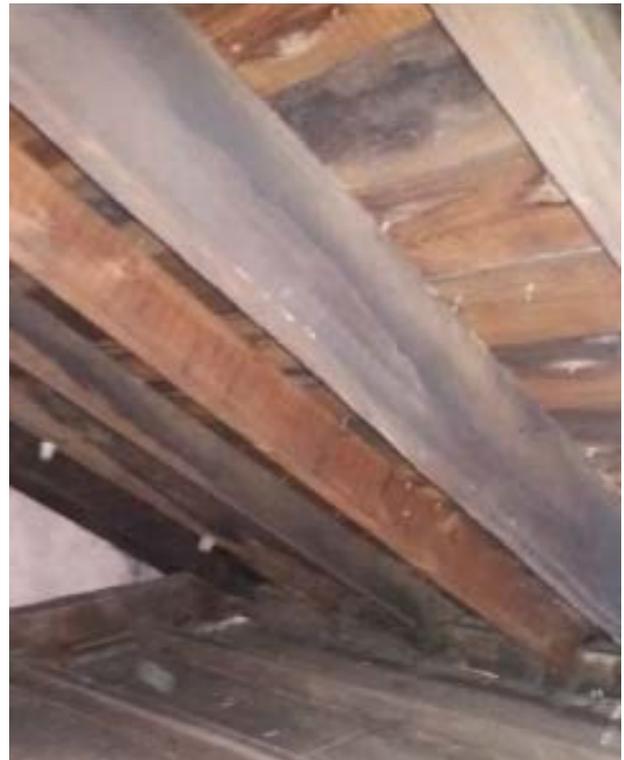
The report notes that *"it is fairly clear that many of the original roof timbers have been replaced with smaller, squarer scantling softwood members, many of which bear mechanical saw marks"*. One original collar has been observed however it is *"clearly not trusted to perform its original structure"* as it has been reinforced with a more recent timber.

Variable sized rafters of different ages - all thought to not be original

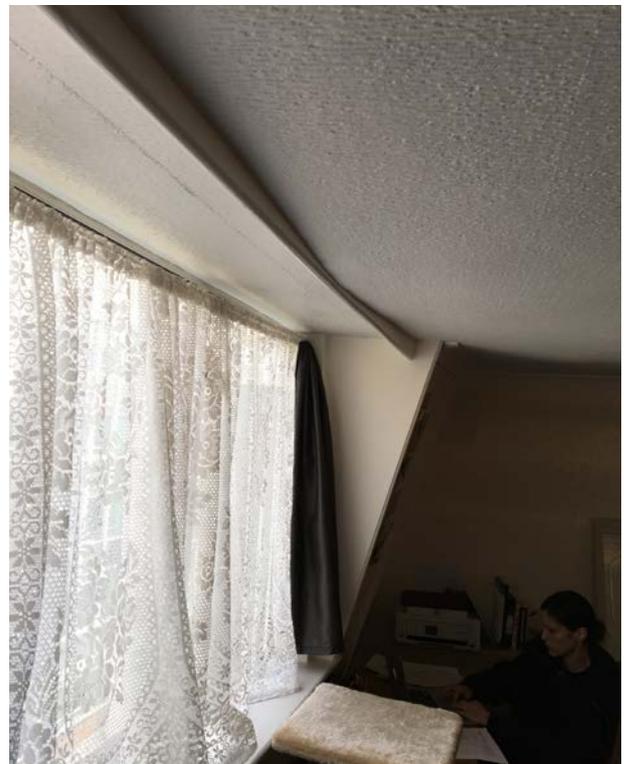
Ceiling in third floor flat is very low and can clearly seen to be sagging at centre

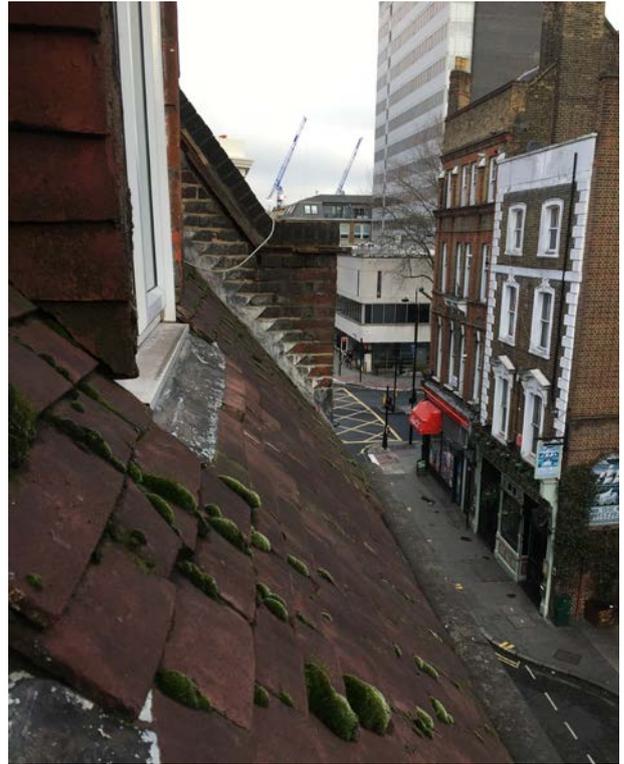
The roof at No 46 has a clay tiled slope to the street with two small dormer windows with tiled cheeks and bitumen felt roofs.

Tiled slope to street with tile-cheeked dormer windows

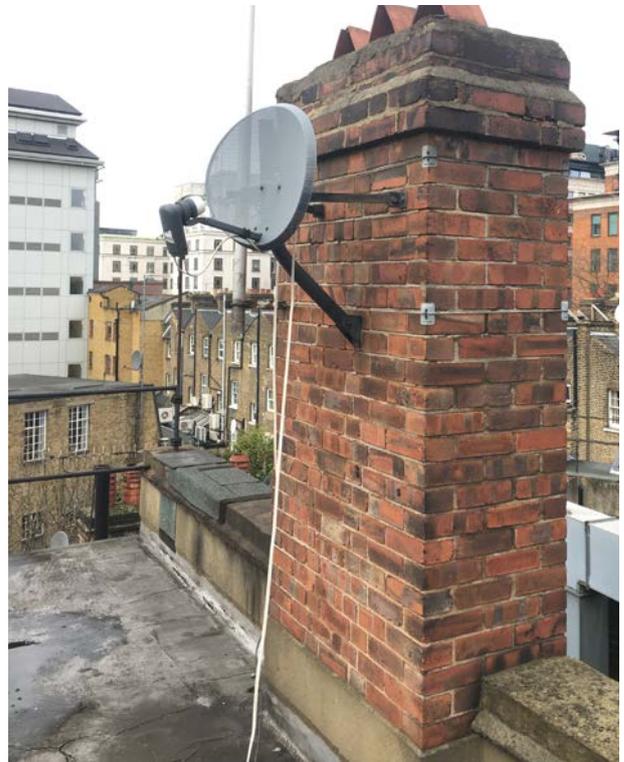
There is no loft space as this roof has been remodelled and a flat roof sits directly above the stair and third floor apartment. The flat roof is covered in bitumen felt which requires extensive repairs. Redundant services, including an old satellite dish, will be removed and repairs to copings undertaken.

Repairs required to roof and party wall coping and redundant services to be removed

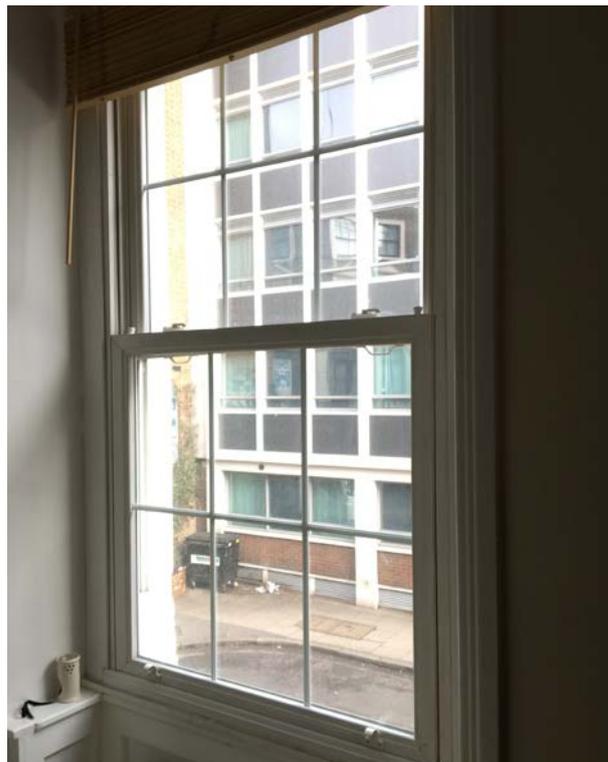
The front windows at no. 45 have all been replaced with double-glazed uPVC sash windows with stuck-on glazing bars which severely detract from the overall character of the property.

uPVC windows to front facade at no. 45

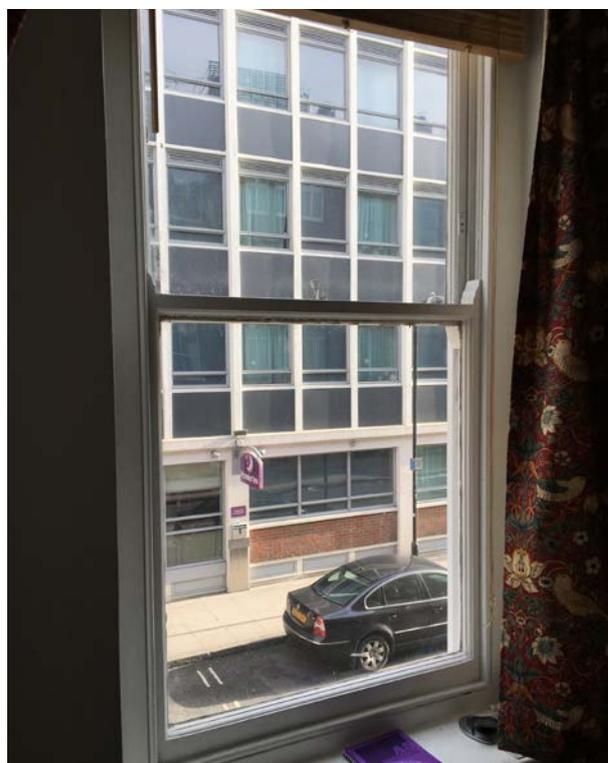
The front windows at no. 46 are single-glazed timber-framed sashes however these appear to be recent as the frames are crisp and the glass is float glass without glazing bars. In addition some of the frames and sashes are rotten and require repairs or replacement.

Recent timber sash windows to front facade at no. 46

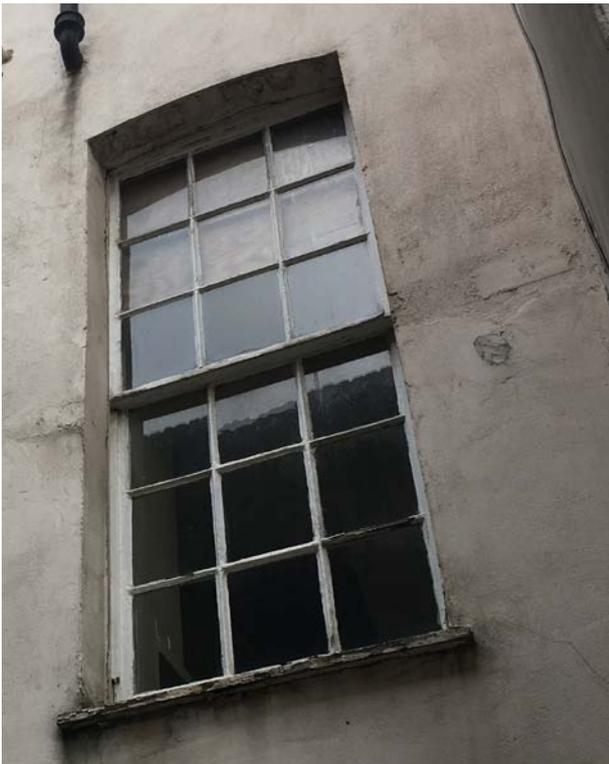
The exception is the large window to the second floor stair landing at no. 46. Although the glass appears recent, the frame is considered to be original and incorporates original lambs tongue glazing bars and timber panelling internally.

Large original window to rear appears complete from outside

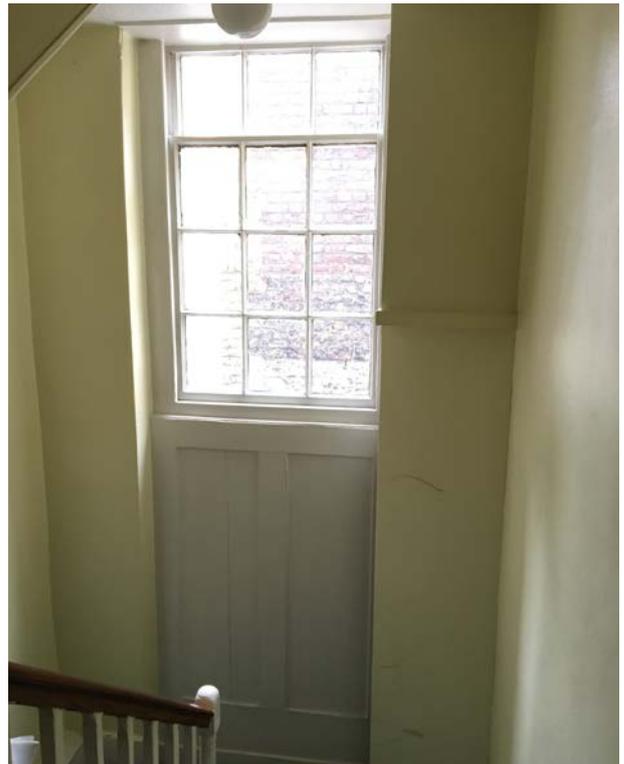
Although this window appears complete from the rear facade, internally it has been truncated and sealed off in line with the lowest top-sash glazing bars, most likely to separate the internal flats and meet fire regulations. This window is to be carefully repaired and decorated. Please refer to section 3.3.3 for more details.

Internally, this has been truncated. Original timber panelling remains below.

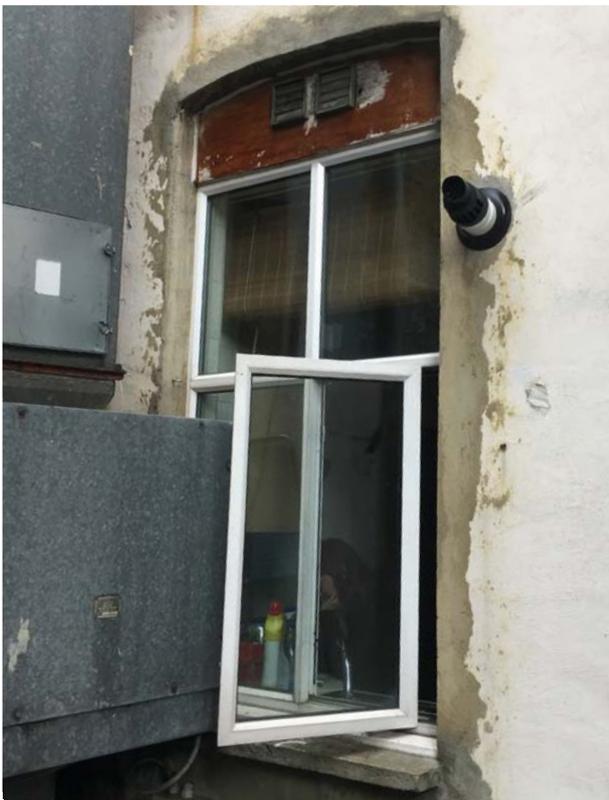
uPVC casements to rear of no. 45

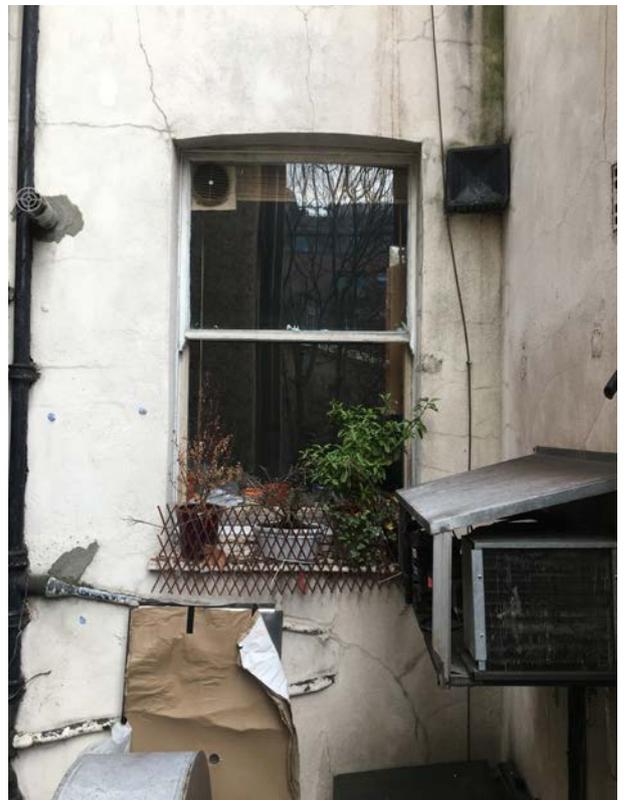
Recent timber sash windows to rear facade at no. 46

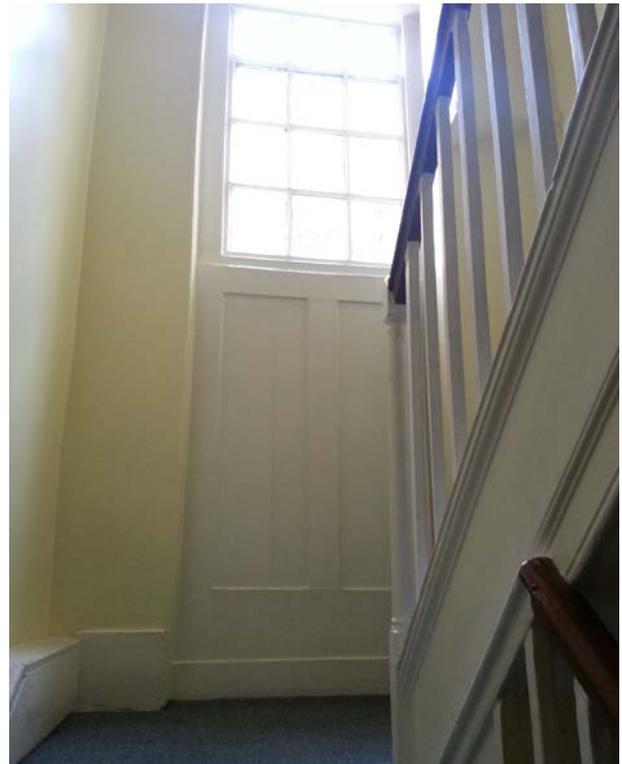
At no. 46, there is no evidence of original balustrades or newels. Linings and boxings have been added to separate the different flights.

Stair at no. 46: short run of historic painted timber stringers, newels and balustrades

The proposal is to remove modern linings and finishes to both stairs and reveal/retain as much of the historic balustrading as possible, refer to section 3.4.4 for more details.

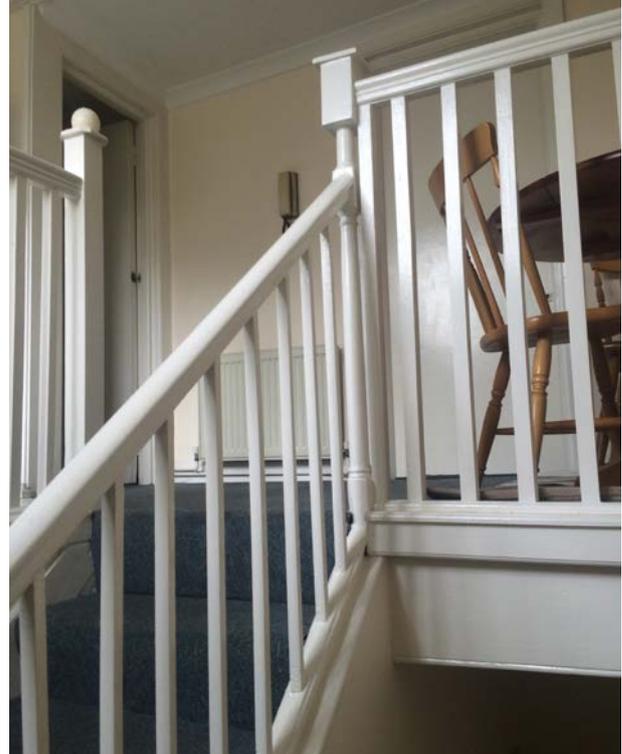
At the third floor the balustrade and newel have been replaced, probably at the same time as much of the structure was replaced (most evident in the level floors).

Replacement 20th Century balustrade at top floor
