Arboricultural Impact Analysis

**144 Mill Lane
London
NW6 1TF**

date: 07.04.17

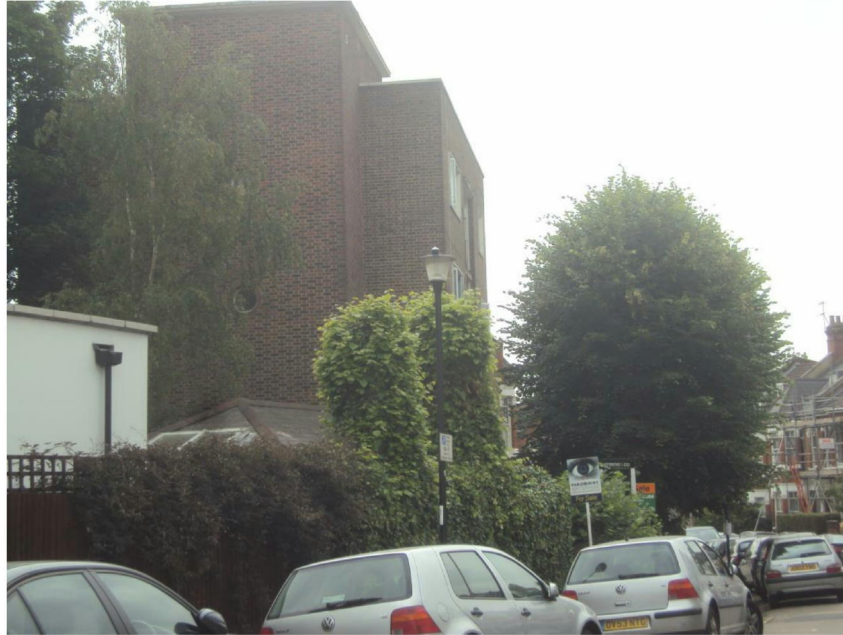
- 3.3.5 Such an approach would enhance the visual amenities of the locality in the short-to-medium term.
- 3.3.6 The successful establishment of a row of young Limes on the Holmdale Road frontage of the adjacent apartments immediately to the east of the proposed development site also renders the continued retention of Trees 001 and 002 less critical than it might at one time have been (see **Photograph 1** in **Appendix b**).

Photograph 1: Limes 001 and 002 in foreground, Birch 003 on left edge of image, young Limes in Holmdale Road behind

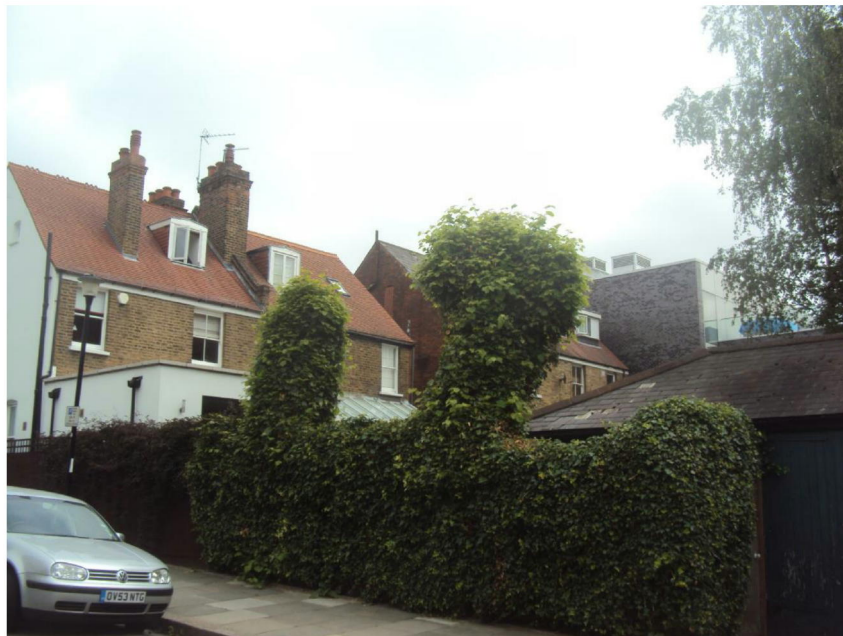
- 3.1.2 In the case of Limes 001 and 002, the crowns of these trees have been very severely reduced in the past on a regular basis and as a result their stems are disproportionately large in relation to the crowns that they support.

Photograph 2: Trees 001 and 002 (2013)
