Pre-existing Floor Plan:

Drawing Title: Intervention Plan / Removal		Alex Sargeson 07447082328
Project: Flat 3, 34 Museum St. London. WC1A 1LH.		
Scale: 1:50	Date: 020317	Drawn by: AS
Drawing Number: 003

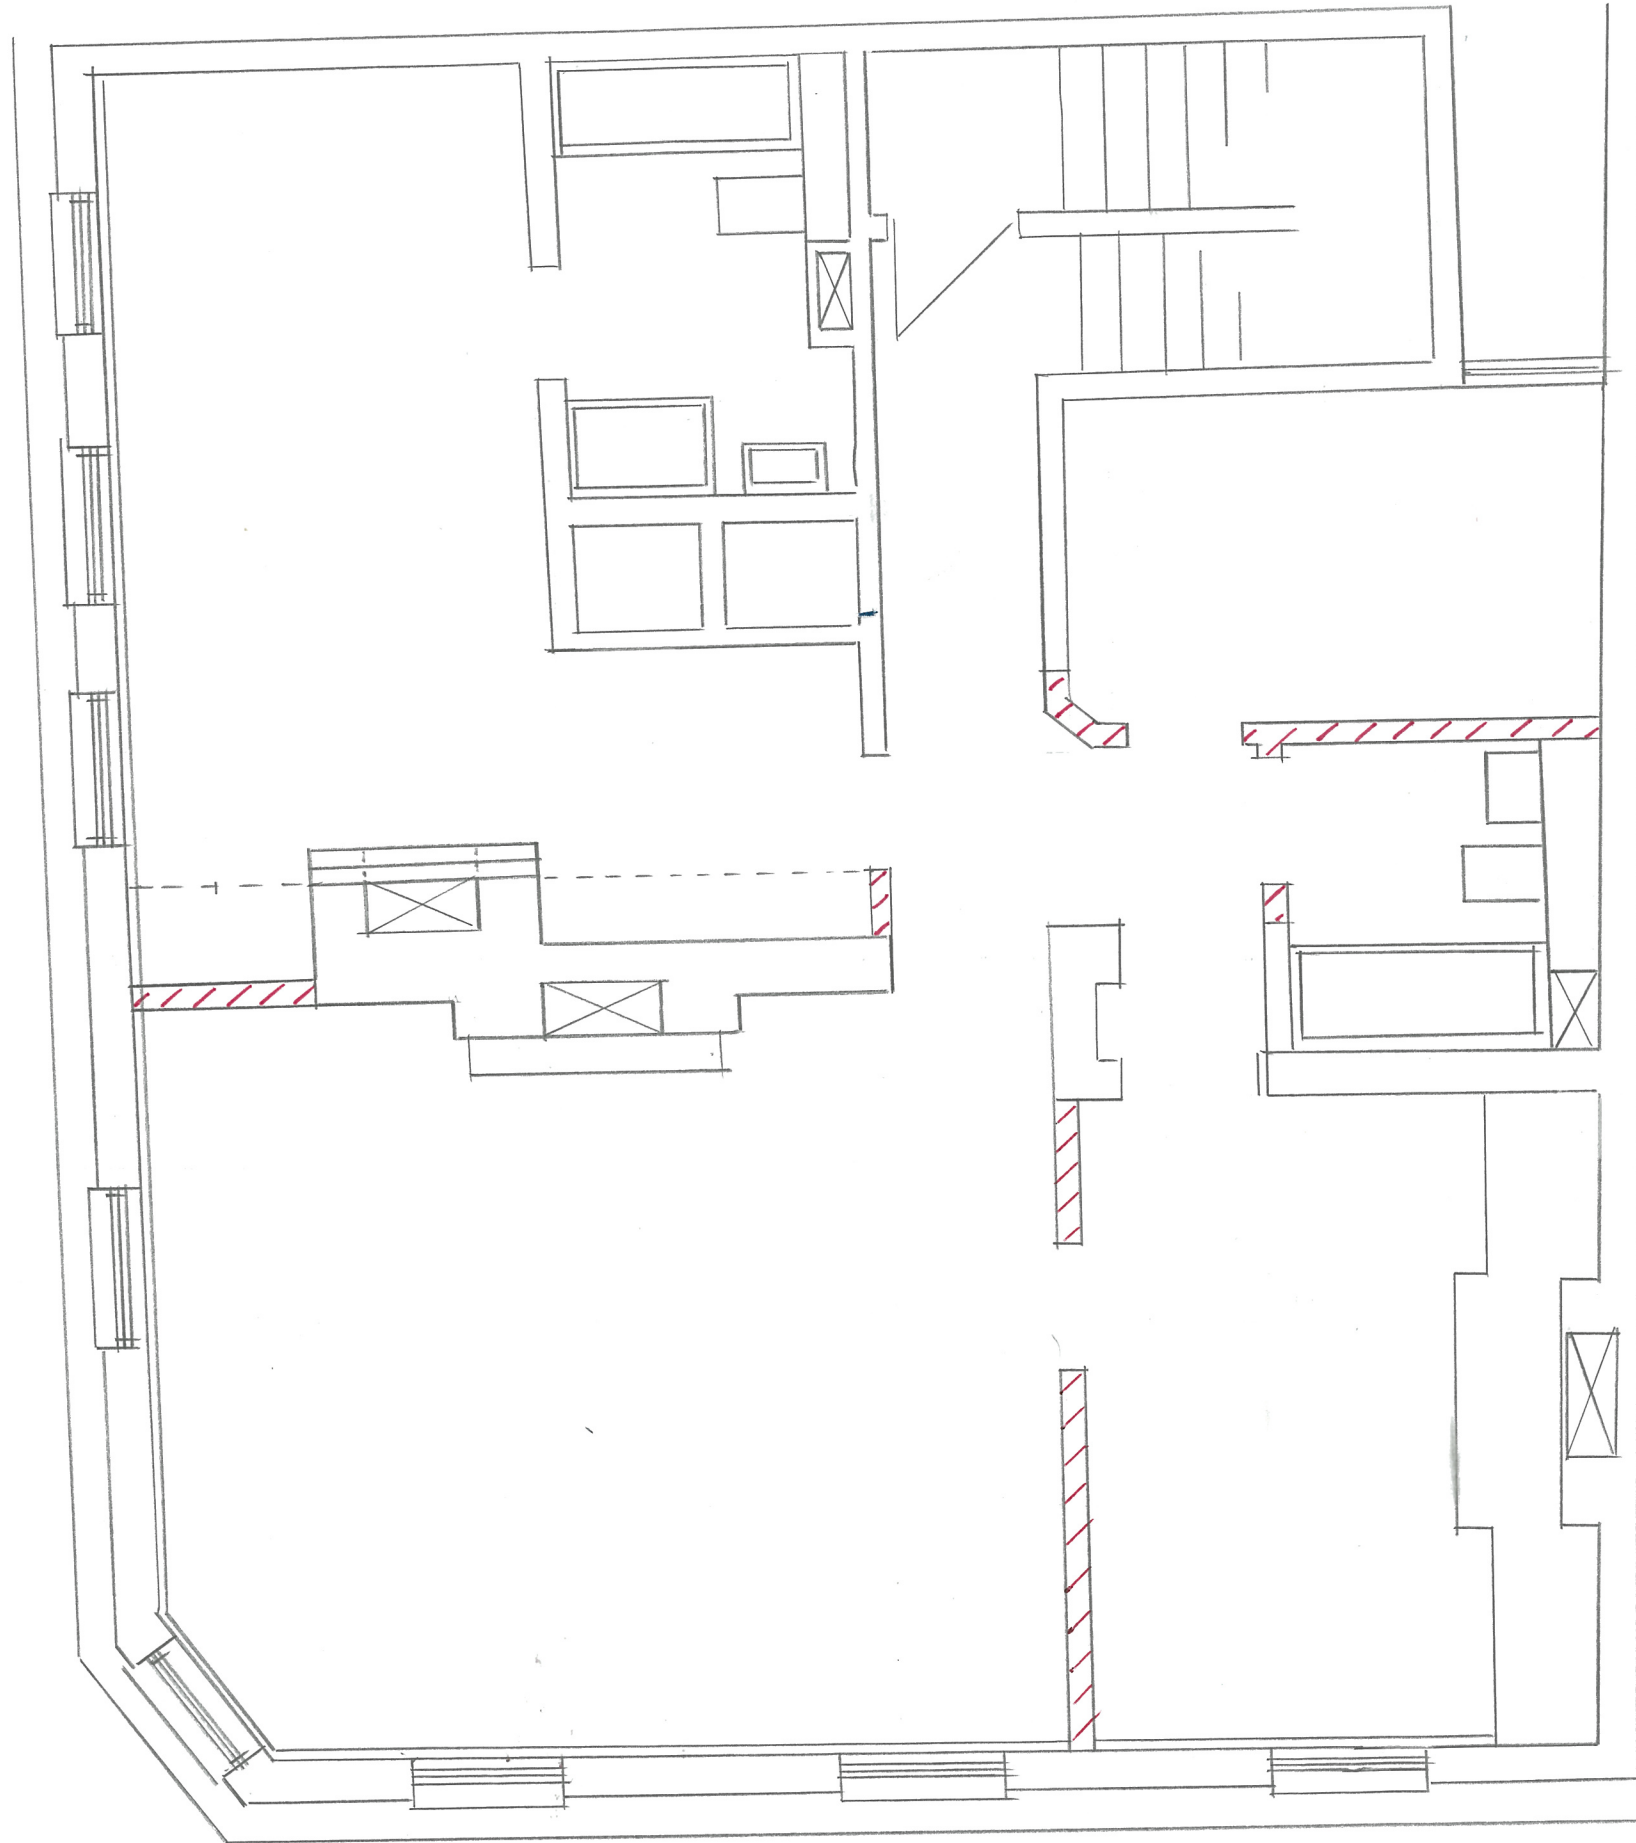
Areas shaded are where walls were taken down

- Notes:**
- All walls removed were built in 1993
  - All walls shaded were 'non load' bearing walls
  - Some walls were badly damaged from water ingress and mould
