**60 – 70 SHORTS GARDENS, LONDON**  
PRELIMINARY BASEMENT IMPACT ASSESSMENT

Ref No: 24509

| Title | Preliminary Basement Impact Assessment |

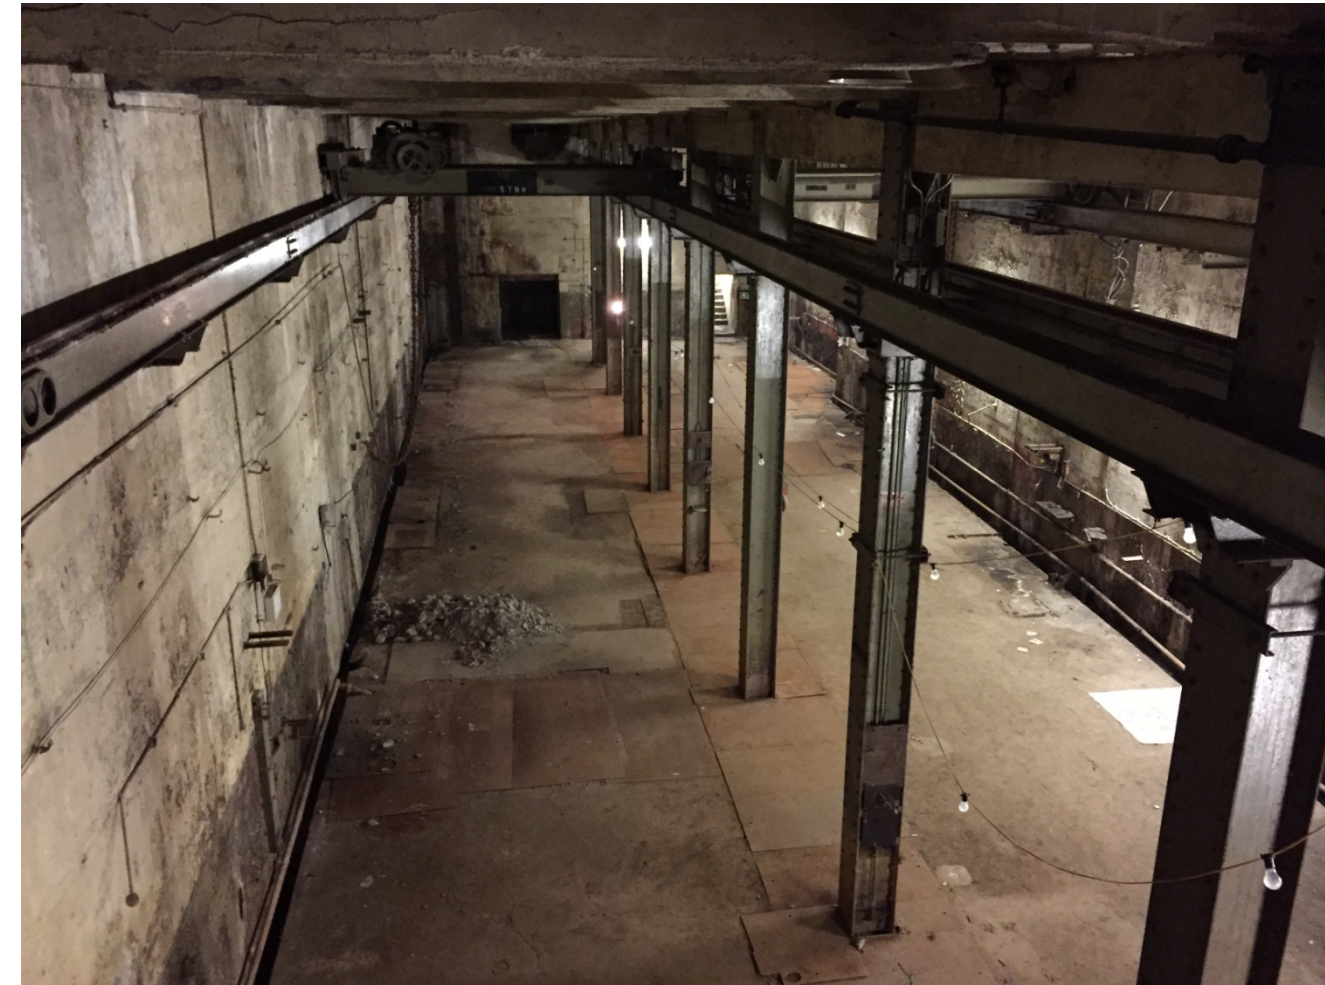
16.1 VIEW INSIDE EXISTING BASEMENT TAKEN FROM STAIRS

Constructed in the late 1800s/early 1900s, the existing building of 60-70 Shorts Gardens is approximately 44m x 10.5m on plan and consists of three storeys plus basement level, with the top storey having a mansard construction to the rear. The ground floor is a double storey height and incorporates a mezzanine for about 30% of the footprint. The basement has, in the main body, a clear storey height of around 7.3m and is relatively unobstructed save for a row of steel columns running centrally down the length, spaced at circa 4.25m centres. Shallower basements of circa 3.5m deep are located at either end of the deeper basement (one each end). Photos taken from within the basement can be seen in the Appendices.

During a visual inspection of the property in January '16 water was found to be entering the deeper section of basement, indicated by the drainage channels that run at the edge of the basement slab having running water within them. It is also understood that the basement has flooded to a depth of around 2 metres in the past.
