#### **FACTUAL GROUND INVESTIGATION REPORT**

## 251 GOLDHURST TERRACE, SOUTH HAMPSTEAD, LONDON NW6 3EP

#### 483 NCR Ltd c/o GML Architects

Report Reference:	GWPR1852/GIR/April 2017	Status: FINAL			
Issue:	Prepared By:	Verified By:			
V1.01 April 2017	AAAA	S-T. Williams			
Miltiadis Mellios MSc(Eng) GMICE Francis Williams M.Geol. (Hor CGeol CEnv AGS Director					
	File Reference: Ground and Water/Project Files/				
GWPF	GWPR1852 521 Goldhurst Terrace, South Hampstead, London, NW6 3EP

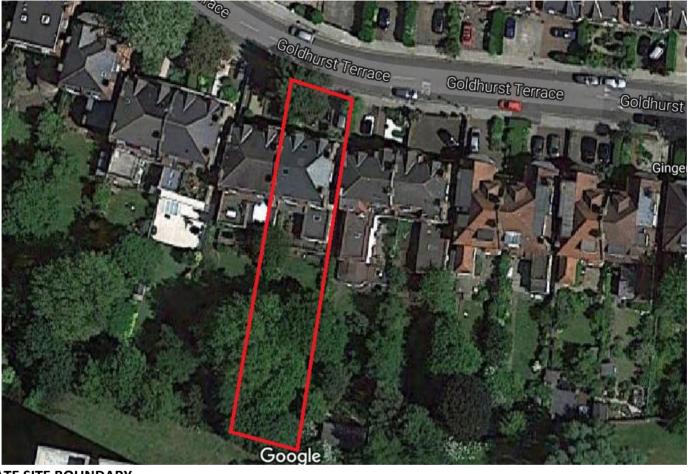
Project:	251 Goldhurst Terrace, South Hampstead, Lo	Figure 2	
Client:	483 NCR Ltd c/o GML Architects	Date: April 2017	ground&water
	Site Development Area	Ref: GWPR1852	<b>3.00.100</b>

## **APPROXIMATE SITE BOUNDARY**

A site location plan can be seen in Figure 1 with a plan showing the site area presented in Figure 2. The approximate O.S. National Grid Reference for the centre of the site was TQ 25794 84027.
