## **Desk Study Data for Basement Impact Assessment**

**63 Hillfield Road,  
London, NW6 1QB**

Ref: 18630/R1

May 2017

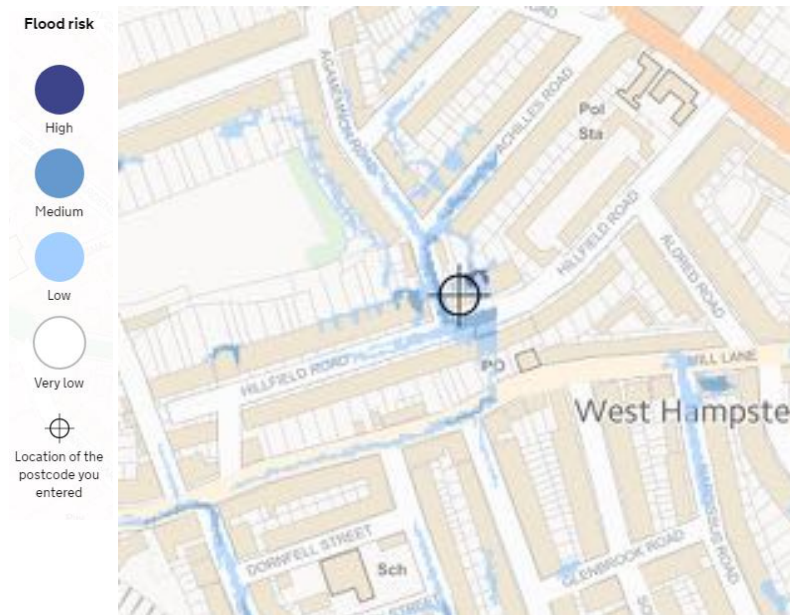
5.10 The EA's modelling (see Figure 6 below) indicates that the risk of flooding from surface water at 63 Hillfield Road ranges from 'Very Low' (which is the lowest, national background level of risk) to 'Low'. While the quality of this mapping is relatively low at a large scale, it is apparent that the front gardens and main upper level rear gardens of No.63 and the adjacent No's 61 and 65, and the footprints of these properties, are considered to be at 'Very Low' risk of surface water flooding, while the courtyards around the rear projections and extensions of No's 63 and 65 are considered at 'Low' risk. The area of 'Low' risk extends beneath the footprints of No's 67 and 69, and into the rear garden of No.67 (which also contains a small, localised area of 'Medium' risk). An area of 'High' risk is located around the rear projections of No's 67 and 69. The Hillfield Road footway and carriageway directly in front of No.63 are part of an area considered to have a 'Low' to 'Medium' risk, which extends further along Hillfield Road, and along Agamemnon Road and Achilles Road in the vicinity of No.63. The area of 'Low' to 'Medium' risk on Agamemnon Road and Achilles Road must reflect flow routes owing to the gradient on these roads and appears to extend into the front garden of No.59 Achilles Road. The area of 'Low' risk extends through the driveway at the side of No.57 Achilles Road, including a small area at the northernmost end of No.65's rear garden, through the rear of No.57's footprint and into the rear garden; this is the flow route from which the predicted flooding around No.63's rear projection would be derived.

5.11 It must be noted that there appears to be an error with this mapping; two different datasets appear to have been stitched together, creating a vertical line through the map just east of No.63. The EA advised that this data is the responsibility of Camden Council, who have not yet got back to the author, so it would appear that the mapping to the east of No.63 may not be as accurate as the mapping around No.63 and to the west.

**Figure 6:** Extract from the Environment Agency's 'Flood risk from Surface Water' map, with the site located beneath the black crosshairs.

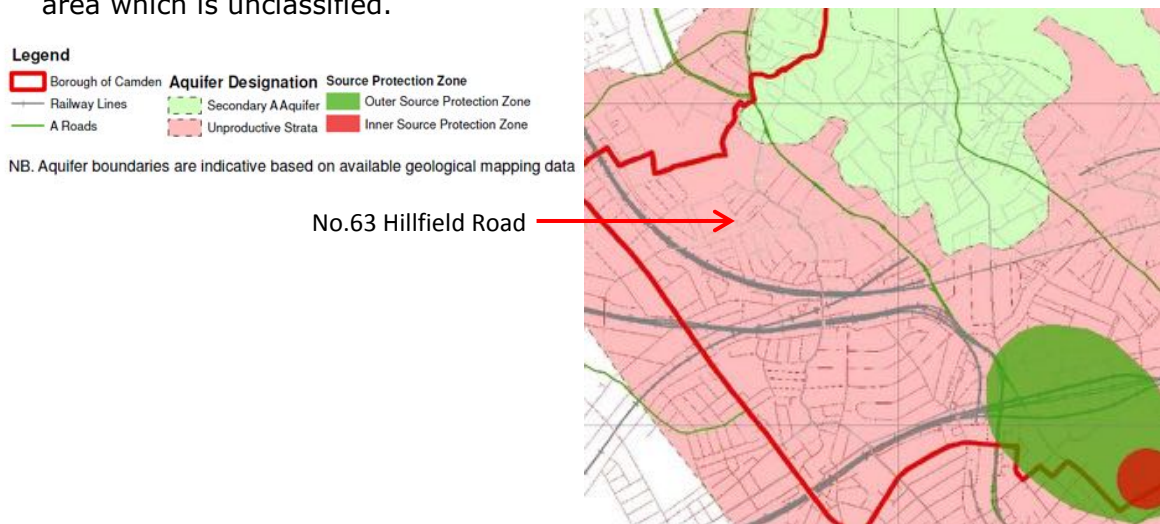
- 6.1 The London Clay Formation is classified by the Environment Agency as an 'Unproductive Stratum', as indicated by Figure 7 below. Under the old groundwater vulnerability classification scheme, which now applies only to superficial soils, the site lies within an area which is unclassified.

**Figure 7:** Extract from Figure 8 of the Camden GHHS (Arup, 2010) showing aquifer designations and Source Protection Zones (SPZs).

- There are no Source Protection Zones (SPZs) within 500m of the site (App.D, Sections 6.6 & 6.7, and Figure 7 above).
- There are three groundwater abstraction licences within 2000m of the site; these are all described as active, and are all located 1998m south-east of the site at the 'Swiss Cottage Open Space' borehole (App.D, Section 6.3).
- There are no potable water abstraction licences within 2000m of the site (App.D, Section 6.5).
- The BGS has classified the area within 50m of the site as 'Not Prone' to groundwater flooding, based on the presence of London Clay to surface (App.D, Section 7.7).

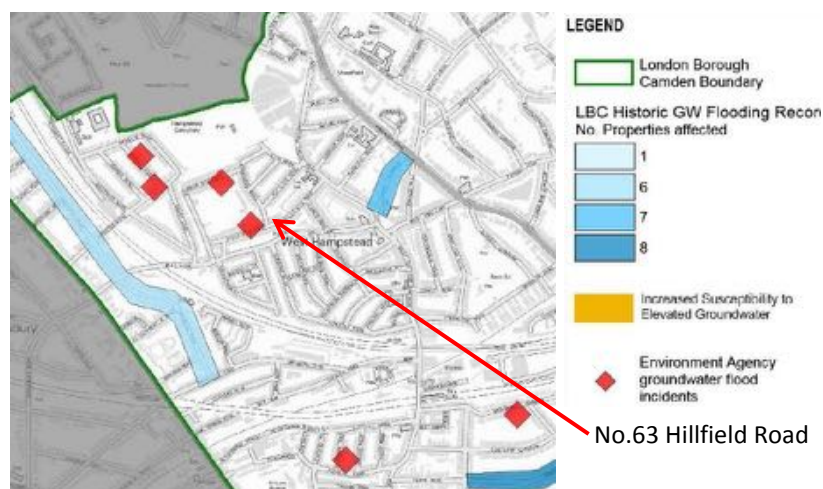
6.7 Groundwater flooding incidents recorded by the EA were presented on Figure 4e of the Camden SFRA (URS, 2014; see Figure 8 below). 23 incidents were reported in the entire borough, the closest of which was around 60m west of the site, on the north side of Hillfield Road. Figure 4e of the SFRA shows that Hillfield Road is not within an area where the LBC have recorded properties as having been affected by historic groundwater flooding. This figure also maps areas with an increased susceptibility to elevated groundwater, but these are all within the south-eastern part of the borough, remote from Hillfield Road, where River Terrace Deposits can be found overlying the London Clay Formation.

**Figure 8:** Extract from Figure 4e of the SFRA (URS, 2014) – 'Increased Susceptibility to Elevated Groundwater'. Ordnance Survey © Crown copyright 2014. All rights reserved. Licence No.100051531.

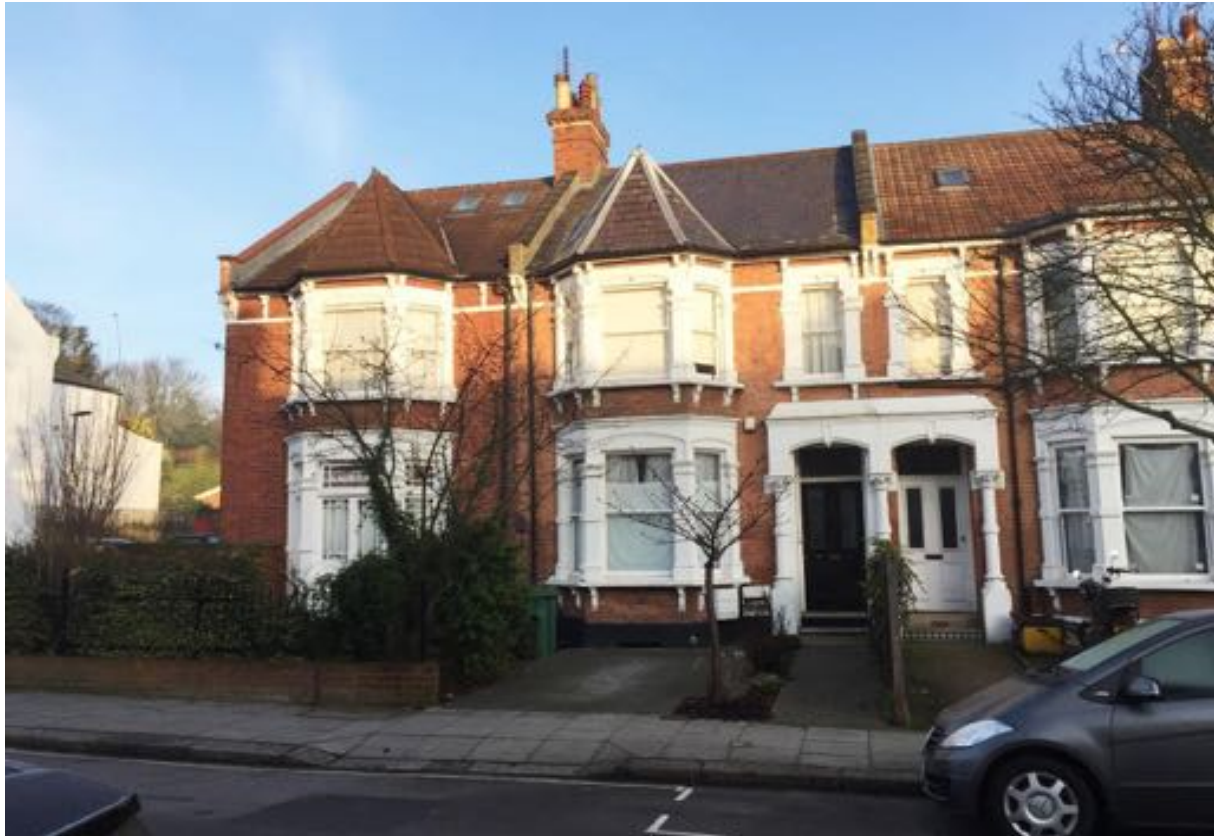
**Photo 1:** Front elevation (looking north-west). No.63 Hillfield Road is a part three-storey, part two-storey mid-terrace house arranged over split levels, with an original cellar.  
(Photo courtesy of Vorbild Architecture)

- 2.1 No.63 Hillfield Road is a part two-storey and part three-storey Victorian terraced house arranged over split levels and containing a cellar (see cover photo). Hillfield Road is located in the Fortune Green area of the London Borough of Camden (LBC), to the south of Hampstead Cemetery, and is not within any of the LBC's conservation areas. It is aligned approximately north-east/south-west, and leads onto Fortune Green Road at its north-eastern end. Hillfield Road splits towards its south-western end, with a short cul-de sac continuing towards the south-west while the other section turns southwards and connects to Mill Lane. Agamemnon Road leads northwards from near the centre of Hillfield Road and is joined from the east after a short distance by Achilles Road which is sub-parallel with Hillfield Road.

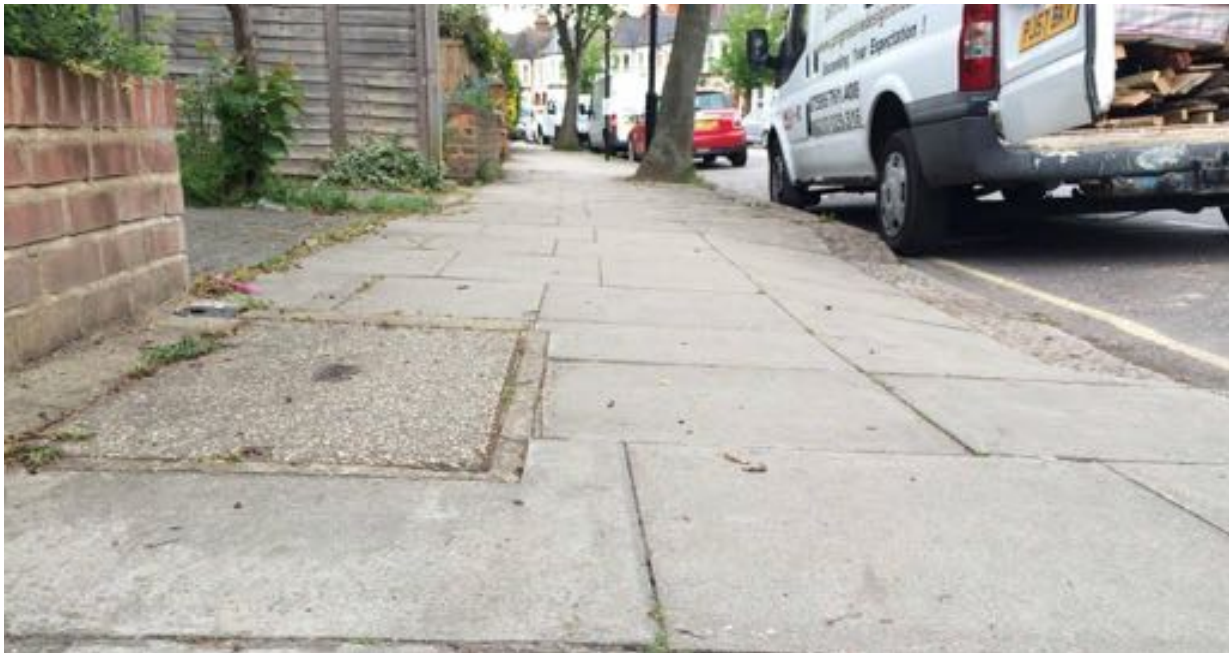
**Photo 2:** At the front of the house, the footway falls gently towards the Hillfield Road carriageway, away from the property.

- 5.5 The gentle falls of the front driveway and Hillfield Road footway away from the front of the property (Photo 2), together with the slight fall of Hillfield Road towards the west in front of the property, are likely to ensure that most surface (rain) water falling at the front of the property drains away under normal conditions. The property's paved front driveway is separated from the adjoining front driveway of No.65 on the upslope side, and the adjoining front garden of No.61 on the downslope side, by concrete gravel boards (which appear to be made from paving slabs) topped by wooden fences (e.g. Photo 3). Because of this, only minimal surface water run-off is expected into No.63's front driveway from the adjoining properties. Thus, the catchment for No.63's front driveway are likely to be limited almost exclusively to direct rainfall and any roof areas which discharge onto it, such as the small porch.

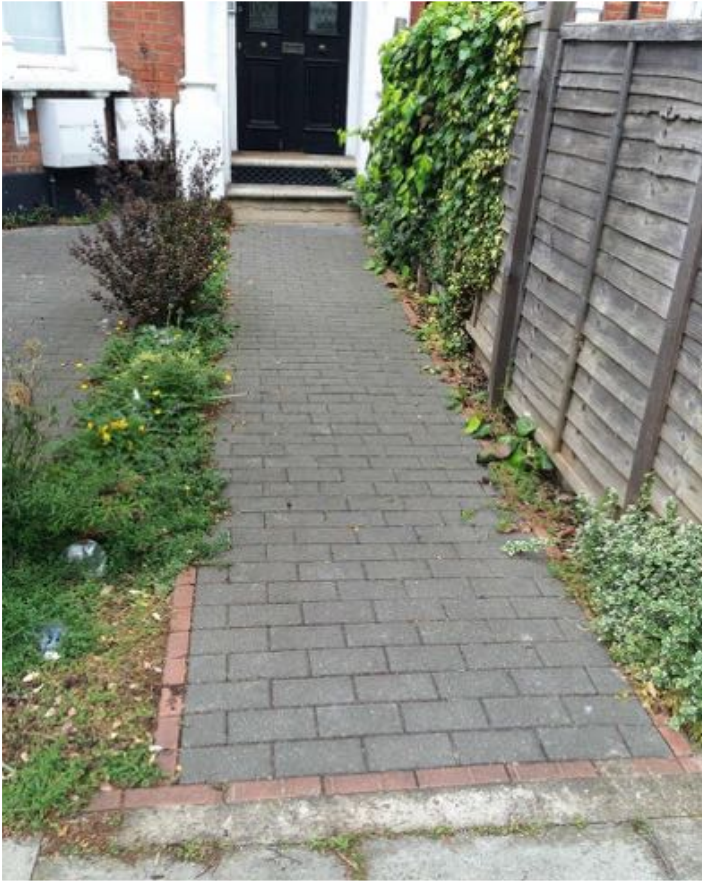
**Photo 3 (left):** Externally, at the front of the property, there is a block-paved driveway and path to the front door, which are open to the Hillfield Road carriageway, and bounded on both the eastern and western sides with wooden fences.

- 2.6 No major crack damage was noted in the interior of No.63, but some external crack damage was evident, in particular in the steps leading up to the front door (Photo 3). In addition, evidence of spalling (from frost damage) can be seen in the brickwork on the west flank wall of No.63's rear extension.

- 5.7 The front driveway of No.63 is surfaced with brick pavers (Photo 3), which will likely only allow a limited amount of infiltration between the bricks, although infiltration can occur within all three flower beds within this area. The courtyard which forms the lowest level of the rear garden is mainly surfaced with concrete in poor condition (Photo 4) and is positively drained by two gullies, so infiltration is likely to be minimal in all of this area except in the flower bed. One of these gullies did appear to be in need of

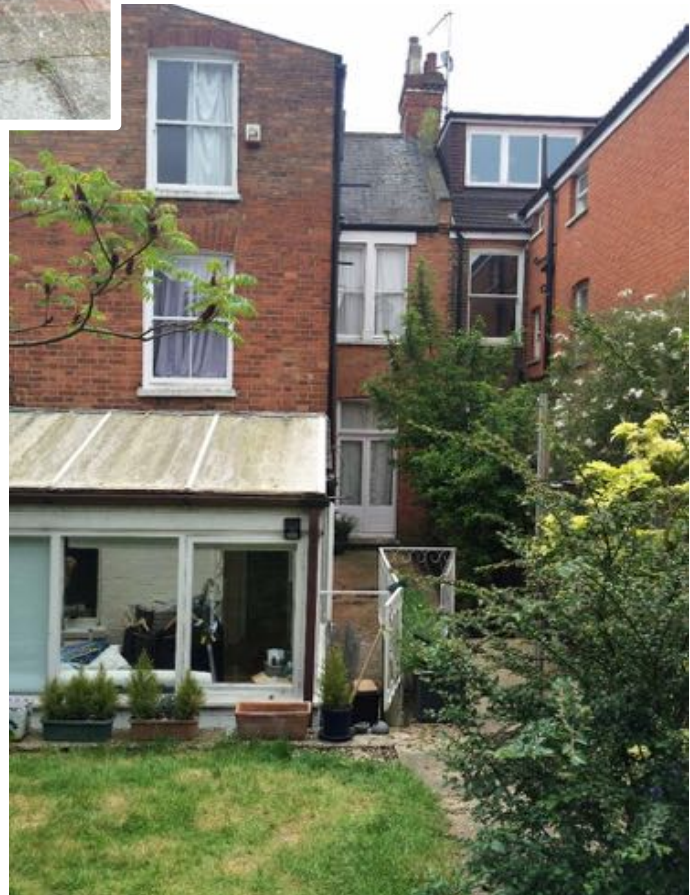
**Photo 4 (right):** To the rear of the property is a long, thin, multi-level garden. The lowest level of the garden comprises a courtyard alongside the rear projection; it is mainly surfaced with concrete. A set of steps alongside the single-storey extension lead to the upper levels of the rear garden.

- 2.4 To the rear of the property is a long, thin, split-level garden (Photo's 4 & 5), which can be accessed both from the western side of the conservatory at the rear of No.63, and via French doors in the rear (north) wall of the main part of the house. The lower level of the garden comprises a courtyard alongside the rear projection of the house. It is set approximately 0.35-0.53m below the ground floor level of the main part of the building. This area is mostly surfaced with concrete, which contains numerous cracks and two surface water gullies (one of which appeared to be blocked with leaves). A wooden fence marks the boundary between this courtyard and the rear courtyard to No.61, and a narrow flower bed is present between the concrete surfacing and this fence. A set of concrete steps opposite the external conservatory door, leads from this courtyard level up to the main rear garden, which is separated from the lower level by a retaining wall. That wall appears to have been built when the garden was excavated to allow construction of the conservatory, leaving a narrow gap/path along the remainder of the western side of the conservatory and the entire length of its northern side. There is a small, inaccessible gap between the eastern side of the conservatory and the boundary with No.65 (which is formed here by the flank wall of No.65's rear extension).

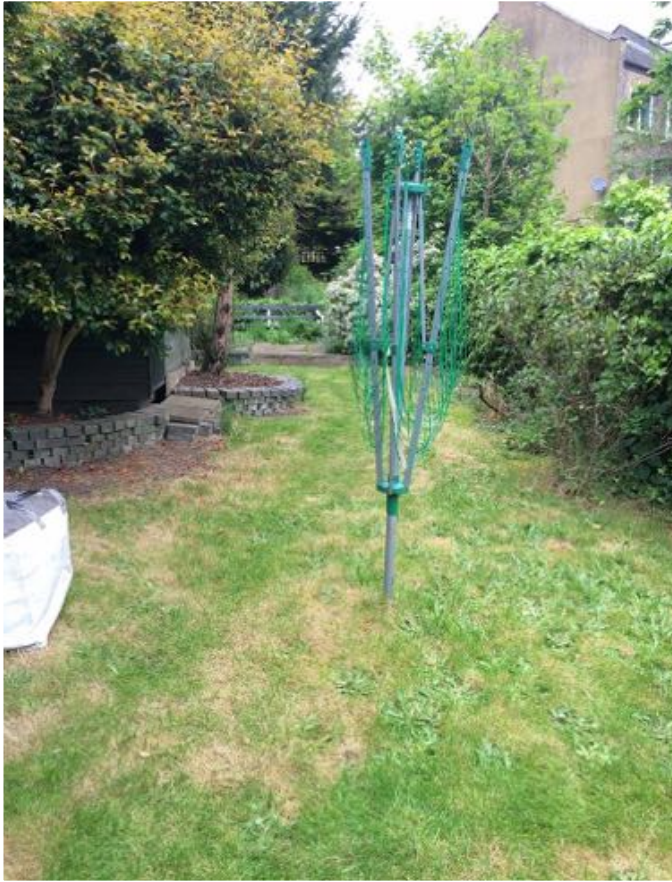
**Photo 5 (left):** The upper levels of the rear garden consists of a lawn area, a small patio area, and a raised planting area located within the northernmost part of the garden. There are a number of small-medium sized trees within the rear garden, and medium-large sized trees within the raised planting area.

- 2.5 The main rear garden consists of three levels. The first level consists of a lawned area which slopes gently upwards away from the property (Photo 5), spanning the area between the retaining wall by the rear of the conservatory and approximately half way down the garden. On the garden's western boundary, a small, concrete-surfaced area is located at the top of the steps, which leads to a flower bed/planting area which extends along approximately one third of the western boundary and is separated from the lawn by a narrow concrete path. A raised flower bed/planting area and shed are located just beyond this, separated from the eastern flank wall of No.59 Achilles Road by a narrow gap. Another flower bed/planting area extends along approximately two thirds of the length of the garden's eastern boundary, at both first and second levels

maintenance. A majority of the upper level main rear garden is soft landscaped and well vegetated (Photo 5), and where the surfaces are paved, run-off is likely to lead into a soft landscaped area, so infiltration is likely to occur throughout this area. However, any infiltration within the site’s soft landscaped areas would become ineffective when the ground is saturated or frozen.

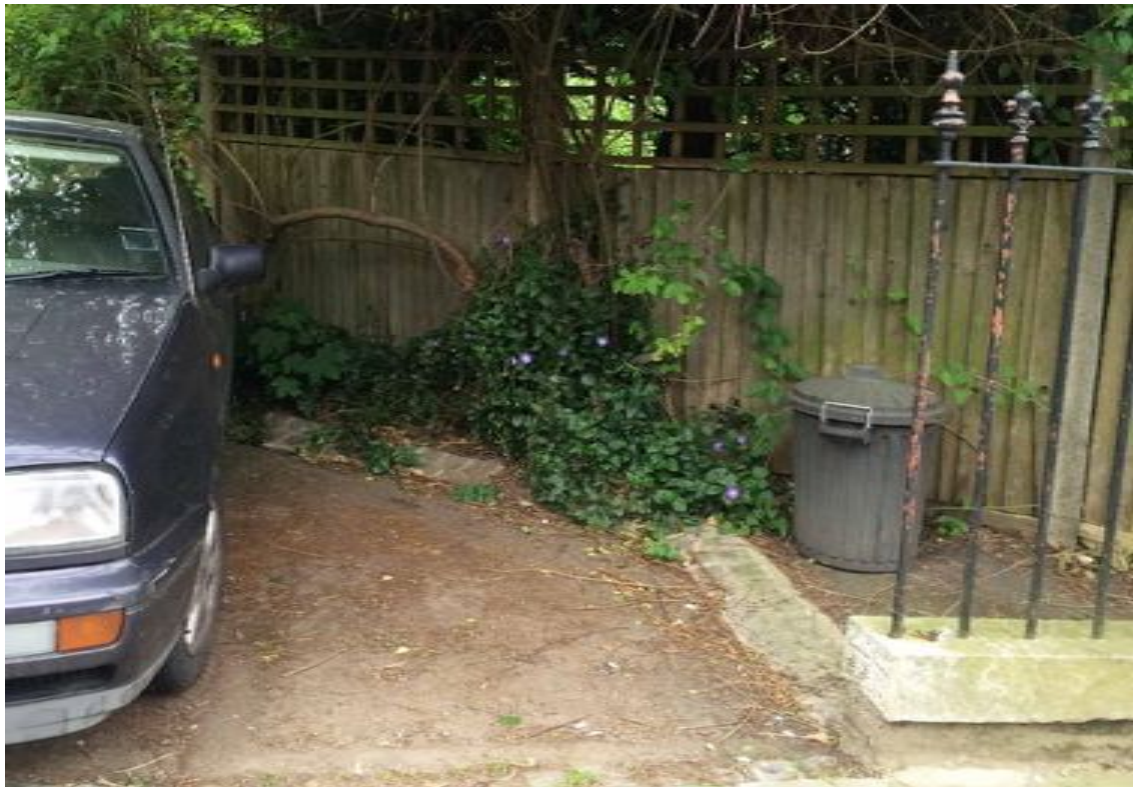
**Photo 6 (below):** The rear boundary to No.63's rear garden consists of a wooden fence with concrete king posts and wooden gravel boards. In front of the fence is a short ramp, formed of granite setts.
