SITE INVESTIGATION AND BASEMENT IMPACT ASSESSMENT REPORT

115 Frognal
London NW3

J16245

May 2017

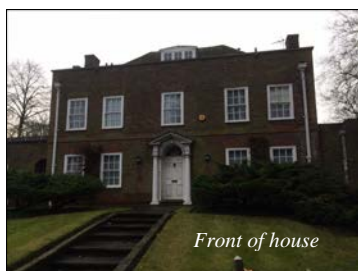
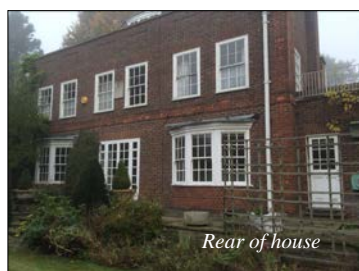
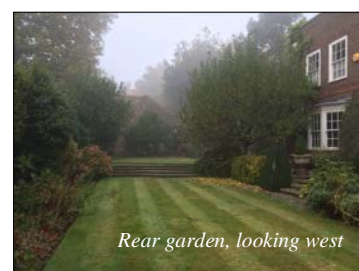
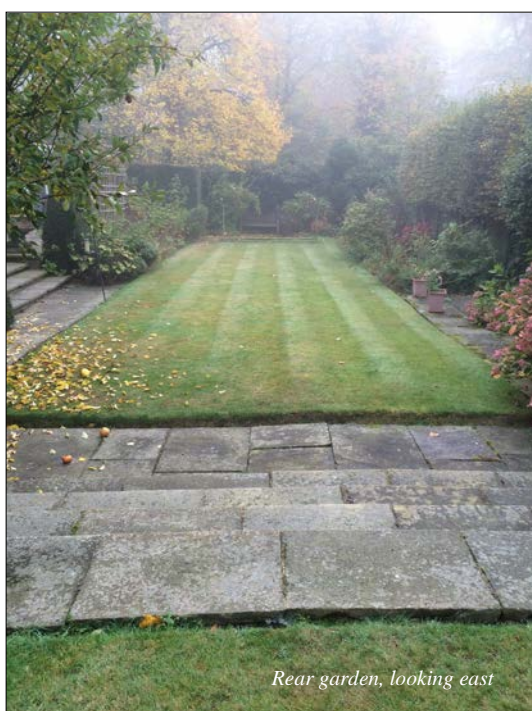
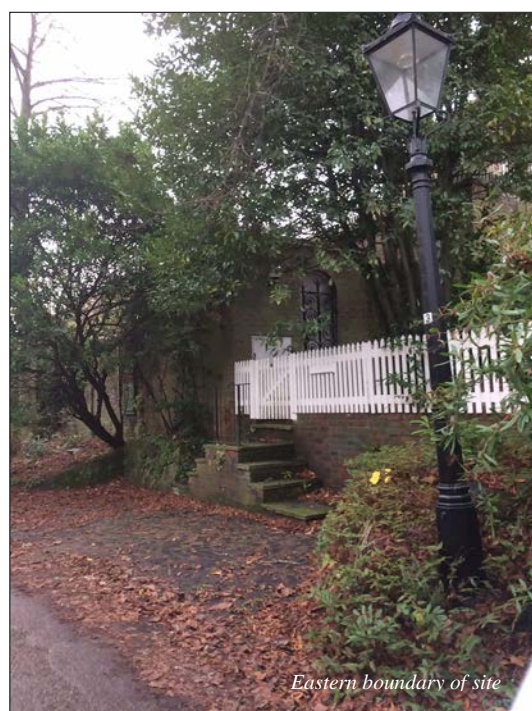
The local topography slopes down in easterly and southerly directions and the site is on a number of levels. The site is currently occupied by a detached two-storey brick house, with an adjoining single storey garage and single storey building, known as the garden room, located along the eastern elevation of the main house, with another garden located along the western elevation.

The front garden slopes up in a southerly direction to the house from 50.73 m TBM to 52.00 m TBM over a distance of roughly 10 m. The existing house is located on a relatively level plot at approximately 52 m TBM. The rear garden can be accessed externally through a gate located at the western end of the site and comprises two levels at roughly 52.00 m TBM and 51.85 m TBM. A paved area is present along the southern elevation of the house, with steps leading down to a central lawn with planted borders, predominantly comprising shrubs and bushes.

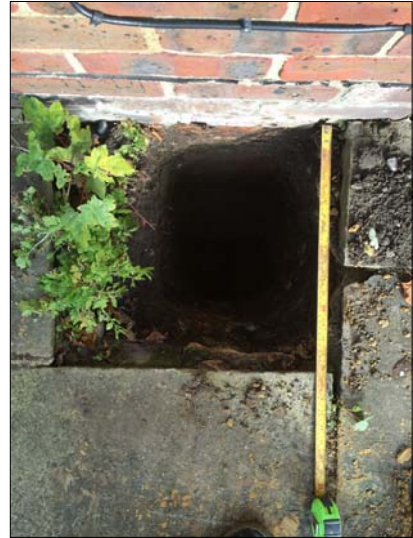
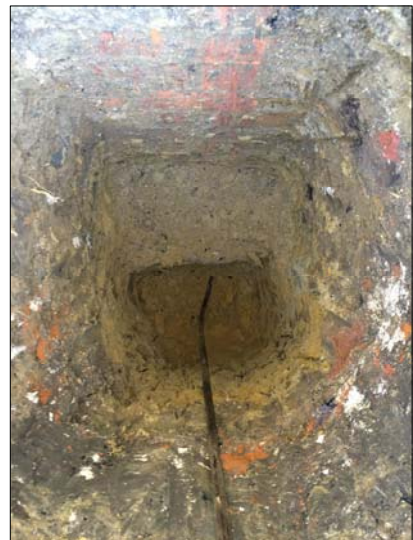
Plan

Paving Slab
CONCRETE
MADE GROUND (black clayey silty sand with frequent roots and rootlets, flint gravel, brick and concrete)
MADE GROUND (brown mottled black sandy clay with rootlets, flint gravel, coal/ash, brick and ceramic fragments)
Firm light brown silty very sandy CLAY with rare coarse sub-angular flint gravel

Proven under by probing

Notes:
Groundwater not encountered

Two trial pits were excavated to expose the foundations of the existing buildings and the findings are summarised in the table overleaf. Trial pit records and photographs are included within the appendix.

Trial Pit No	Structure	Foundation detail	Bearing Stratum
1	Main house	Brick over concrete Top 0.90 m Base 1.25 m Lateral projection 200 mm	Natural soil. Firm brown mottled orange-brown silty sandy CLAY with rare coarse subangular flint gravel
2	Garden room Section A-A'	Brick over concrete Top 1.08 m Base of footing not proved Lateral projection at least 150 mm	Not proved
	Garage Section B-B'	Brick over concrete Top 0.75 m Base 1.00 m Lateral projection 230 mm	Made Ground

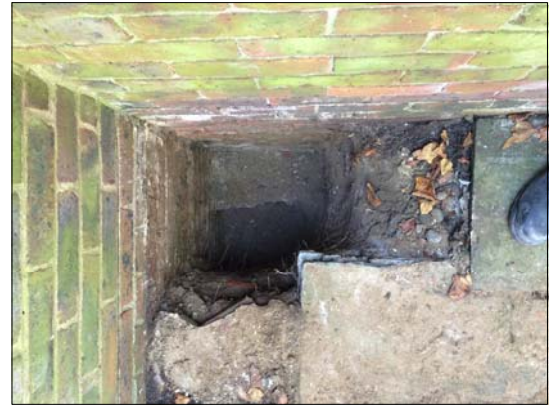
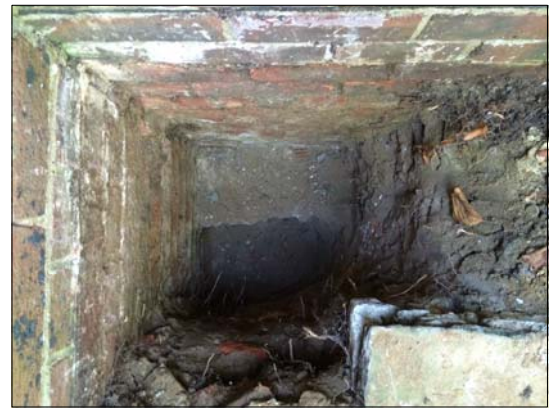
Plan

Paving Slab
CONCRETE
MADE GROUND (light brown silty sand with roots and rootlets, gravel, chalk and occasional brick)

Notes:
Groundwater not encountered
