07 LISTED BUILDING STAIR WORKS

08 VISUAL IMPACT

09 VERIFIED VIEWS

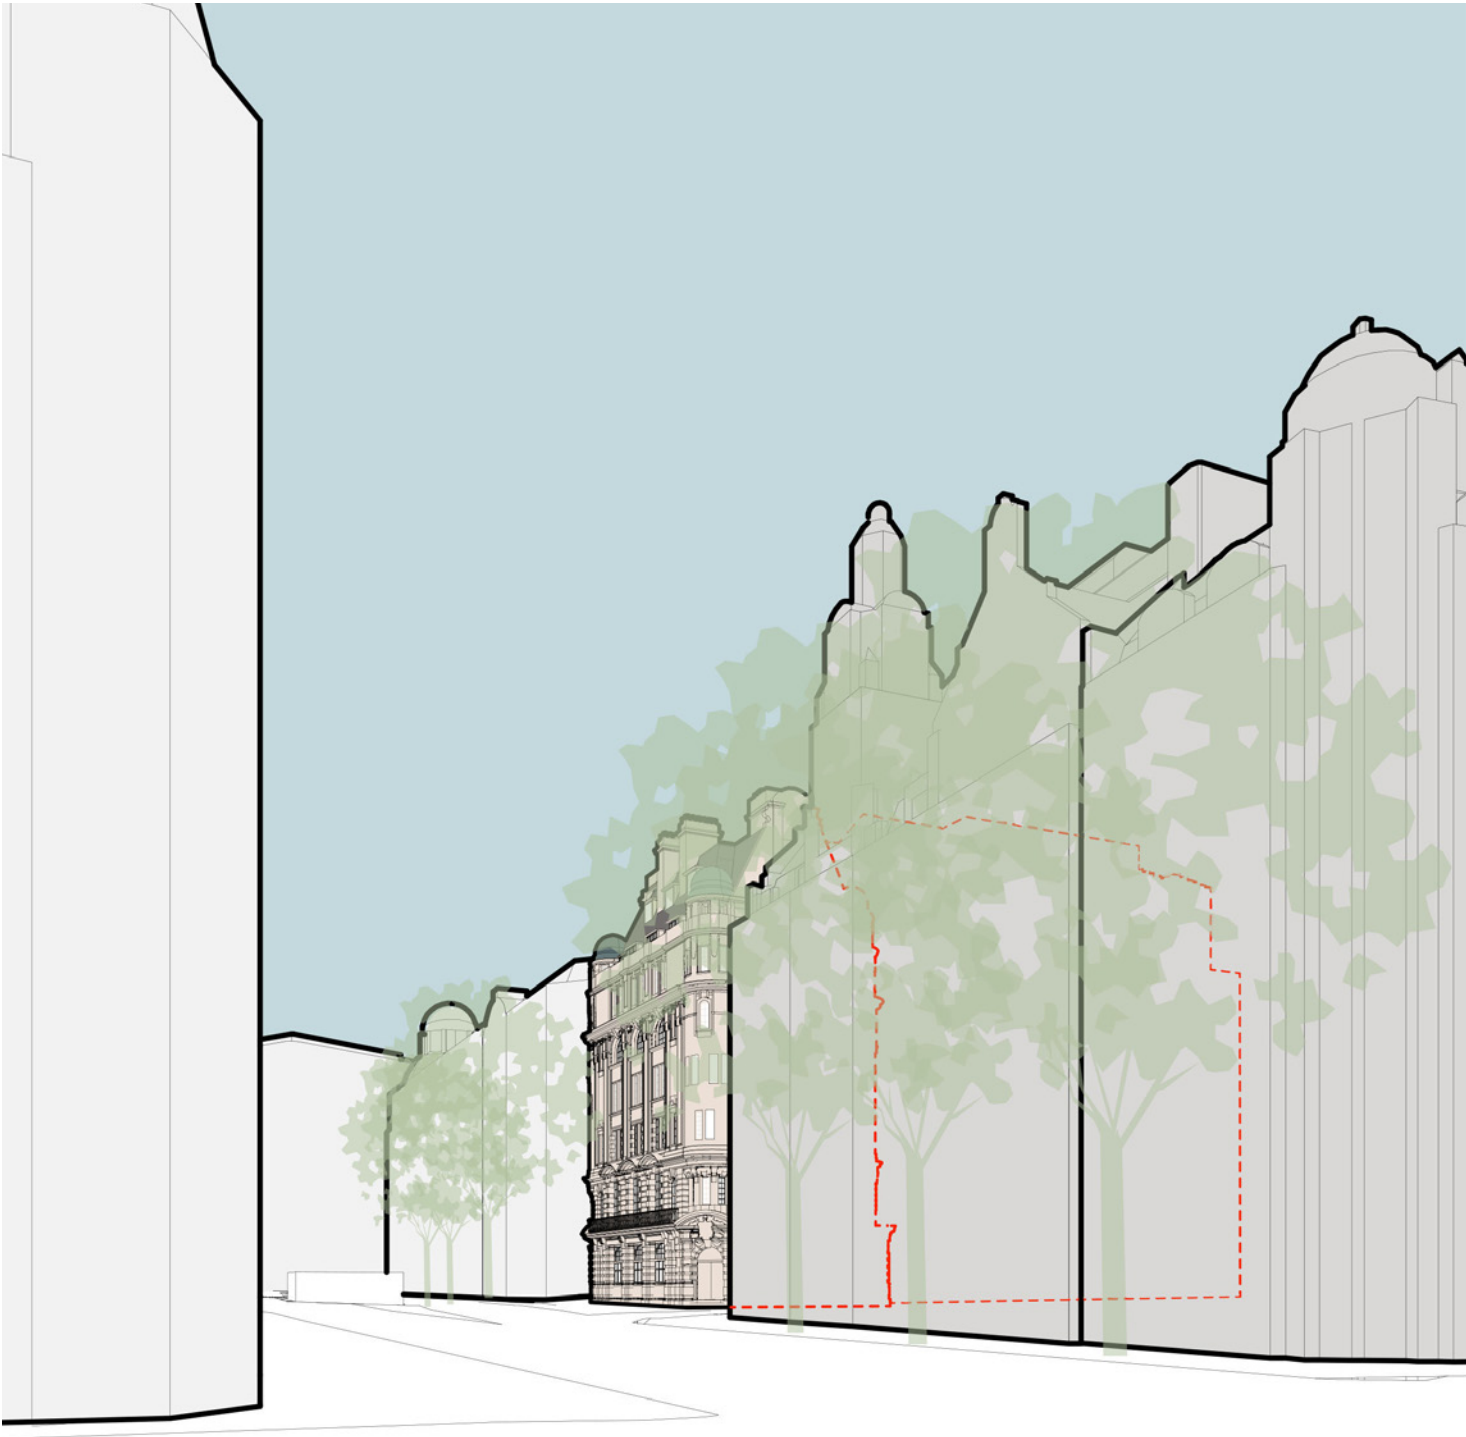
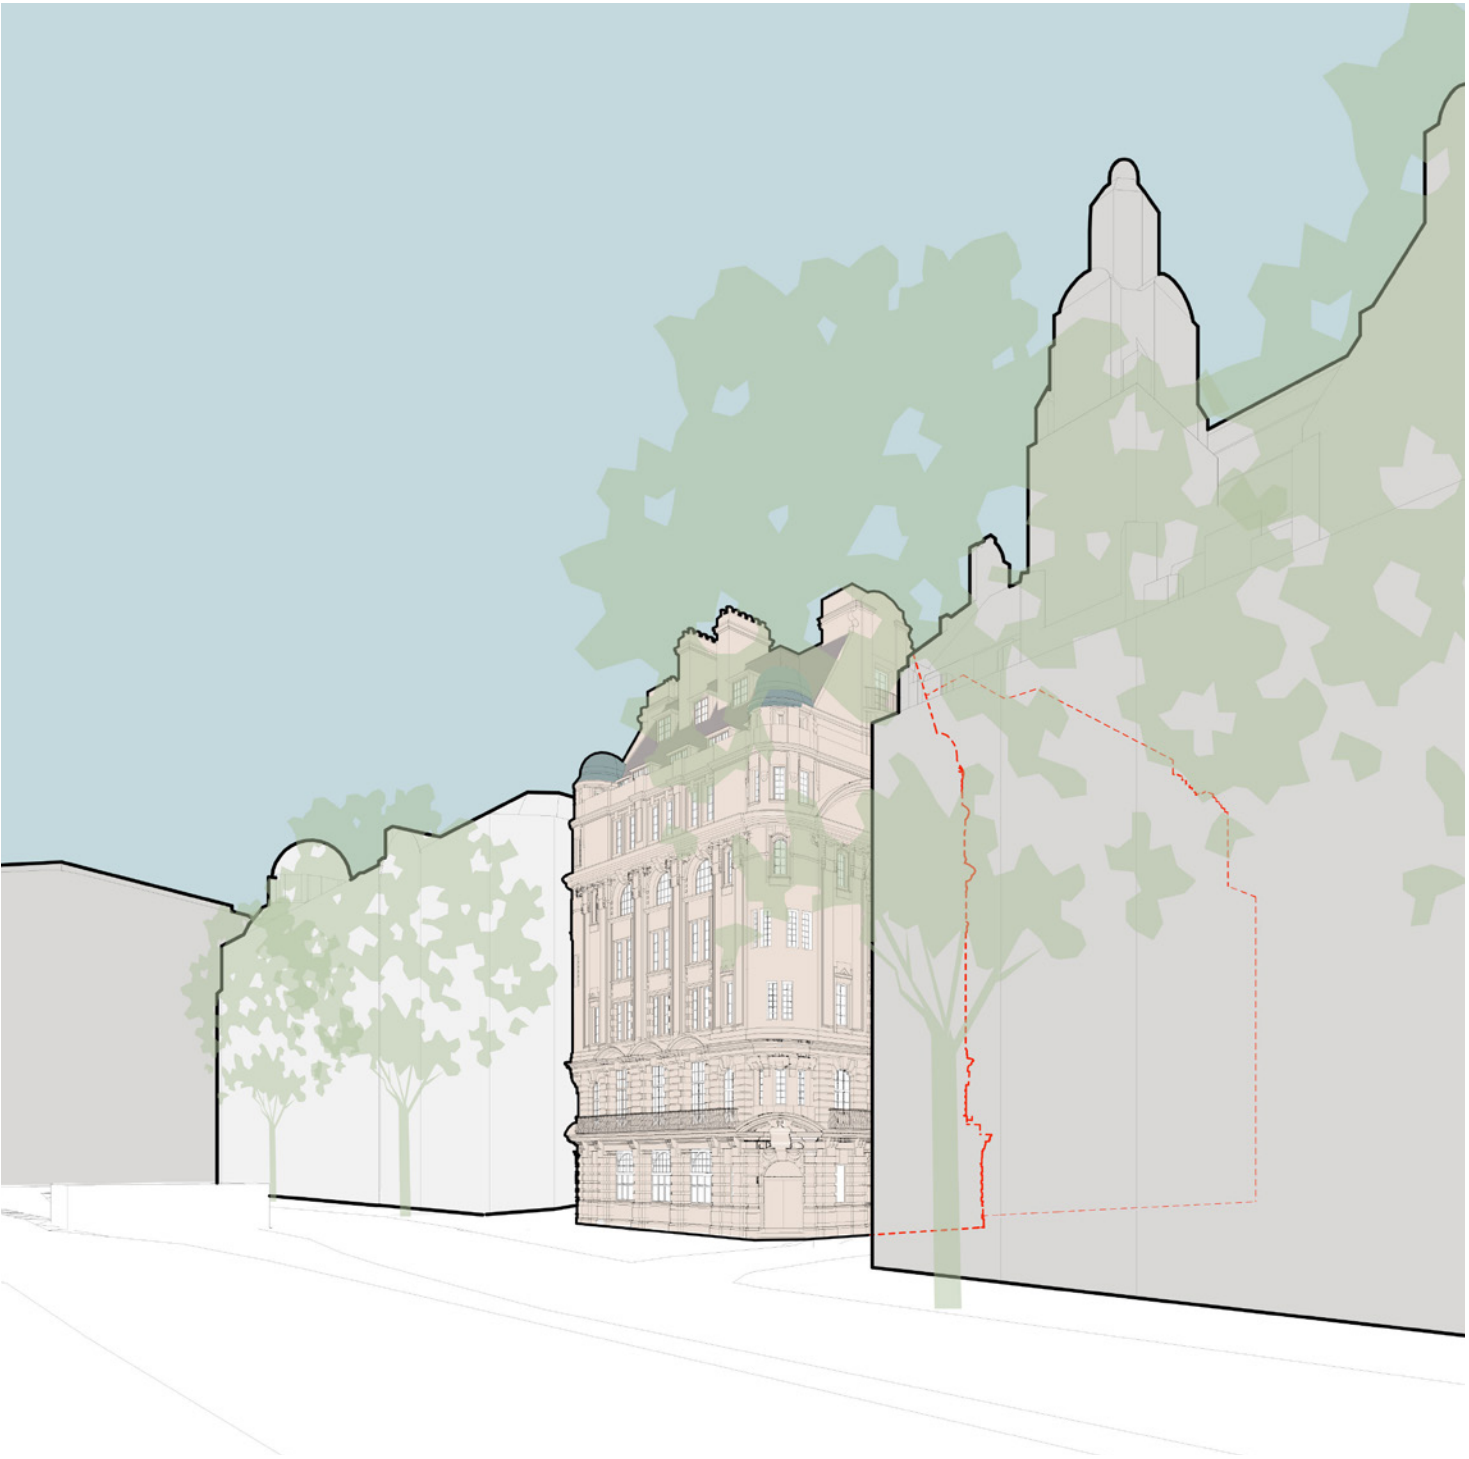
**VISUAL IMPACT
HOLBORN/SOUTHAMPTON
ROW**

These sketch visuals illustrate how the proposal interacts with its context and with the Kingsway Conservation area
