34A, KING HENRYS ROAD,
LONDON, NW3 3RP

APPENDIX F

Factual Report

Site	34 Kings Henrys Road Camden NW3 3RF
Client	Rupert West
Date	11 th October 2016
Our Ref	FACT/7806

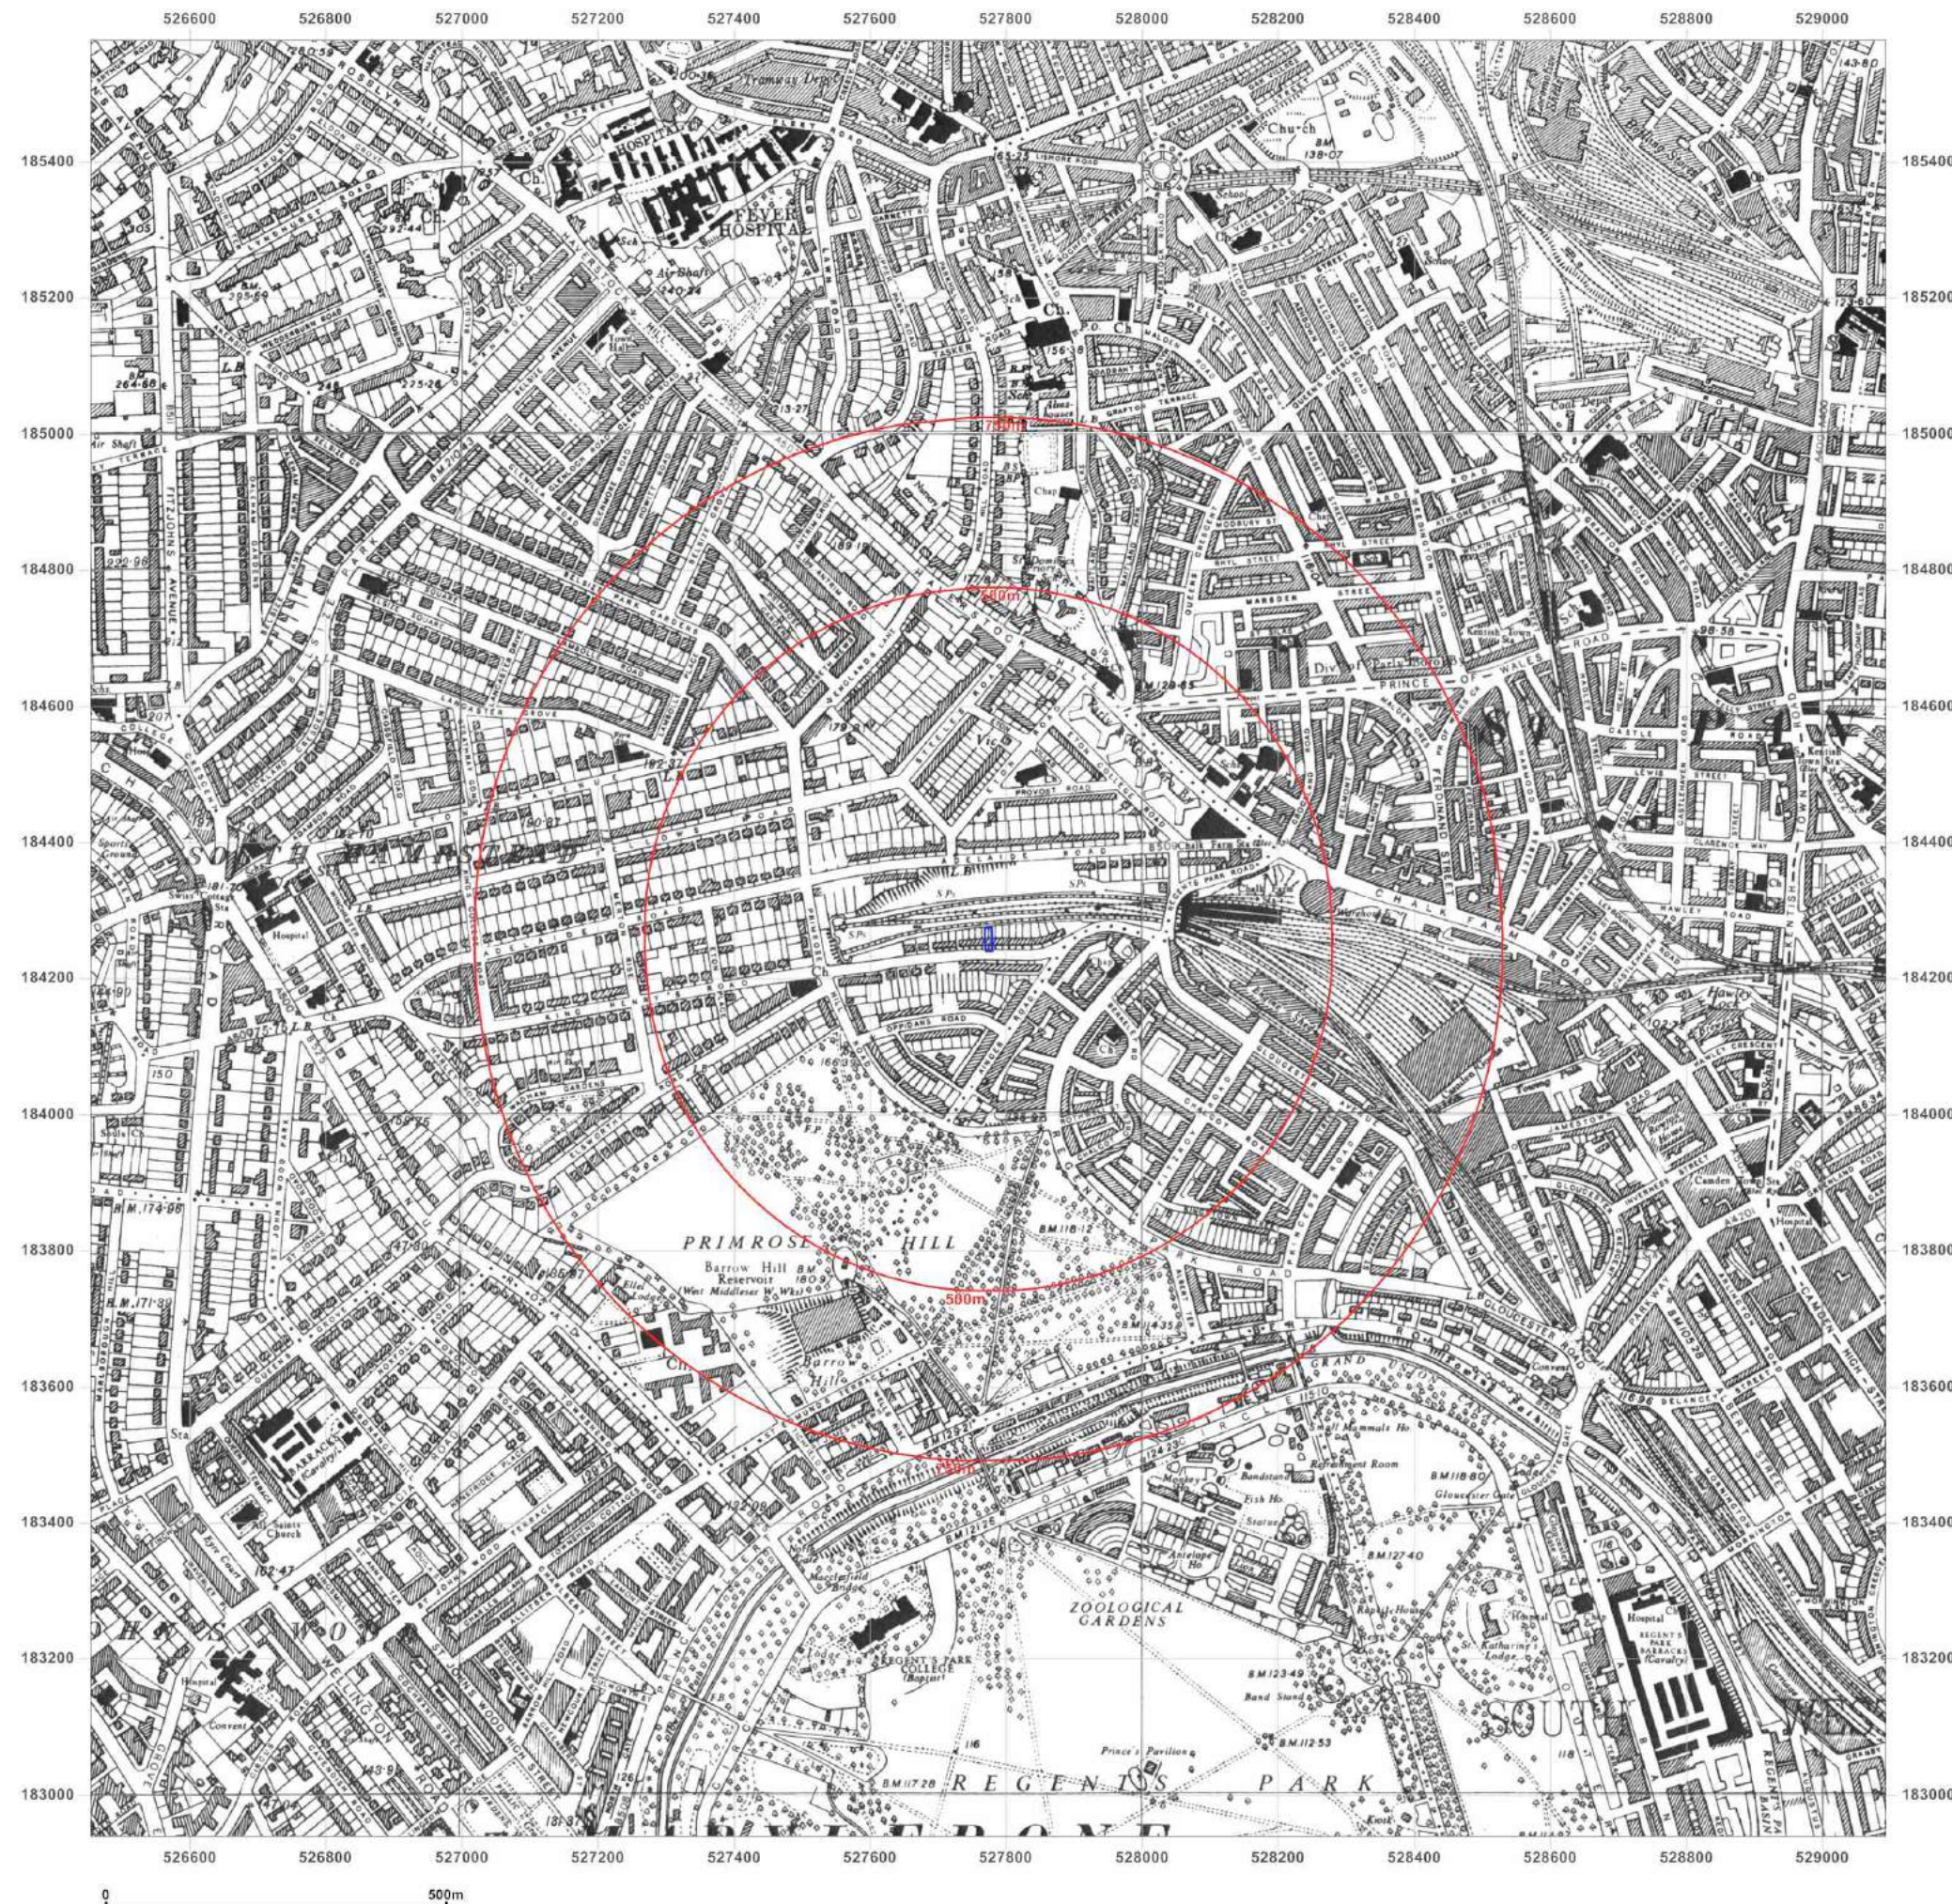
Map Name: Provisional

Map date: 1951

Surveyed N/A
Revised 1949
Edition 1951
Copyright N/A
Levelled N/A

Surveyed N/A
Revised 1949
Edition N/A
Copyright 1951
Levelled N/A

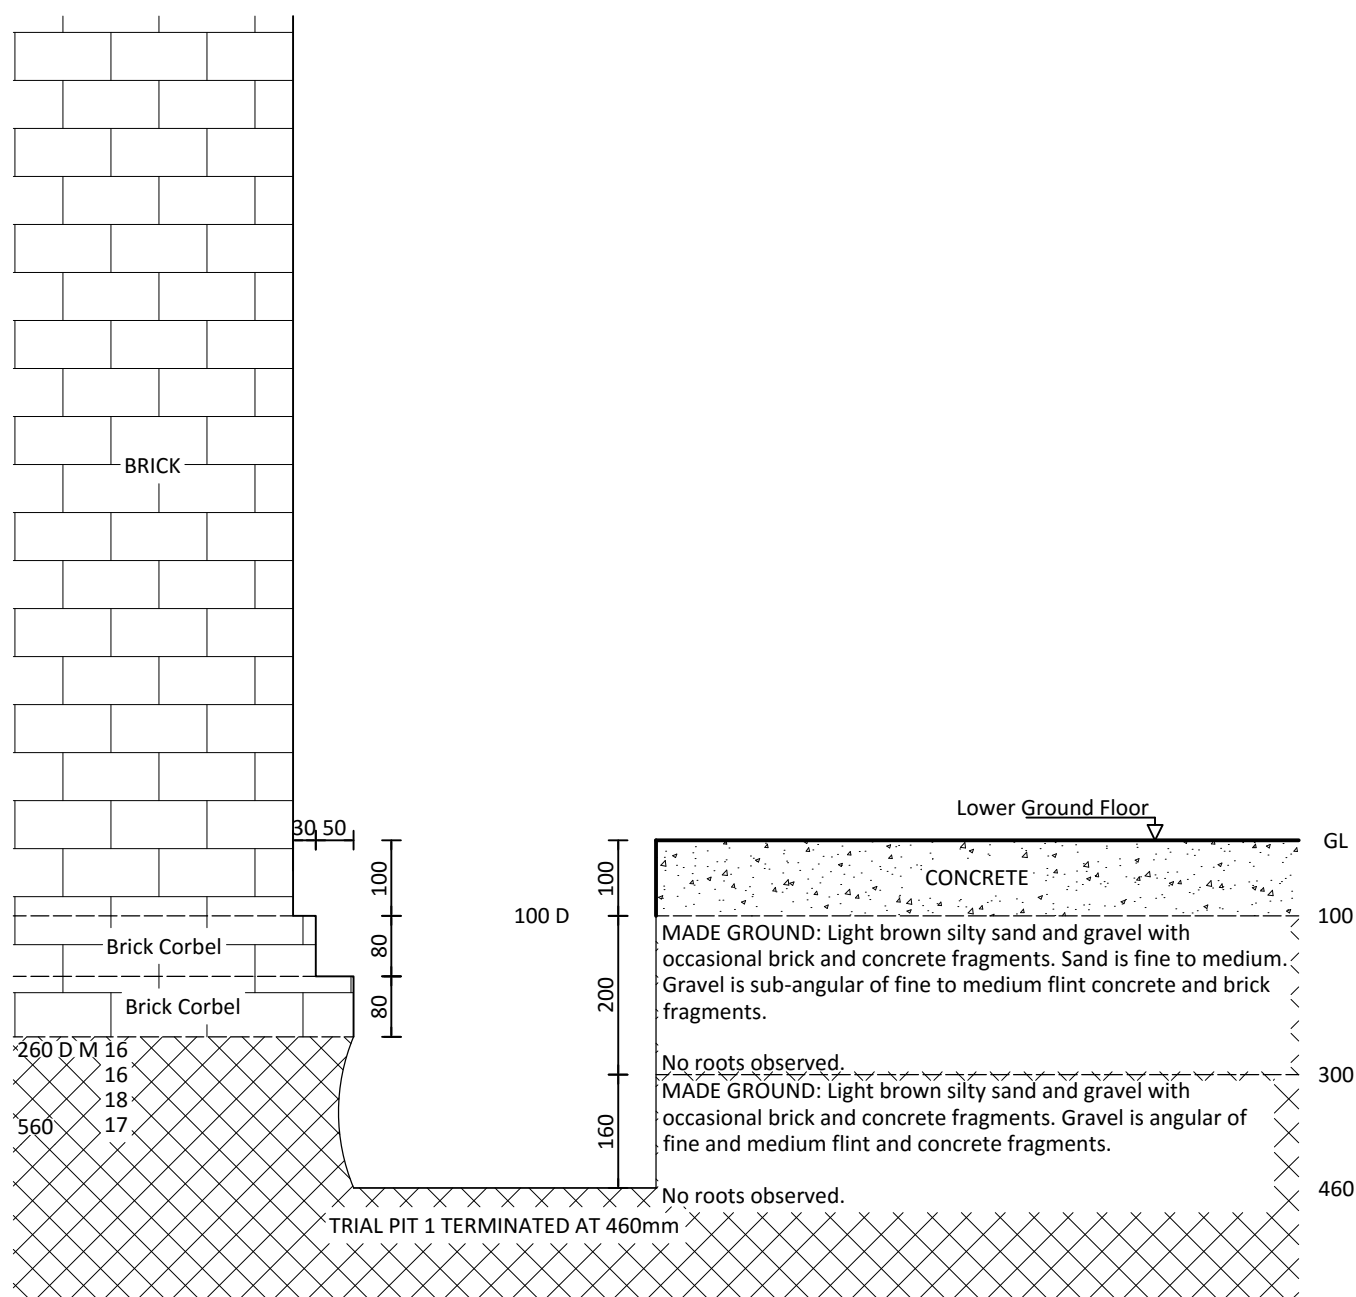
Client: Rupert West	Scale: N.T.S	Sheet No: 1 of 1	Date: 11.10.16
Site: 34 King Henry's Road, Camden NW3 3RP	Job No: 7806	Trial Pit No: 1	Weather: Dry
Excavation Method: N/A		Drawn by: T.P.	Checked by: J.H.

Remarks: All dimensions in millimetres.

Key: GL Ground Level
D Small Disturbed Sample
M Mackintosh Probe

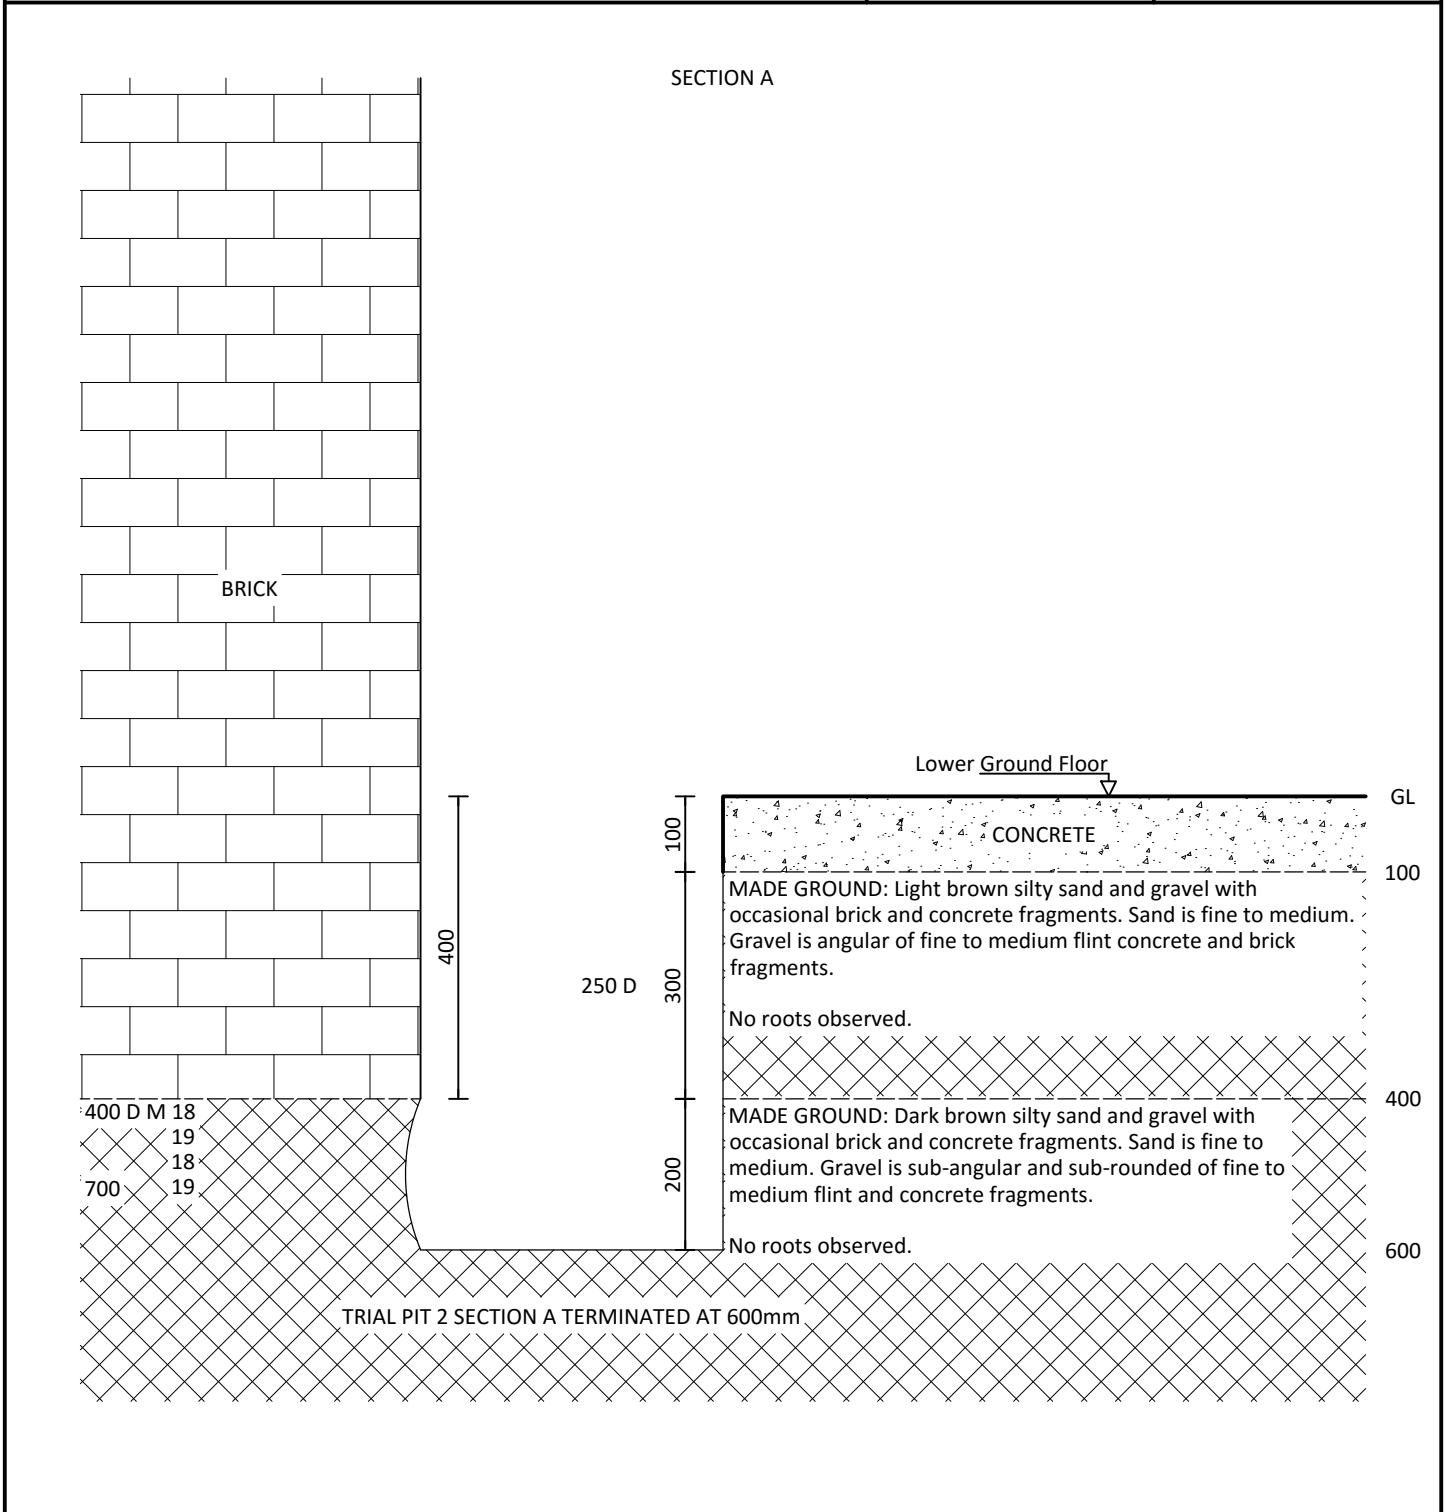
Client: Rupert West	Scale: N.T.S	Sheet No: 1 of 1	Date: 11.10.16
Site: 34 King Henry's Road, Camden NW3 3RP	Job No: 7806	Trial Pit No: 2	Weather: Dry
Excavation Method: N/A		Drawn by: T.P.	Checked by: J.H.

Remarks: All dimensions in millimetres.	Key: GL Ground Level D Small Disturbed Sample M Mackintosh Probe
--	--

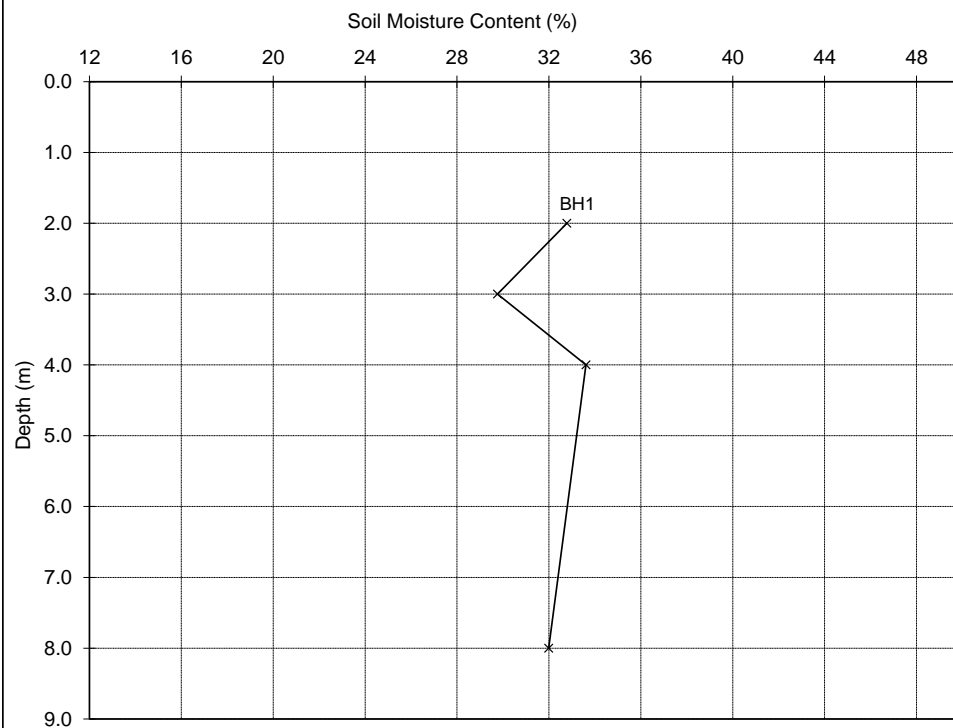
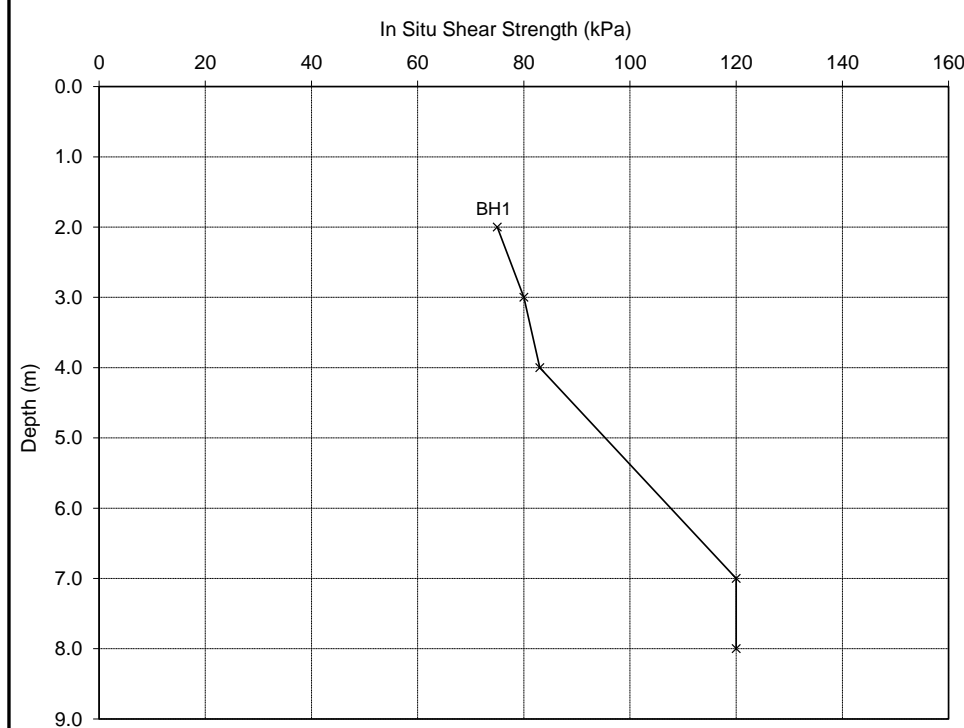
Moisture Content/Shear Strength Profile

1. If the Soil Fraction > 0.425mm exceeds 5% the Equivalent Moisture Content of the remainder (calculated in accordance with BS 1377: Part 2 : 1990, cl.3.2.4 note 1) is also plotted and the alternative profile additionally shown as an appropriately coloured broken line.
2. If plotted, 0.4 LL and PL+2 (after Driscoll, 1983) should only be applied to London Clay (and similarly over consolidated clays) at shallow depths.

Unless otherwise stated, values of Shear Strength were determined in situ by Chelmer Site Investigations using a Pilcon Hand Vane the calibration of which is limited to a maximum reading of 140 kPa. (Not UKAS accredited)

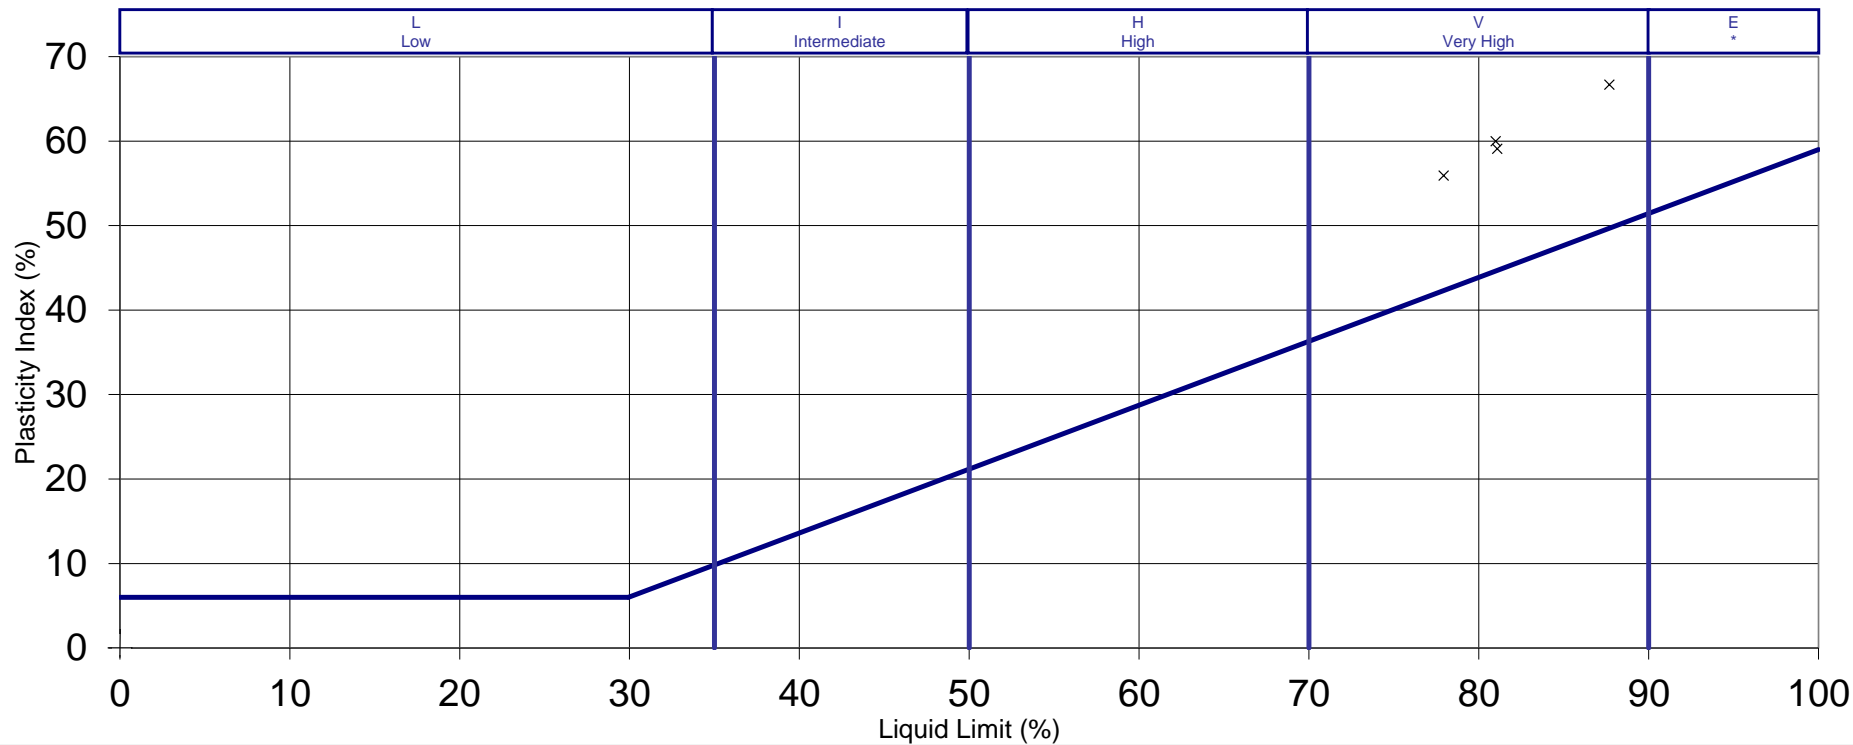
Plasticity Chart for the classification of fine soils and the finer part of coarse soils
In Compliance with BS5930 : 1999

SILT (M-SOIL), M, plots below A-Line
CLAY, C, plots above A-Line ; M and C may be combined as FINE SOIL, F.

Key :- BH1

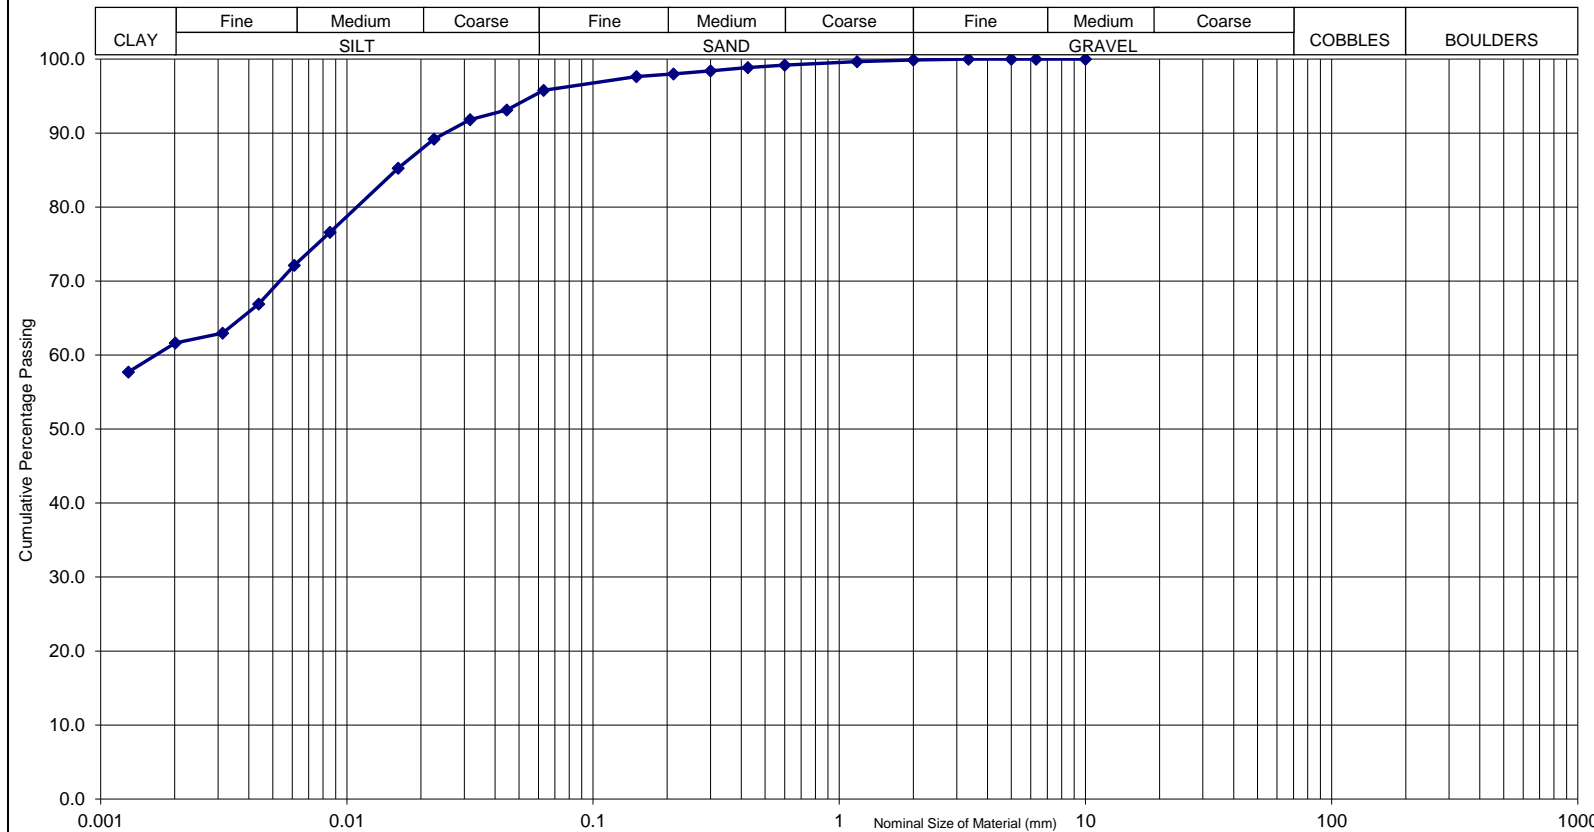
Job Number : CGL7806
 Sample Number : BH1
 Depth (m) : 3.50
 Sample UID : 80792

Site Name : 34 Kings Henrys Road, Camden, NW3 3RF
 Soil Description : Brown Silty CLAY

Sieve Size (mm)	% Passing
90.0	100.0
75.0	100.0
63.0	100.0
50.0	100.0
37.5	100.0
28.0	100.0
20.0	100.0
14.0	100.0
10.0	100.0
6.3	100.0
5.0	100.0
3.35	100.0
2.00	99.9
1.18	99.7
0.600	99.2
0.425	98.9
0.300	98.4
0.212	98.0
0.150	97.6
0.063	95.8
0.045	93.1
0.032	91.8
0.023	89.2
0.016	85.3
0.009	76.6
0.006	72.1
0.004	66.9
0.003	63.0
0.002	61.6
0.001	57.7

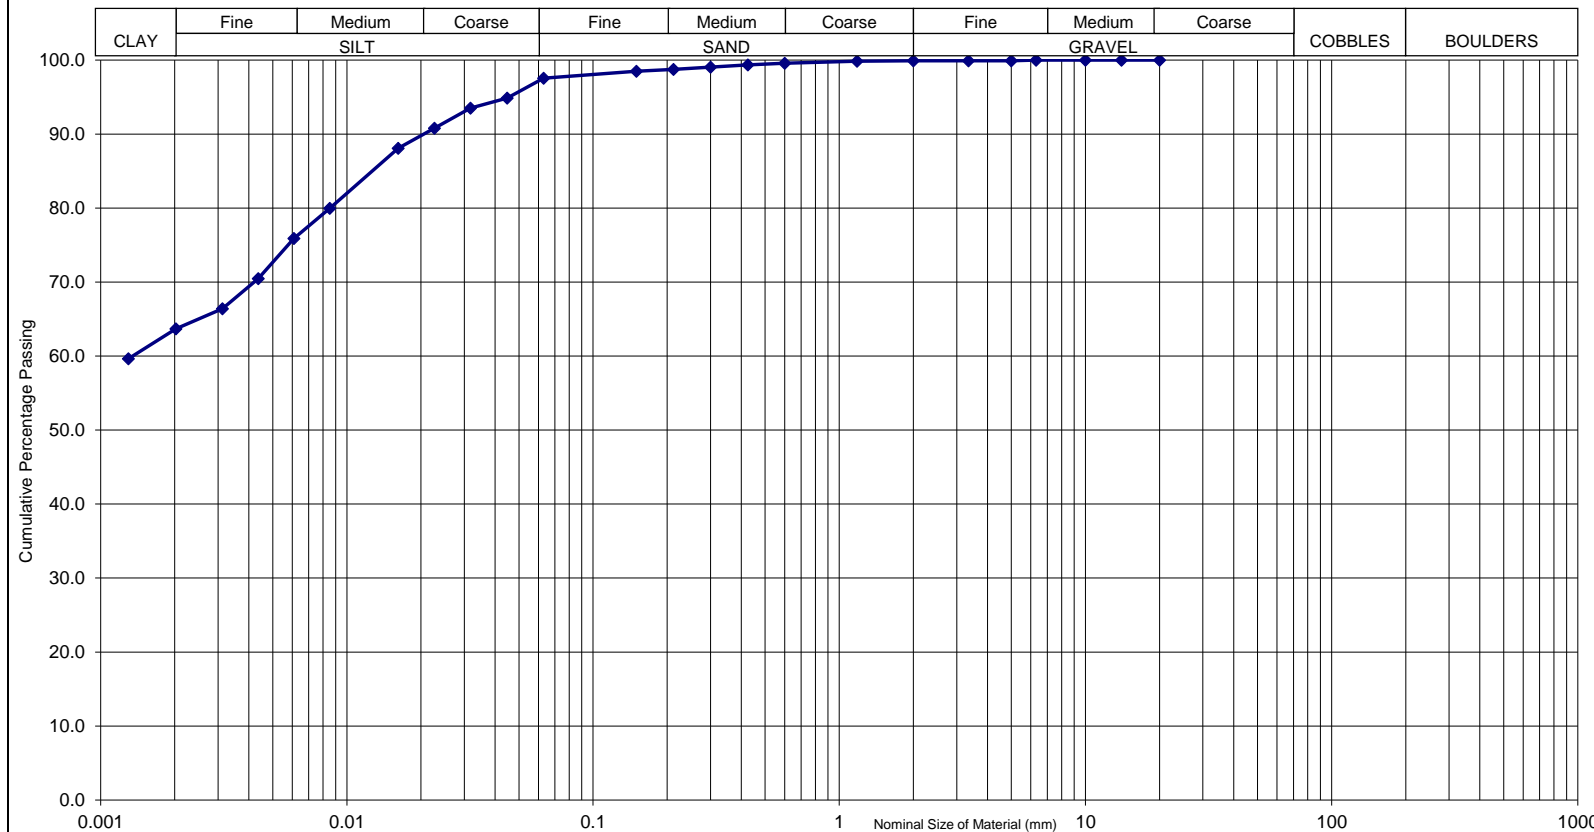
Job Number : CGL7806
 Sample Number : BH1
 Depth (m) : 4.50
 Sample UID : 80794

Site Name : 34 Kings Henrys Road, Camden, NW3 3RF
 Soil Description : Brown Silty CLAY

Sieve Size (mm)	% Passing
90.0	100.0
75.0	100.0
63.0	100.0
50.0	100.0
37.5	100.0
28.0	100.0
20.0	100.0
14.0	100.0
10.0	100.0
6.3	100.0
5.0	99.9
3.35	99.9
2.00	99.9
1.18	99.9
0.600	99.6
0.425	99.4
0.300	99.0
0.212	98.7
0.150	98.5
0.063	97.6
0.045	94.9
0.032	93.5
0.023	90.8
0.016	88.1
0.009	80.0
0.006	75.9
0.004	70.5
0.003	66.4
0.002	63.7
0.001	59.6
