6 JOHN STREET

Listed Building Application Design & Access Statement 14th June 2017

- 2.1 Marek Wojciechowski Architects have been instructed to prepare a Listed building Consent application for the property at 6 John Street, WCIN 2ES. The site consists of a 5-storey property, arranged over lower ground to third floor levels, and is Grade II listed. The 2014/6795/P (amended 2015/3149/P) consent, converting the property from B1 office to C3 residential has been substantially implemented onsite. Works ceased on 15th July 2016 and the site has remained vacant until may 2017, when works recommenced under new ownership.

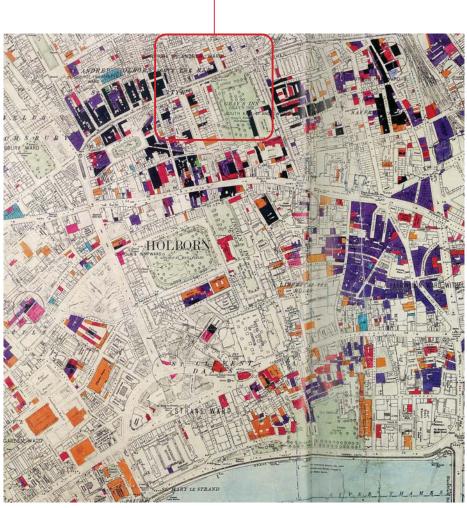
Bomb Damage Map Bloomsbury Area

4.1 The bomb damage map as documented by the architect's department of London County Council between 1939-1945 illustrates that the application site suffered extensive damage during WWII. This diagram suggests that the property suffered extensive structural damage and explains why it was not present on the 1960's OS Map.

- 3.3 The ordnance survey maps shows that the footprint of the property and surrounding buildings have remained largely unchanged until the 1960s when the site was vacant due bomb damage (See overleaf). The property was later rebuilt in keeping with the rest of the row.
- **3.4** A full historic building assessment, 'Statement of Significance' has been undertaken by The Architectural History Practice (AHP) and has been appended to this application. -
