# STUDIO ASTRAGAL

## STATEMENT OF HERITAGE SIGNIFICANCE 1-22 REGENT'S PARK TERRACE, LONDON NW1

Regent's Park Terrace Residents Association November 2016

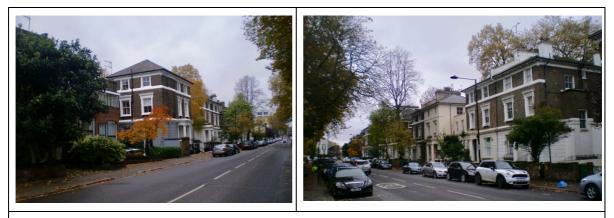
The paired stucco-trimmed villas on the west side of Oval Road opposite Regent's Park Terrace

2.2 Regent's Park Terrace is situated on the east side of Oval Road, which runs approximately north – south. Behind it is Gloucester Crescent. Oval Road is lined on its west side by a short row of modern red brick townhouses at its south end and beyond this paired villas of yellow stock brick with stuccoed mouldings. This part of Primrose Hill was developed after part of the estate of Lord Southampton was sold off in the 1840s. According to Pevsner the construction of the railway line into Euston Station prevented the realisation of the original grand layout of two crescents (6). Pevsner describes Gloucester Crescent as the most ambitious part of the development, constructed as terraces in the form of linked villas in an Italianate style between 1845-50 and having "*rather disorganised elevations*" (6) In my opinion the eclectic mixture of styles is rather pleasing.

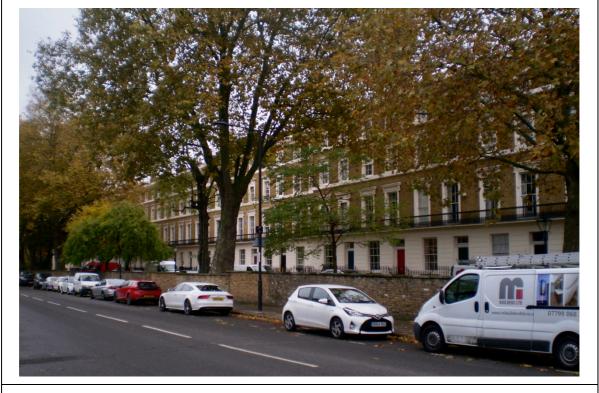
The long even stretch of Regent's Park Terrace seen from Oval Road

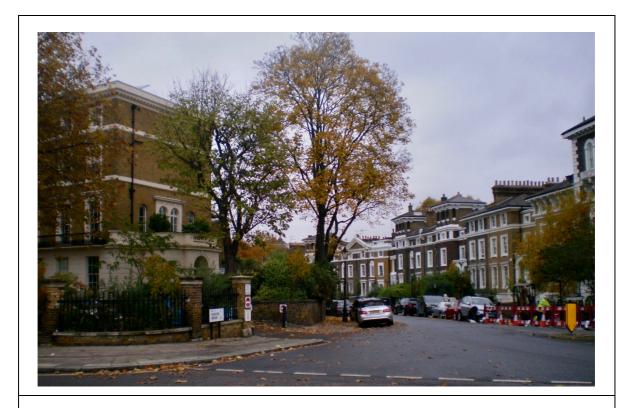
The south end of Regent's Park Terrace and Gloucester Terrace with its Italianate terraces in the form of linked villas.

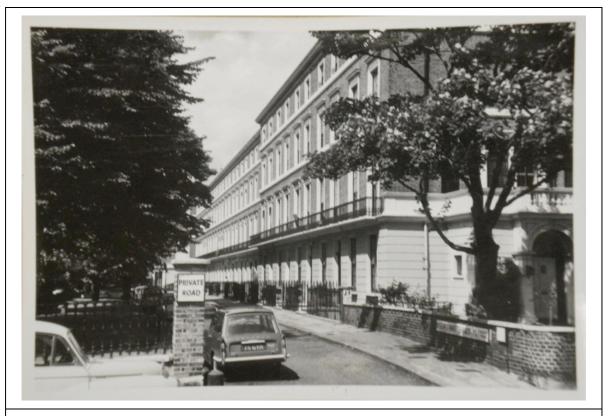
The south entrance circa 1964

- 4.6 Photographs taken circa 1964 & 1968 in LB Camden's archive also show the south entrance as it is today (14).
