DESK STUDY & GROUND INVESTIGATION REPORT

The Coach House
50A Belsize Square
London NW3

J17062

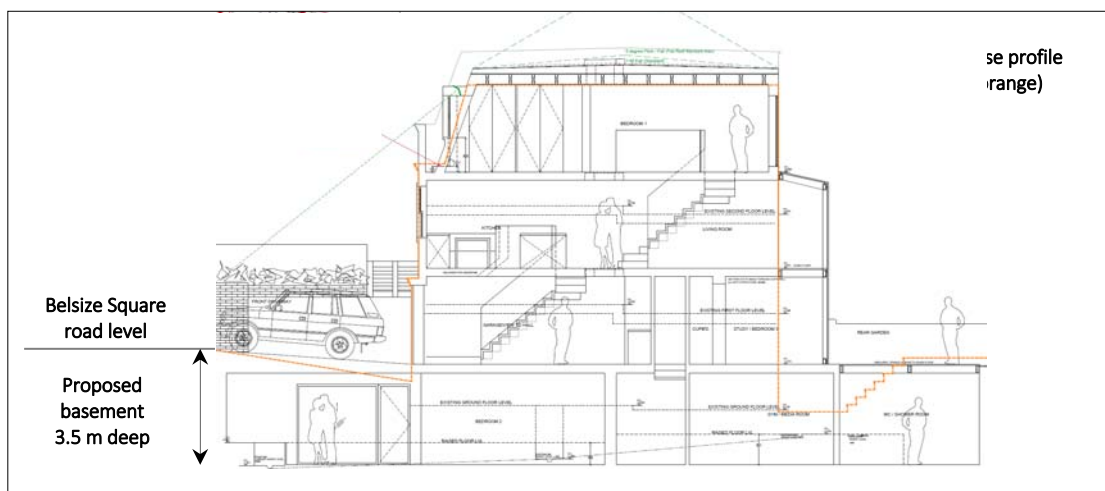
It is understood that it is proposed to demolish the existing house and construct a new house which will be slightly higher than the existing building and will include a new single level basement. The new basement will be 3.5 m deep from existing pavement level and it will extend beneath the entire building footprint, beneath the front driveway and into the rear garden by roughly 5 m. It is proposed that the new house will be supported by means of a new raft foundation. A section through the proposed development is shown below.

It is understood that it is proposed to demolish the existing house and subsequently construct a new house that will be slightly higher than the existing building height and will include a new single level basement. The new basement will be 3.5 m deep from existing pavement level and it will extend beneath the entire building footprint, beneath the front driveway and into the rear garden by roughly 5 m. It is understood that the new house will be supported by means of a raft foundation.

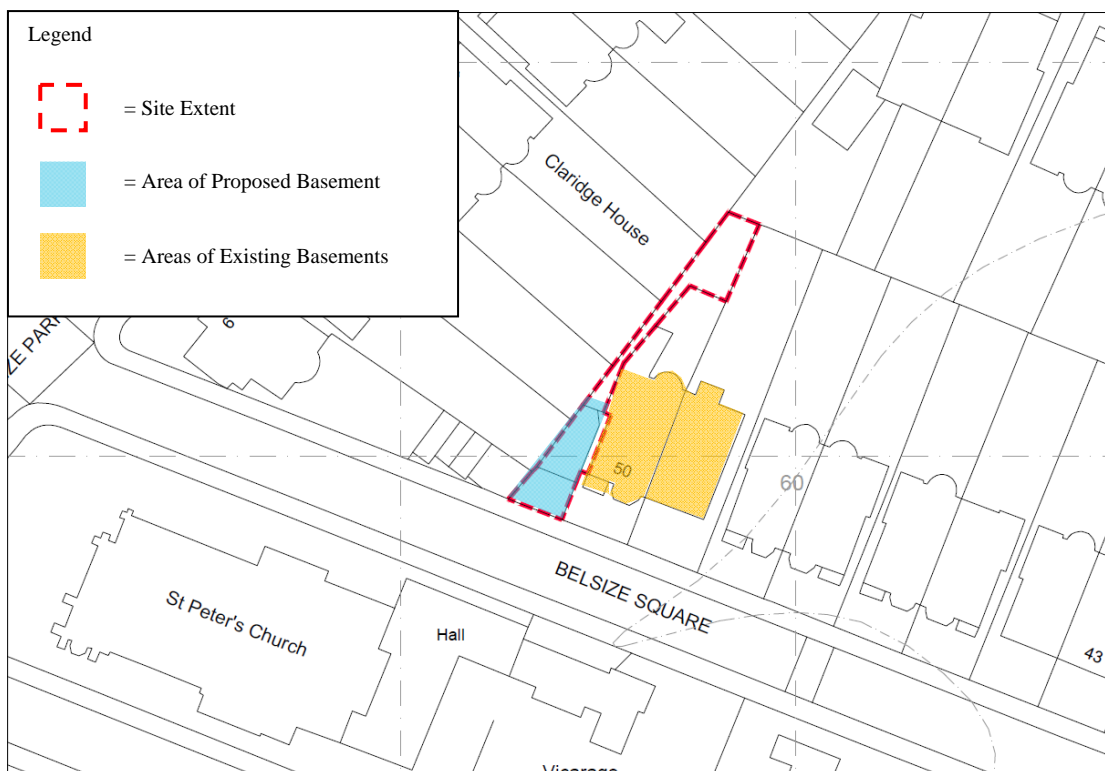
A plan showing the nearby sensitive structures is shown below.

Sensitive structures relevant to this assessment include Nos 49 and 50 Belsize Square, the garages to the southwest of the site and the vicarage and church hall on the opposite side of Belsize Square. Garden and boundary walls have not been included in this assessment. A search of the Camden Planning Portal indicates that there is a basement beneath the entire footprint of the main house of No 50 Belsize Square, which is consistent with the known site levels and trial pit findings.

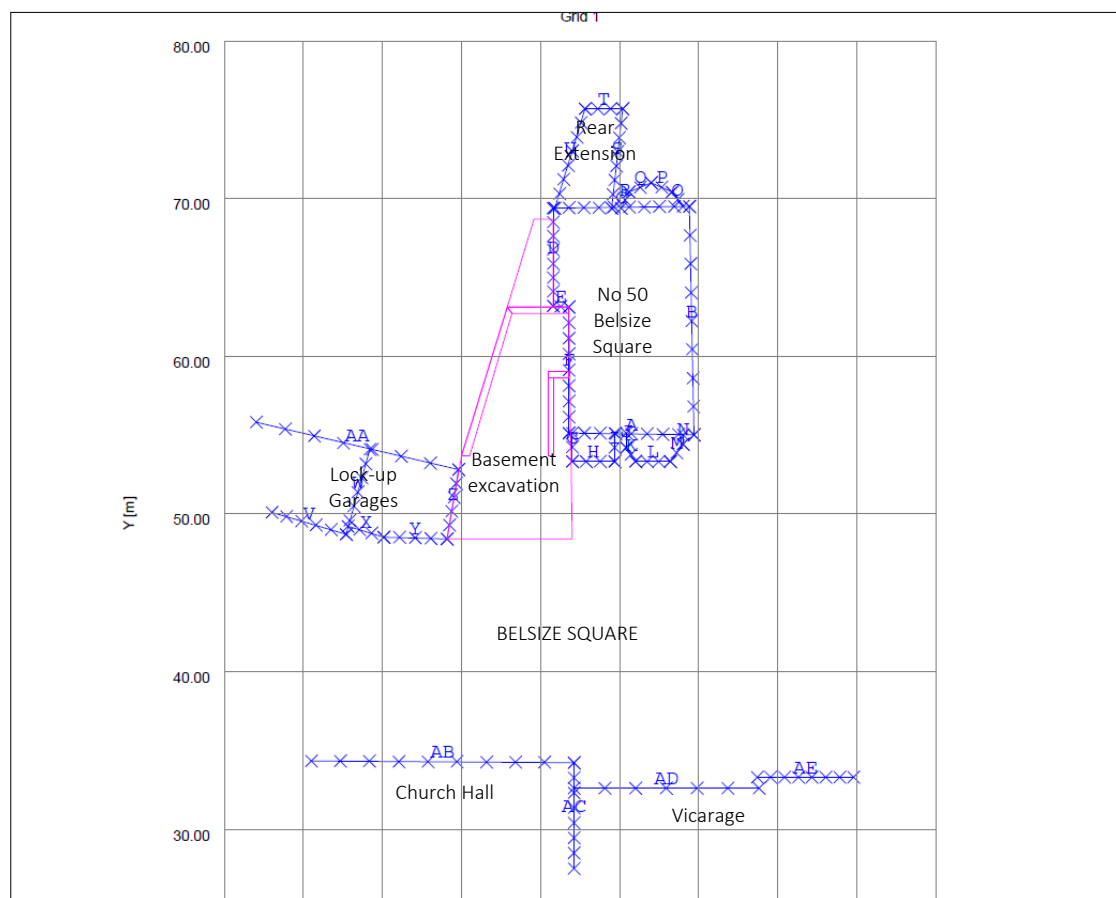
The diagram below details the sensitive structures in relation to the proposed excavation.

Sensitive Structure	Structure Reference	Depth below existing ground level of foundations (m)	Height of building above ground level (m)
No 50 Belsize Square (main house)	A to C	1.0	10.50
No 50 Belsize Square (main house underpinned party walls)	D to F	3.5	10.50
No 50 Belsize Square (bay window, underpinned party wall)	G	3.5	4.86
No 50 Belsize Square (bay windows)	H to R	1.0	4.86
No 50 Belsize Square (rear extension)	S to U	1.0	3.00
Not Used	V, X and Y	-	-
Lock-up garages	W, Z, AA	1.0	2.67
Church Hall	AB and AC	1.0	4.00
Vicarage	AD and AE	1.0	4.00

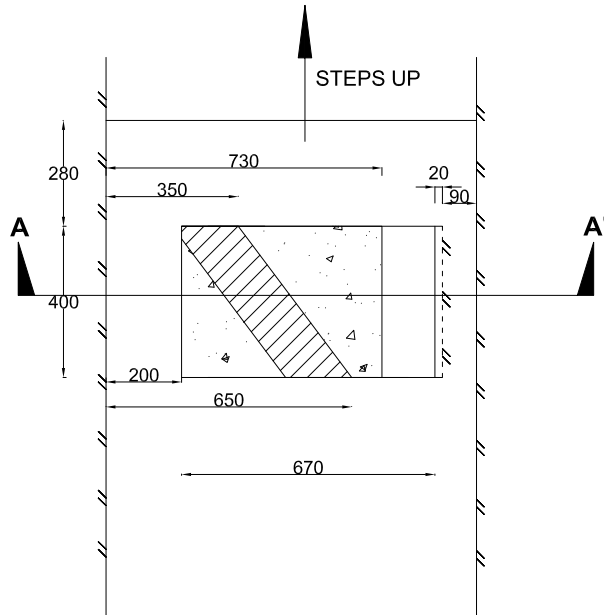
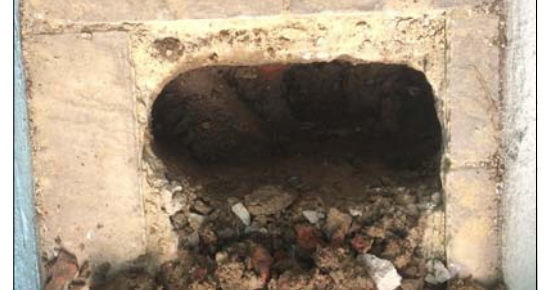
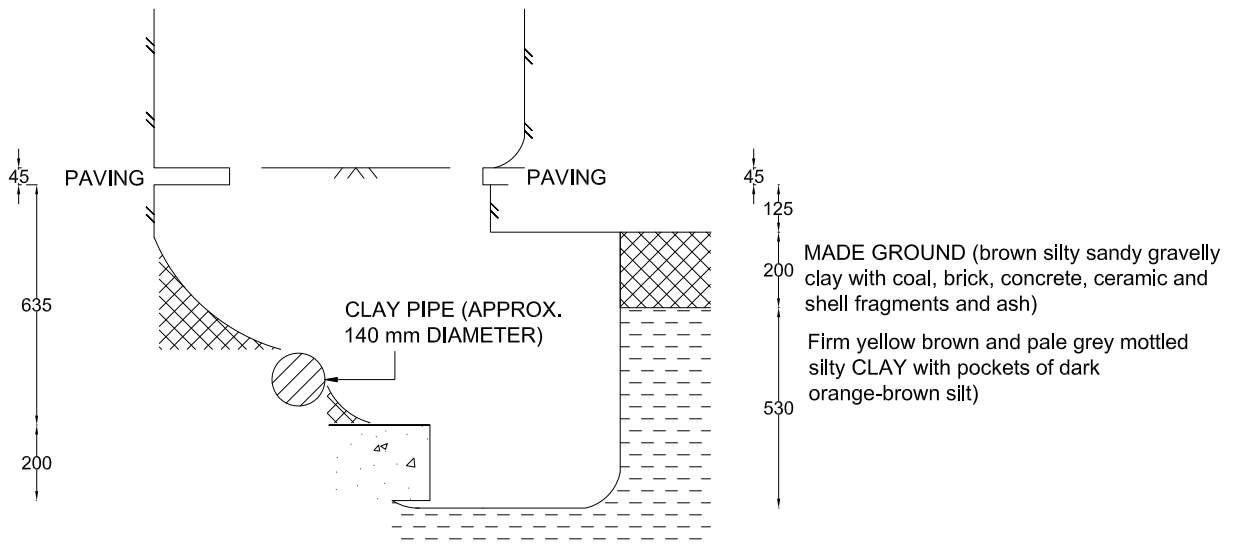
Section A - A'

A single trial pit was excavated in the passageway between the Coach House and No 50 Belsize Square, to expose the existing foundation of each building. The full trial pit record is appended to this report.

Trial Pit No	Foundation detail	Bearing stratum
1 (adjacent to the Coach House)	Concrete footing Depth to top of footing 680 mm Depth to underside of footing from GL 880 mm Lateral projection 730 mm from building elevation	Firm yellow brown and pale grey mottled silty CLAY with pockets of dark orange-brown silt
1 (adjacent to No 50 Belsize Square)	Shallow brick footing immediately beneath wall Depth to underside of brick footing from GL 170 mm Lateral projection 90 mm from building elevation
